# Mill Plaza Redevelopment and Relationship to College Brook

*An assessment of existing system health and observations on possible future improvements*

21 June 2018

STREAMWORKS, PLLC

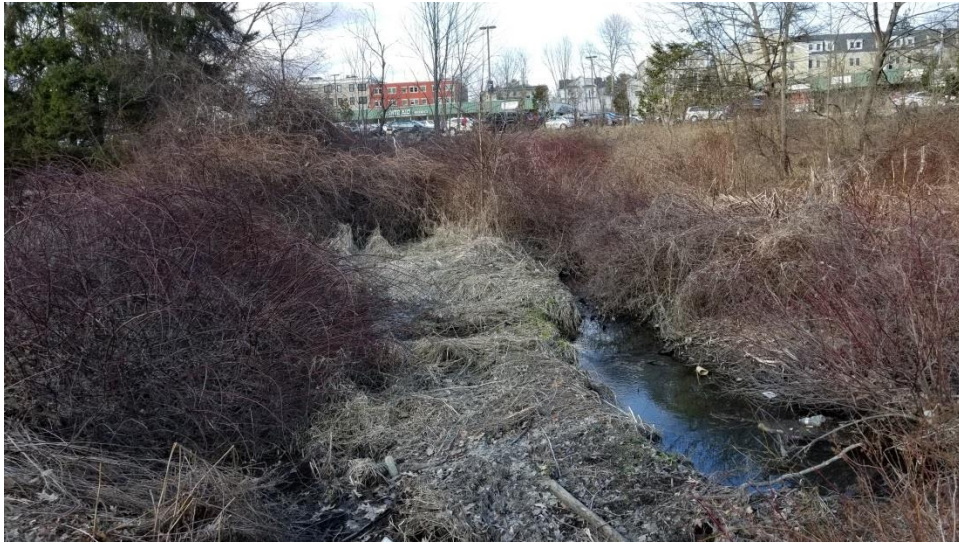
At the upstream end of College Brook at Mill Plaza, after being buried for 600 feet at UNH under the Campus Crossing lot, the stream daylights at the site and flows for approximately 1,150 feet (1,000 feet along the valley) as it passes by the Mill Plaza site. The first few hundred feet of Brook here are highly confined. After the first few hundred feet the brook corridor exhibits a large floodplain, although due to incision access of the floodwaters to that floodplain may be limited. The average riparian corridor width is 70 feet. The fill necessary to create the existing parking lot development at the Mill Plaza site created a steep bank that drops off to the riparian corridor below, which in several places has: riprap bank armoring, direct impervious surface runoff, and stormwater outfalls (the latter two to be discussed in the following section). To the south of the brook lies residential land use (multi-unit housing, mostly) where the vegetation is cleared and maintained for the first half of the corridor length (Picture A), then turning to over 100 feet of wooded buffer for the remaining downstream half (Pictures B and C).

**Picture A - Example of maintenance up to the stream**

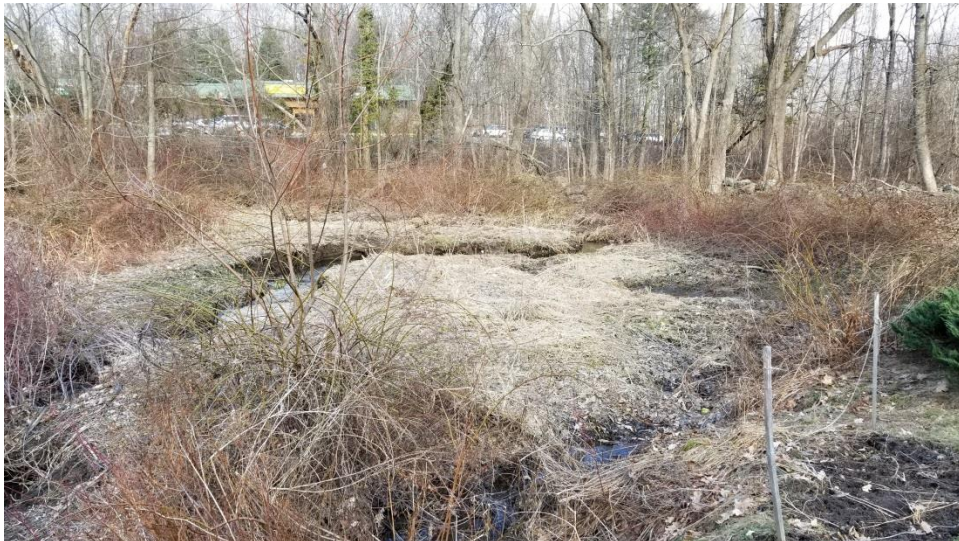
**Picture B - Good example of riparian vegetation and buffer (in the distance)**

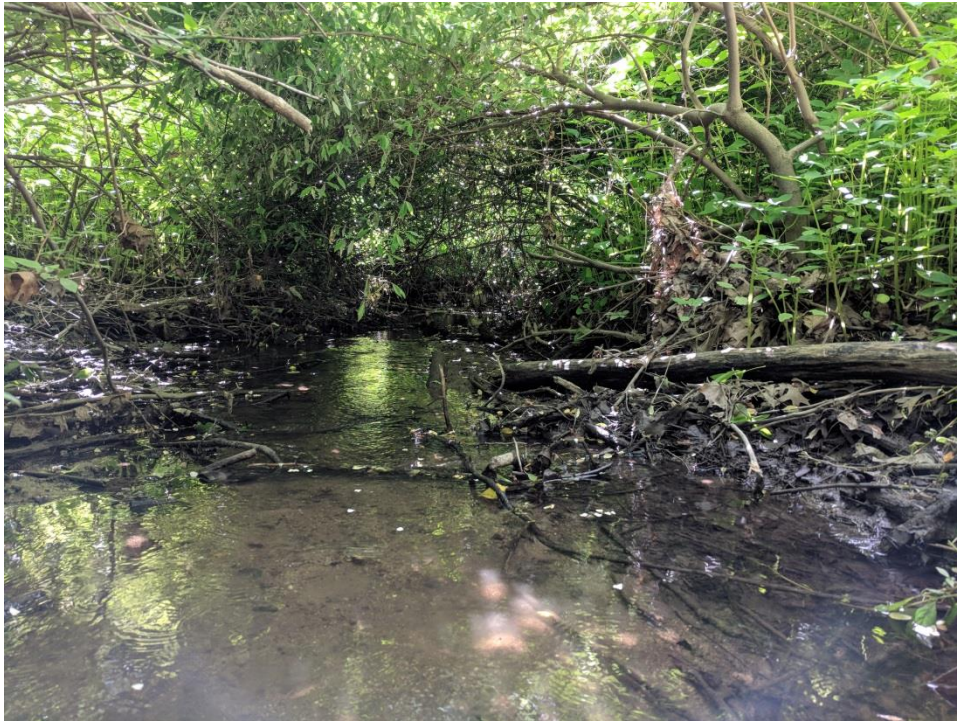
**Picture C - Taken from the stream June 20, 2018 depicting the heavy vegetation growth seen in most of the stream and above the banks**

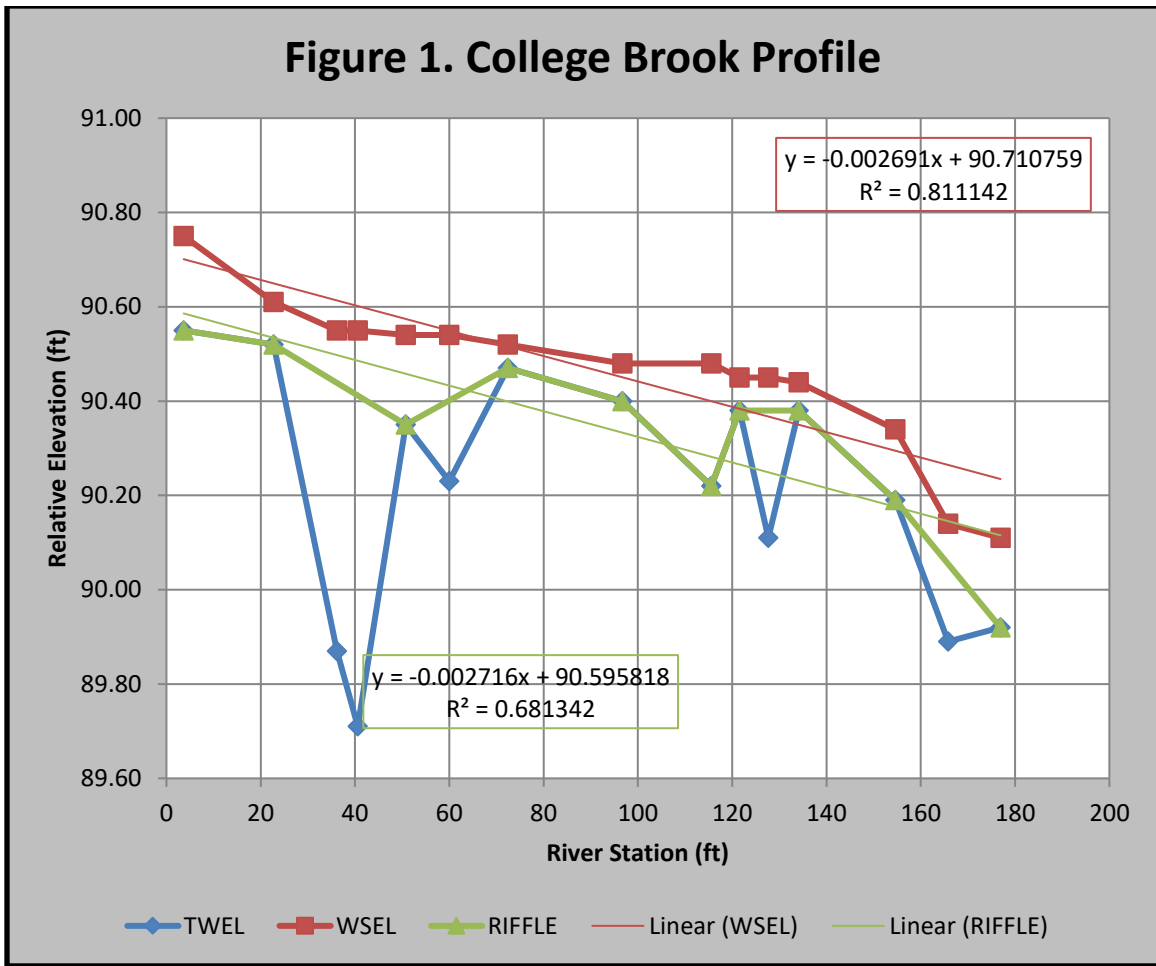
The stream was surveyed and was classified as a Rosgen F4 type. The collected cross sections did not exactly fit one select Rosgen Classification type very well, but overall – and based on professional judgement – the stream most well conformed to an F4 type stream. Properties of an F4 stream include: a low entrenchment ratio, moderate width to depth ratio, moderate sinuosity, and low streambed slopes. An F-Type stream is typically considered an impaired stream and very often associated with the urban stream syndrome. Shown in Table 1 are the results from the cross section surveys at the site. Note that the entrenchment ratio is quite high when averaged overall – especially compared to what is typically classified as an F-type stream. This is due to the relatively large floodplain width where the sections were taken, and the apparent ease with which the stream accesses it. Also out of character (on average) is the sinuosity; though calculated as 1.15 overall for the stream adjacent to the Mill Plaza property, that sinuosity value is due mostly to one very large, atypical meander bend in the stream. Looking at just upstream and downstream of that bend, and calculating the sinuosity, a value of 1.06 is likely more representative of the actual sinuosity for this entire stream reach. This is well below the typical 1.2 or greater sinuosity for F-type streams. But the slope and the width to depth ratio conform nicely to the F-type stream classification metrics. The slope was calculated to be quite slight, at around 0.37%, but this could be due in part to the amount of in-stream blockages (fallen trees, foot bridges) that may result in large steps at these locations, though none were observed to be acting as such. It may be that the stream is just very flat through here. Calculating the slope from the most recent flood insurance study base flood elevations (FIS BFEs), the slope was found to be about 0.29%, which conforms well to what was surveyed. A plot of the profile (thalweg and water surface elevation shots) for the surveyed part of the stream may be found in Figure 1. Also of note, and referring to Figure 2, the

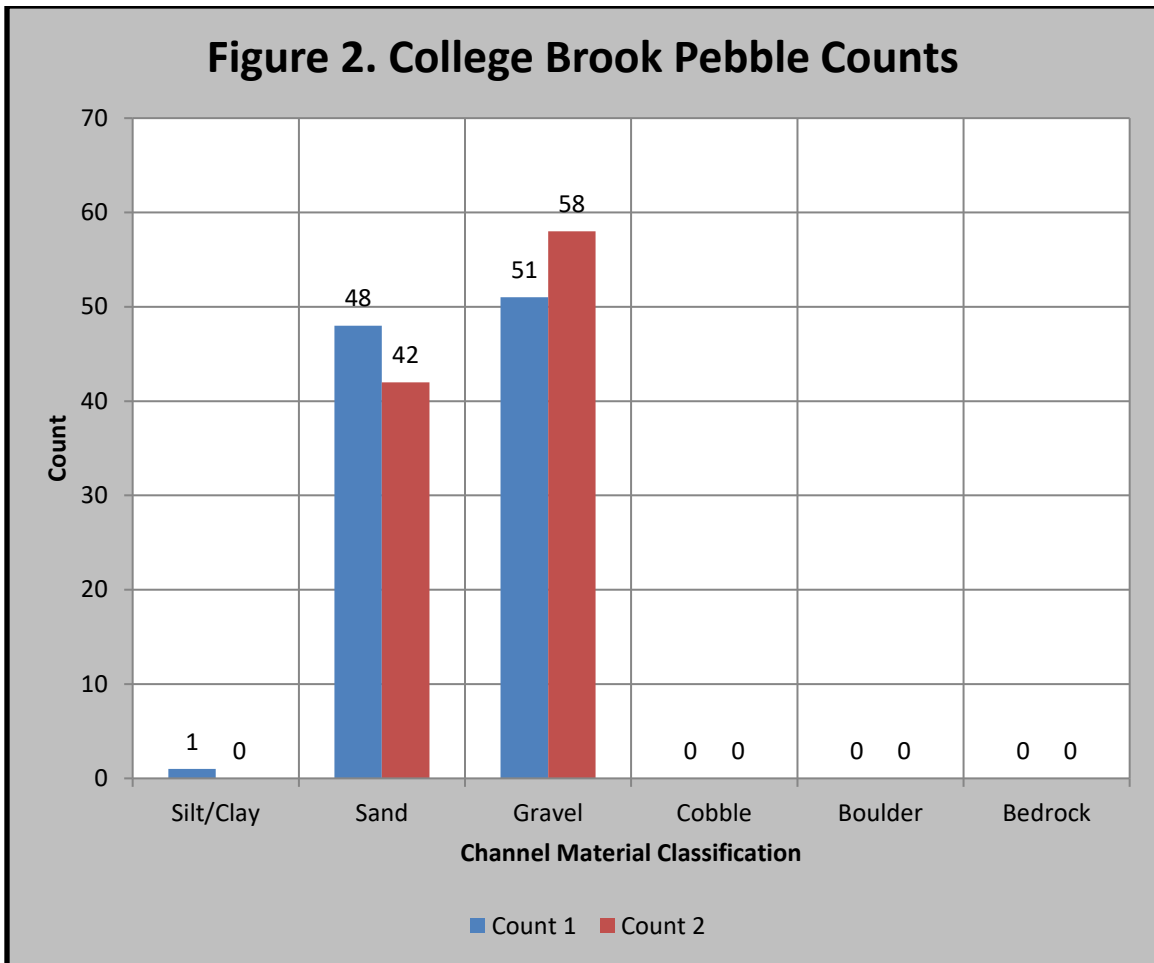
stream technically was classified based on the two pebble counts performed at the site as a gravel-bed stream, or channel material type 4. Though this is the actual rating based off the pebble counts, it is worthy to note that the amount of sand and gravel were very similar, so the stream could also likely be classified as an F5-type stream (a sand-bed stream).

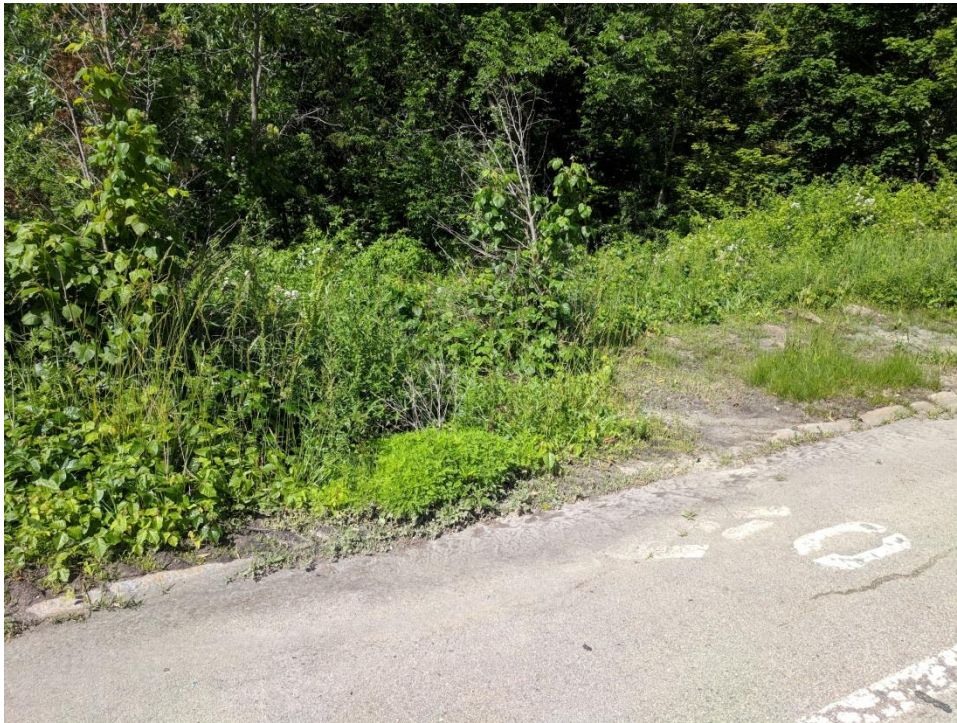
and there are locations where runoff from the parking lot travels directly down the steep bank and into the stream (Pictures D and F). This location is also to where snow is plowed during the winter, and melts into the stream during the spring (Picture E). Thus, 100% of the current impervious area at the site is transported directly into the stream with no treatment. It should also be mentioned that although it was not investigated, that stormwater runoff from the south side of College Brook, across from Mill Plaza, is also unmanaged and also results in consequences to College Brook.

**Picture D - Direct impervious cover runoff over steep bank and into riparian corridor**

Treating the 6+ acres of current impervious area, plus all the other runoff from the site would provide enormous water quality benefits. The seven current outfalls all carry water directly from the site into the stream. These should be removed from service, or be tied in to proposed stormwater treatment systems to the new development. Sprinkling treatment systems throughout the site may help in the winter time, as snow may be piled in the systems, which can treat the water as it melts.

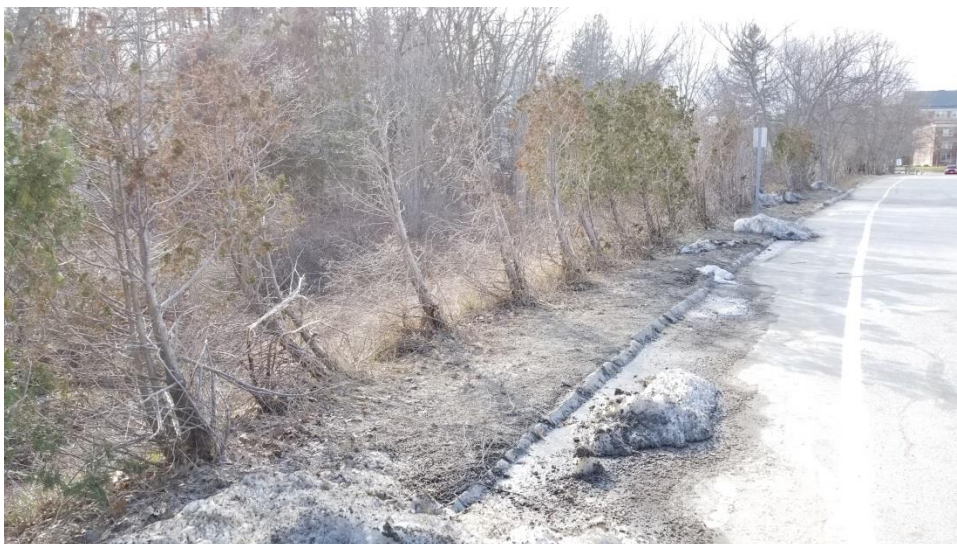
**Picture E - Current snow management, pushing snow over the bank down into the riparian corridor. Notice the trees are bent and dying, from this practice.**

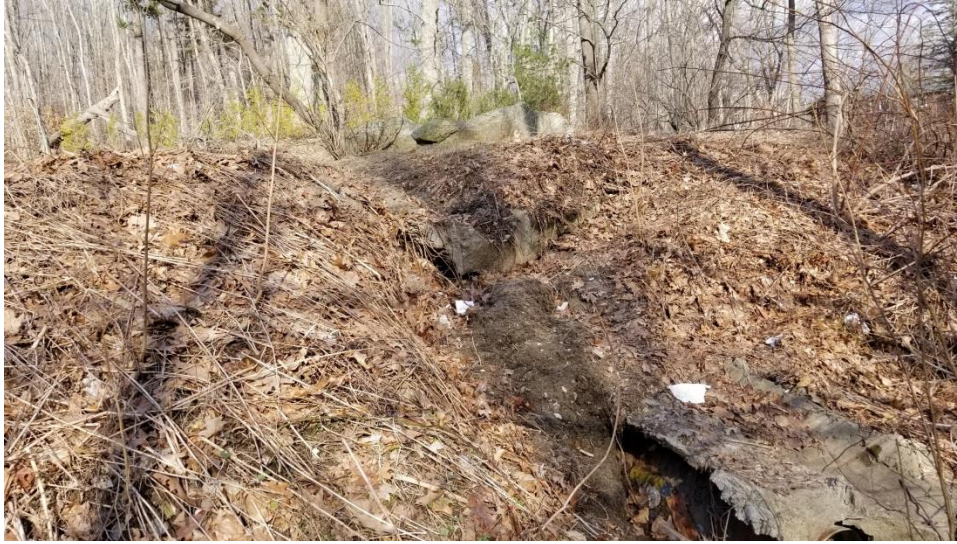
Picture F - Steep bank instability resulting from direct impervious cover runoff over bank

management. Greener bank stabilization techniques and floodplain management should be included to reduce the impact of any such outfalls.

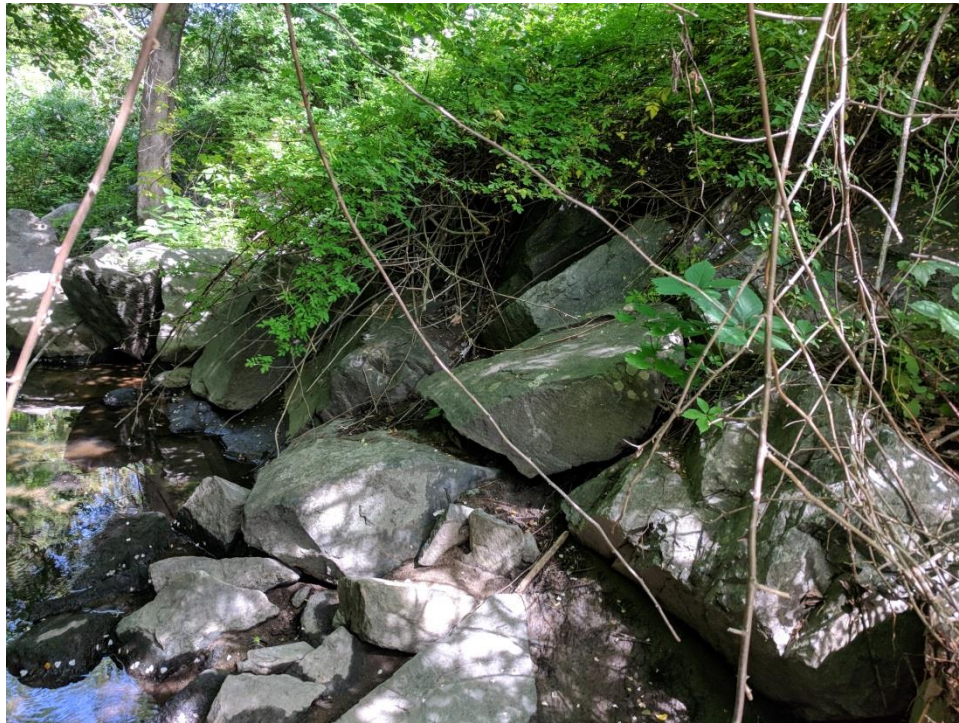
**Picture G - Rip rap armoring on steep bank that was either placed in the stream, or has failed and fallen into the stream. Note the relative lack of vegetation here compared to other pictures of the stream and banks.**

the stream is in a mode of widening itself, which means bank erosion. But until the rate of bank erosion is determined, restoration is not recommended at this time. Removing all rip rap from the slopes and planting/seeding would prove most helpful to habitat value along the steep slope that exists on the property now (Picture G). Some locations of rip rap could be replaced with log vanes and plantings: a greener approach to the bank stabilization than rip rap. Planting at the top of the slope with shrubs and trees to provide a boundary between the parking lot and the stream would help to reduce trash entering the stream, and would provide shade and slope stability.

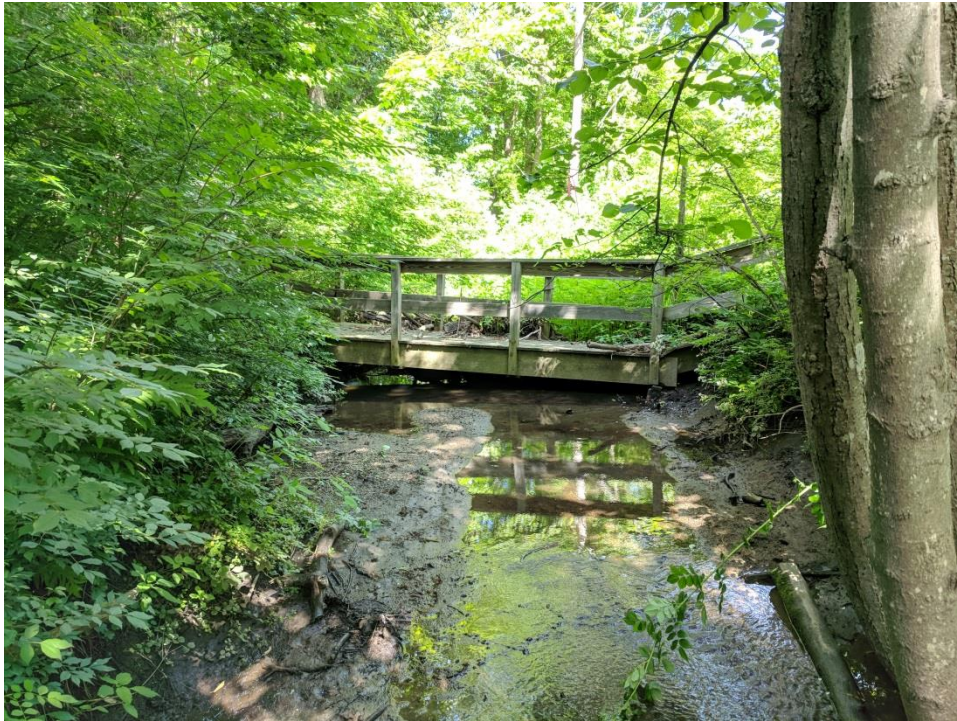
**Picture H - Existing foot bridge that is no longer in use (it is blocked off at both ends). Note that this structure was built almost in the stream, and the effects of it on the channel at this location are noticeable.**

Additional measures that would help the stream system would be to: remove any unnatural in-stream blockages that cross the main channel (Picture H; fallen trees are okay, foot bridges are not); remove all trash and debris from the stream/floodplain (Picture I); and clear or remove all invasive species (Picture J). There are several locations where large trees have fallen and completely block the channel. In these locations, the stream is beginning to form slight avulsions in addition to eroding and over-widening the banks. These are natural occurrences, and as long as they do not affect infrastructure, may be left to evolve. There are also a handful of large debris items, such as metal culvert pipe, that has either been tossed into the stream or has failed and been carried into it (Picture I).

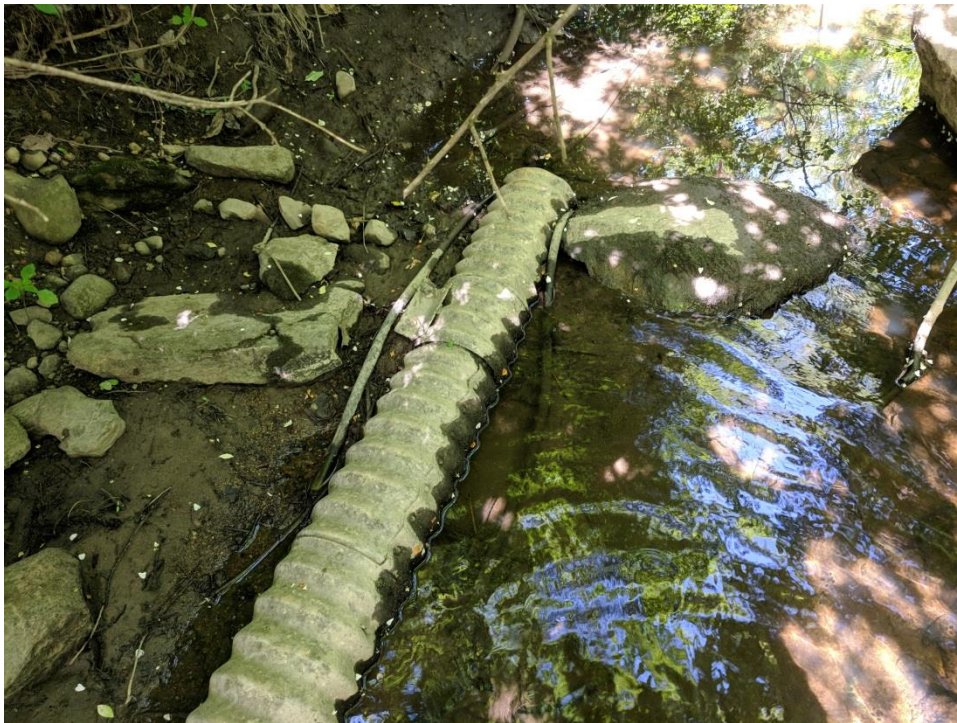
**Picture I - Example of some of the trash that is in the stream and could be cleaned up. This section of CMP culvert was either tossed here or failed and was carried here, now half-buried.**

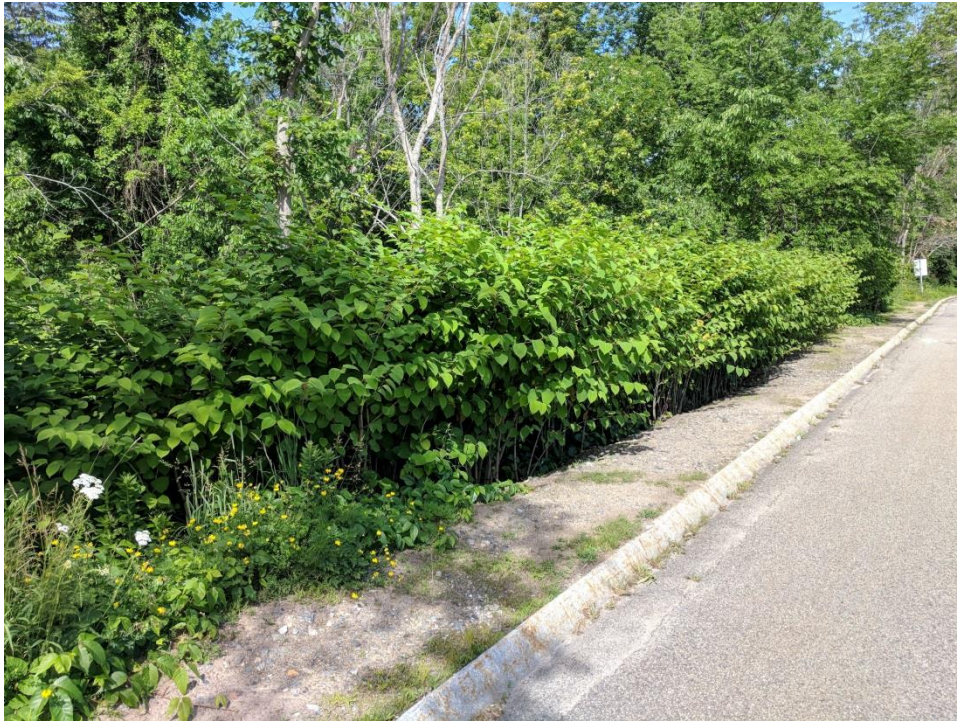
**Picture J - Japanese knotweed, an invasive species, has grown a large and overwhelming stand to the west side of the property, north of the stream.**

There is significant riparian vegetation in the floodplain, except at the locations that are maintained as lawns to the south of the stream. Removing invasive species and nuisance species (there are large stands of Japanese knotweed and some purple loosestrife, and likely to be other species, and removing them would set the stage for higher chances of success for native species), and then planting with native, riparian shrubs and trees would be an ecosystem improvement. In addition, designating a buffer zone (and allowing it to grow) would help stabilize the banks, and provide shade, habitat, and food value for the stream and riparian corridor ecosystem. The stream is mostly held in place by the dense vegetation growing alongside it; it is this reason that stream restoration construction does not seem to offer more benefit, except for adding sinuosity to the plan form. To perform such construction would be highly intrusive, and likely would result in more disturbance than is necessary. Being an F-type stream,
