Pike Family Revocable Trust of 2021 Conservation Easement

Durham, New Hampshire

Baseline Documentation Report

June 2023

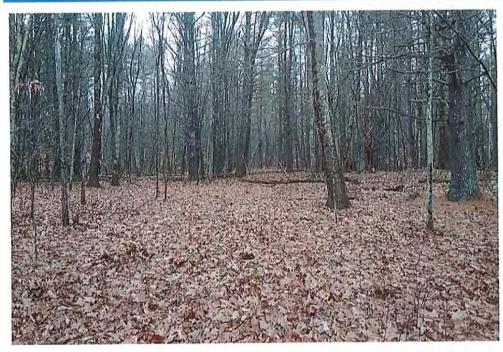
Map Ref.: 9 Date: 12/6/2022
File Name: Photo: 8
photo_Pike_2022-12-06_(8)
Photographer: Shaun Dillon

Standing near eastern boundary, looking southwest at approx. 10 -ft. wide dirt old woods road which appears very little used. Note very old rusted car part in center right side of frame which appears to be from a long time ago and is integrated into the forest floor.

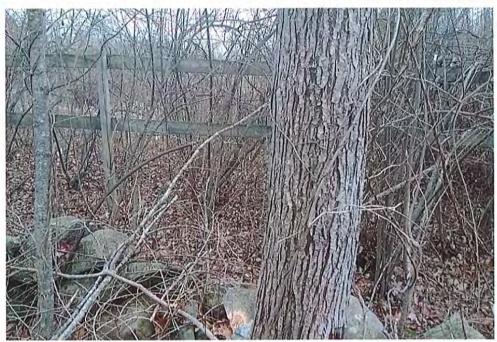
Map Ref.: 25 Date: 12/6/2022
File Name: Photo: 32
photo_Pike_2022-12-06_(32)
Photographer: Shaun Dillon
Location Method:
GPS/Survey interpretation

Standing at drill hole corner, looking southeast approx. along boundary with Property in right side of frame. Note orange painted drill hole in bottom center frame and overgrown approx. 6 -ft. high wooden fence crossing into Property in center frame.

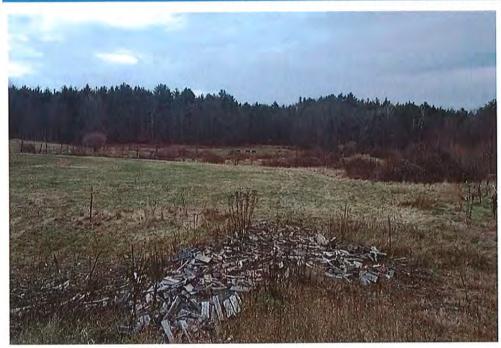
Map Ref.: 29 Date: 12/6/2022 File Name: Photo: 35 photo_Pike_2022-12-06_(35) Photographer: Shaun Dillon Location Method:

Standing within northern portion of Property, looking south at approx. 20x20 -ft. area of old rotting fire-wood pile. Note stake in left side of frame is boundary marker. Also note open field in foreground and pasture with some shrubs in center frame.

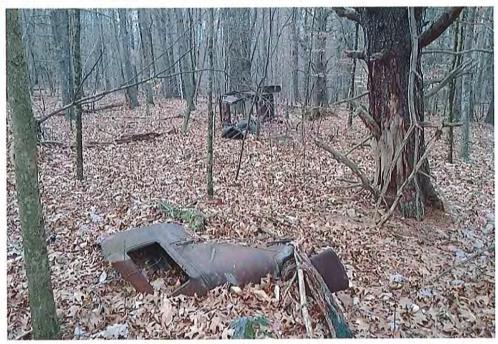
Map Ref.: 31 Date: 12/6/2022 File Name: Photo: 7

There are two old farm dump areas on the Property. Both of these appear to be from a long time ago as most of the debris is integrated into the forest floor and its removal may cause more disturbance and damage than letting it remain. There are no signs of recent dumping at either site.

- Within the central portion of the Property is an approximately eighty by thirty (80x30) foot area with scattered metal and small glass debris. The larger metal debris consist of very old car parts, metal frames, springs and other pieces of metal (see Map Ref. #31).
- Within the southern portion of the Property is an approximately seventy by twenty (70x20) foot area scattered debris of glass, rusted metal pieces and car parts, 3-4 tires and 2-3 tire tubes (see Map Ref. # 36).

Standing within central portion of Property, looking southwest at approx. 80x30 -ft. area with scattered metal and small glass debris that appears to be from a long time ago and is integrated into the forest floor. The larger metal debris consist of very old car parts, metal frames, springs and other pieces of metal.

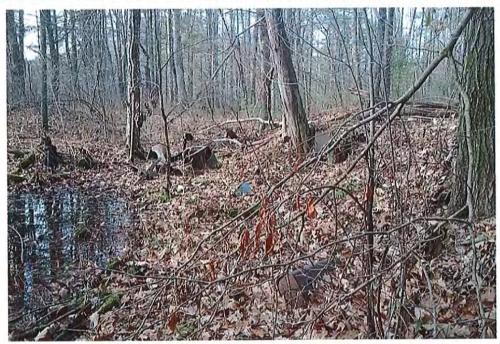
Map Ref.: 36 Date: 12/6/2022
File Name: Photo: 23
photo_Pike_2022-12-06_(23)
Photographer: Shaun Dillon
Location Method:

Standing within southern portion of Property, looking west at approx. 70x20 -ft. area along edge of wetland with scattered debris of glass, rusted metal pieces and car parts, 3-4 tires and 2-3 tire tubes. This is an old area of debris and is integrated into the forest floor. Note wetland in left side of frame with good forest buffer.

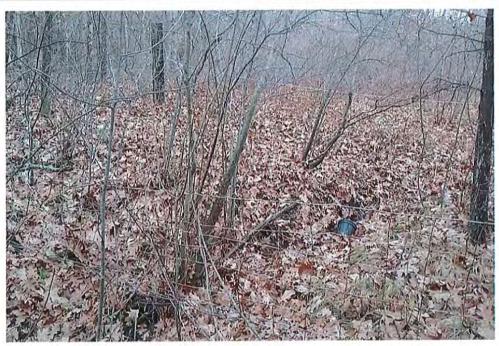
Map Ref.: 43 Date: 12/6/2022

• There are approximately three hundred and fifty (350) feet of an old approximately four (4) foot high chicken wire fence near the southern boundary of the pasture. The fence is in bad repair and non-functional (see Map Ref. # 43).

Standing within the Property near the northwestern boundary, looking northwest at approx. 4 -ft. high chicken wire fence in poor condition in foreground and approx. 6 -ft. high wood fencepost with electric wire fence in background. Note, currently dry, intermittent stream in lower right side of frame.

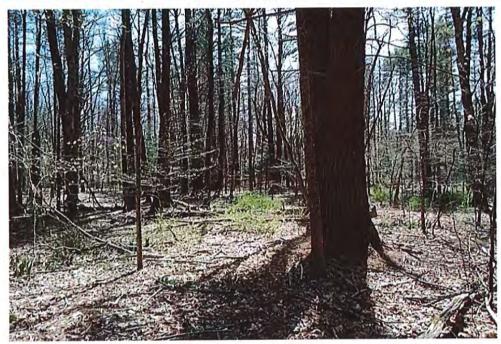
Map Ref.: 45 Date: 4/28/2023 File Name: Photo: 200 photo_Pike_4/28/2023_(200)

Standing within the western portion of Property, looking southeast at representative mature forest of predominantly pine and some beech and maple. Note there is fairly large infestation of the invasive Japanese barberry in this area.
