Durham Old Town Hall

Existing Conditions Photo Report

By Jessica MilNeil | December 11, 2019

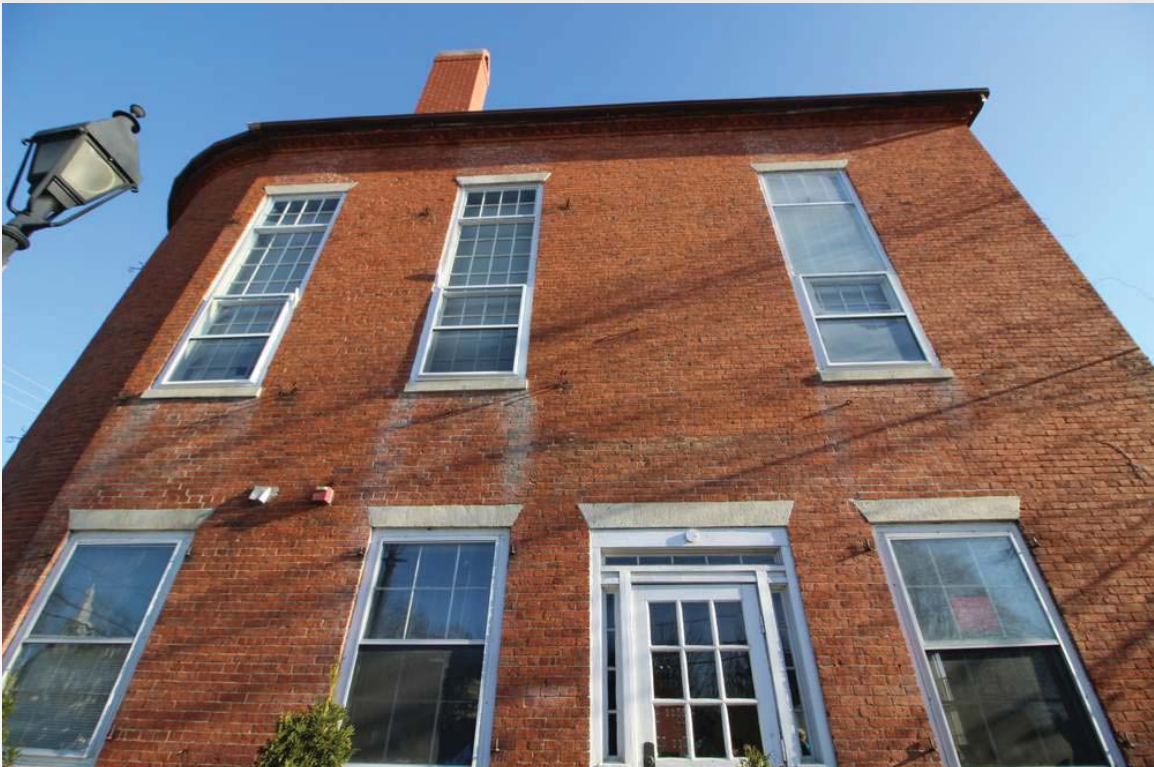
Southwest Elevation. The Durham Old Town Hall is truly one-of-a-kind. Built in 1925 by Joseph Coe, it is an impressive example of Federal-era brick architecture. This entrance has been referred to as the "store entrance" in HABS drawings. At that time, it was a double door, with no transom or sidelights.

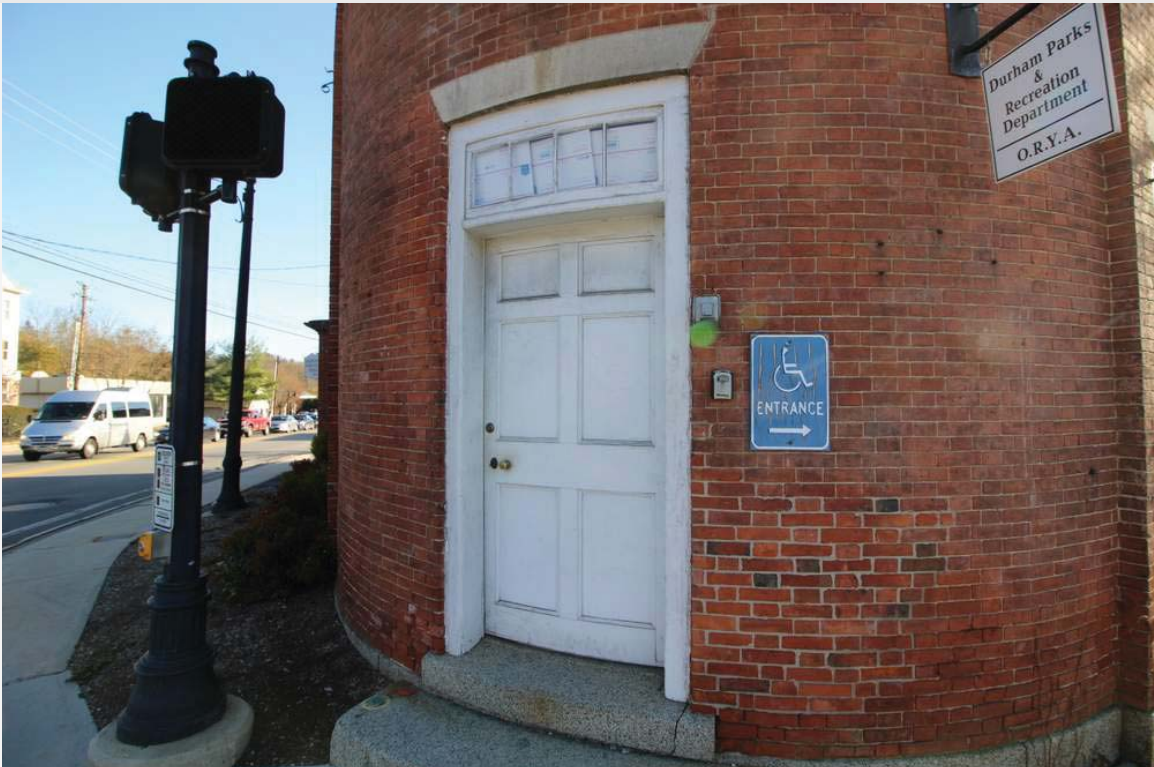
West entrance. Curved door, casing and transom are early or original. High preservation priority.

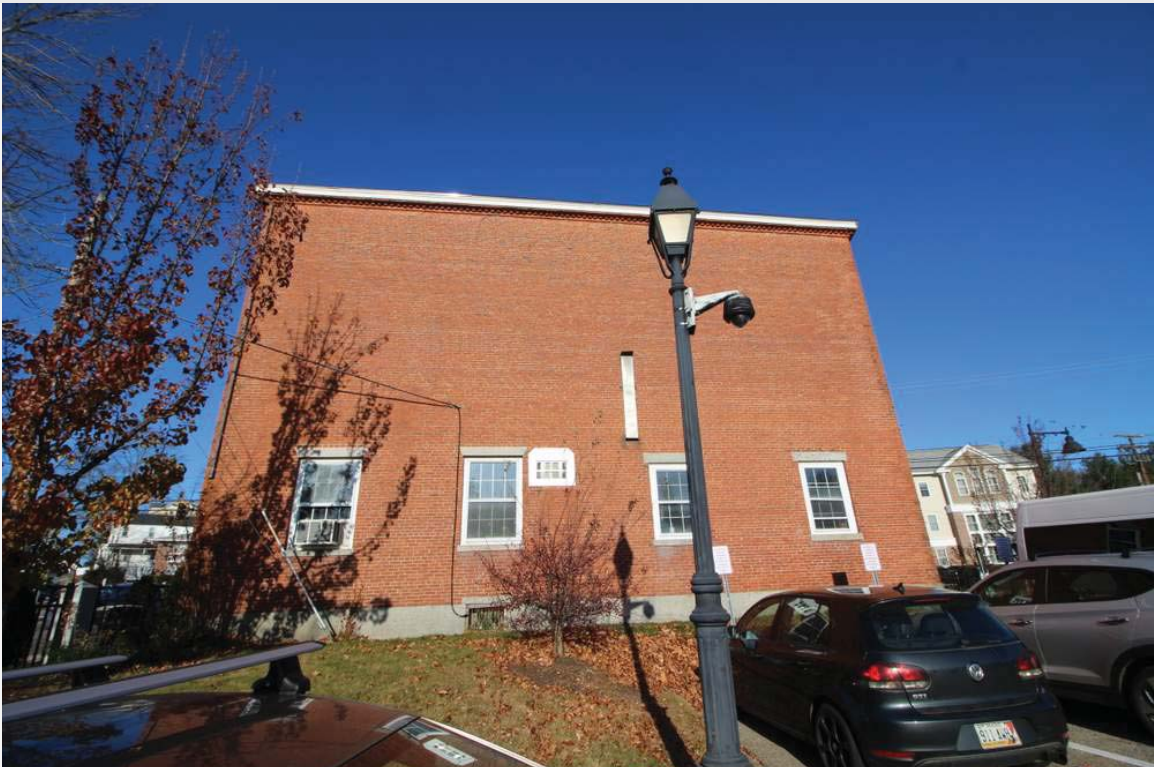
Southeast elevation. This elevation was remarkably blank, the two left windows have been added since 1935.

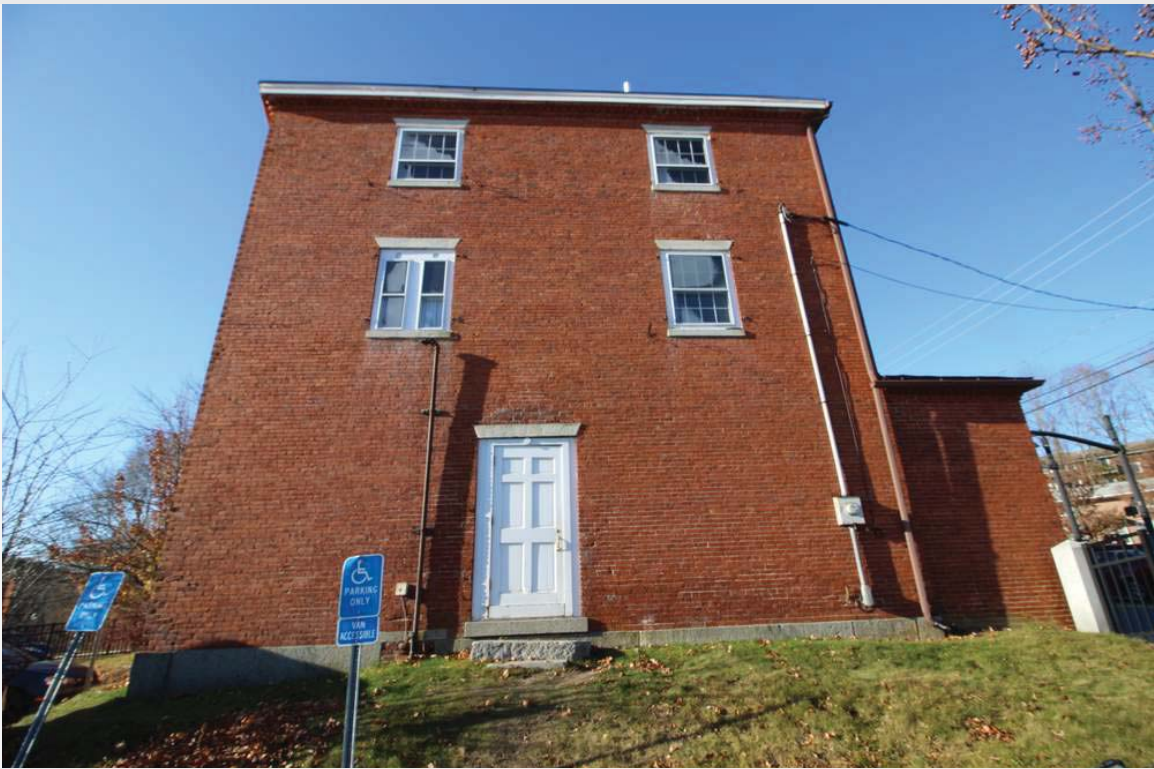
Northeast Elevation. This door has been changed. There are detailed drawings of a vertical plank door present in 1935. The split window was present then, according to photos.

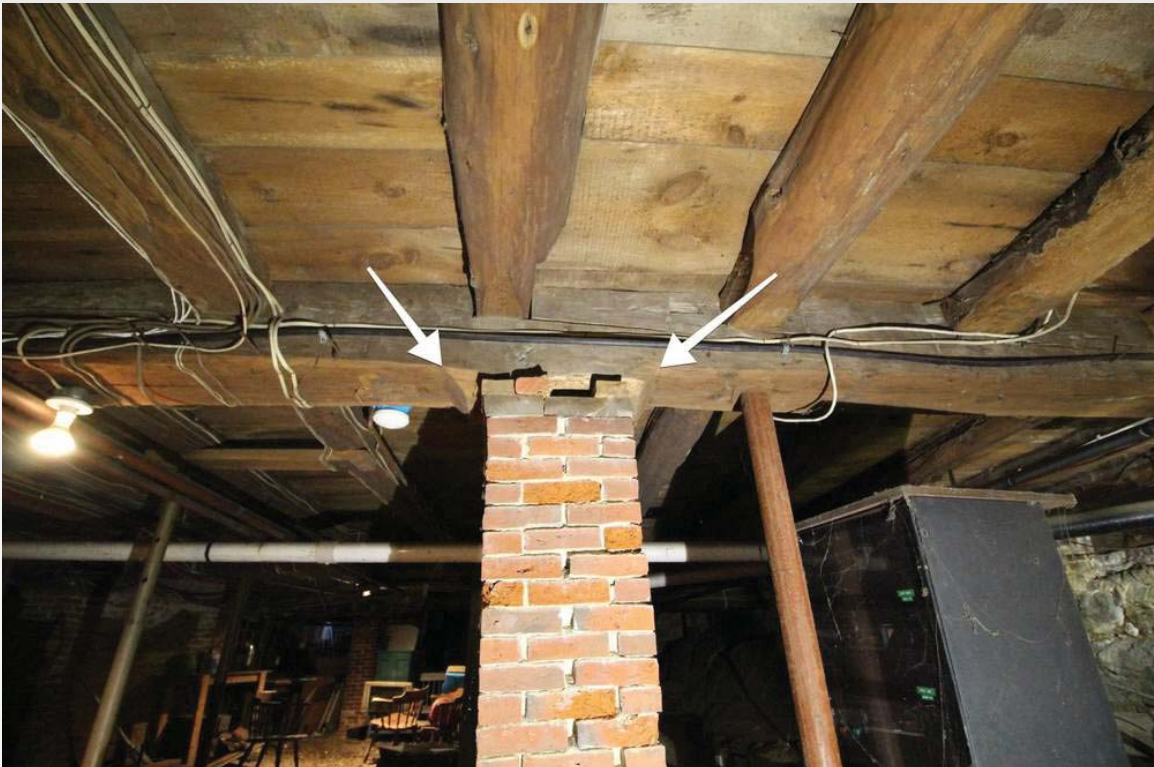
Here, common log joists can be seen cogging into a major floor girt. The floor girt is 3-4" deeper as it passes over the piers; the white arrows point to the chamfers. The pier is spawling and will need to be repaired by a mason with restoration experience.

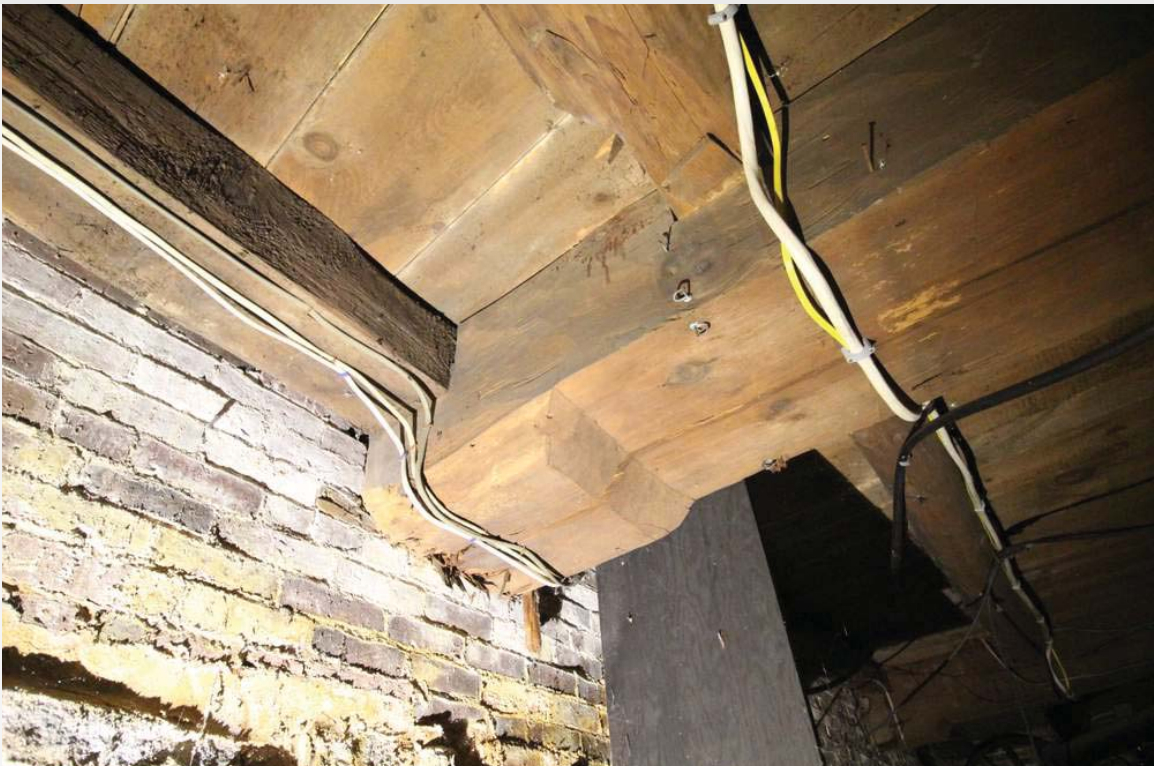
Here, a major floor girt enters the brick wall. The chamfer is present at this joint as well. This is fortunate because the bottom face is showing signs of rot, but there is ample good timber remaining. A rim joist extends from the girt to the upper left corner.

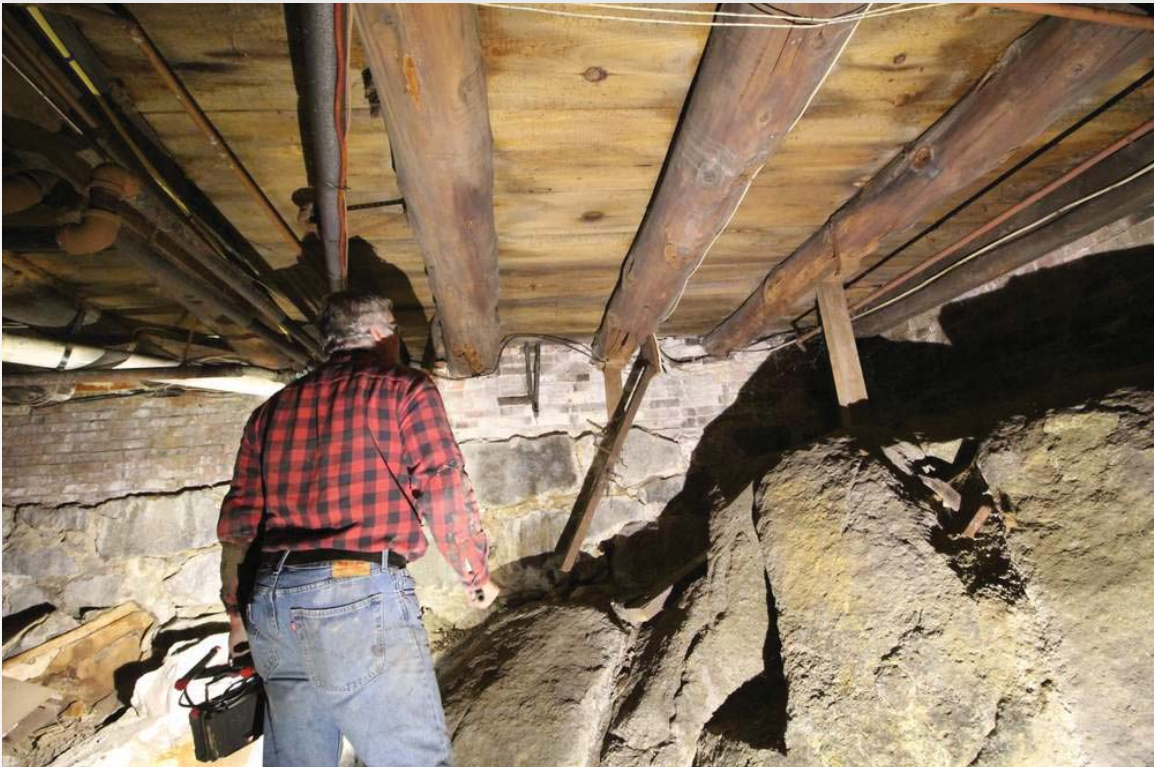
East corner, undercarriage. Log joists and ledge. This is the joist layout under the large rec room. The spacing is ok for tai chi and yoga, but maybe not step classes. The rotted portions will need to be excavated and consolidated. A few ends will need to be replaced with a scarf repair.

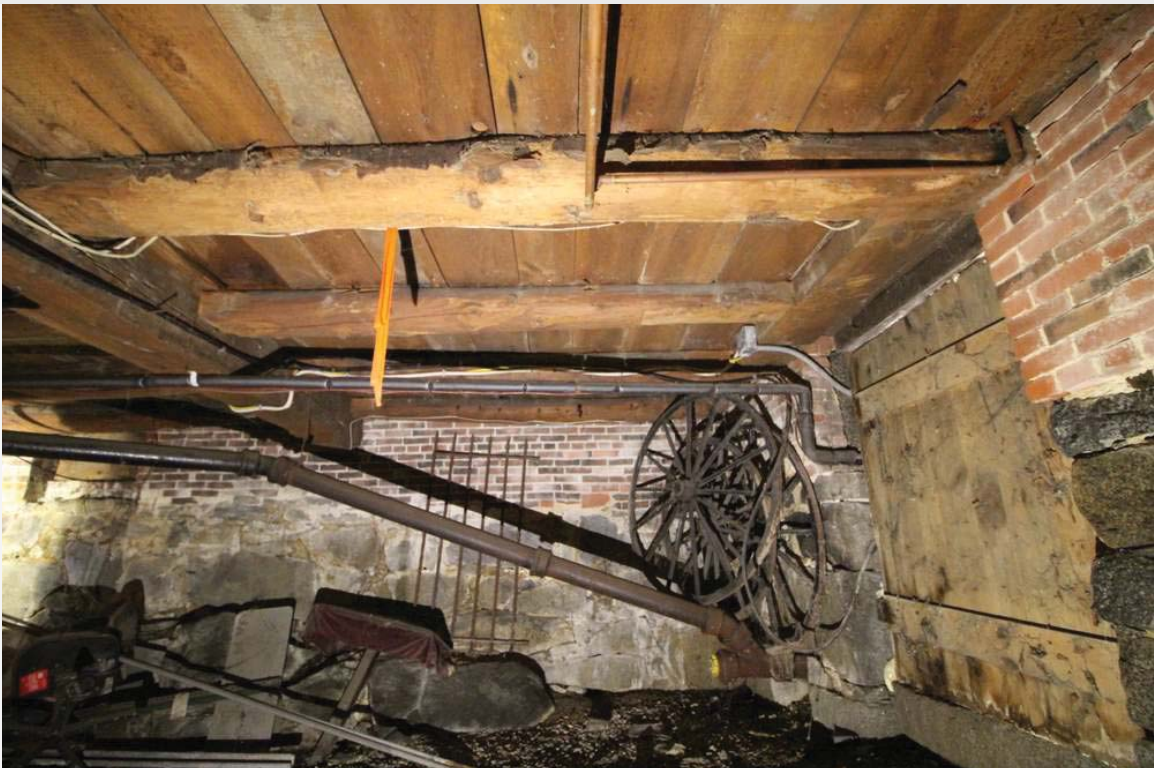
South corner, undercarriage. Log joists here are spread pretty wide. Infill joists are a reasonable addition, but should be installed on hangers.

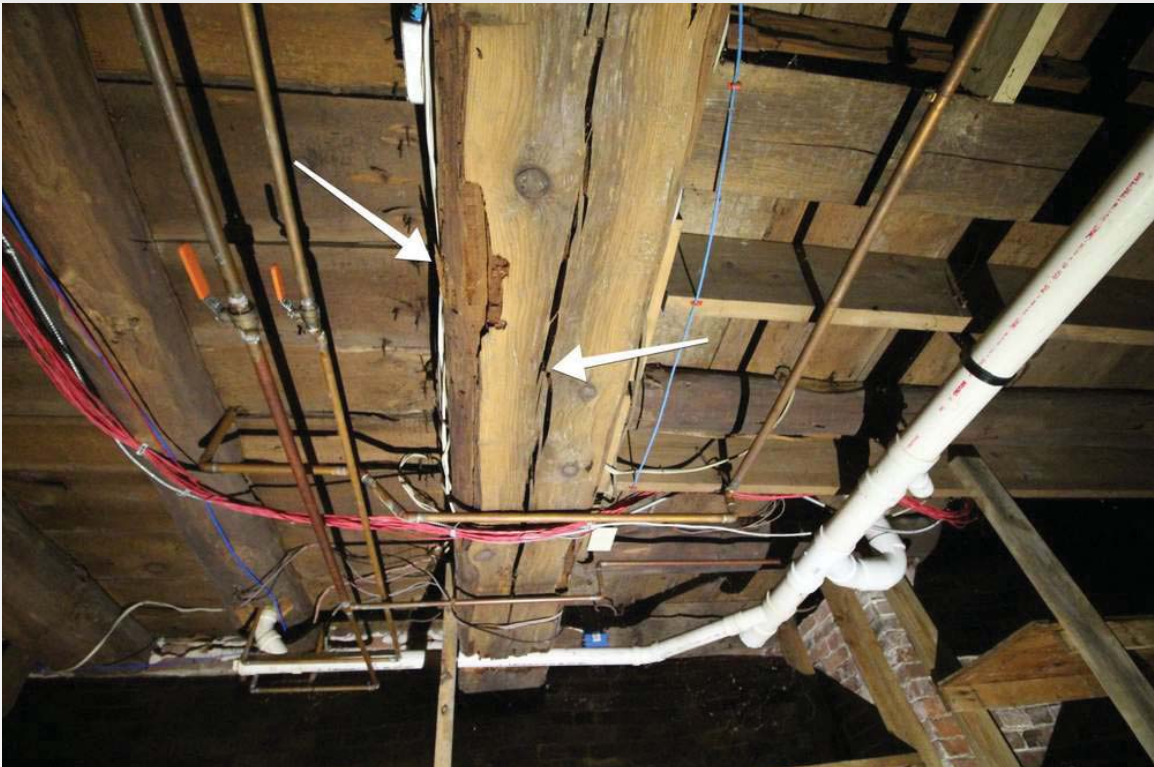
This floor girt borders the quadrant of joists in the west, rounded, corner. The west floor joists have been sistered with conventional 2x8s, but the new joists were hung on nailed cleats. The cleats should be replaced with proper hangers.

The white arrows point to areas of rot. This timber is large and it may be possible to excise rot and leave the remainder to support the floor. There is some indication of center rot, however. If it is extensive, the entire floor girt will need to be replaced.

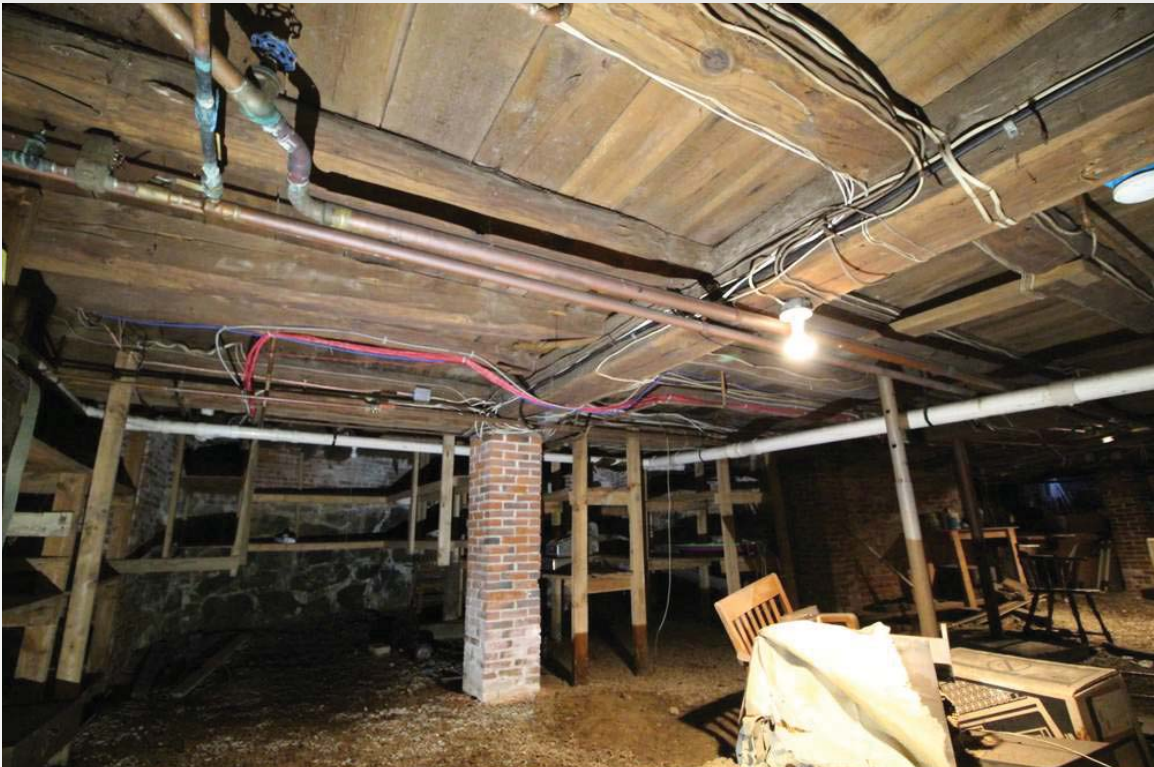
Undercarriage, standing in the south corner, looking west. The gravel floor allows water vapor to enter the basement from the ground up. Instead of a vapor barrier, we recommend installing interior perimeter drains and a sump pump, as well as exterior drainage, where feasible.

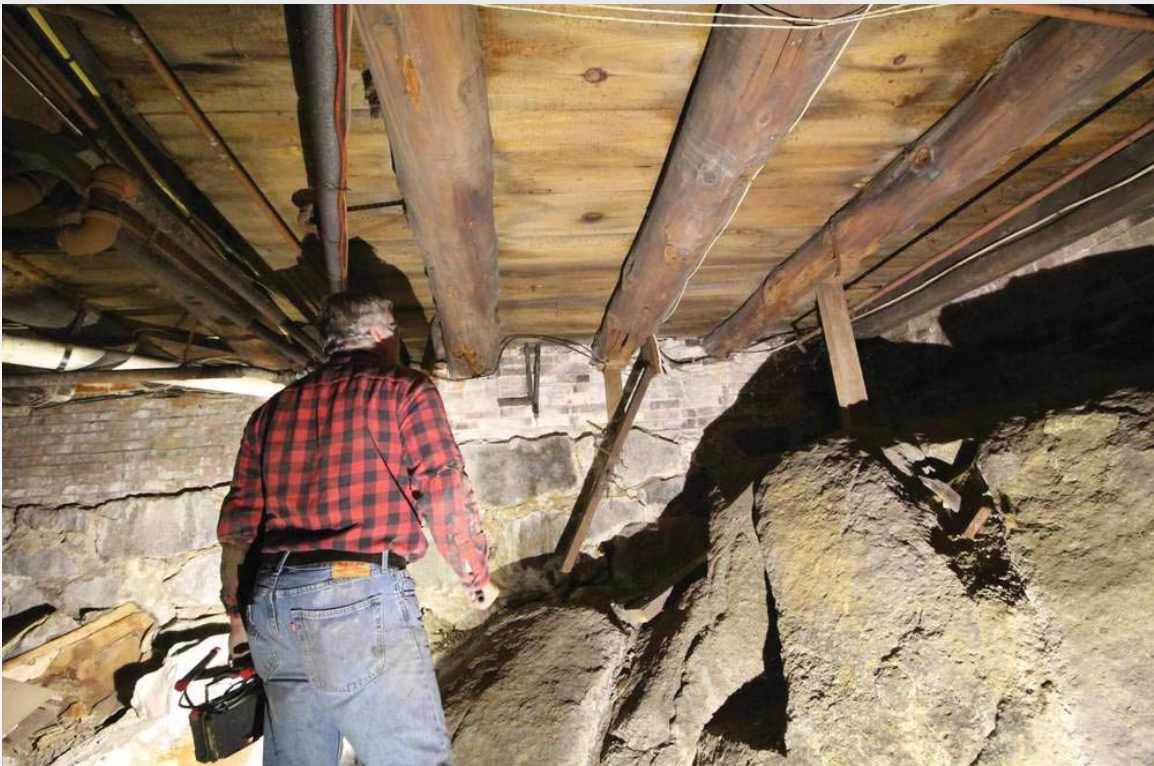
East corner, undercarriage. Ledge is very close to grade here and limits drainage capabilities.

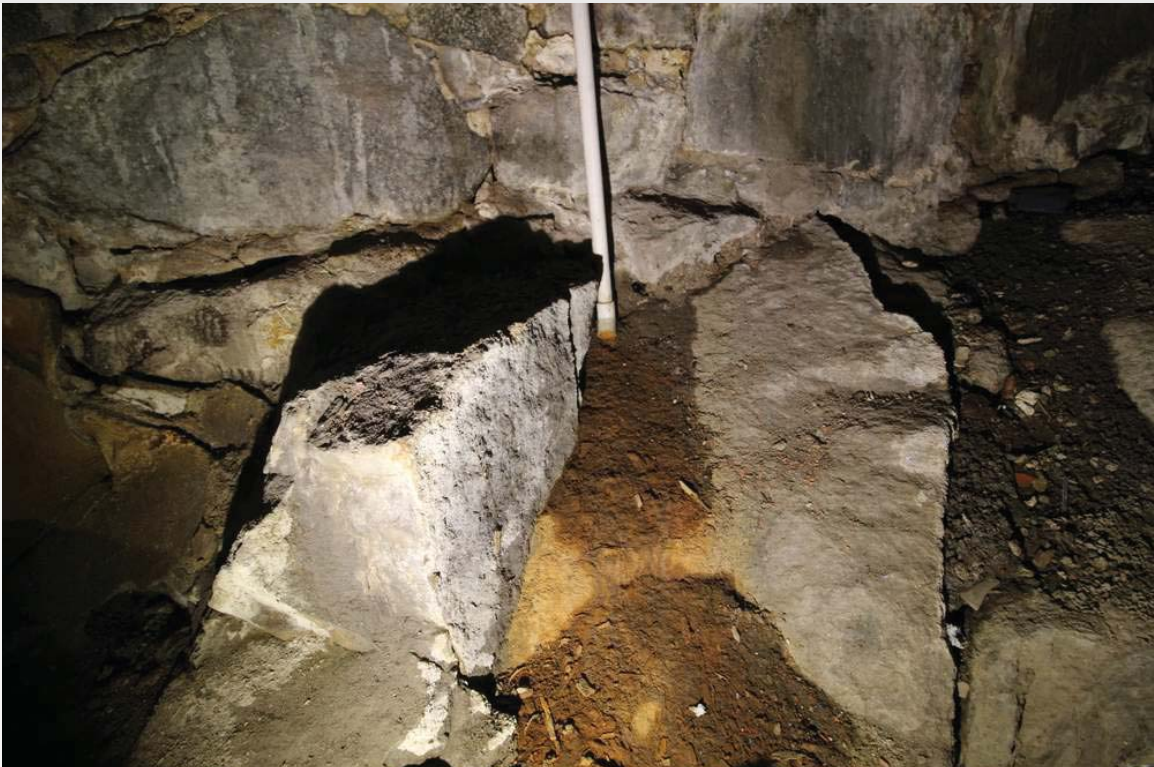
Nearby, along the northeast foundation wall, an appliance drains into the basement. This is not what we mean by "installing drainage."

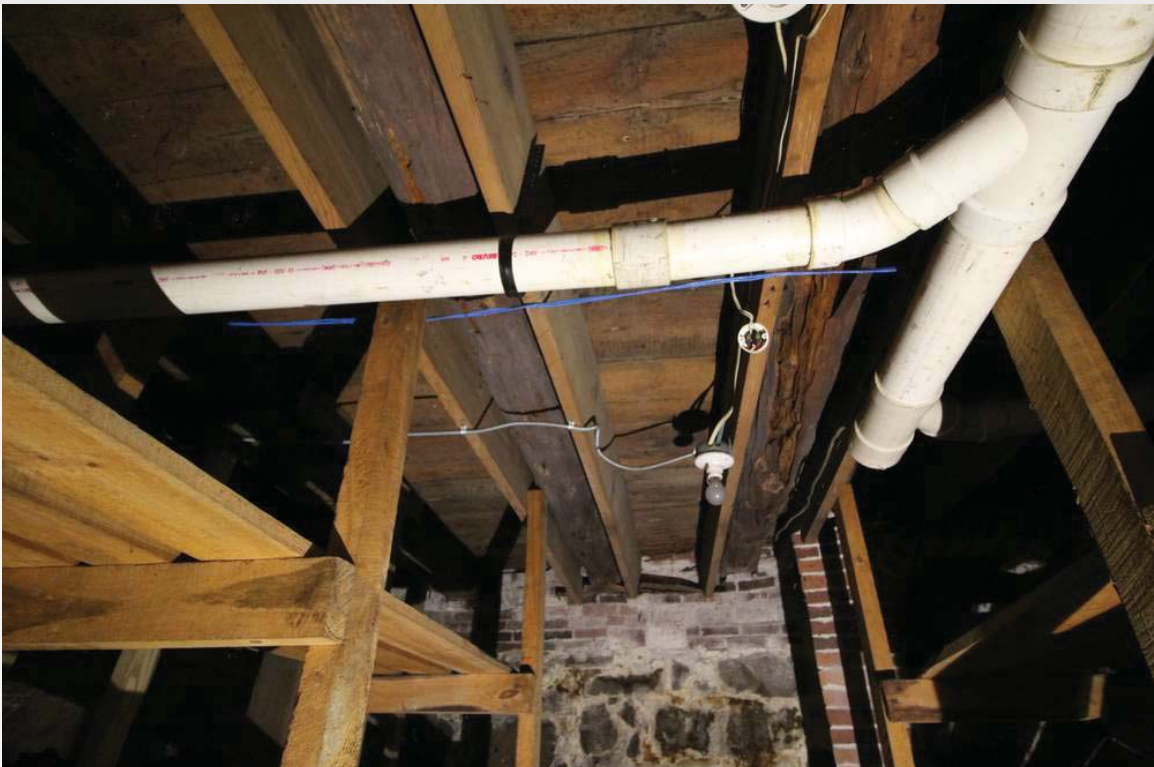
Joists in the west quadrant are badly rotted and have been sistered. The entire assembly should be painted with Bora-care fungicide and the sisters hung on hangers.

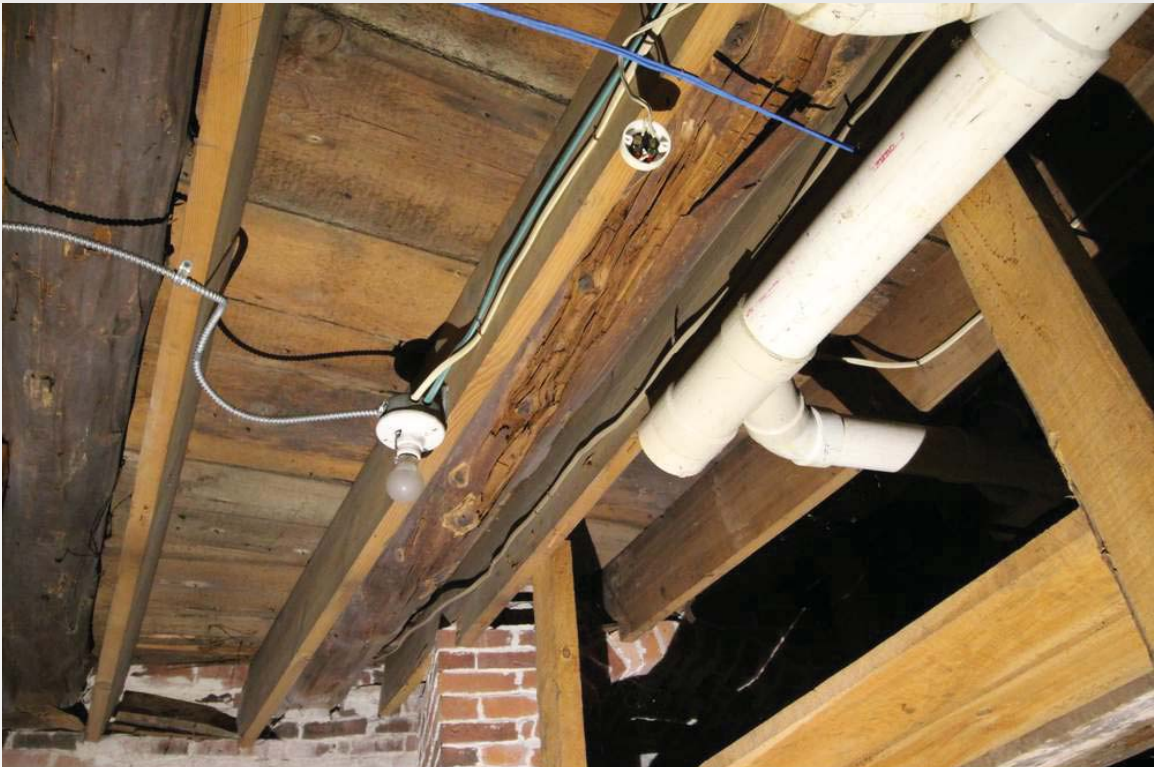
Closeup of joist in the west quadrant. This joist will probably need to be replaced in full.

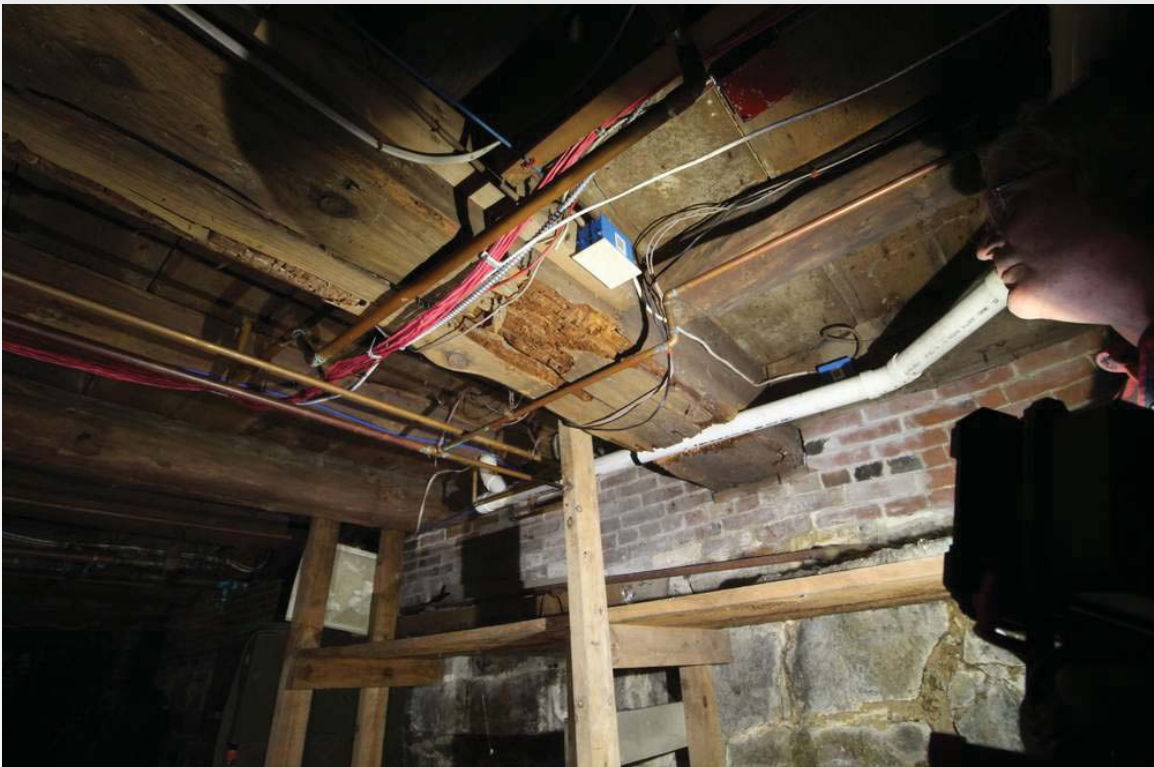
The short floor girt bordering the west quadrant is badly rotted. Fortunately, the timber is quite large, 14" x 14". Rot should be excised and the remainder consolidated with epoxy. A lally column should be installed at its midspan, where a floor girt comes in from the southeast wall and intersects.

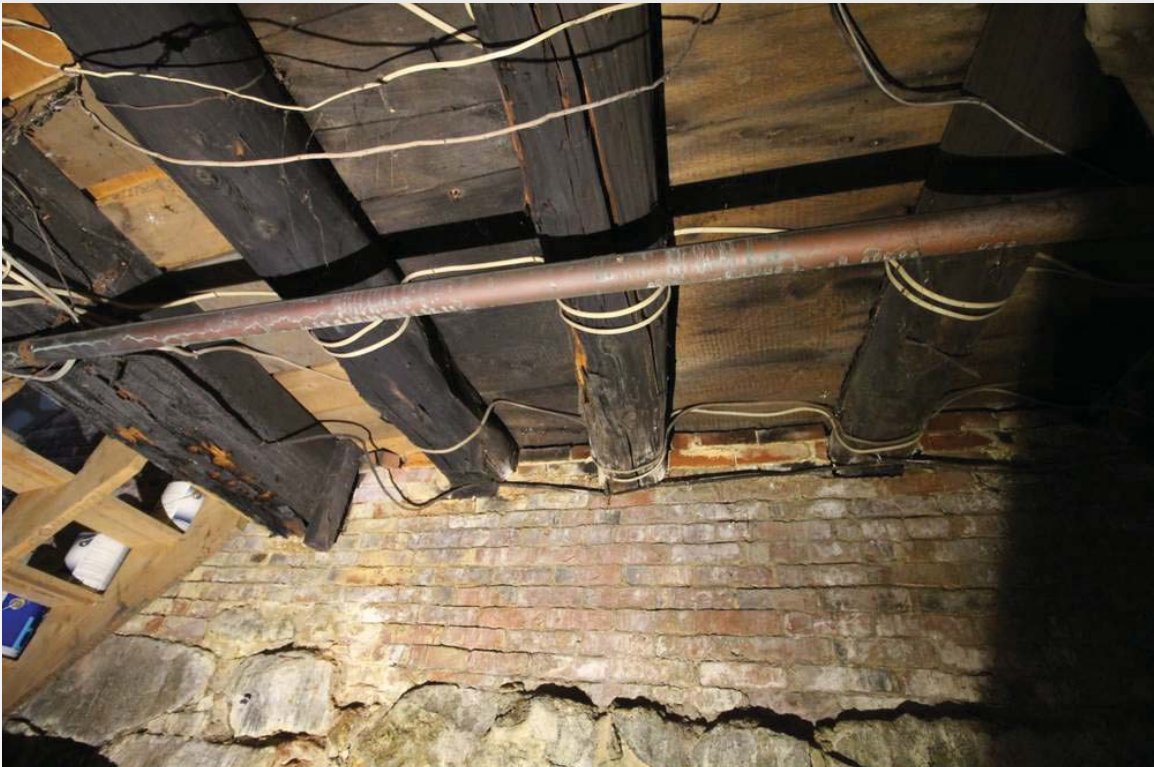
Center floor joists, northeast bay. These floor joists show evidence of a former fire. They also show some rot. The damage can probably be addressed with excavation, epoxy consolidation and application of Bora-care.

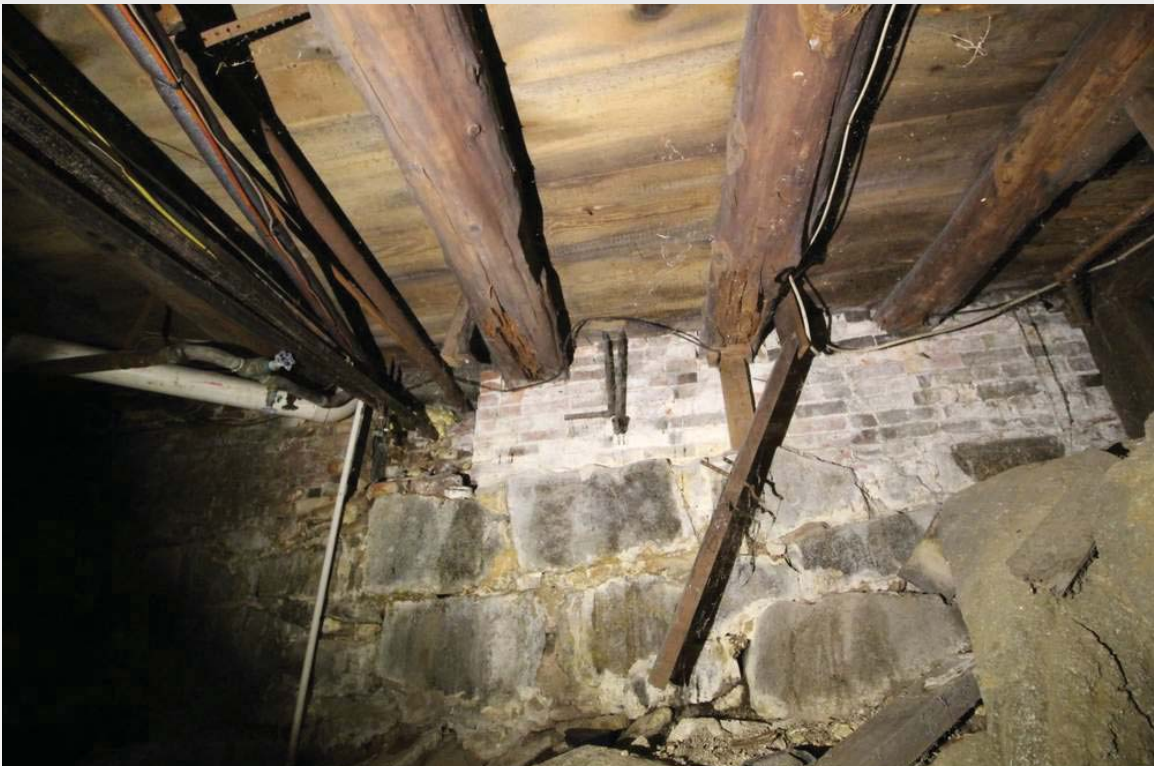
These are the joists further to the east in the northeast bay. The damage here is worse.

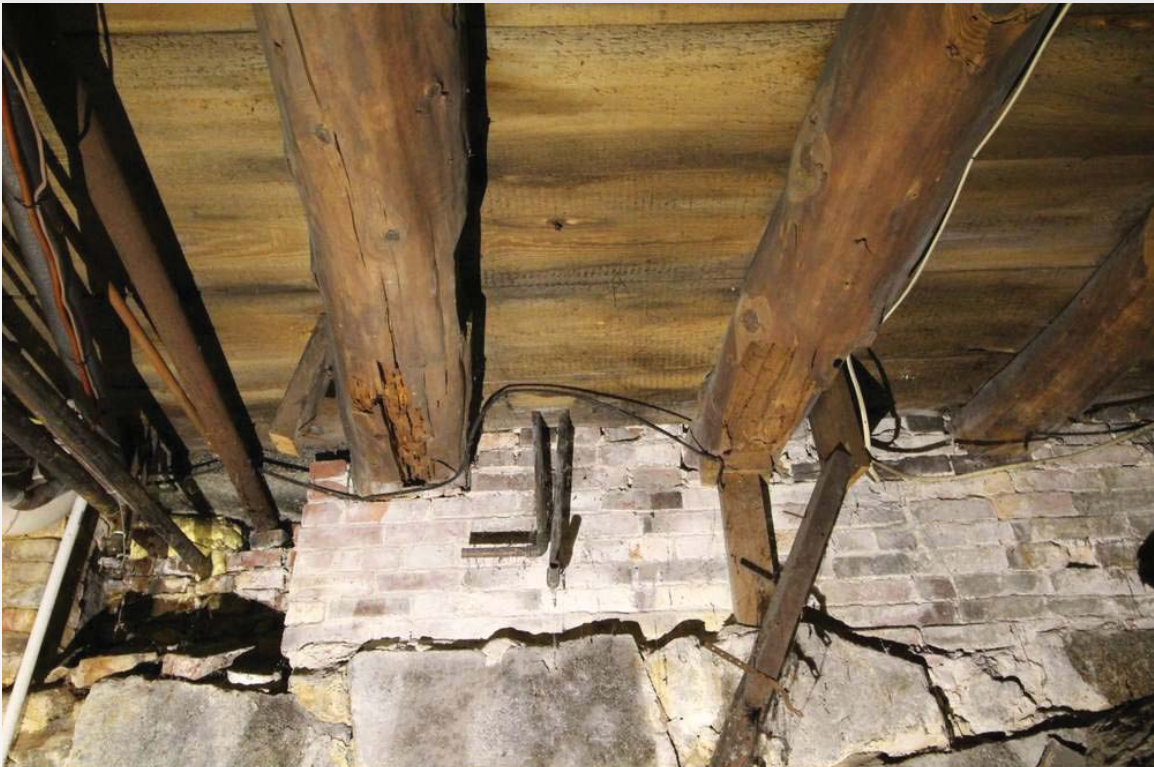
These joists will need to be repaired with scarf repairs, and with the scarf supported over a short post and footing pad, or directly onto the ledge. Alternately, the joists may need to be replaced in full, which is more invasive and expensive.

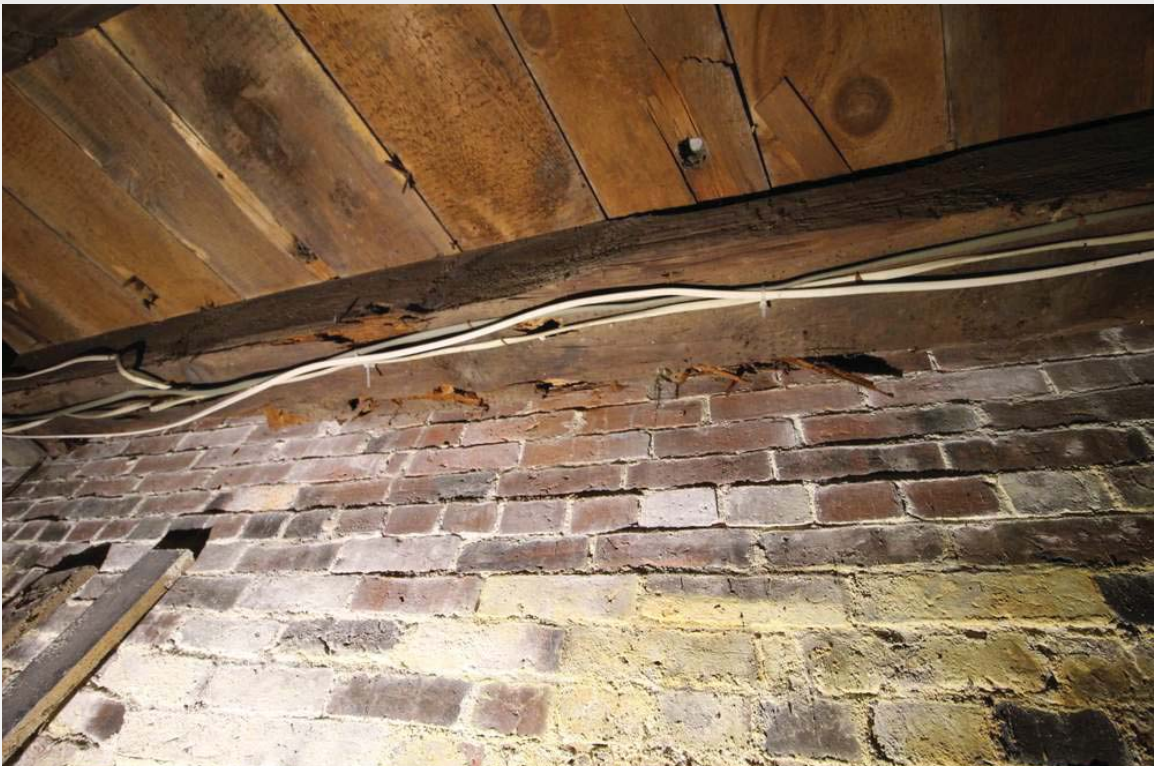
This rim joist is rotting where it touches the brick wall. Water condenses against the cool masonry and gets trapped against the wood, causing rot.

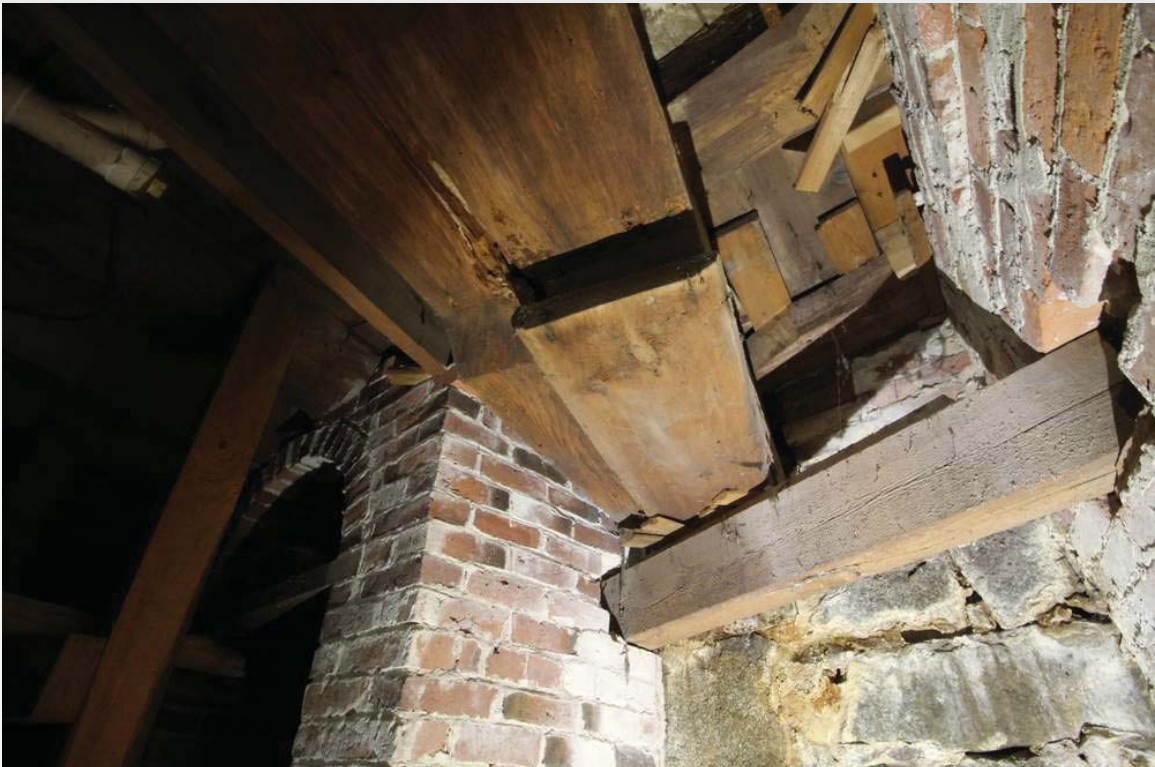
This is the NW end of the center floor girt. The end has rotted so badly that it dropped out of its brick pocket and is now being support on a 4x4 bolster and 2" pad. This end will need to be replaced and scarfed back into good wood.

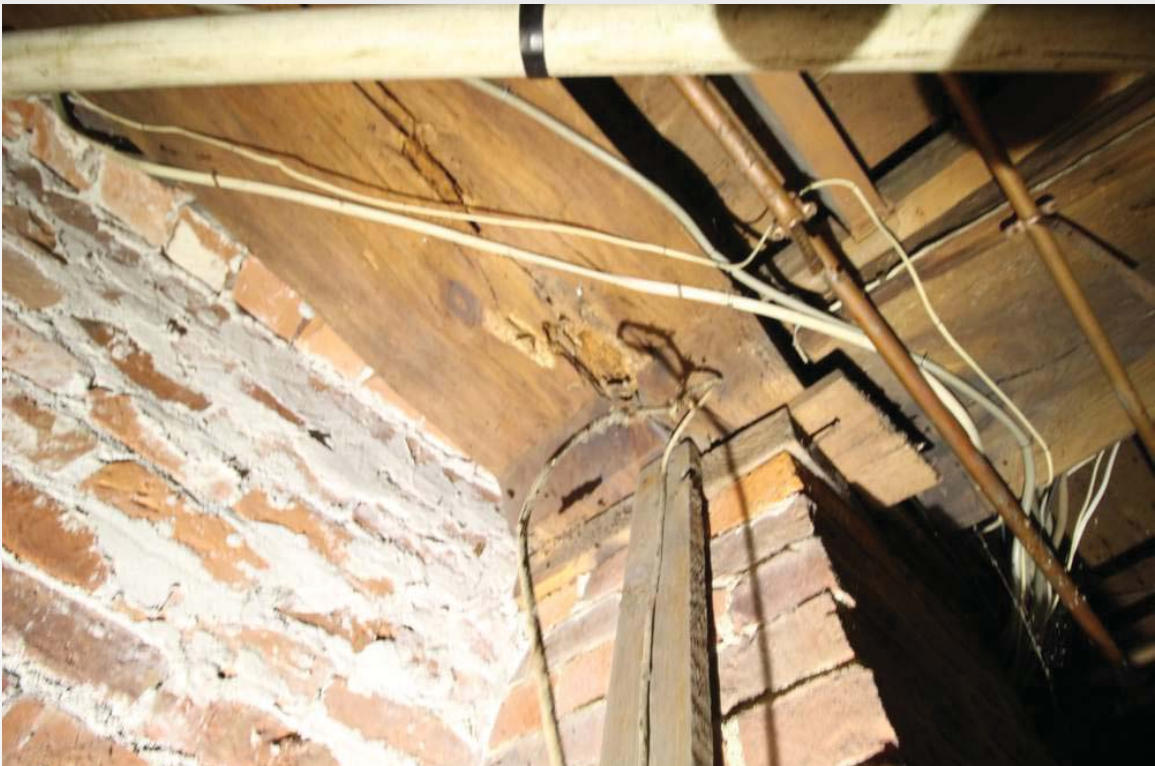
Above is the same center floor girt as it passes by the corner of the vault. It is badly rotted here, too.

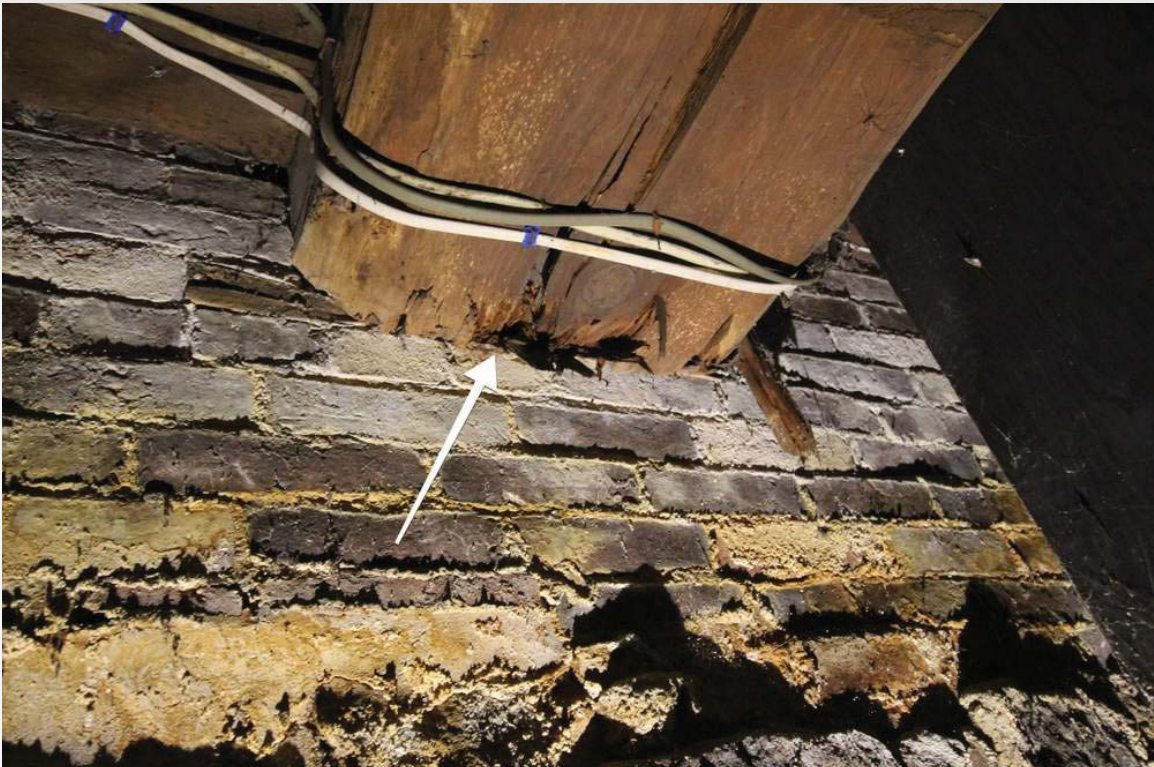
This is the opposite end of the timber, where it enters the southeast wall. Here, the rotted material can be removed and replaced with a pad, white oak might be a good choice here.

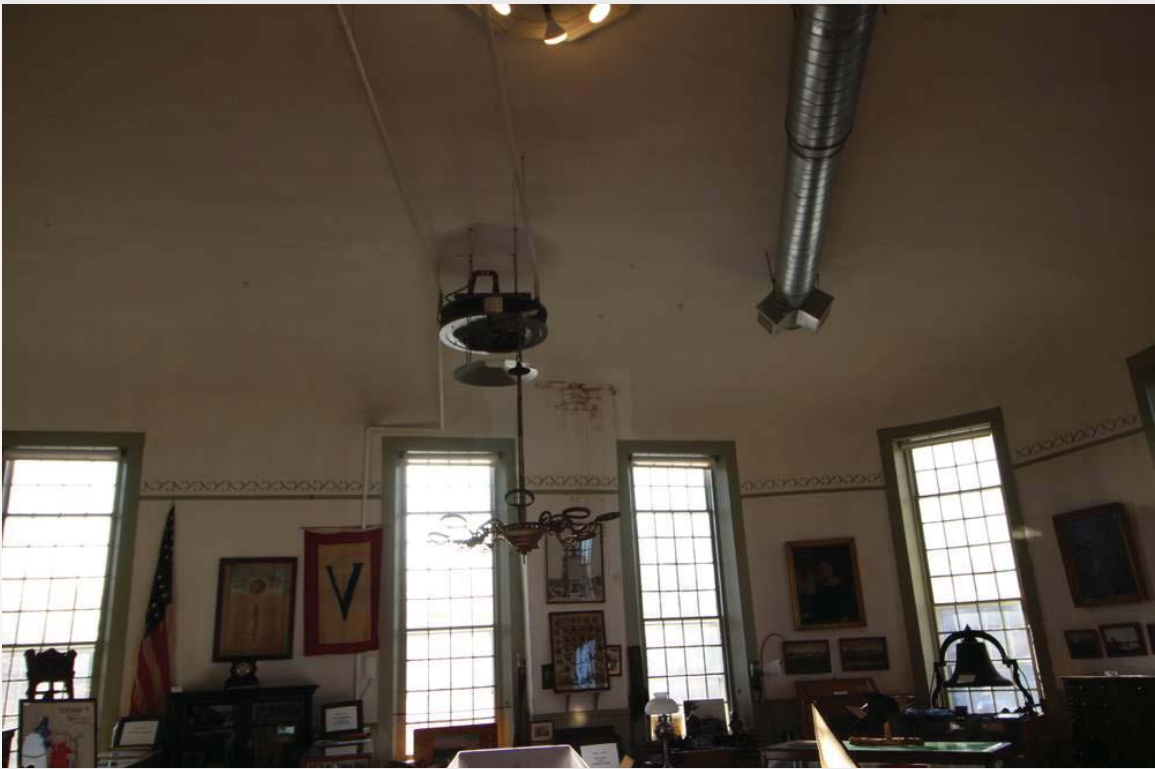
Heating systems are overloading the framing above and drowning out speakers when presentations are given.

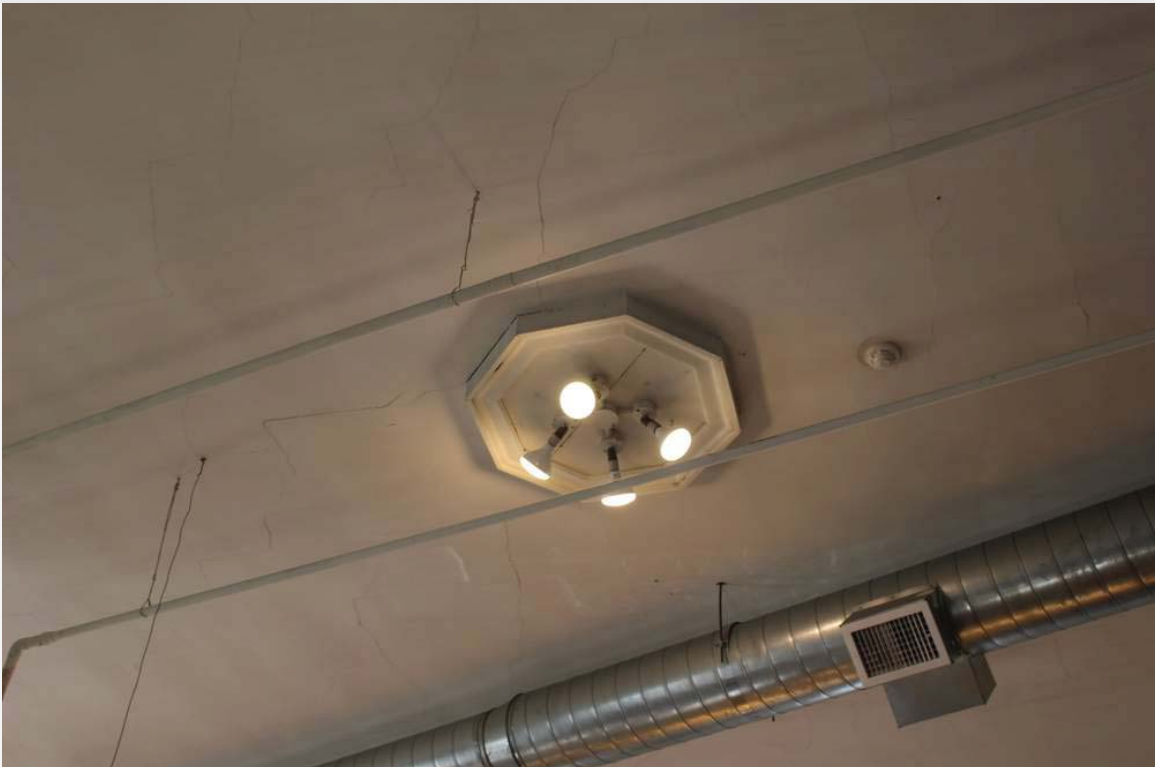
The plaster at the center of the ceiling is showing cracks and may be loose. Loose plaster can be re-adhered and preserved.
