Durham Old Town Hall

Existing Conditions Photo Report

By Jessica MilNeil | December 11, 2019

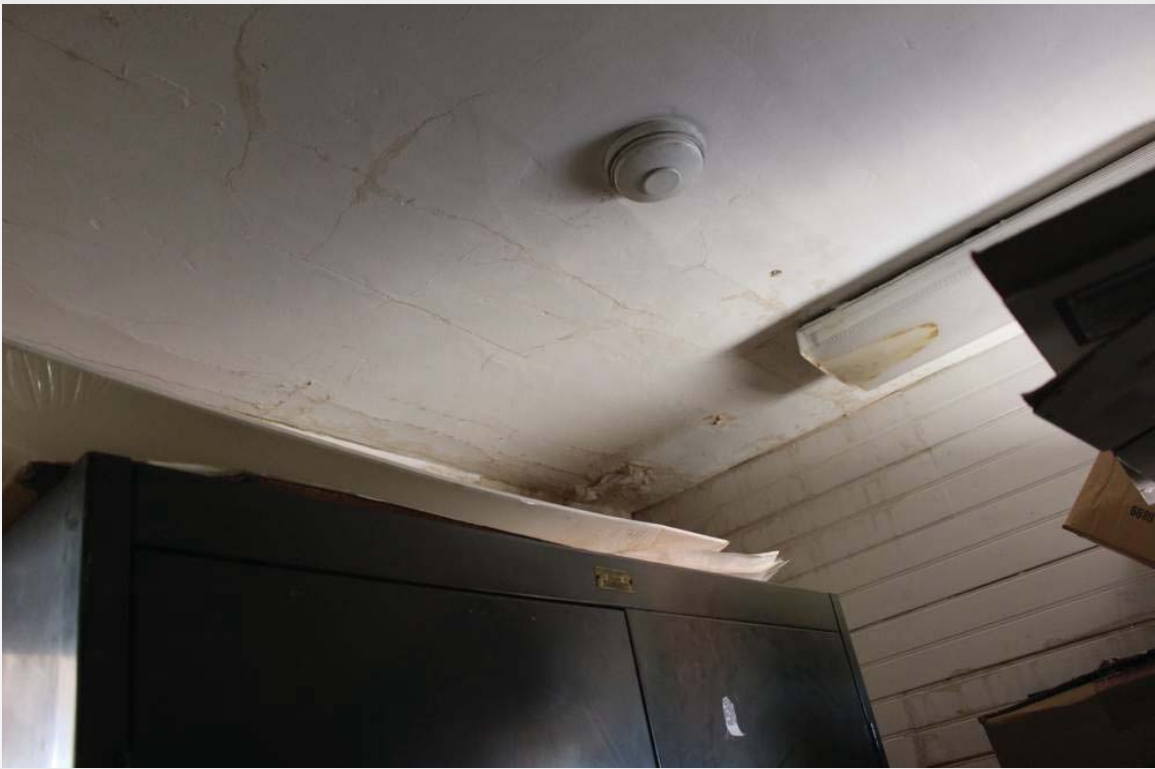
The heating system or ductwork appears to be leaking and causing damage to the ceiling and walls below.

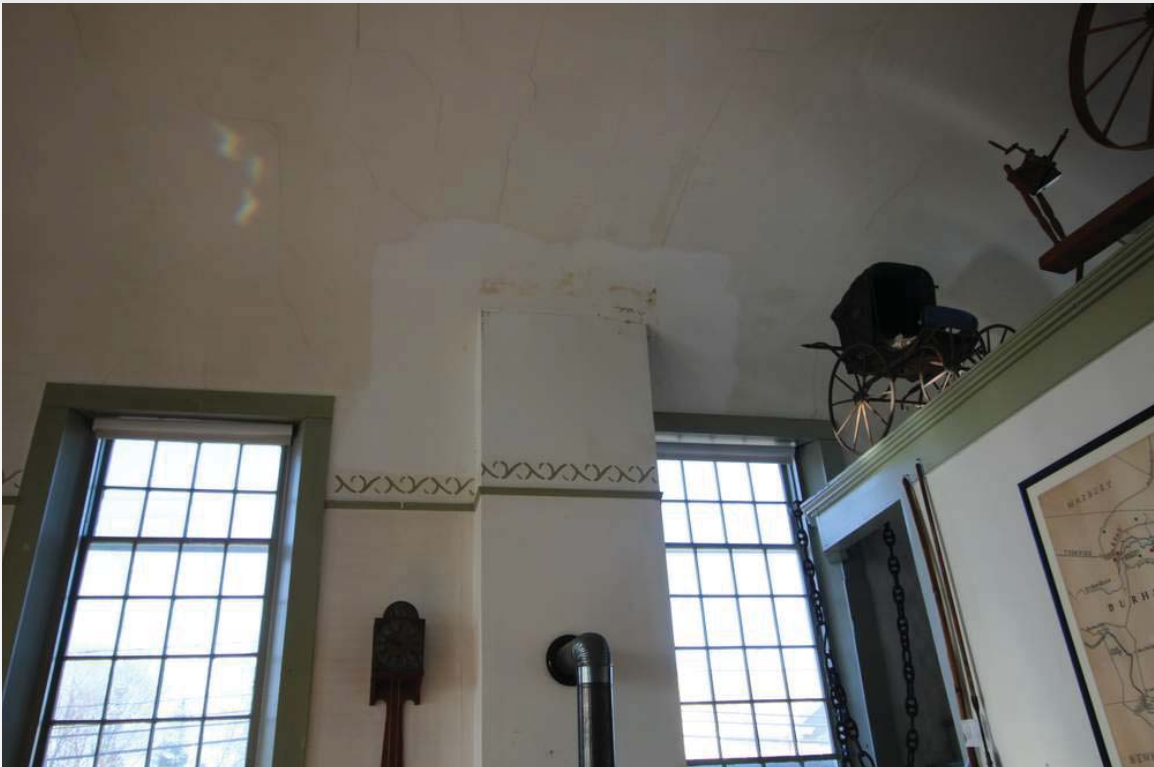
Chimneys show evidence of long term leakage and multiple generations of paint and plaster repair.

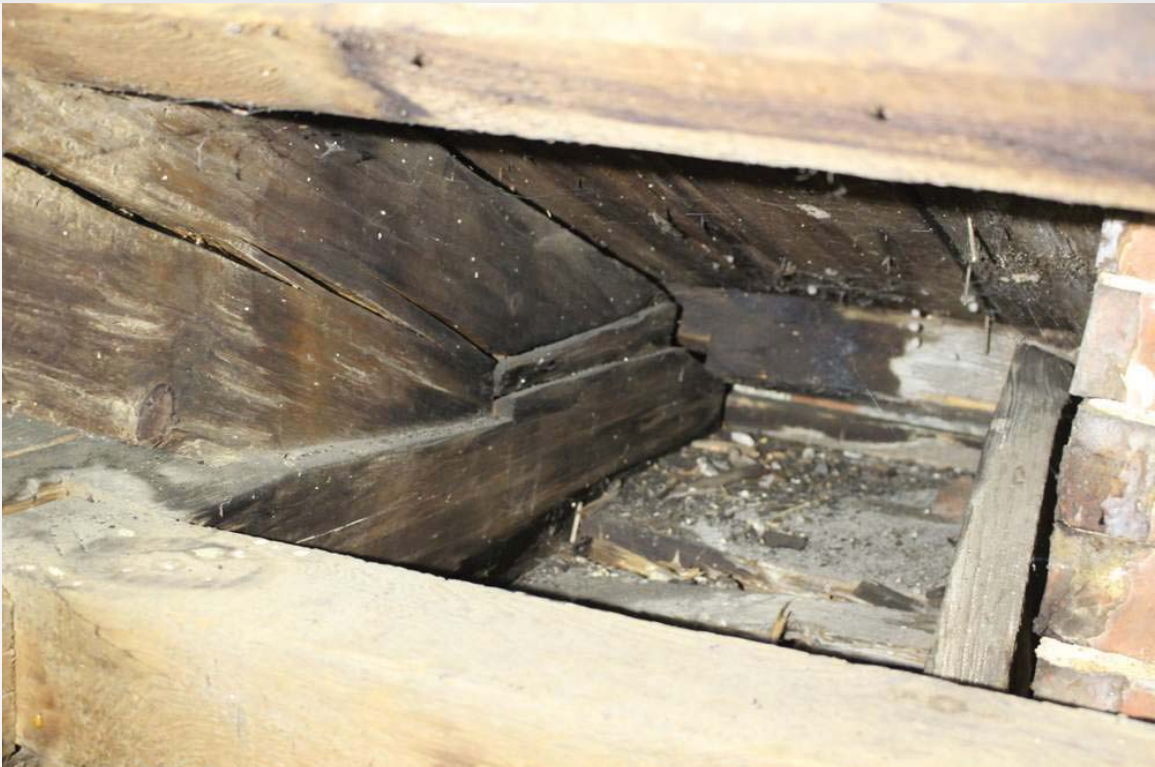
This birds-mouth has suffered from water infiltration. There also appears to be a fracture along the grain, which may be a separate issue related to the thrust of the rafters.

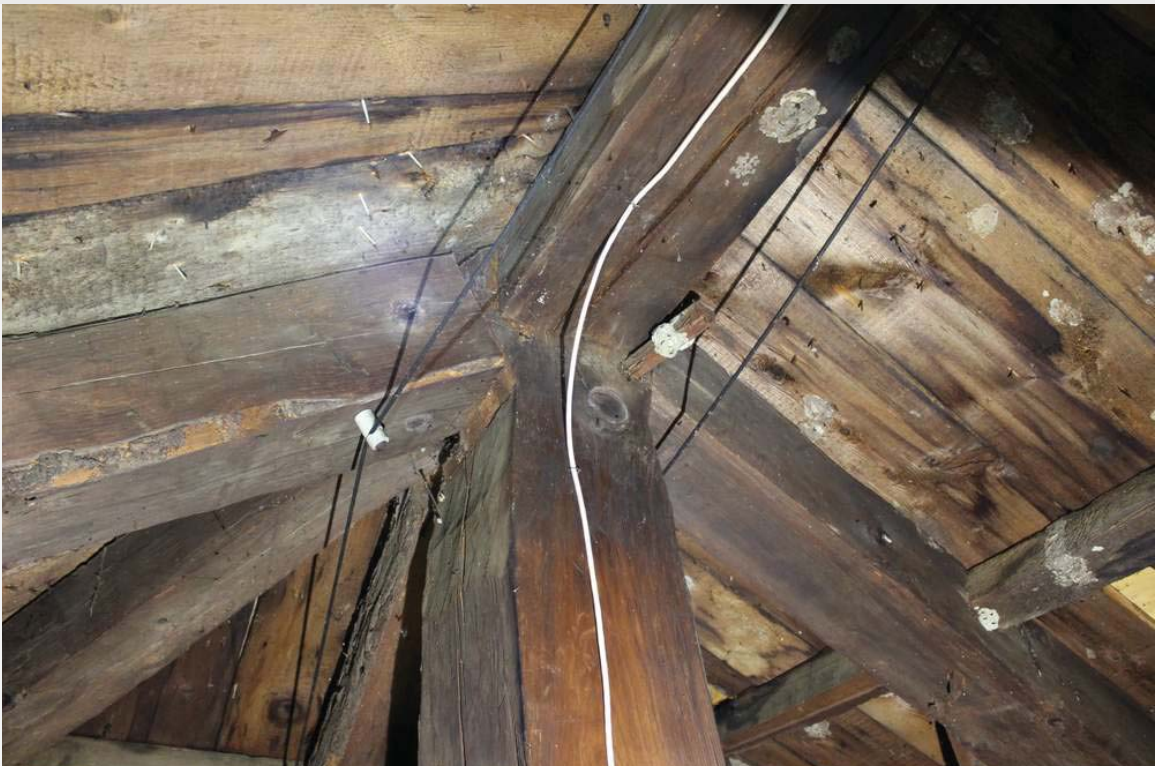
The "king post" has the flared head typical of a king post truss. The post appears to have dropped away from the principal rafters slightly.

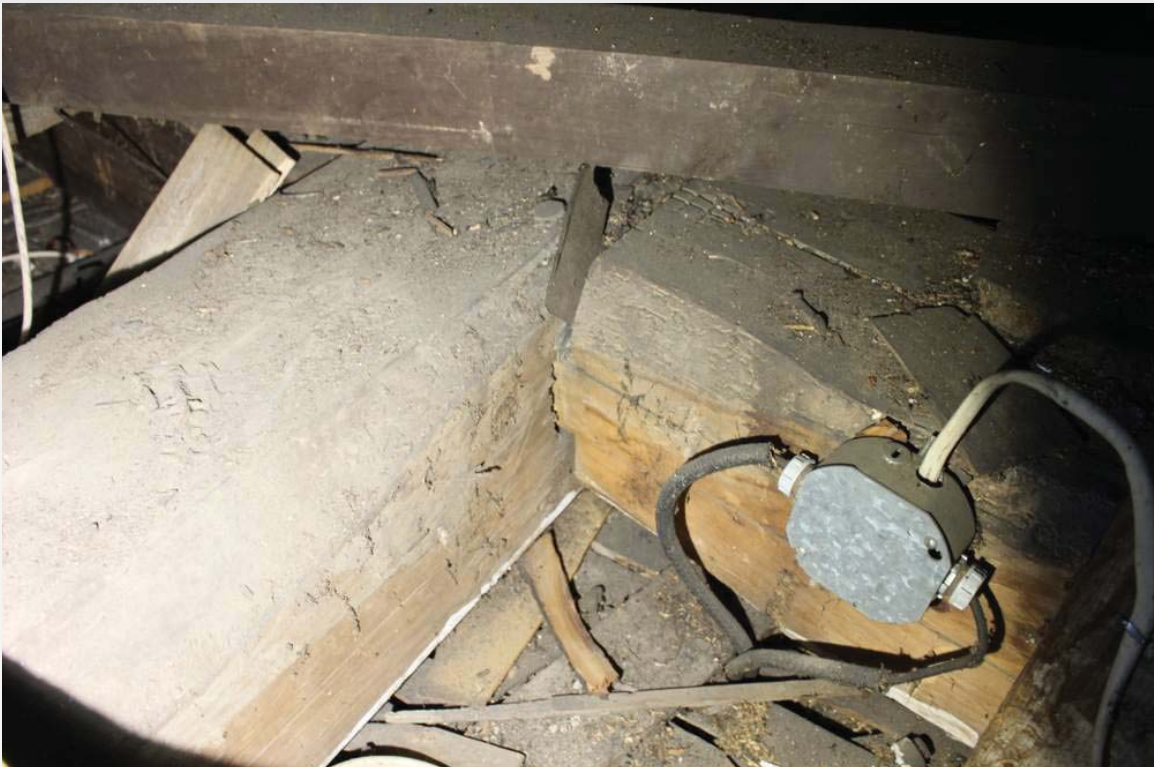
The ceiling girts join the tie beams with a thick, horizontal tenon. The joint is slightly open, due to the sag of the ceiling.

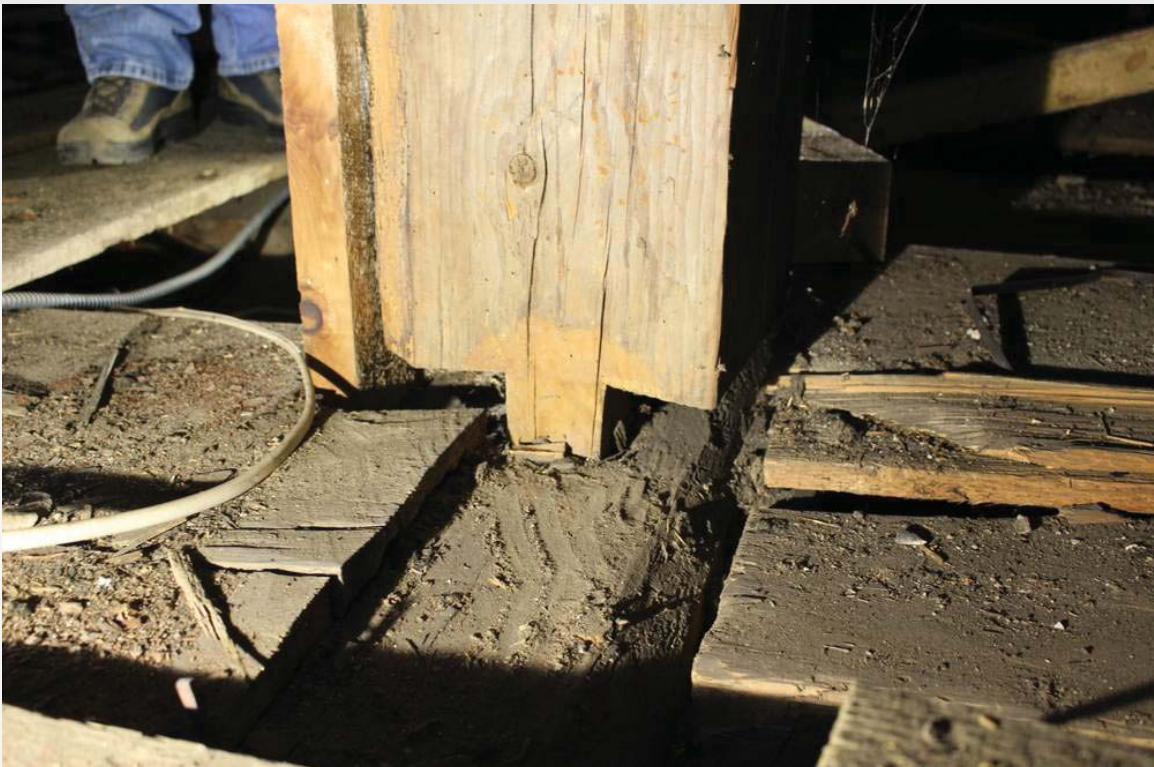
In this ceiling frame, the "king post" joins to a ceiling girt rather than a tie beam. The joint has opened by more than 2". There is a wide board nailed to the faces of the beams, and secured with wrought nails.

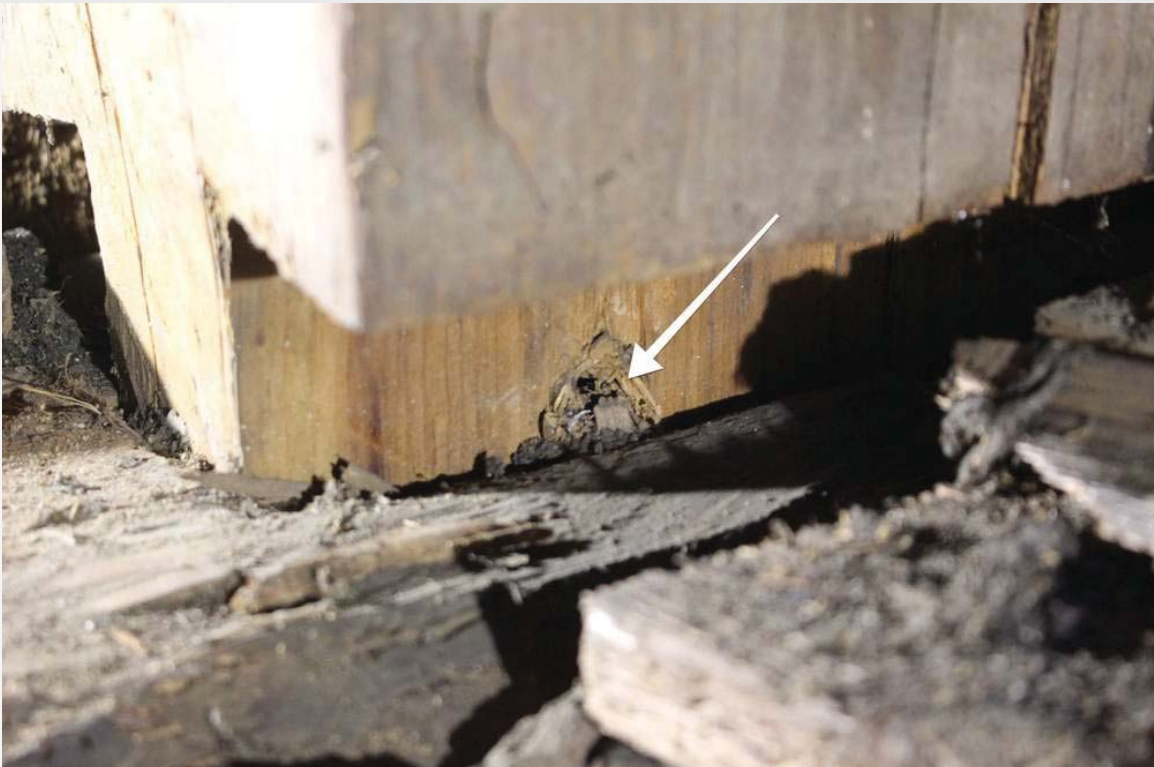
Here, the arrow points to the joint's broken pin.

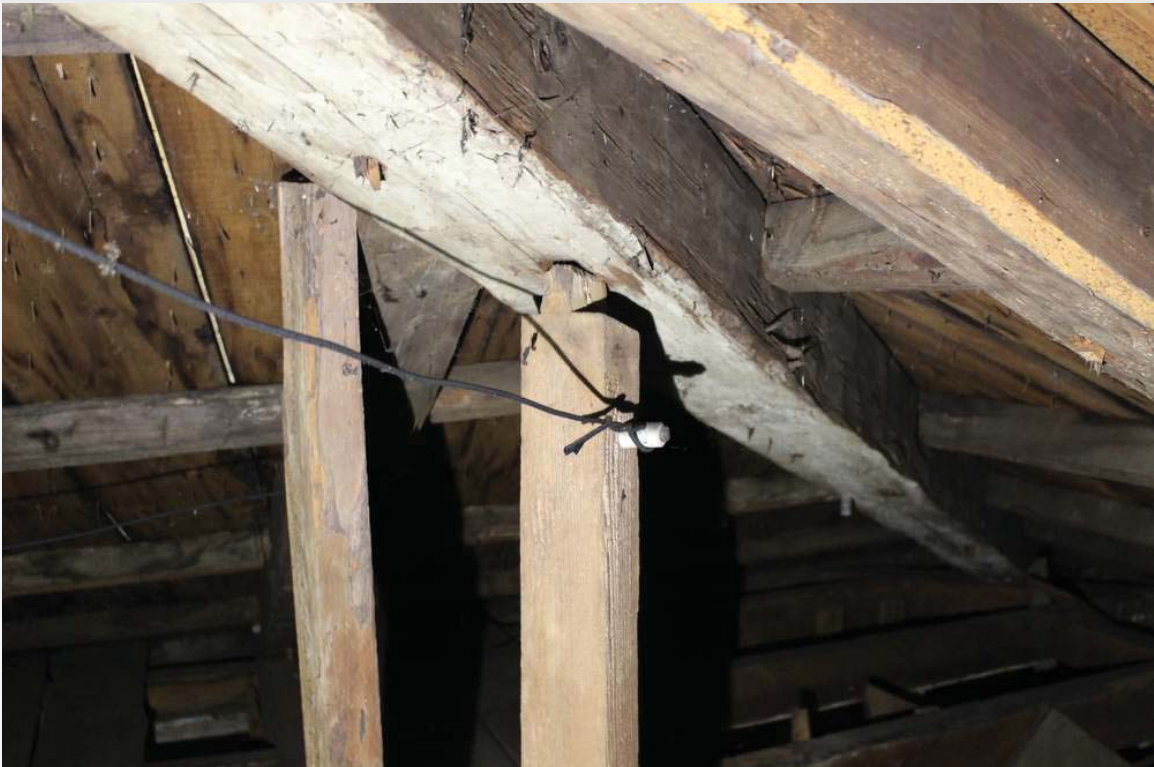
South hip rafter and strut. Four struts were installed beneath the hip rafters. The joints are at varying levels of spread, but the culprit appears to be the sag in the tie beam, the hip rafter appears to be stable.

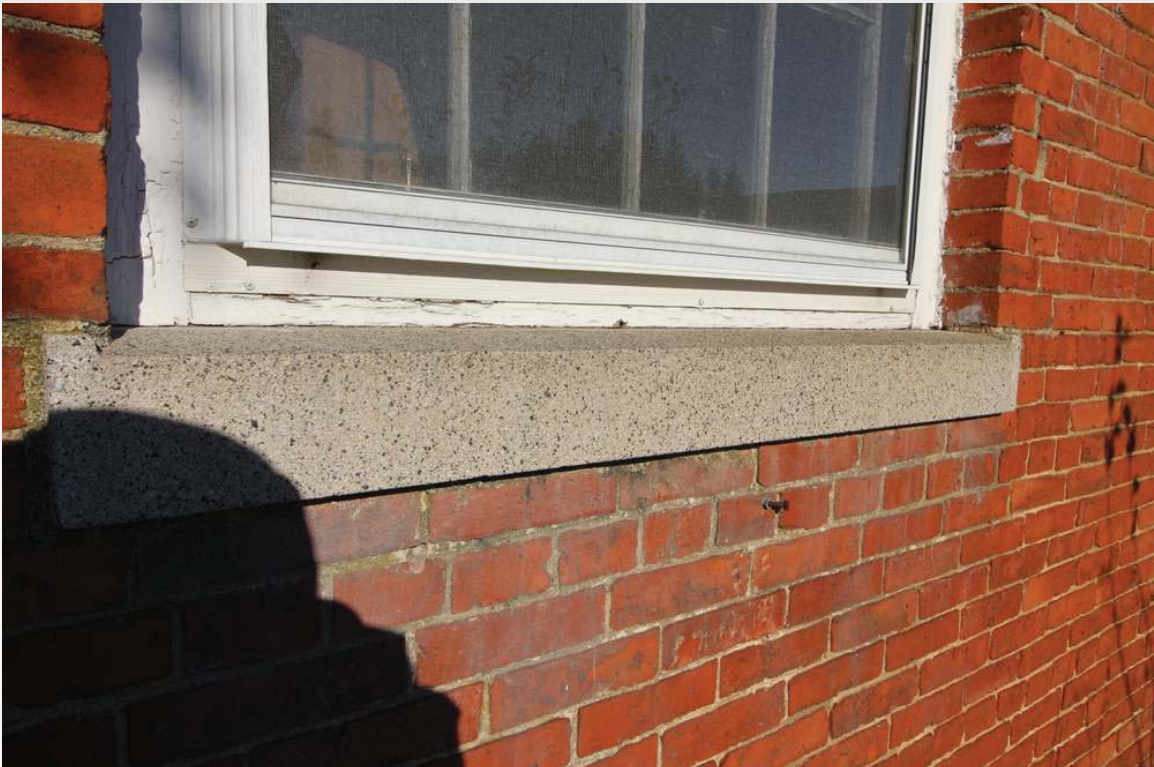
Concrete-style sill is a pretty accurate reproduction. Window trim needs scraping and repainting.

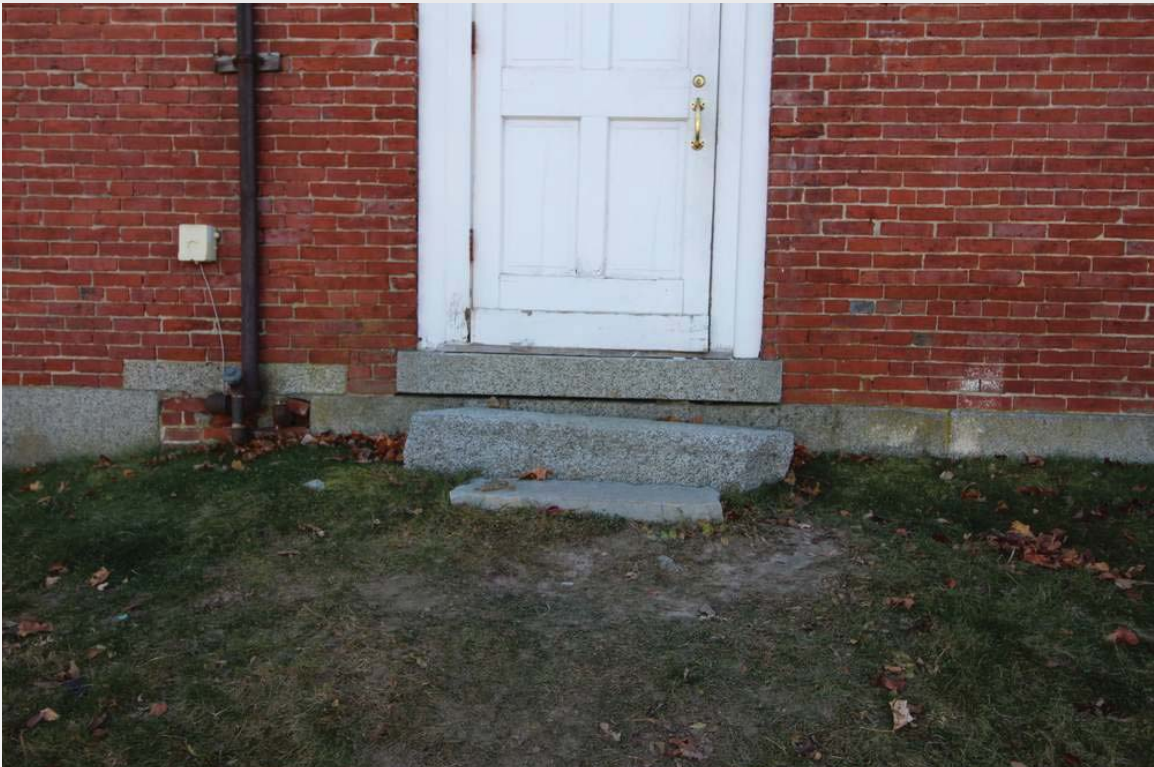
Stone steps should be re-set to ensure that they drain water away from the building rather than trap water against it.

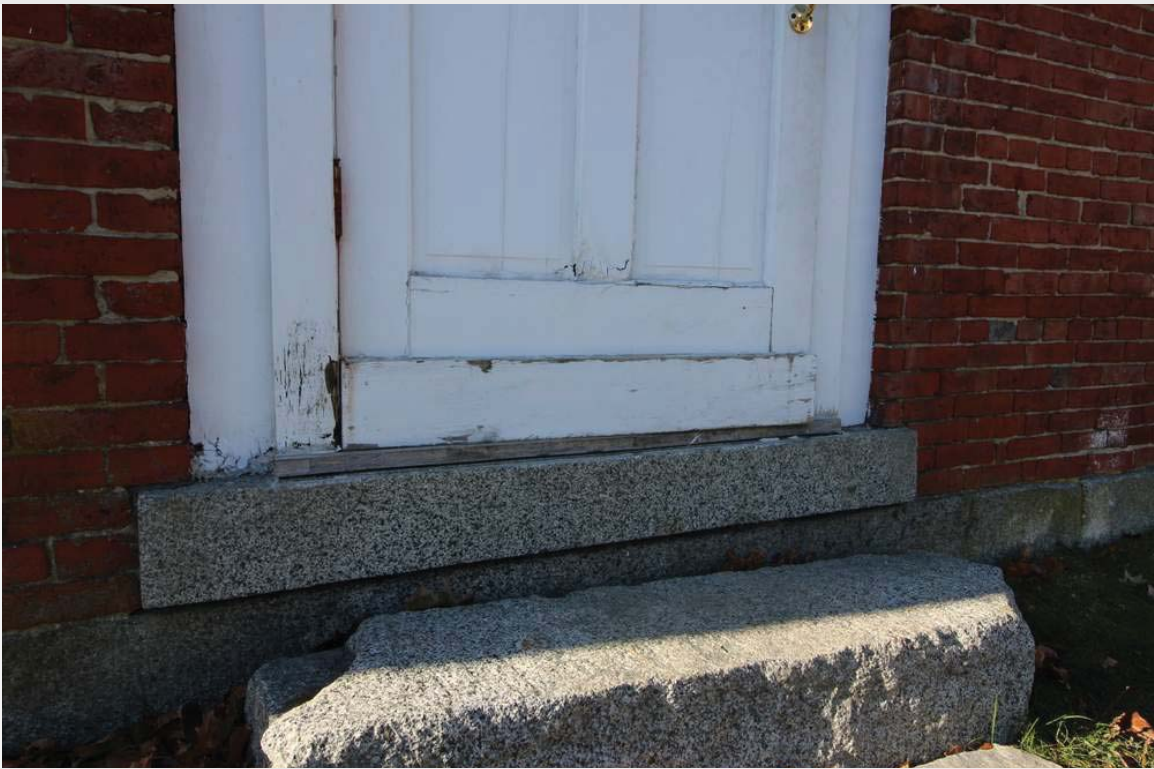
The door is a later replacement and is showing signs of rot. Instead of repair, it may make sense to reproduce the vertical plank door drawn in the HABS details.
