PTF
02.8.2022 Dariusz Mielinski Justyna Mielinski
Wojciech Mielinski Consulting Drawings Wojciech Mielinski Dziwny, 101-0224
PRESERVATION TIMBER FRAMING P.O. Box 28 03041 207-698-1552
12

Image 1: Front elevation framing plan showing fenestration and chimneys.

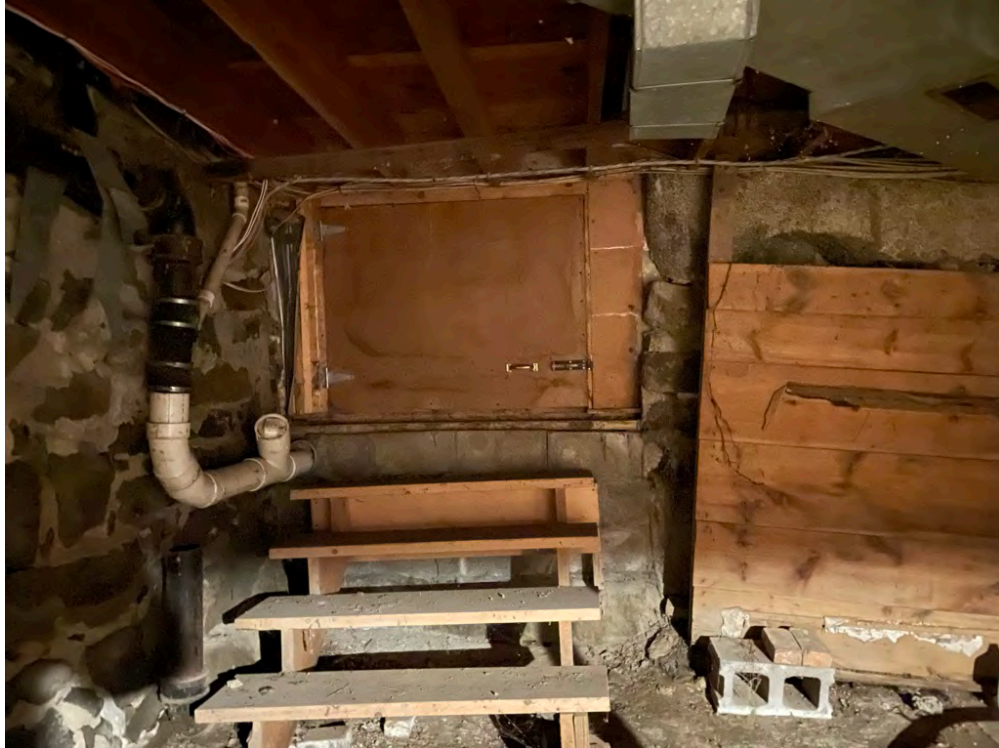
Image 33: View of basement, southwest corner looking west, showing replaced floor framing.

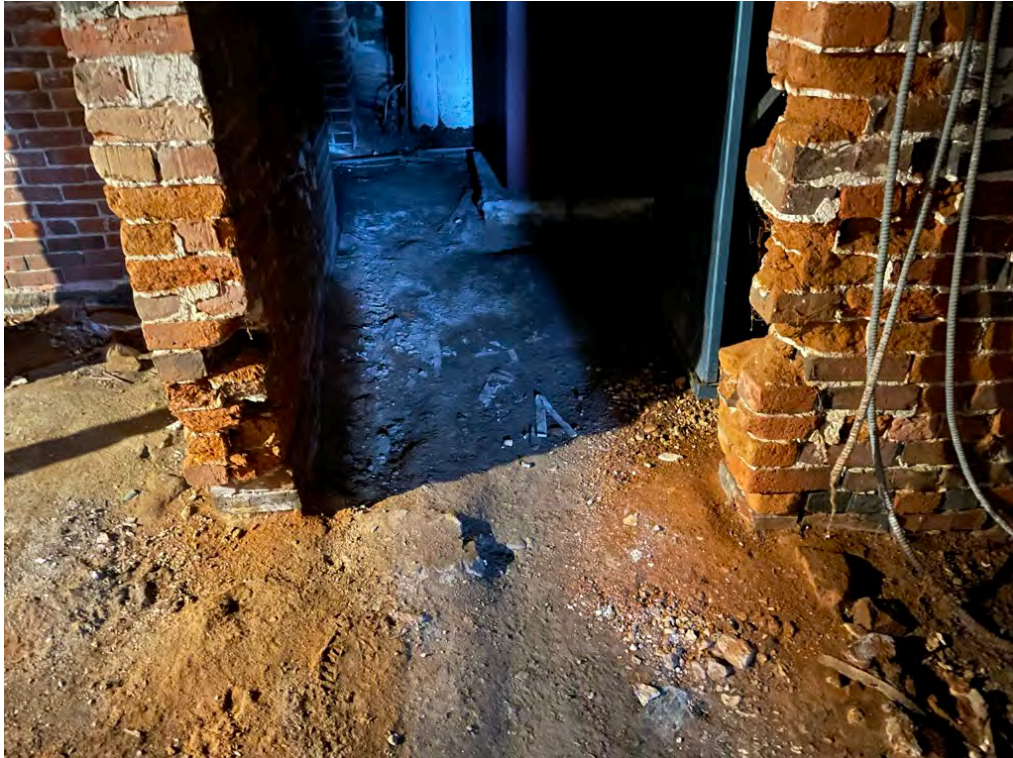
Image 34: View of typical rising damp in basement brick elements.

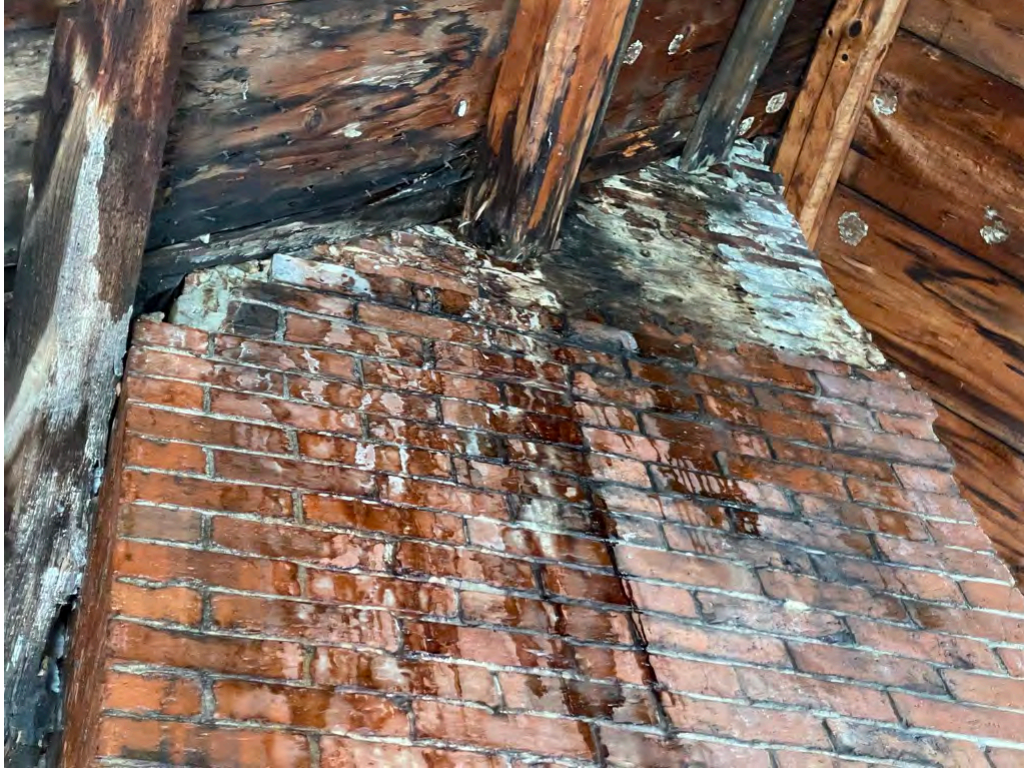
Image 35: Detail of east chimney showing the stack extension on top of the original corbel, and old water staining.

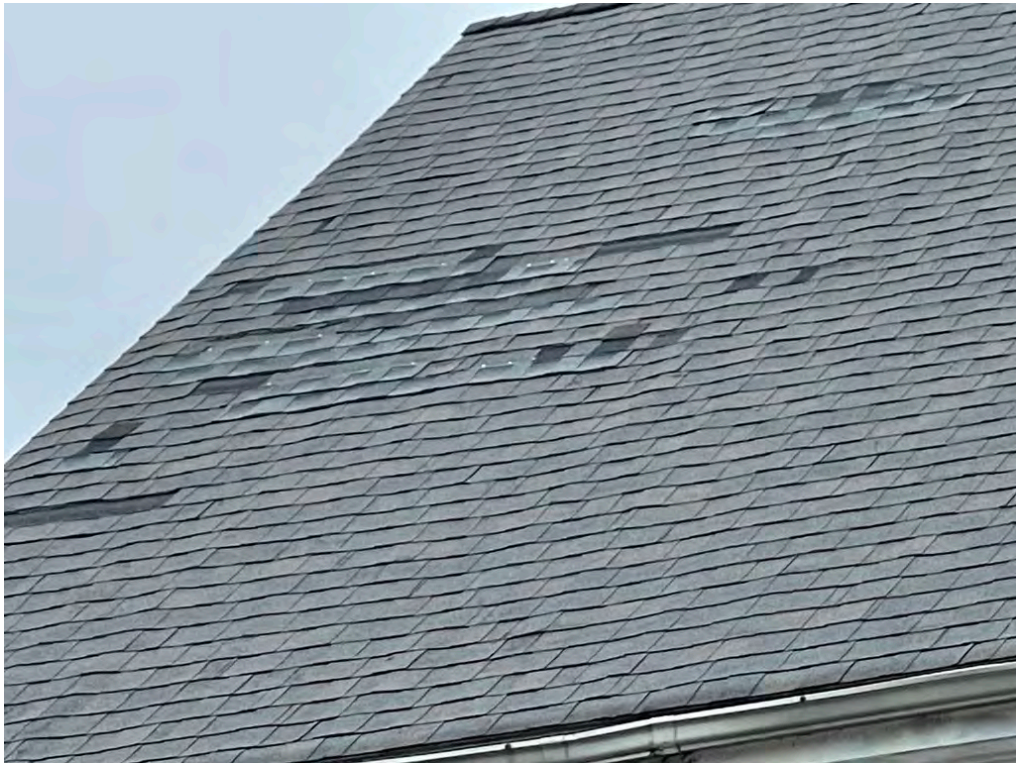
Image 36: Detail of the roof, main house, south elevation, showing shingle repairs.

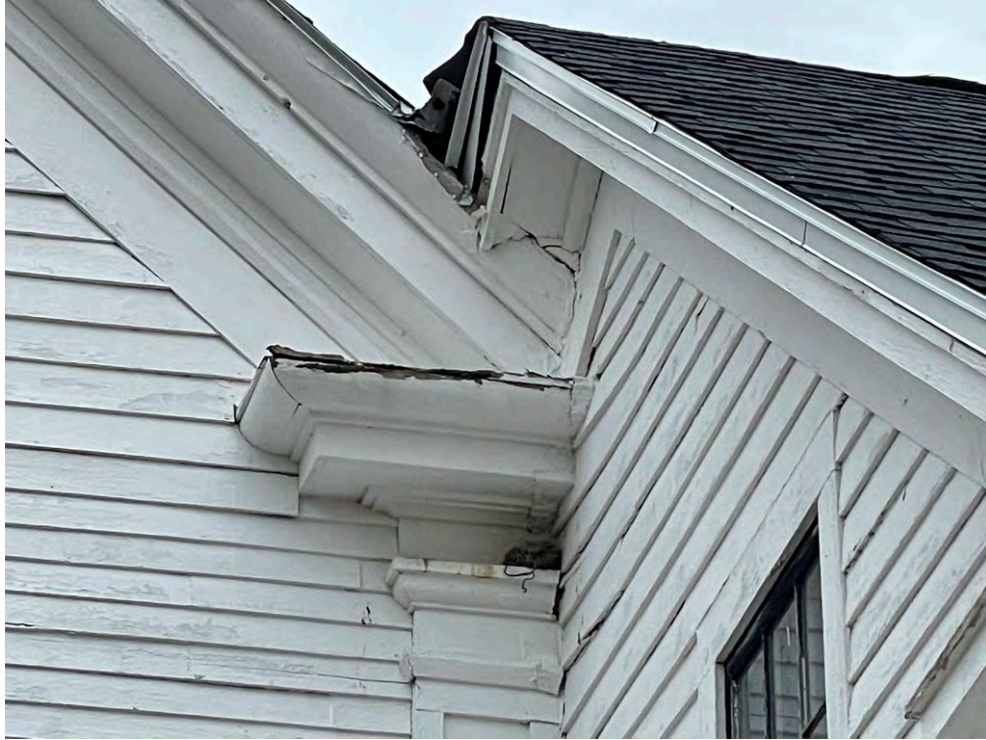
Image 37: Detail of cornice return and intersection of the main house to the ell, west elevation, showing water-related damage due to poor flashing and drainage.

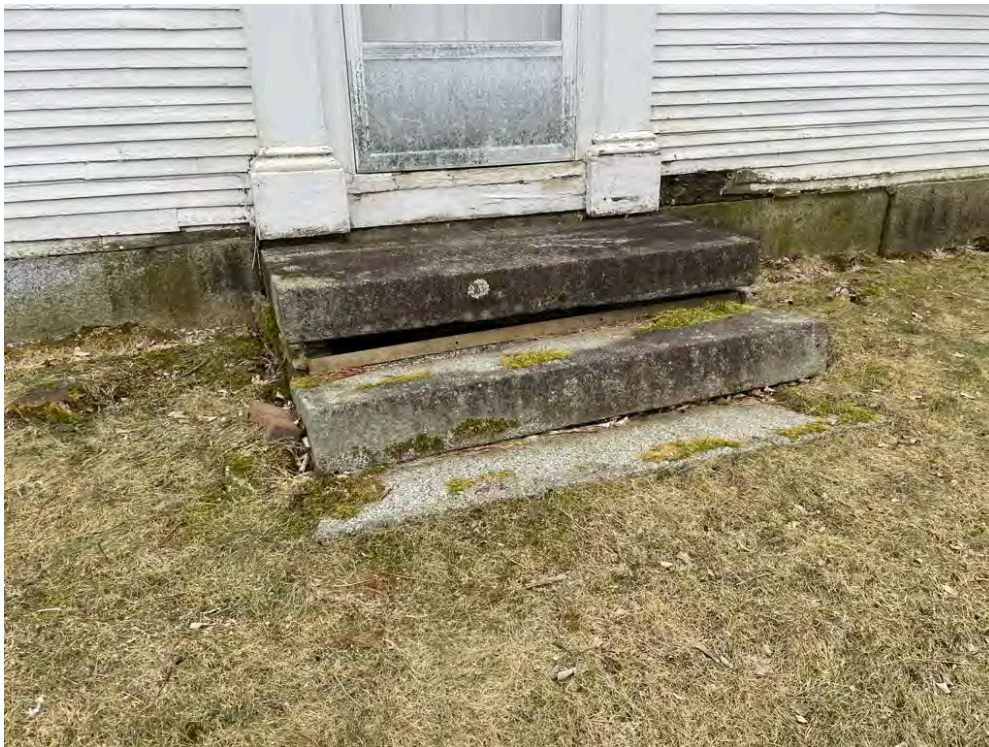
Image 38: Detail of the front entrance showing decay in original wooden elements and deflection of the stone steps.

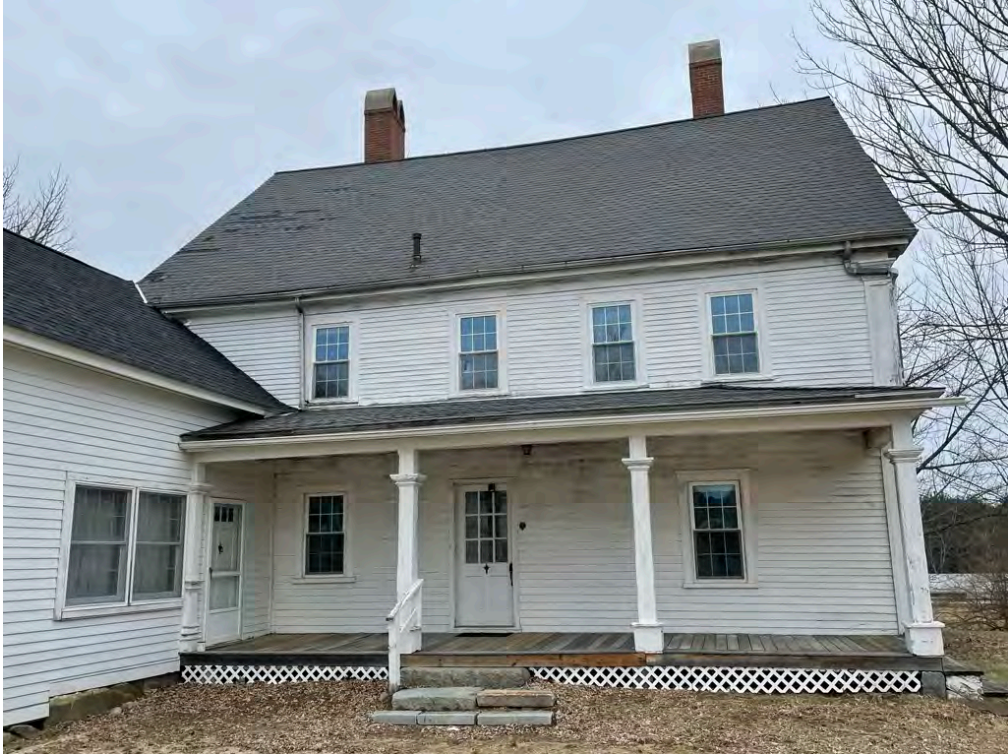
Image 39: View of the porch looking north, showing downward settling to the east.

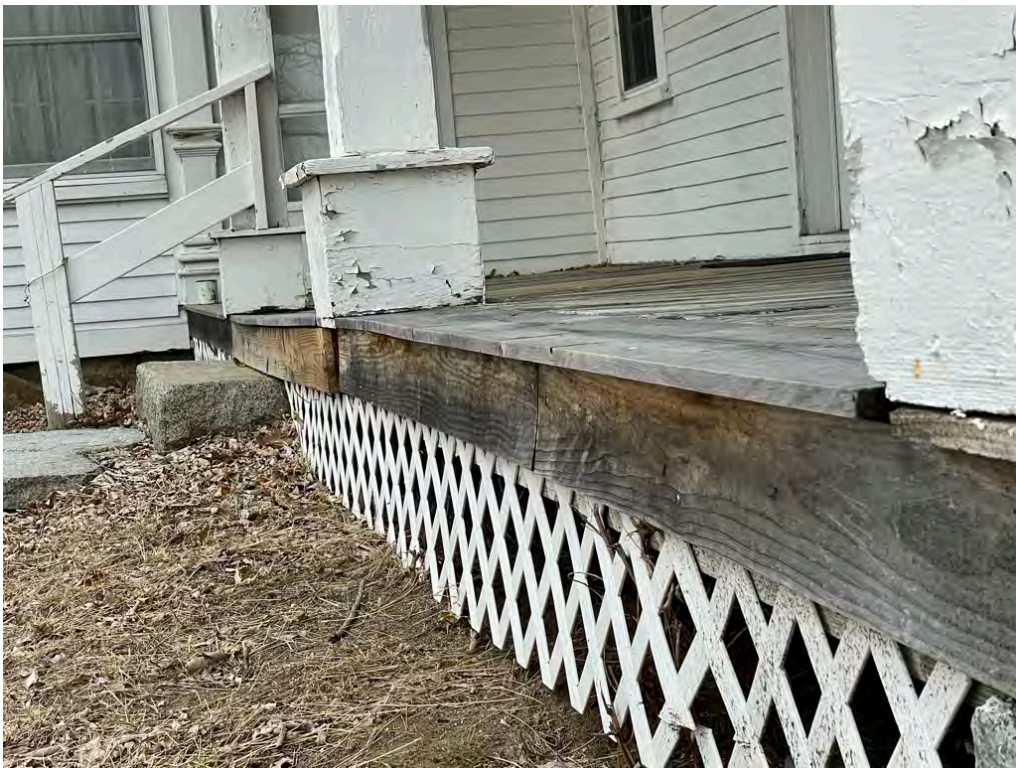
Image 40: Detail of the porch showing downward settling and decay of wooden elements.

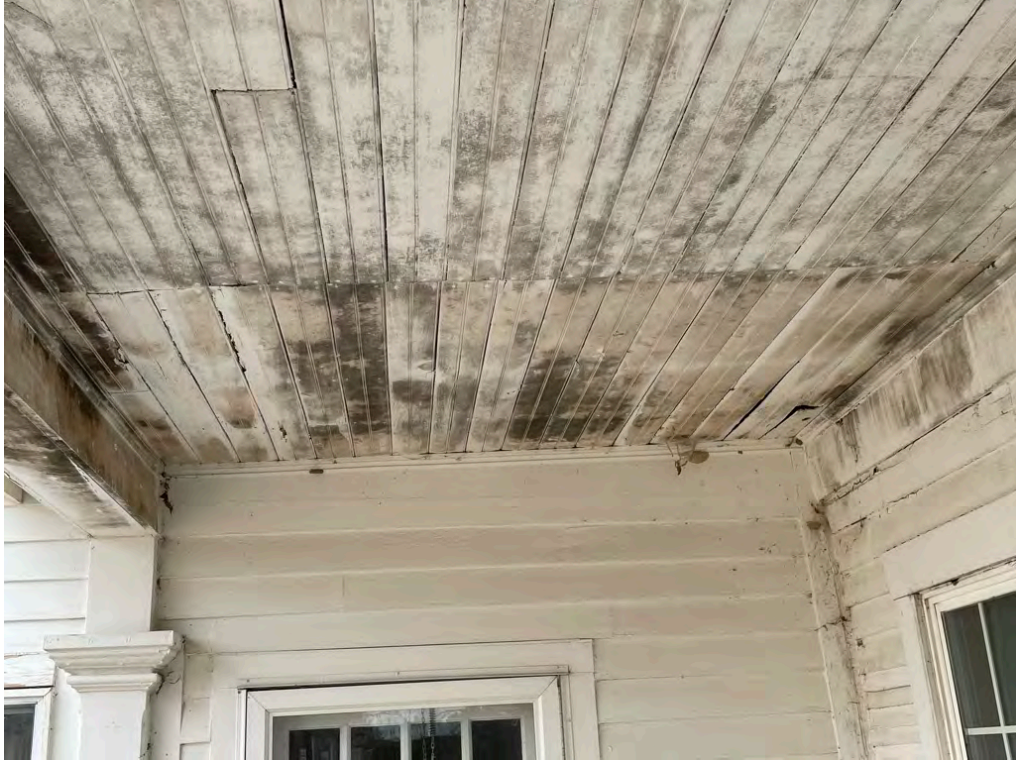
Image 41: Detail of the porch ceiling looking west, showing mold growth and warping due to past water infiltration.

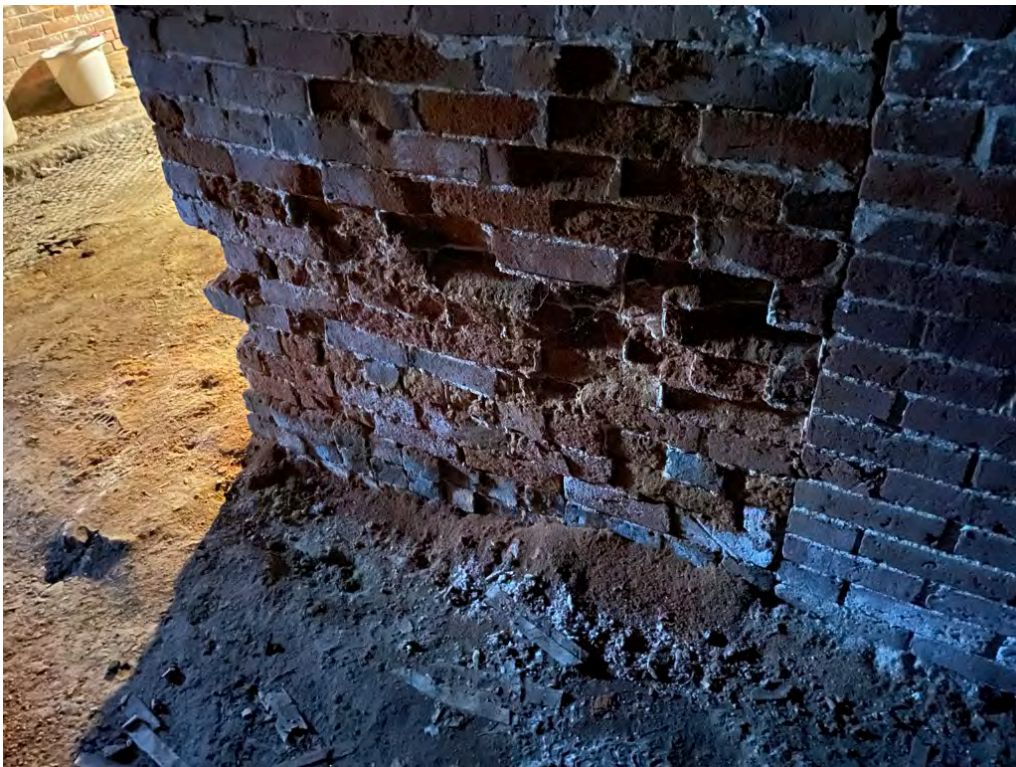
Image 42: Detail of the west chimney base in the basement showing typical brick deterioration from rising damp.

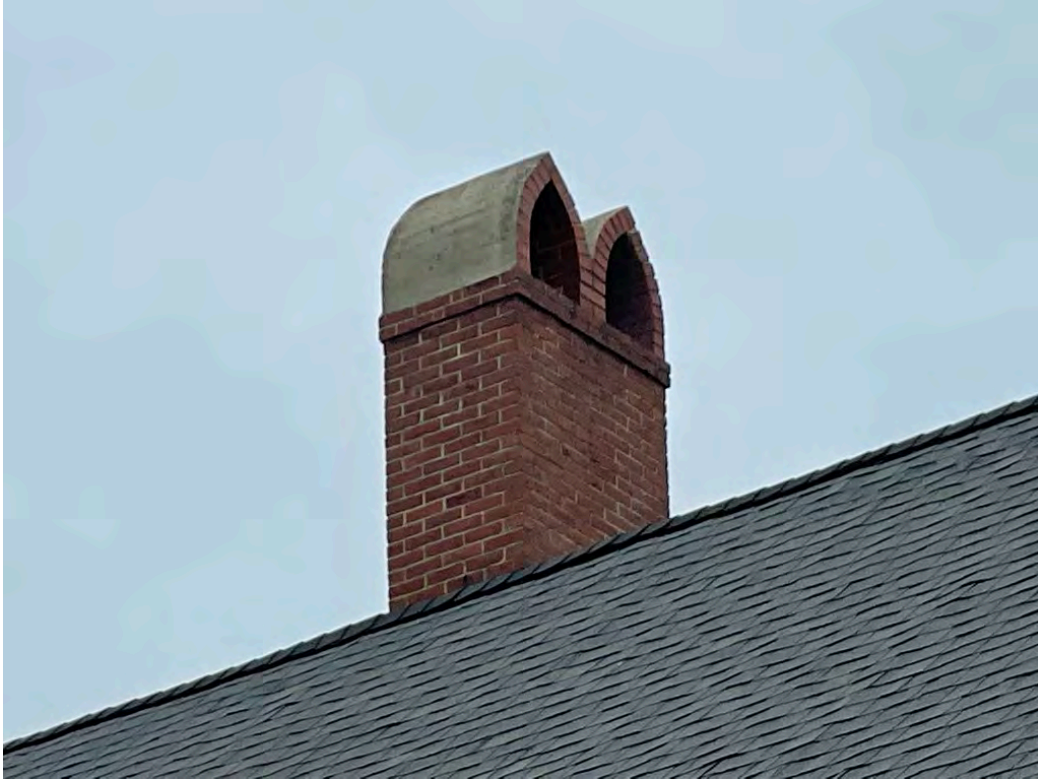
Image 43: View of the east chimney stack looking southwest, showing typical, minor mortar loss.

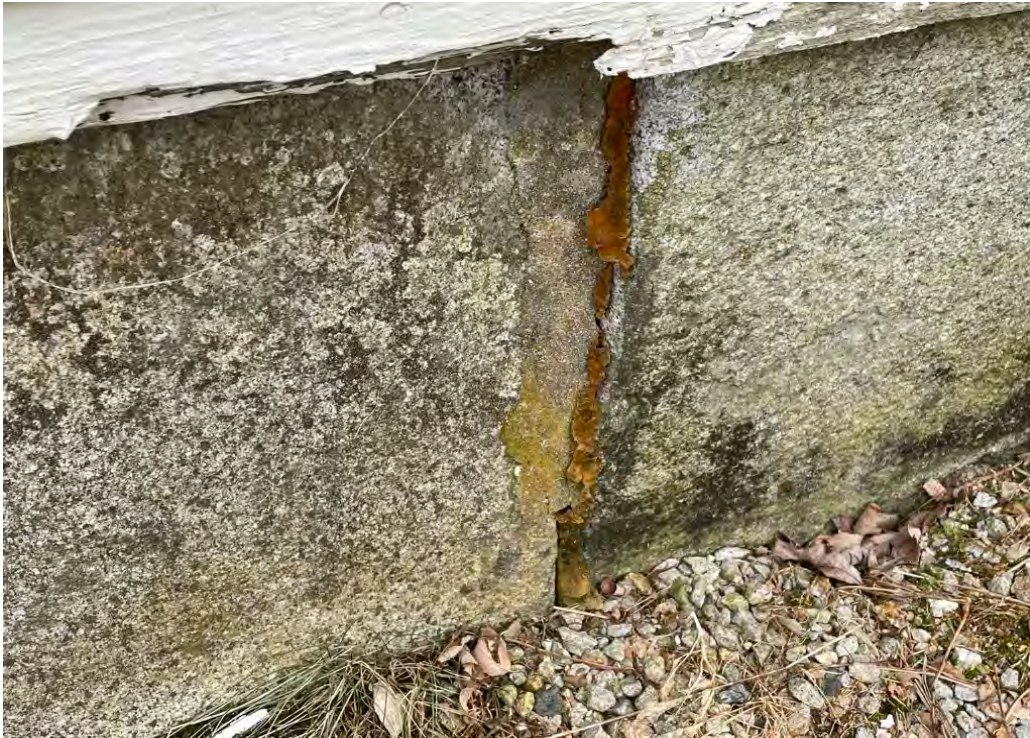
Image 44: Detail of foundation stone joint showing typical mortar loss and Spray foam repair.

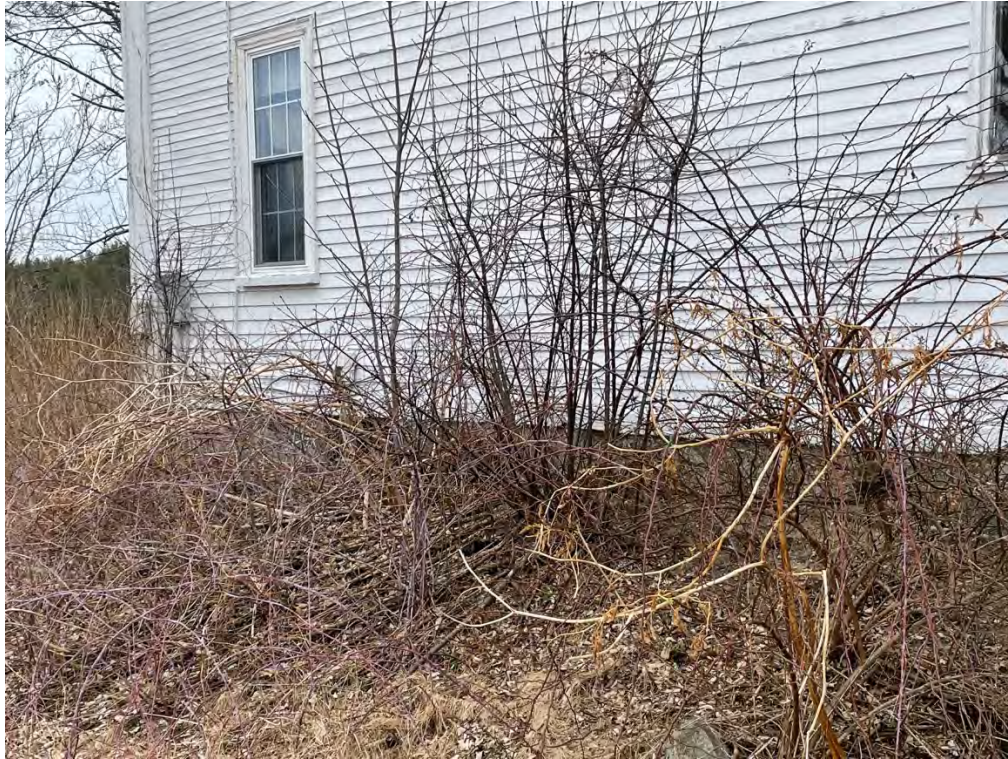
Image 45: View of the west elevation foundation, main house, showing overgrowth.

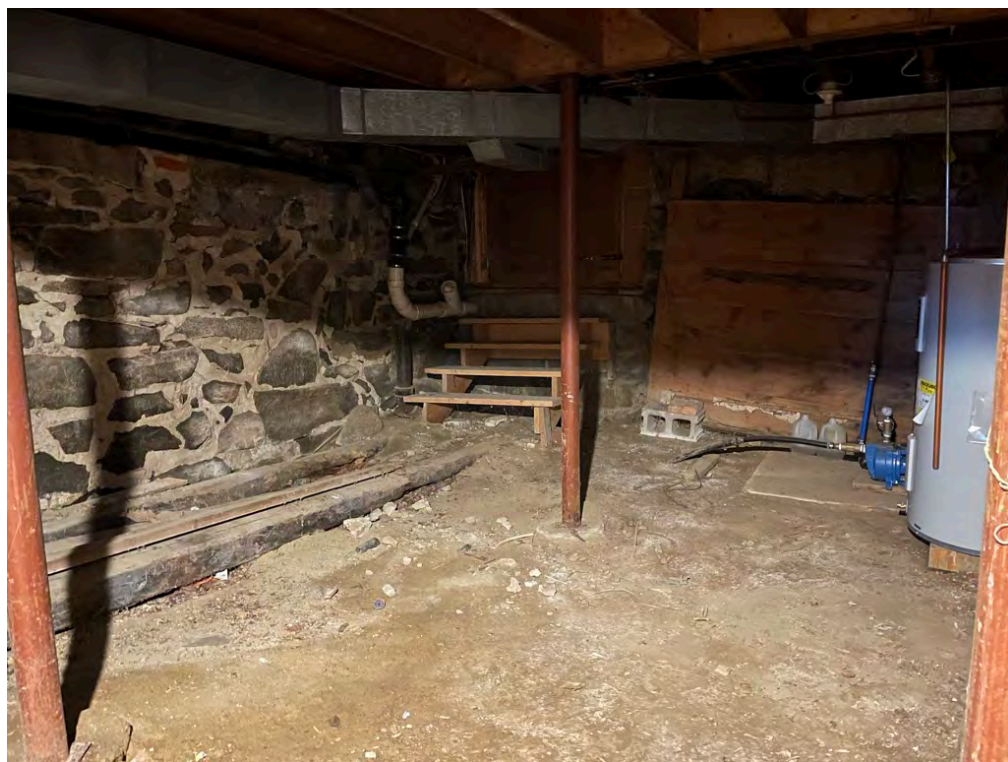
Image 46: View of the south basement wall, west end, looking west.

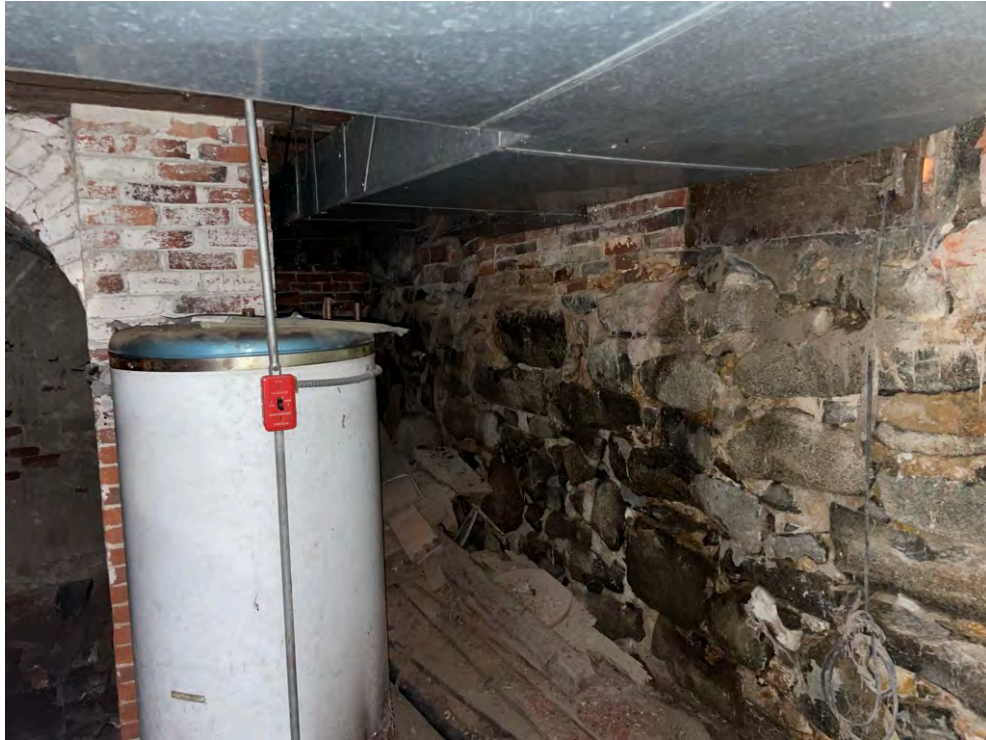
Image 47: View of the north foundation wall, west end, looking west.

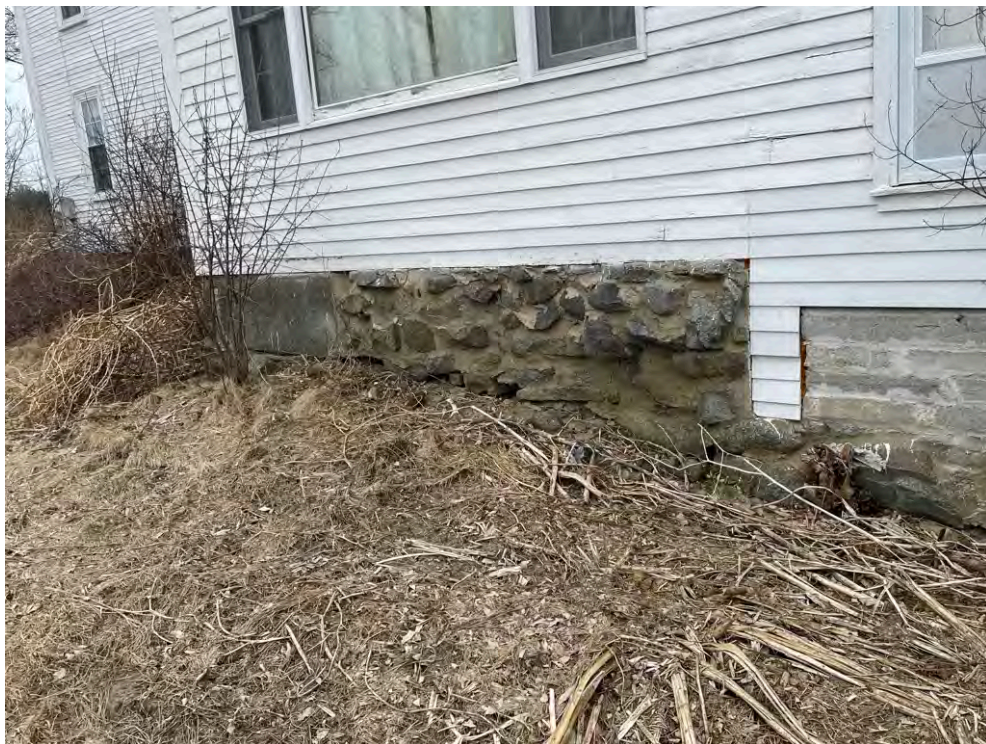
Image 48: View of the west elevation of the ell's foundation, showing variable materials and conditions.

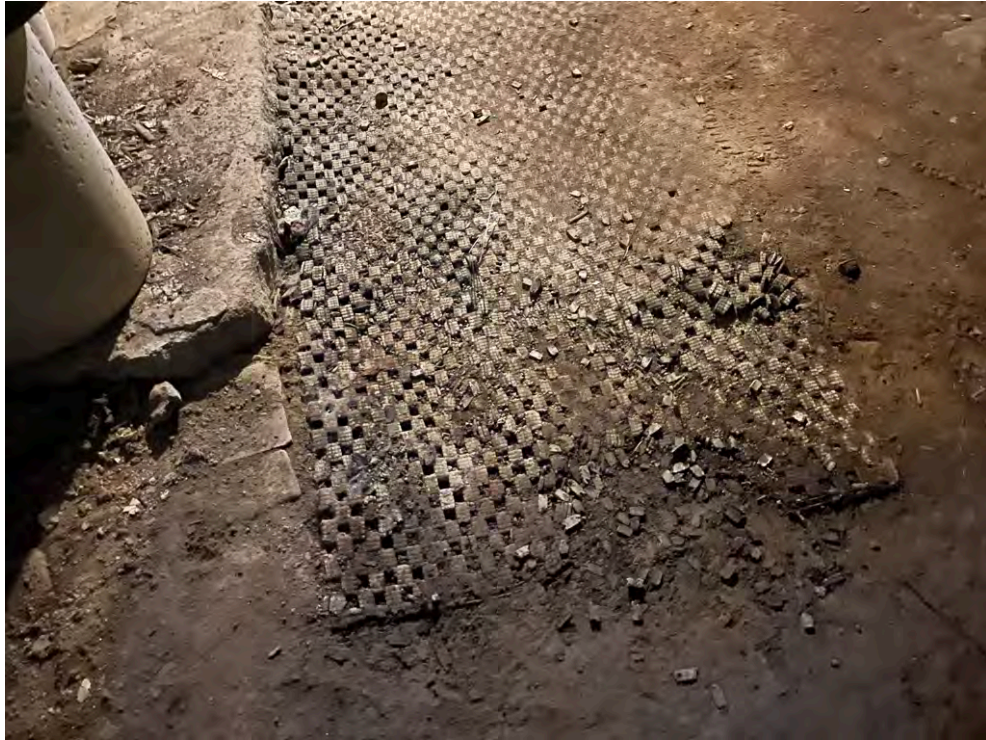
Image 49: Detail of the basement floor showing compacted soil from past water infiltration, and degraded floor mats.

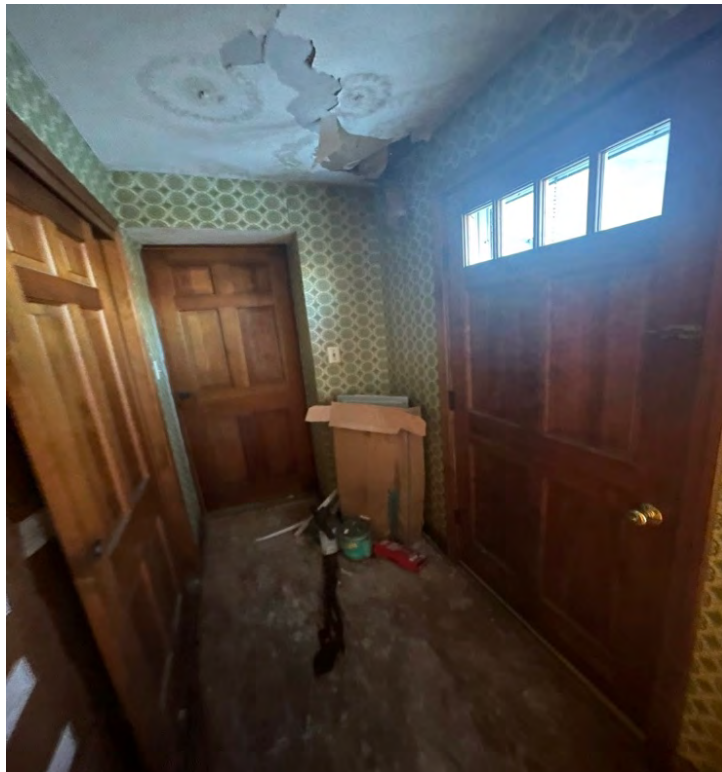
Image 50: View of the entrance to the ell apartment showing collapsed drywall from a past leak.

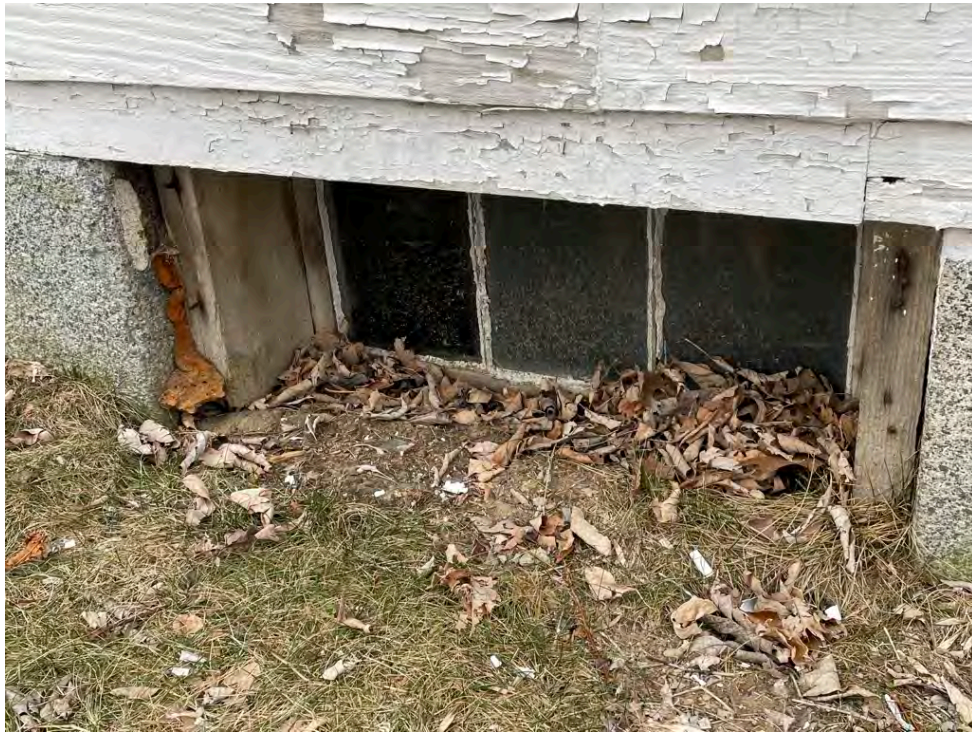
Image 51: Detail of a basement window, east elevation, showing encroaching grade and decay of the window elements.

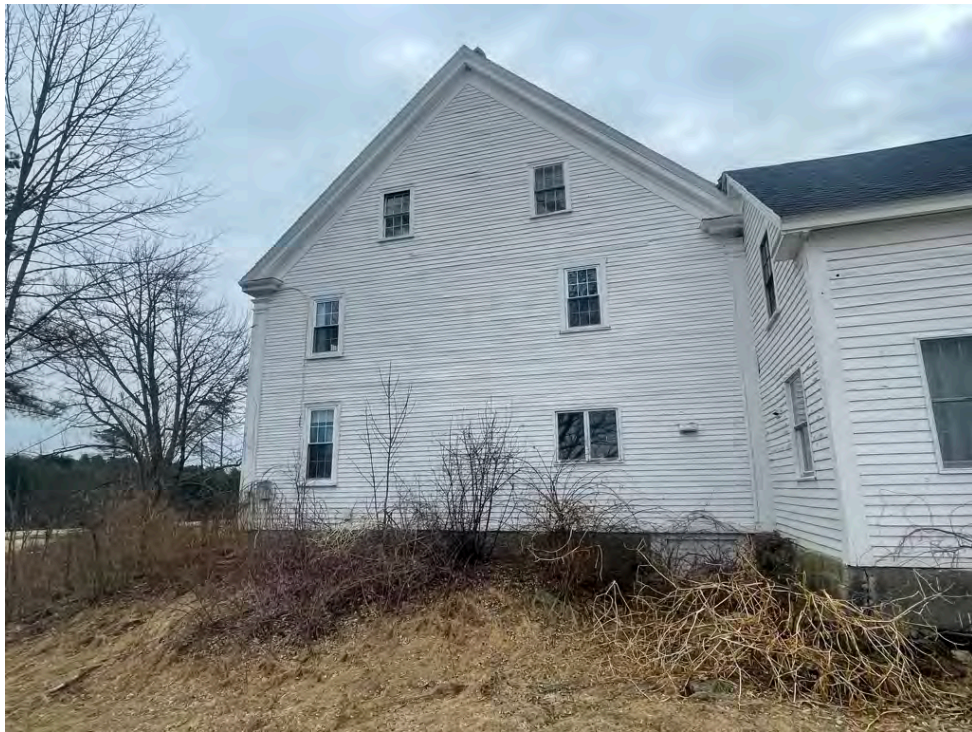
Image 52: View of the west elevation looking east, showing overgrowth.
