Historic Building Conditions Assessment

**Wagon Hill Farm, the Bickford-Chesley House, c. 1804
156 Piscataqua Road, Durham, New Hampshire**

**Prepared by Steven C. Mallory, Architectural Conservator
April, 2022**

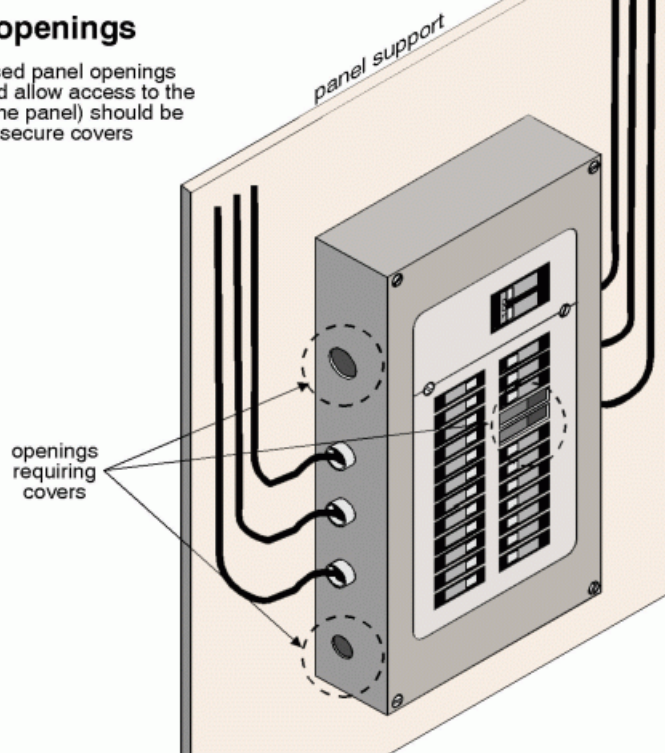
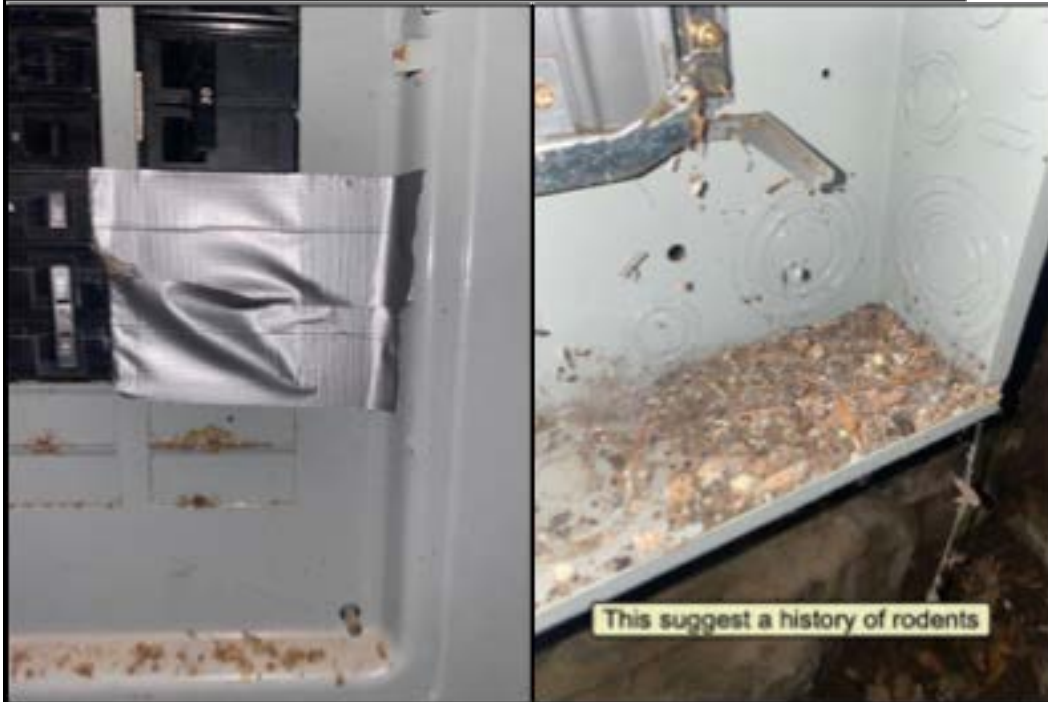
Panel openings

any exposed panel openings (that would allow access to the inside of the panel) should be fitted with secure covers

Missing knockouts in small panel Debris bottom of larger panel

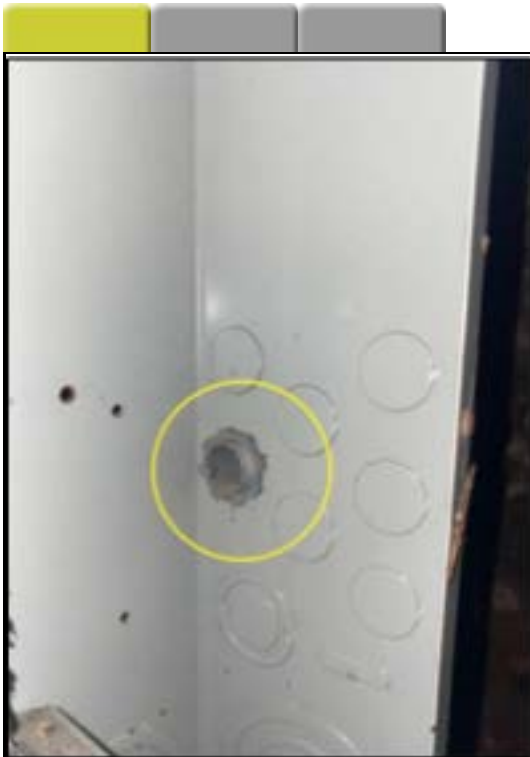
Small opening in large panel

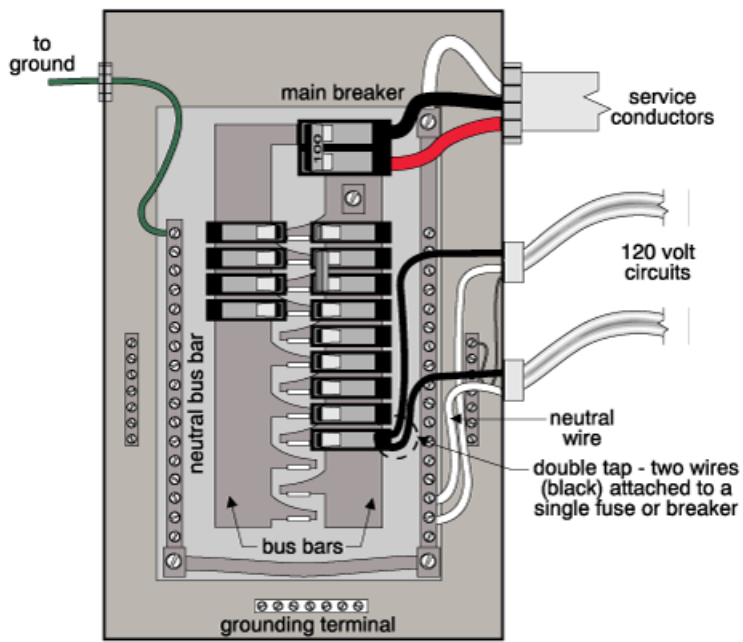
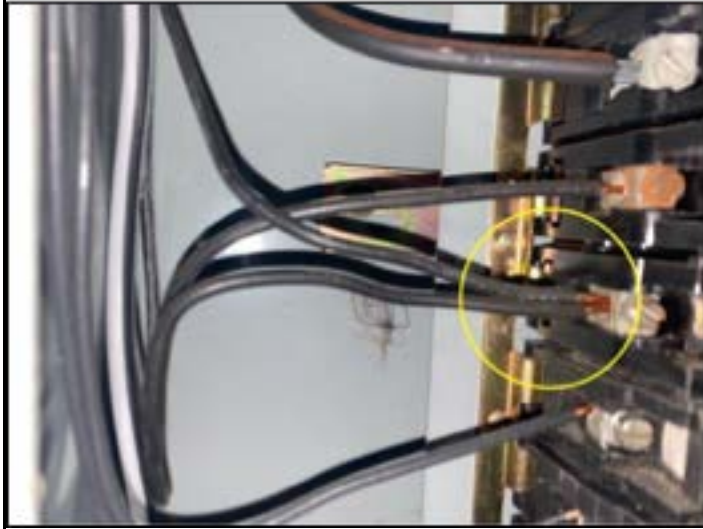
3. Condition: Double taps

Double tapping (double lugging)

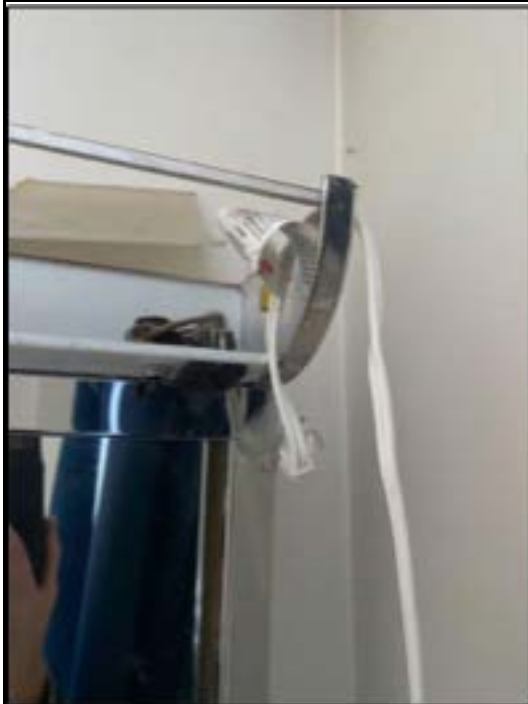
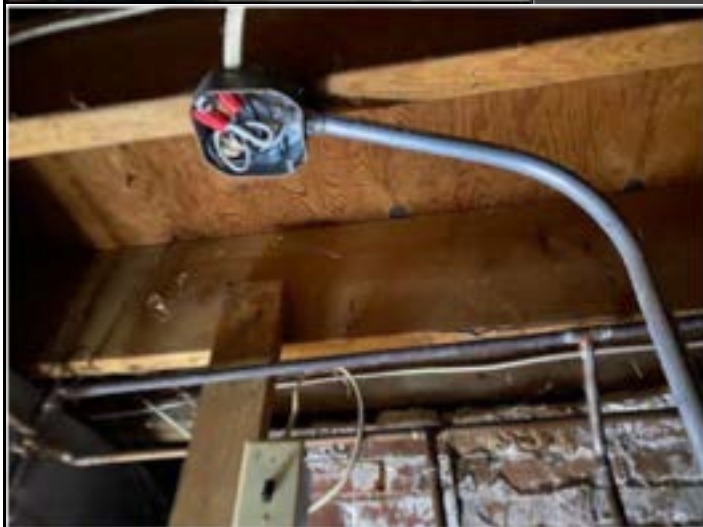
There are numerous junction boxes on the property that are missing their protective covering, leaving live wiring exposed. This is a shock hazard that should be properly repaired.

Example of open junction box

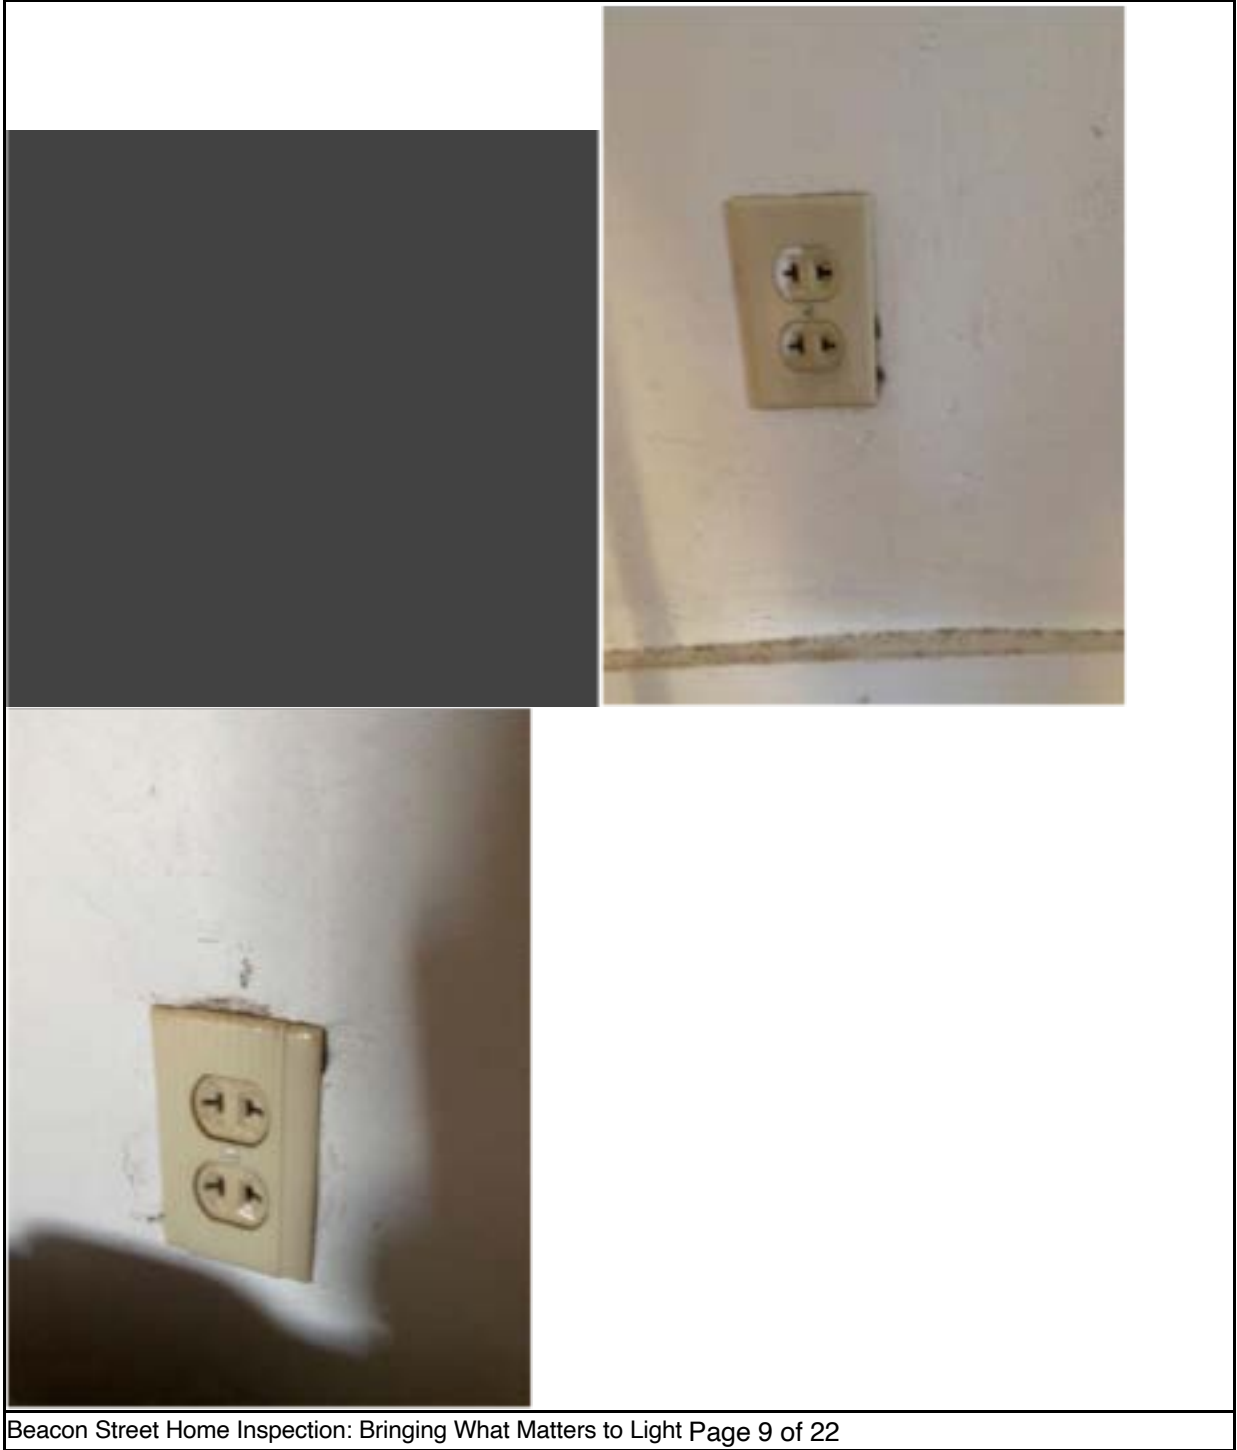
The majority of outlets in the original building - on both floors - are two-prong, ungrounded outlets, (with the exception of the first floor bathroom and kitchen). These outlets remain an active part of the home's electrical system. Ungrounded outlets are considered to be obsolete by today's electrical standards and usage. They may prove to be a short or shock hazard due to the lack of a proper ground. It is recommend that you remove or upgrade any ungrounded outlets remaining in the home. This would require re-wiring most of the building. Discuss with a licensed electrician. **Implication(s):** Electric shock

Example of outdated outlets Example of outdated outlets

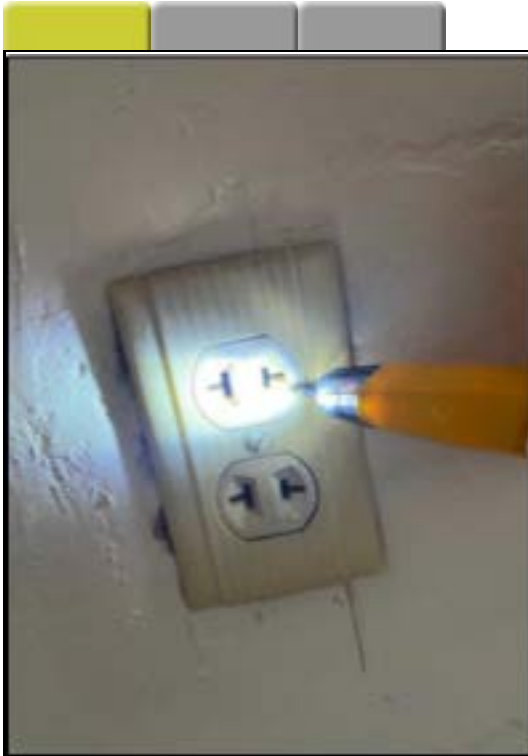
Active two-prongs in bulilding

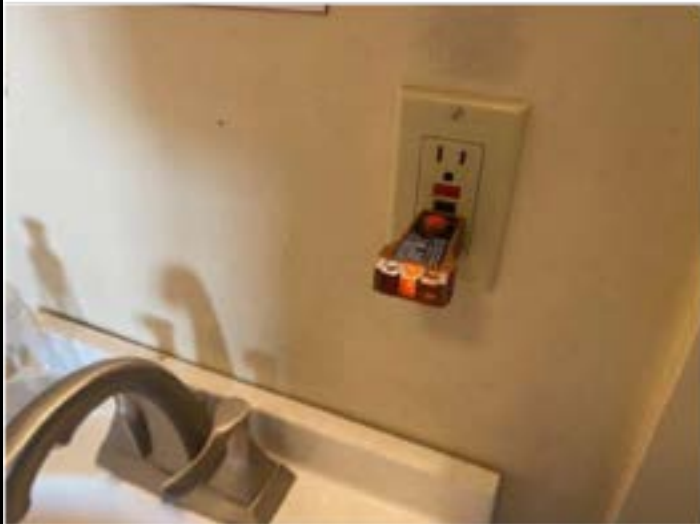
No ground at bathroom outlet

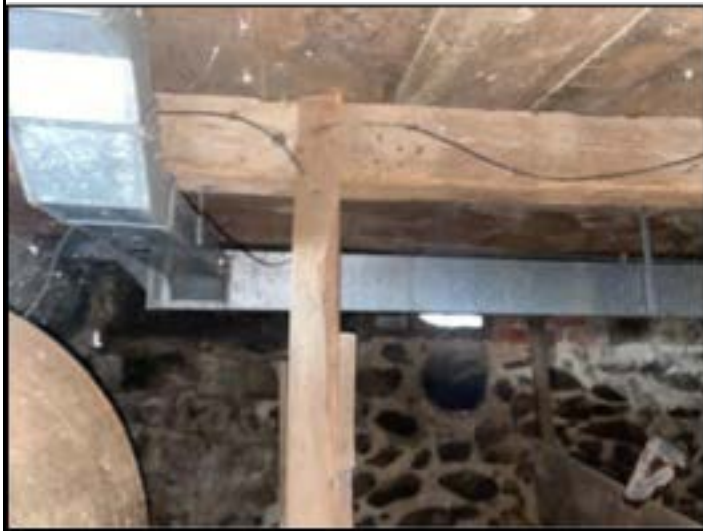
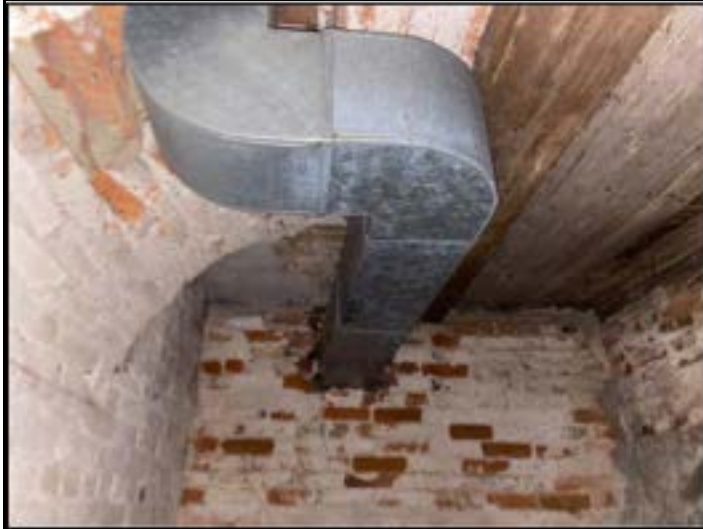
Furnace duct work uninsulated Furnace duct work uninsulated

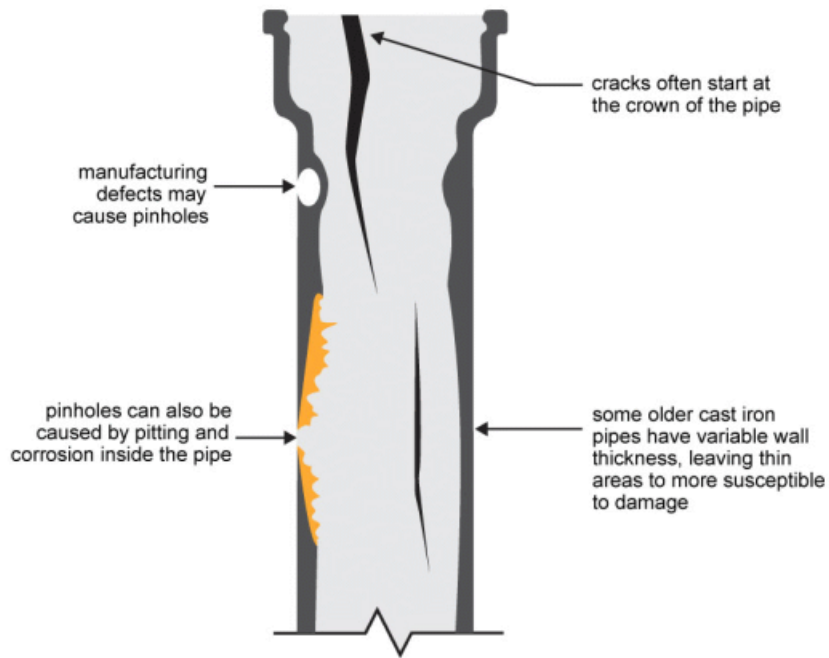
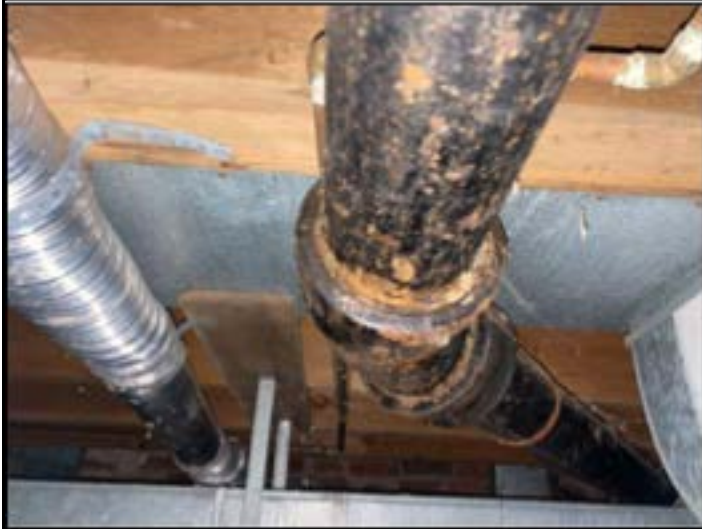
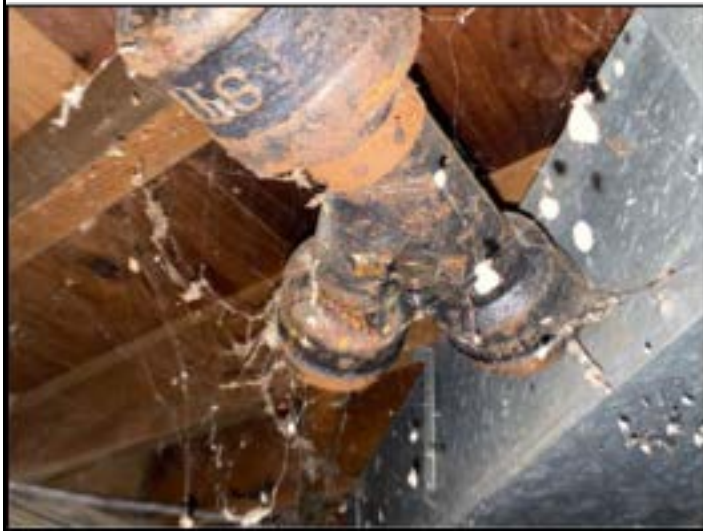
Pinholing and cracks in cast iron stacks

Surface rusting on cast iron drains Rusting on cast iron unions

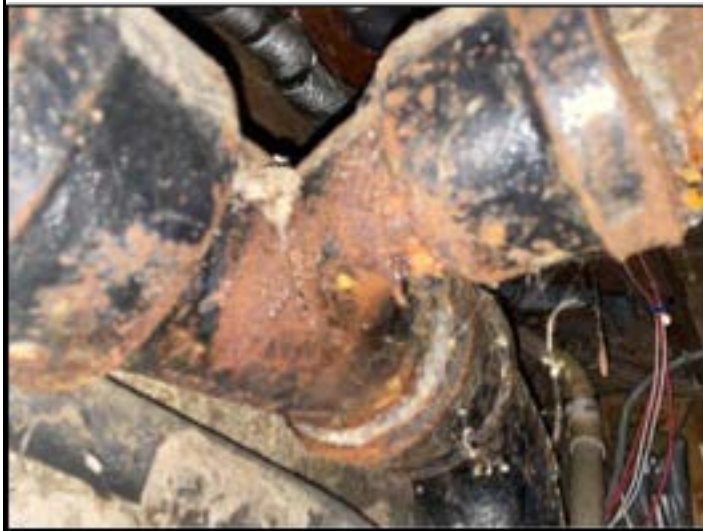
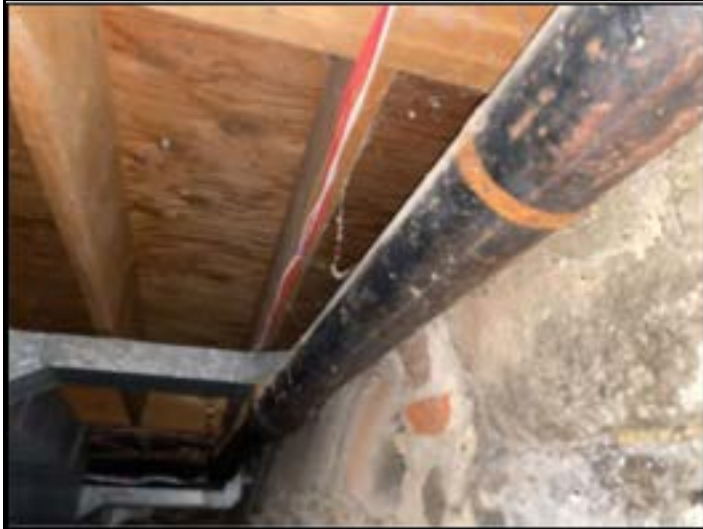
Heavy rusting at union Example of rusting in drain lines

Example of rusting in drain lines

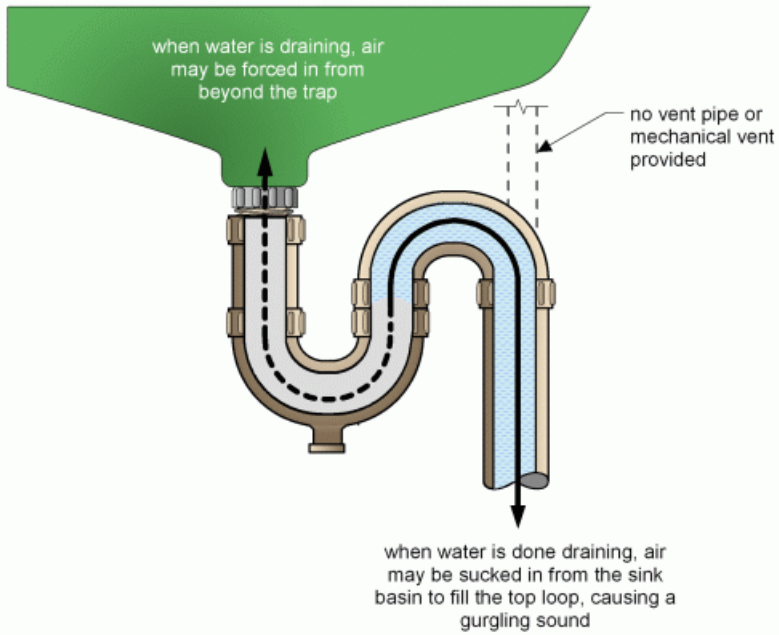
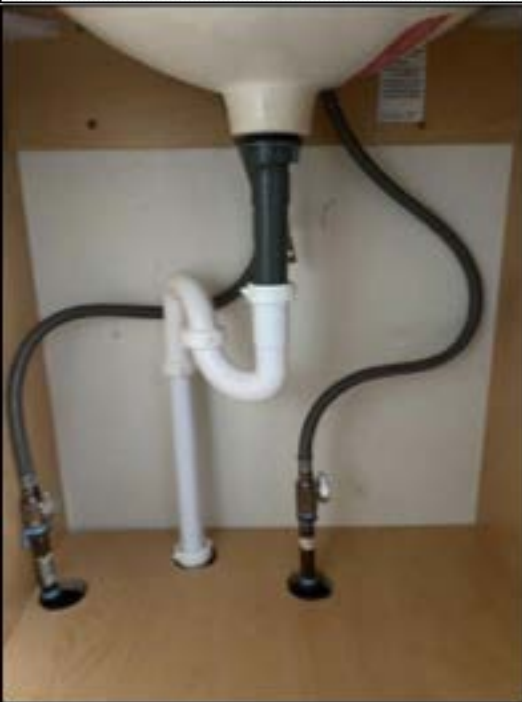
The second floor vanity sink is serviced by a suboptimal trap configuration. The drain line contains what's called an S-trap. These configurations oftentimes can be self-siphoning, suggesting that water draining from the line can also drain the trap. P traps are universally considered to be more reliable and effective. Discuss feature with a licensed plumber and consider improving.

S-traps can lead to siphoning

S-trap, may self-siphon

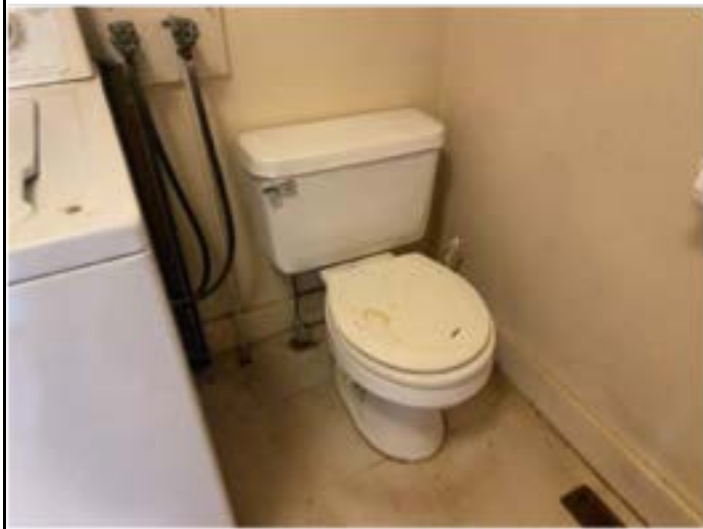
Most of the plumbing fixtures in the building are loose and not properly secured. Improvements are needed.

Loose toilet in first floor bathroom

Loose toilet

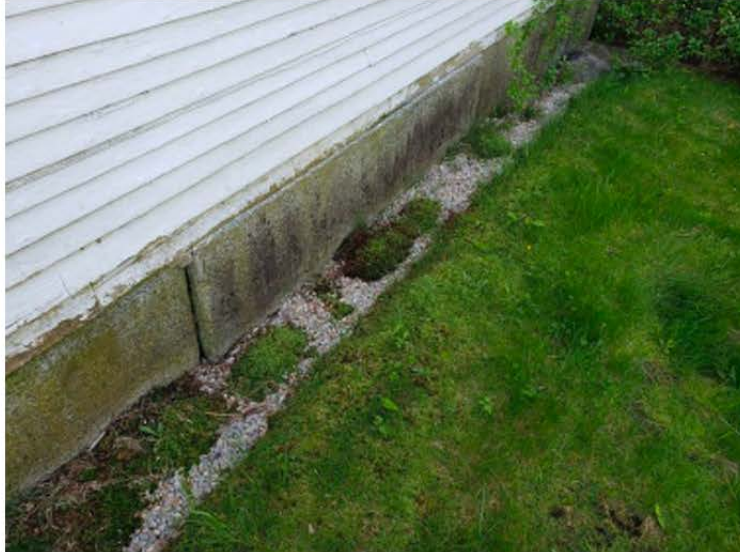
Photo 3
Shifted stones at north elevation of main house (facing southwest)

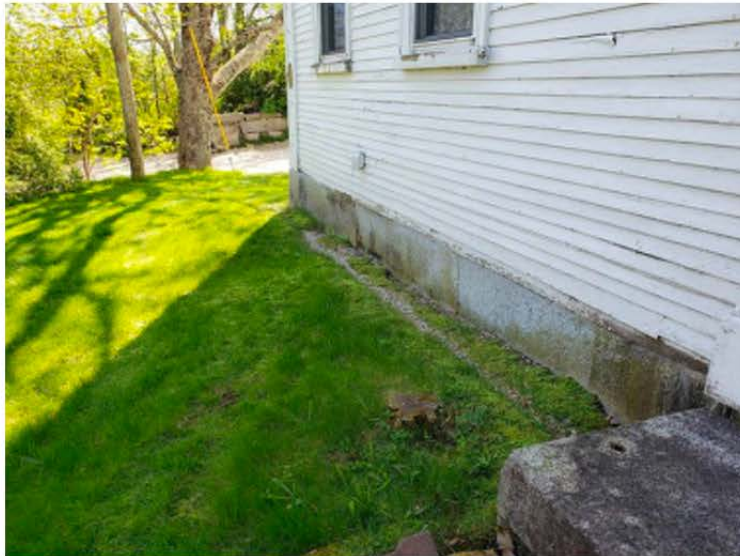
Photo 4
Shifted stones at north elevation of main house (facing southeast)

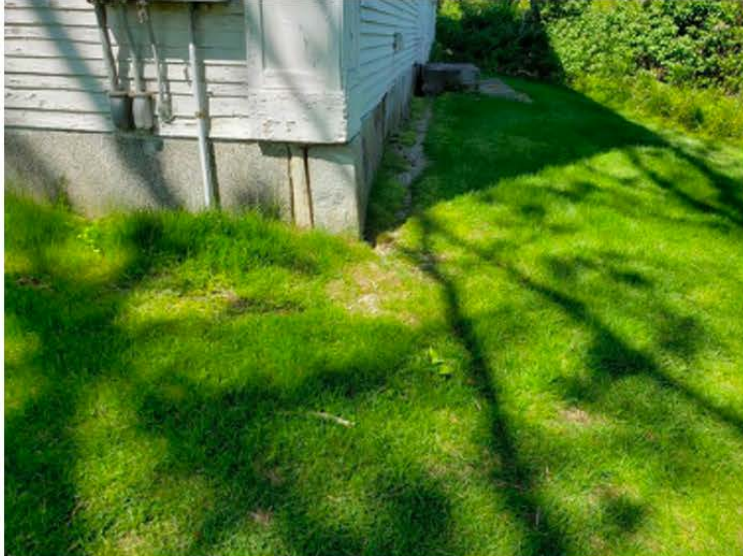
Photo 5
Shifted stones at northeast corner of main house (facing west)

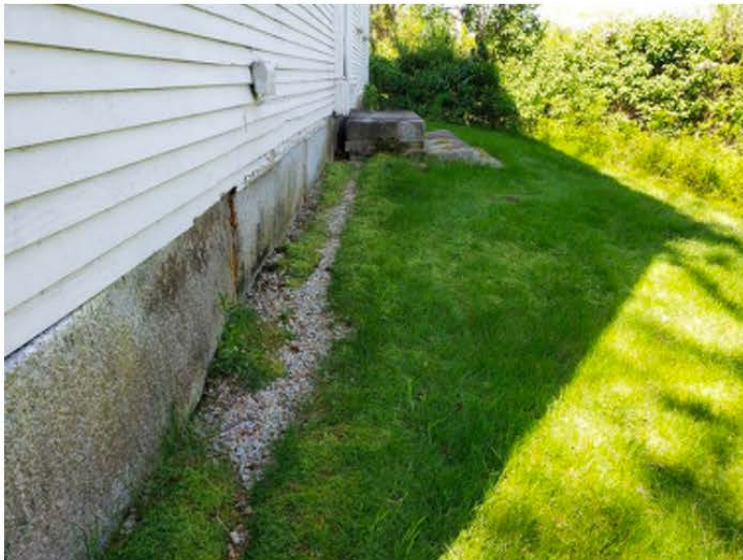
Photo 6
Shifted stones at north elevation, including steps (facing west)

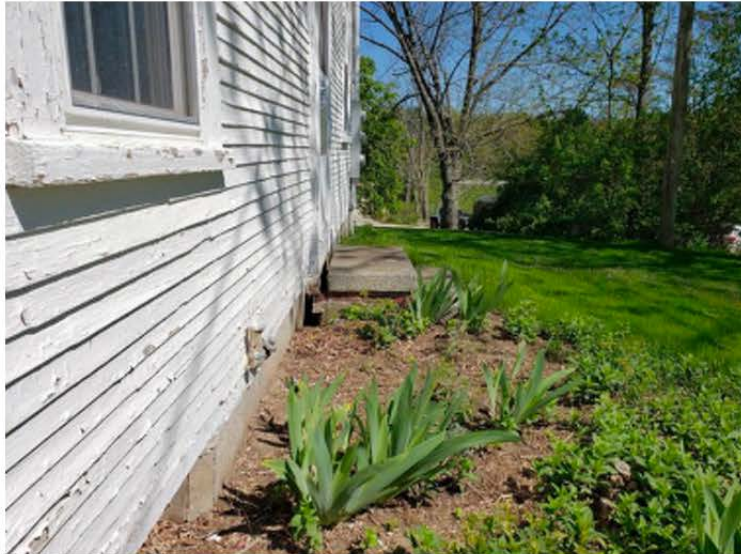
Photo 7
Shifted stones at east entry of main house (facing north)

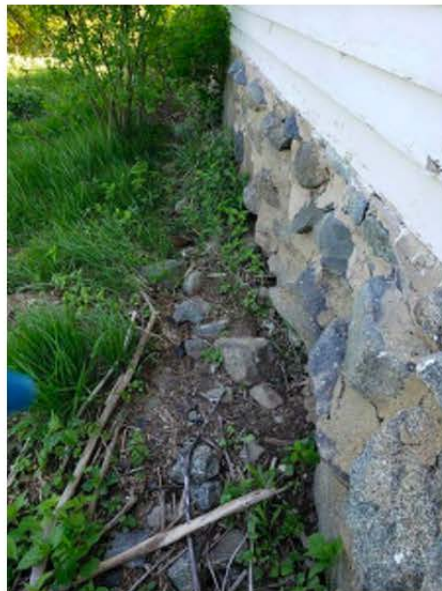
Photo 8
Foundation buckling inward at west wall of ell (facing north)

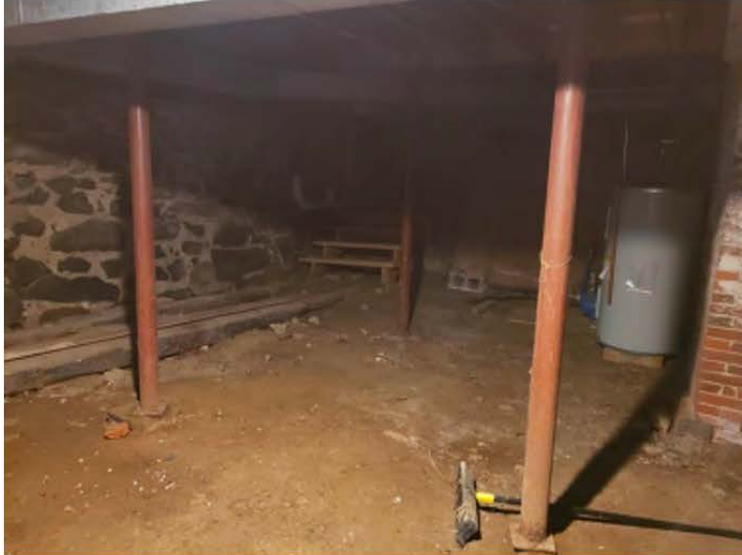
Photo 9
Previously re-framed section at southwest corner of main house

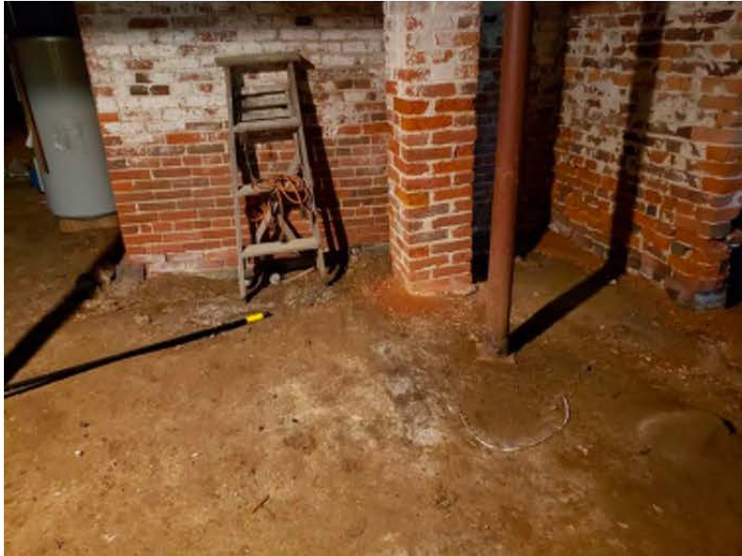
Photo 10
Corroded column base and deteriorated bases of brick walls and pier

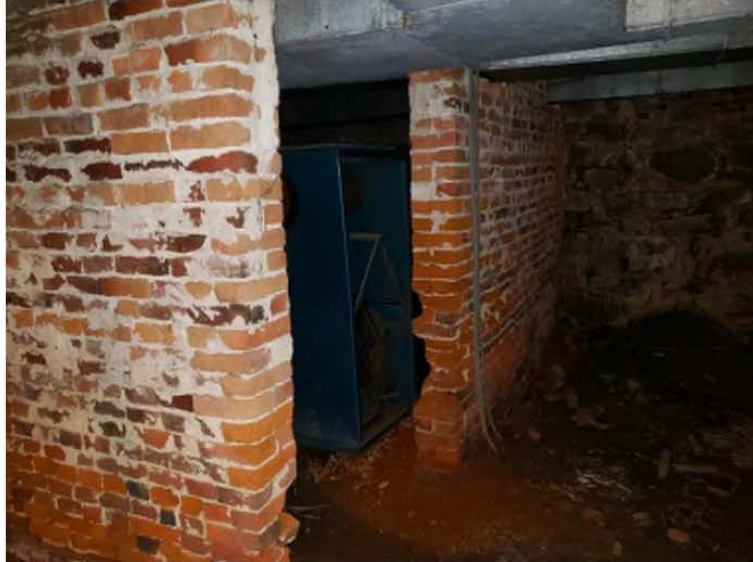
Photo 11
Deteriorated bases of brick walls

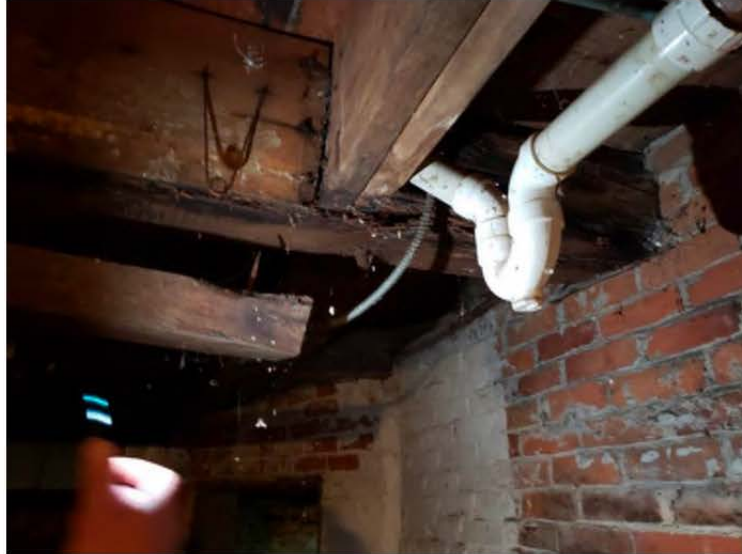
Photo 13

Rotted beam at intersection, also lacking proper connection hardware (facing north)

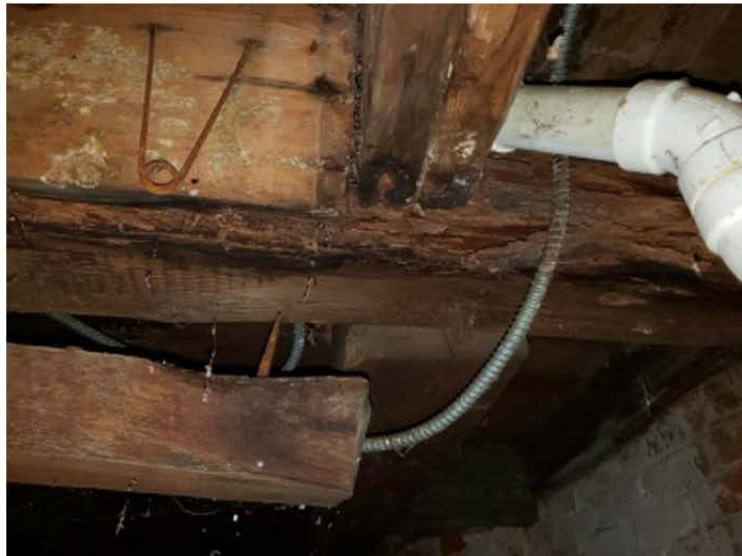
Photo 14

Rotted beam at intersection, also lacking proper connection hardware (facing north)

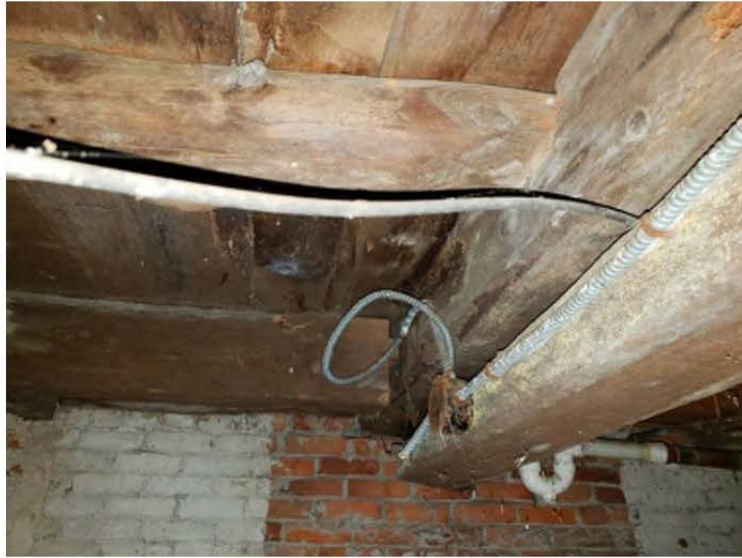
Photo 15: Various flush-framed conditions

Photo 15
Various flush-framed conditions

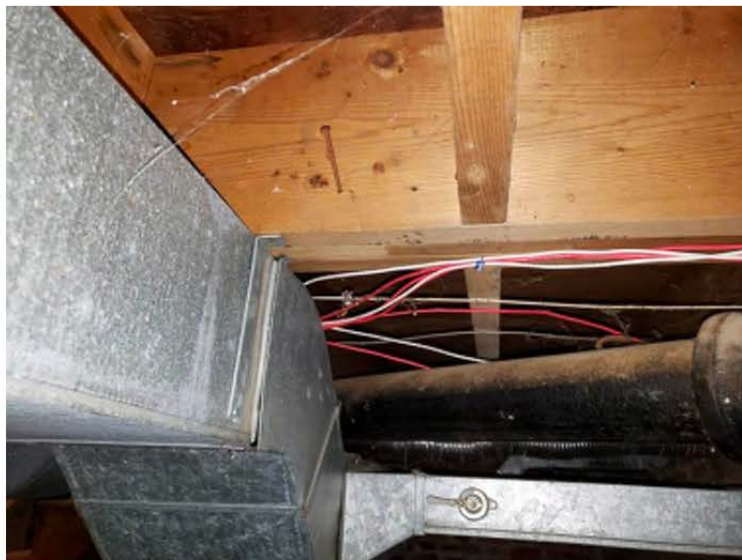
Photo 16: Reframed area at southwest corner of main house lacking hangers at common joists, beam is improperly spliced

Photo 16
Reframed area at southwest corner of main house lacking hangers at common joists,
beam is improperly spliced
