Historic Building Conditions Assessment

**Wagon Hill Farm, the Bickford-Chesley House, c. 1804
156 Piscataqua Road, Durham, New Hampshire**

**Prepared by Steven C. Mallory, Architectural Conservator
April, 2022**

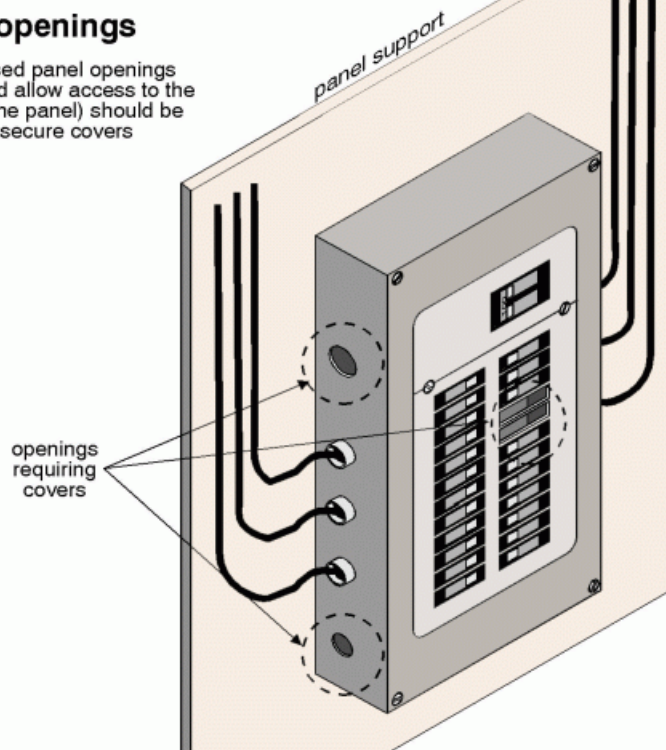
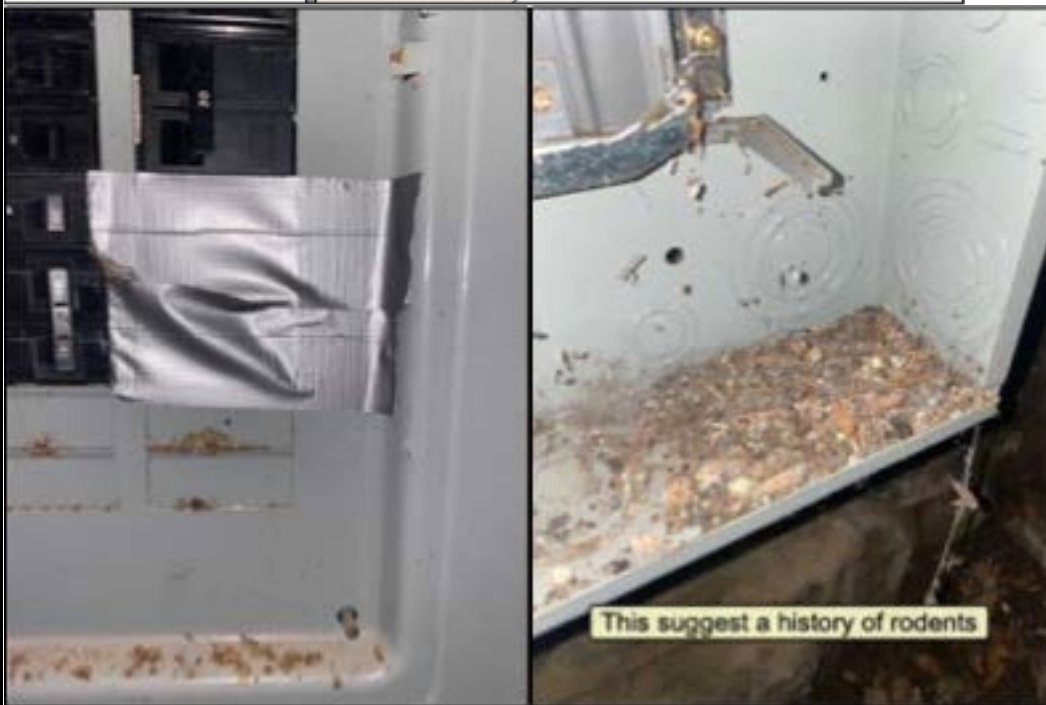
any exposed panel openings (that would allow access to the inside of the panel) should be fitted with secure covers

Missing knockouts in small panel Debris bottom of larger panel

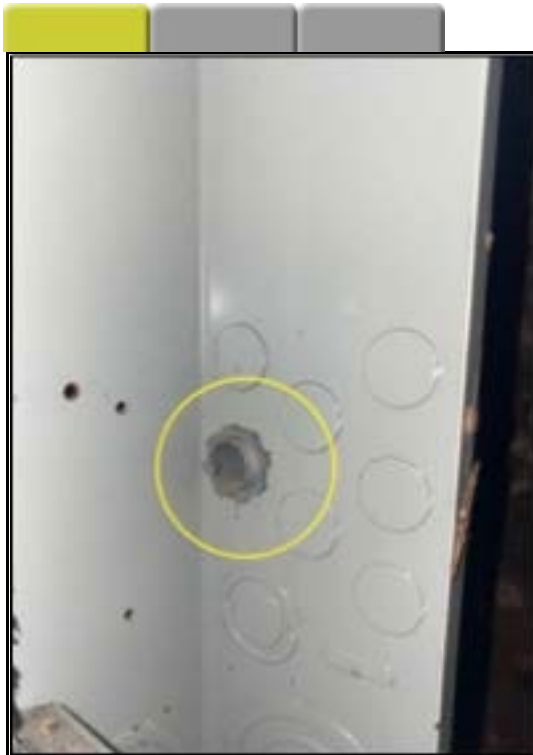
Small opening in large panel

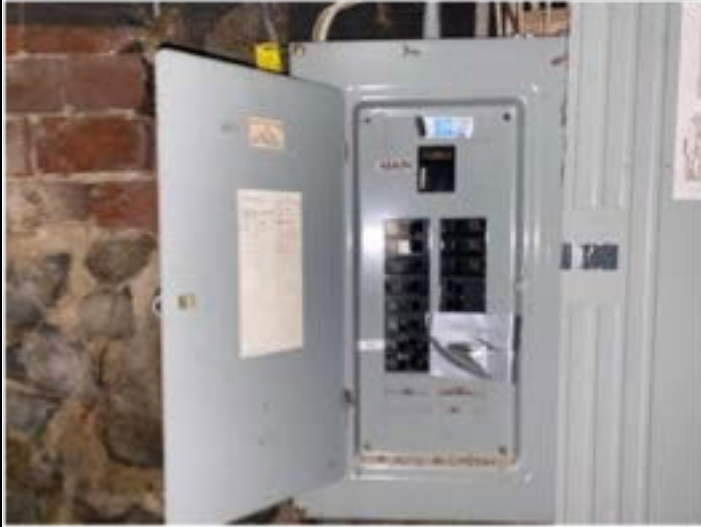
3. Condition: Double taps

Double tapping (double lugging)

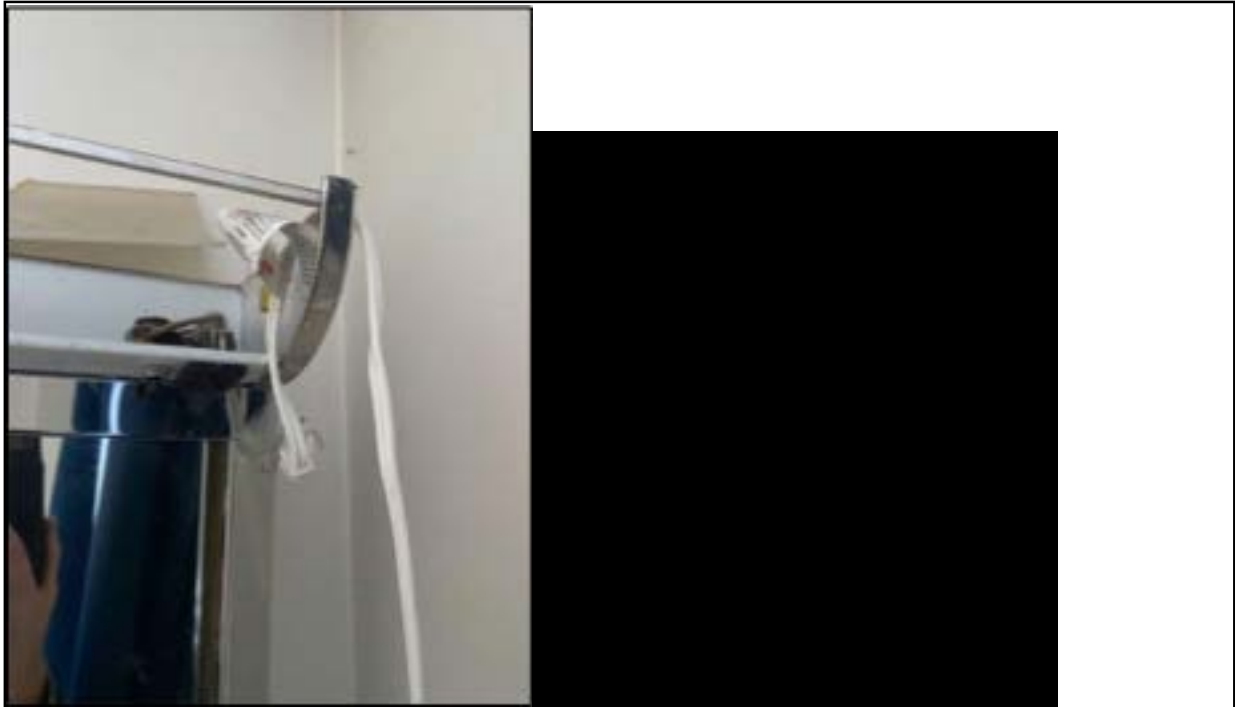
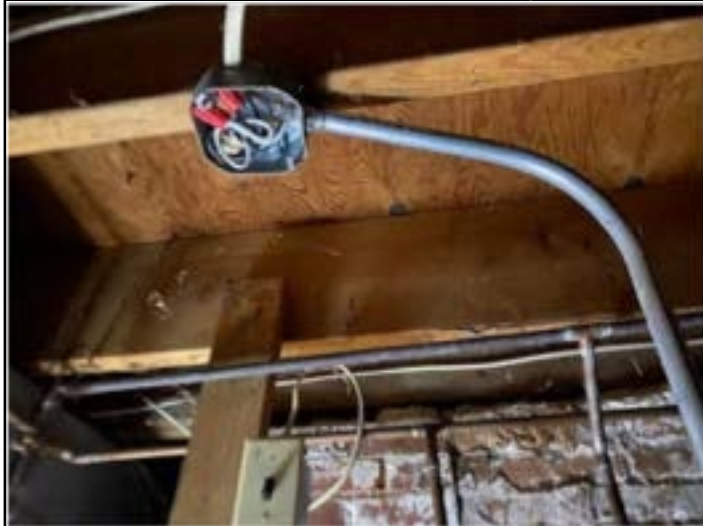
There are numerous junction boxes on the property that are missing their protective covering, leaving live wiring exposed. This is a shock hazard that should be properly repaired.

Example of open junction box

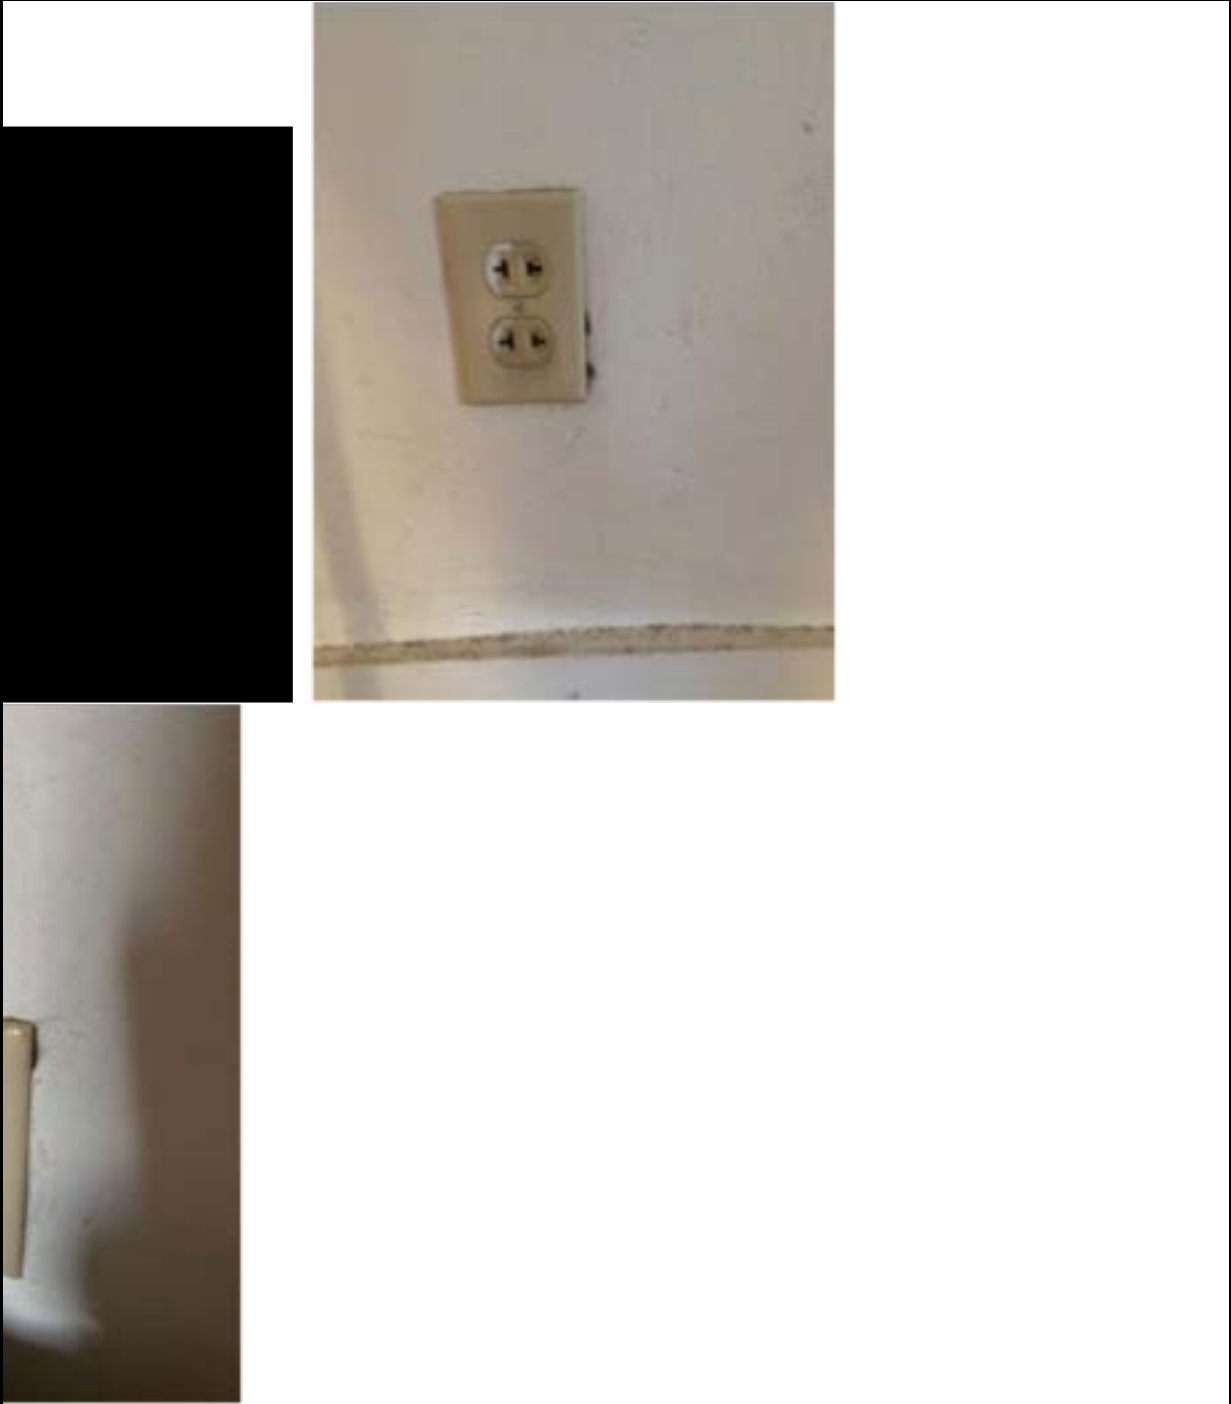
The majority of outlets in the original building - on both floors - are two-prong, ungrounded outlets, (with the exception of the first floor bathroom and kitchen). These outlets remain an active part of the home's electrical system. Ungrounded outlets are considered to be obsolete by today's electrical standards and usage. They may prove to be a short or shock hazard due to the lack of a proper ground. It is recommend that you remove or upgrade any ungrounded outlets remaining in the home. This would require re-wiring most of the building. Discuss with a licensed electrician. **Implication(s):** Electric shock

Example of outdated outlets Example of outdated outlets

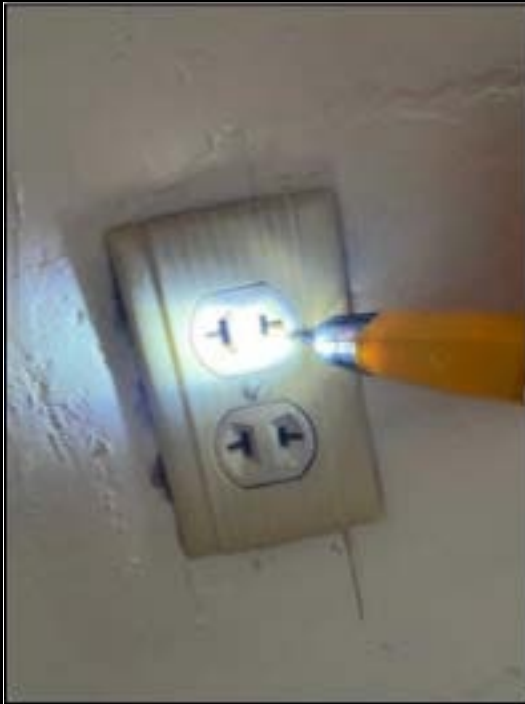
Active two-prongs in building

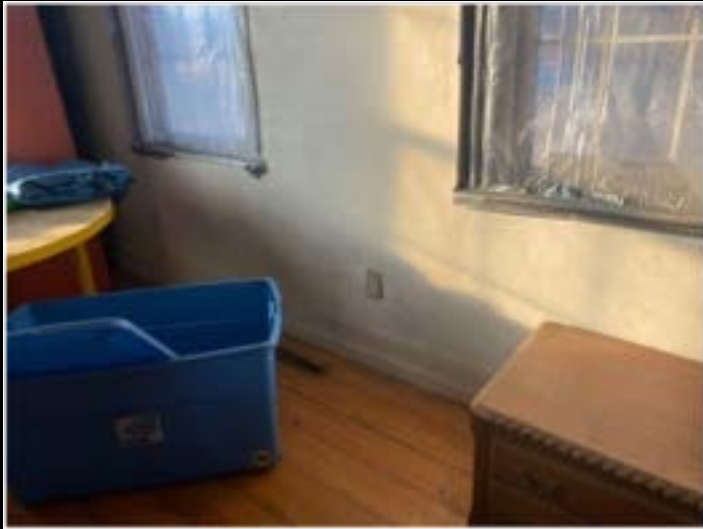
Some Three-prong outlets were ungrounded

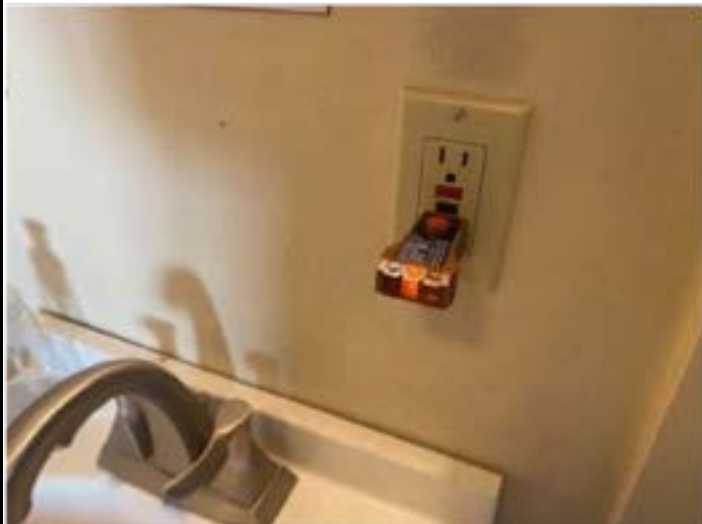
No ground at bathroom outlet

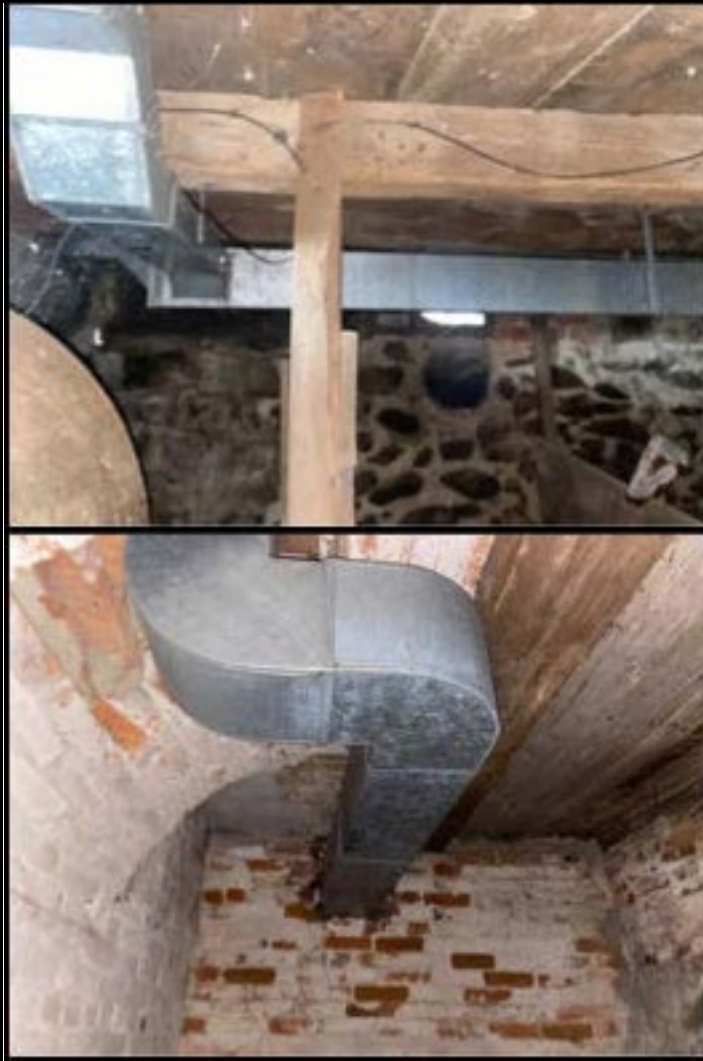
Furnace duct work uninsulated Furnace duct work uninsulated

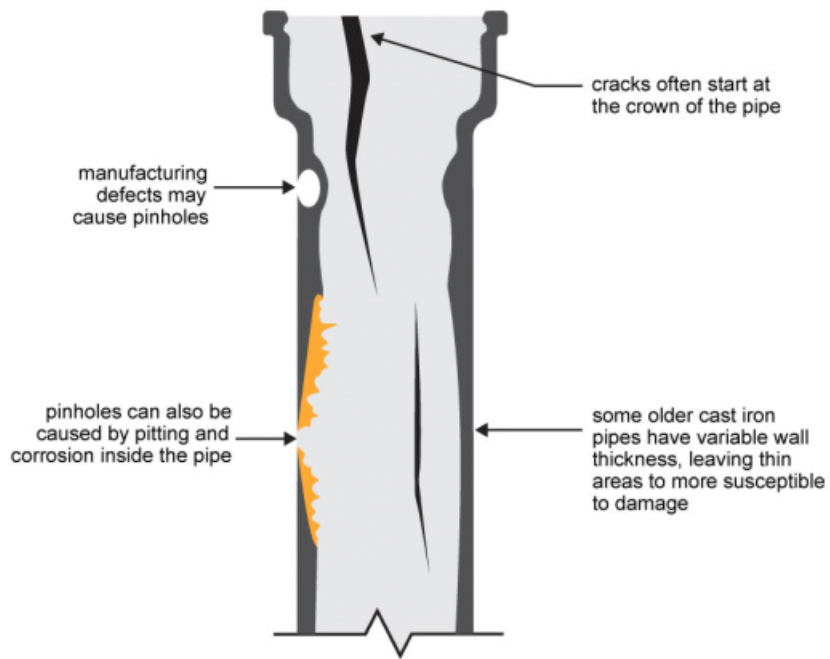
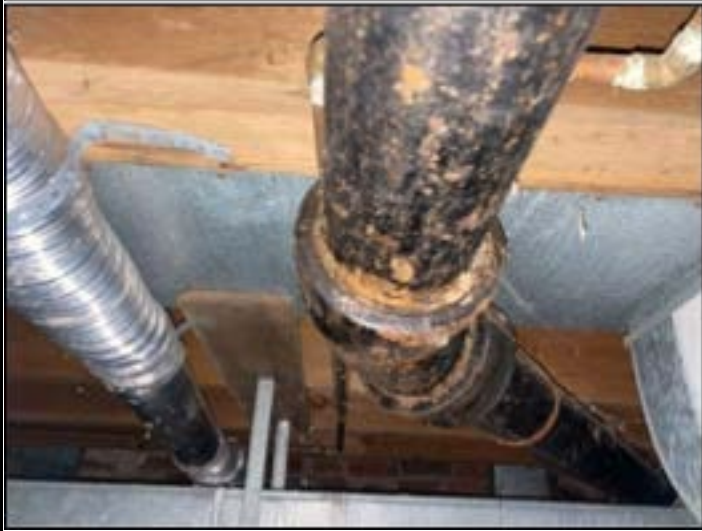
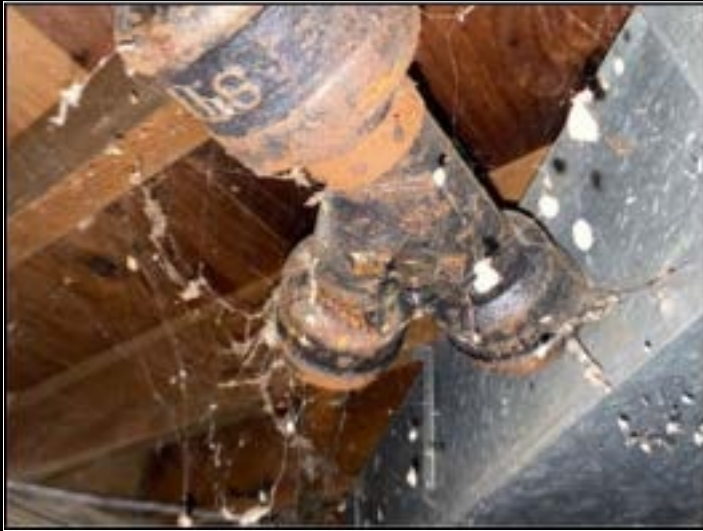
Pinholing and cracks in cast iron stacks

Surface rusting on cast iron drains Rusting on cast iron unions

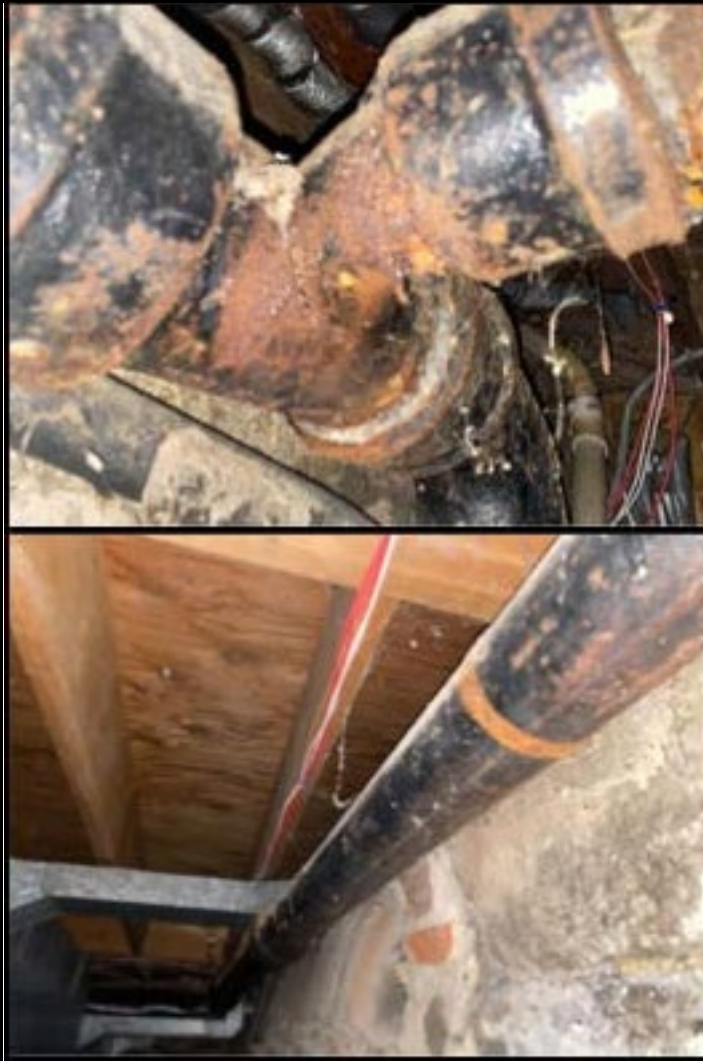
Heavy rusting at union Example of rusting in drain lines

Example of rusting in drain lines

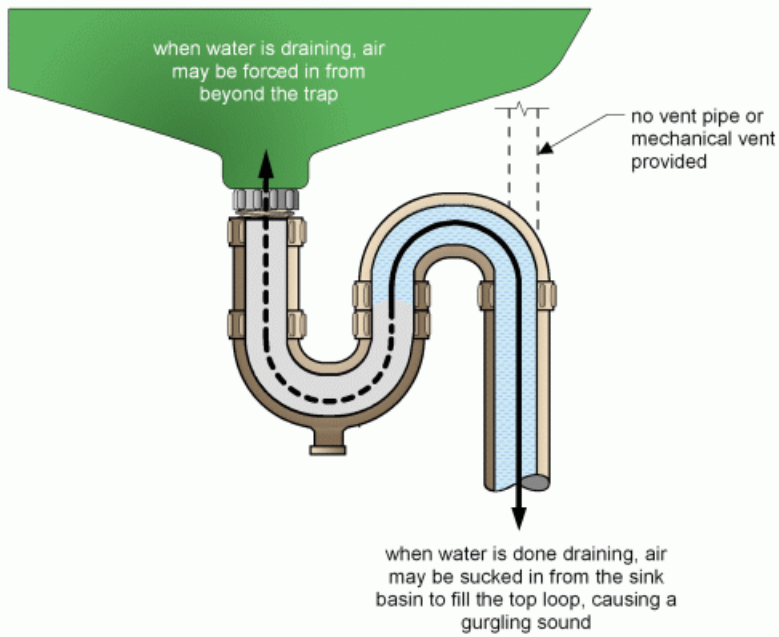
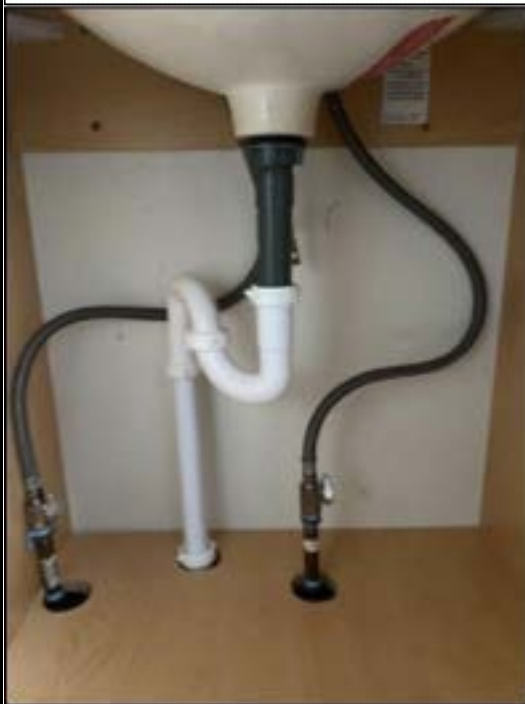
The second floor vanity sink is serviced by a suboptimal trap configuration. The drain line contains what's called an S-trap. These configurations oftentimes can be self-siphoning, suggesting that water draining from the line can also drain the trap. P traps are universally considered to be more reliable and effective. Discuss feature with a licensed plumber and consider improving.

S-traps can lead to siphoning

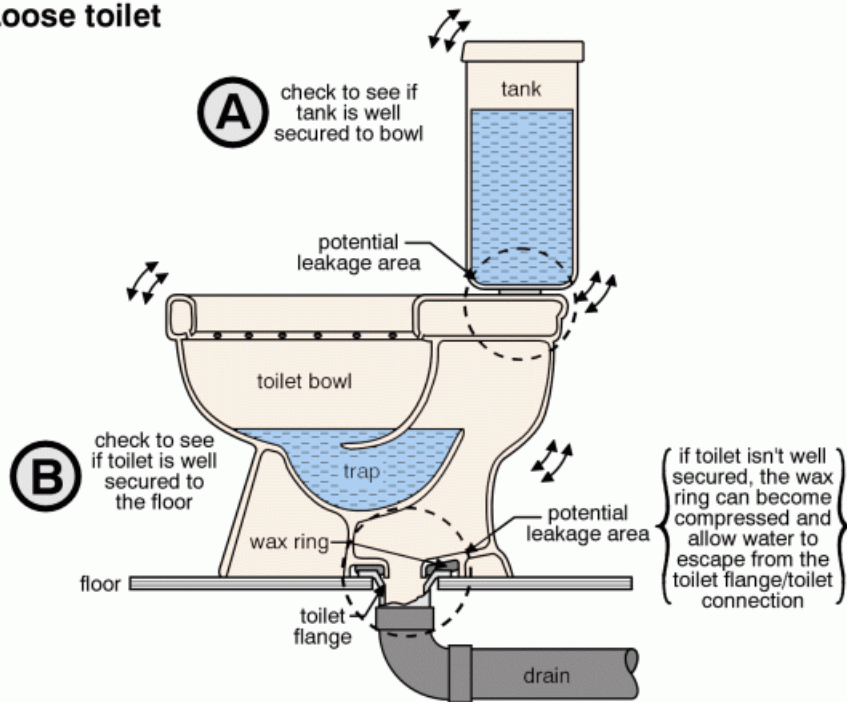
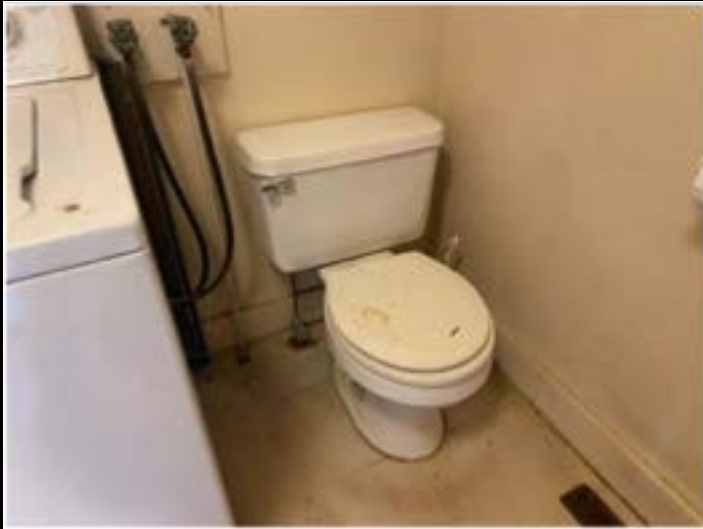
Most of the plumbing fixtures in the building are loose and not properly secured. Improvements are needed.

Loose toilet in first floor bathroom

Loose toilet

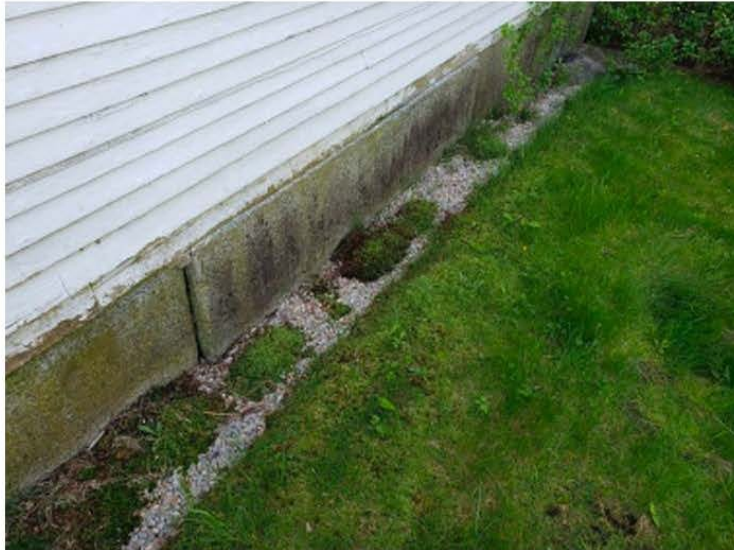
Photo 3
Shifted stones at north elevation of main house (facing southwest)

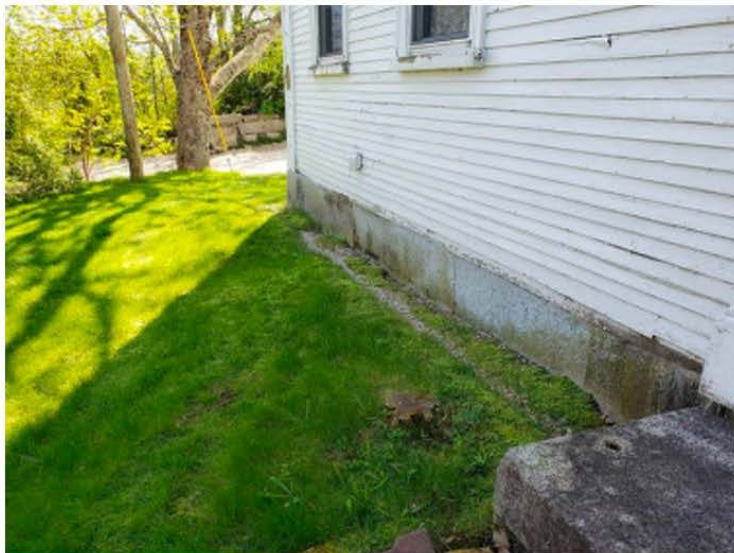
Photo 4
Shifted stones at north elevation of main house (facing southeast)

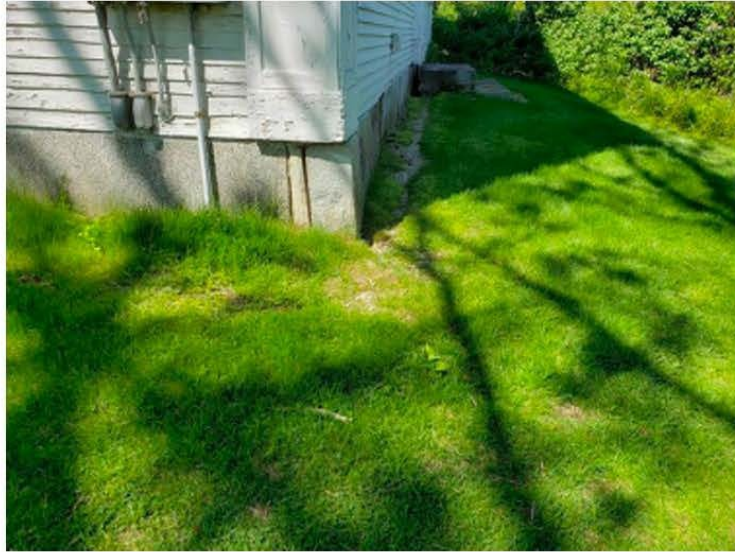
Photo 5
Shifted stones at northeast corner of main house (facing west)

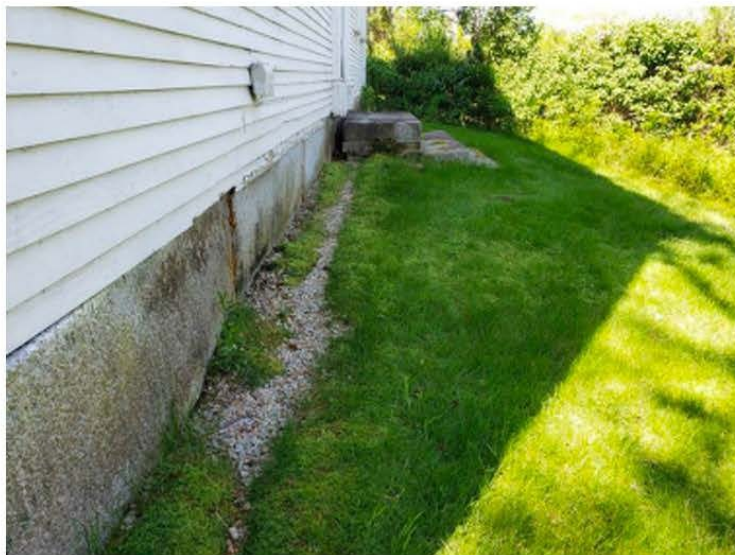
Photo 6
Shifted stones at north elevation, including steps (facing west)

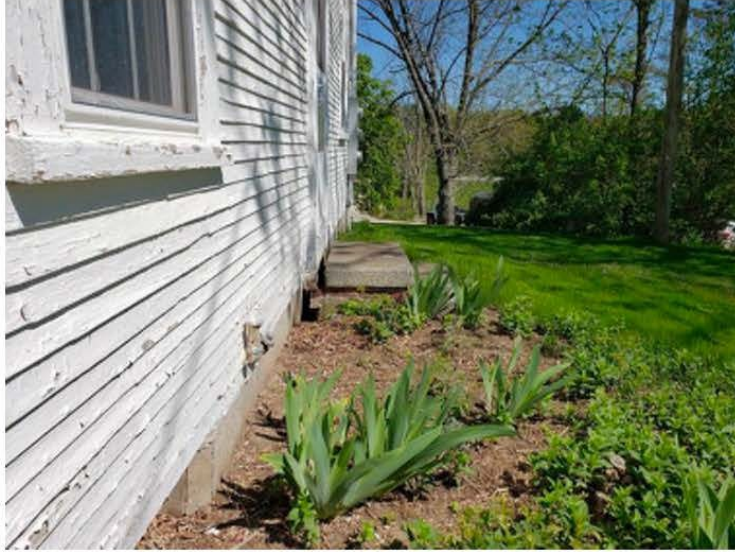
Photo 7
Shifted stones at east entry of main house (facing north)

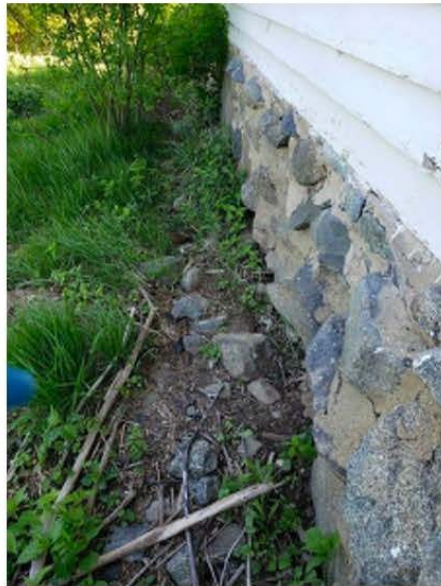
Photo 8
Foundation buckling inward at west wall of ell (facing north)

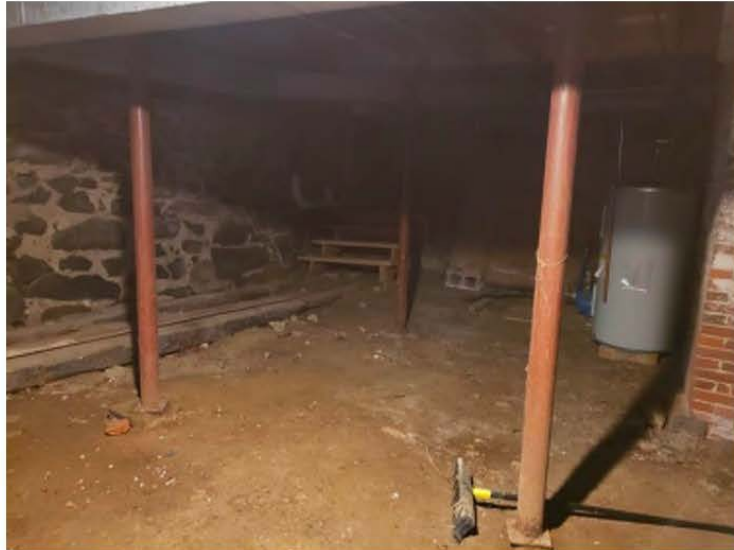
Photo 9
Previously re-framed section at southwest corner of main house

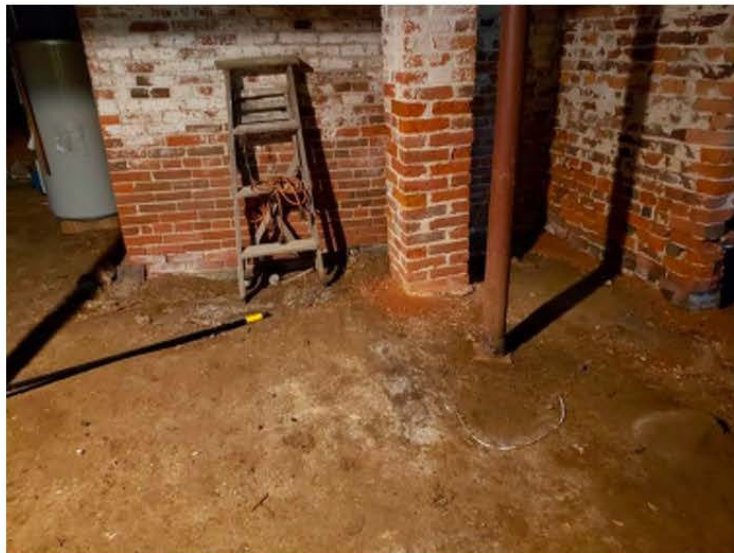
Photo 10
Corroded column base and deteriorated bases of brick walls and pier

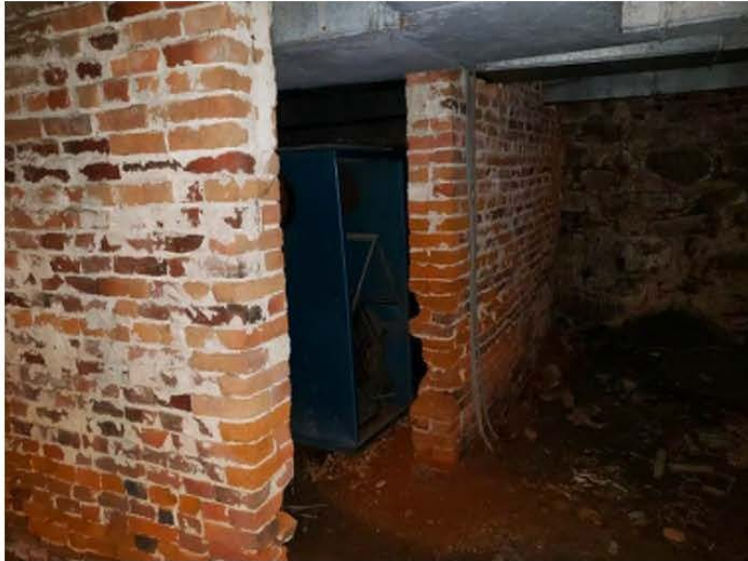
Photo 11
Deteriorated bases of brick walls

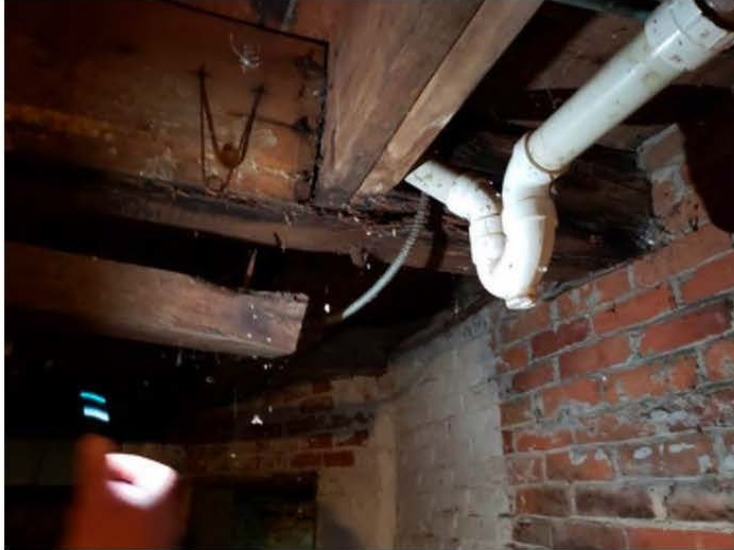
Photo 13

Rotted beam at intersection, also lacking proper connection hardware (facing north)

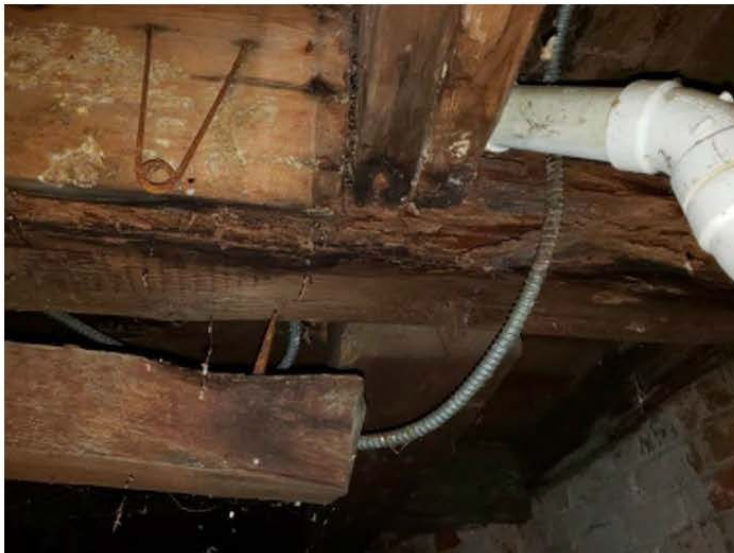
Photo 14

Rotted beam at intersection, also lacking proper connection hardware (facing north)

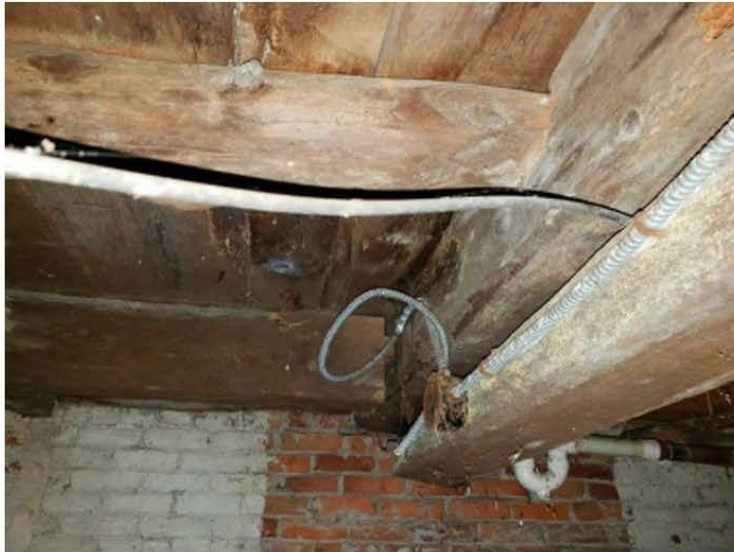
Photo 15
Various flush-framed conditions

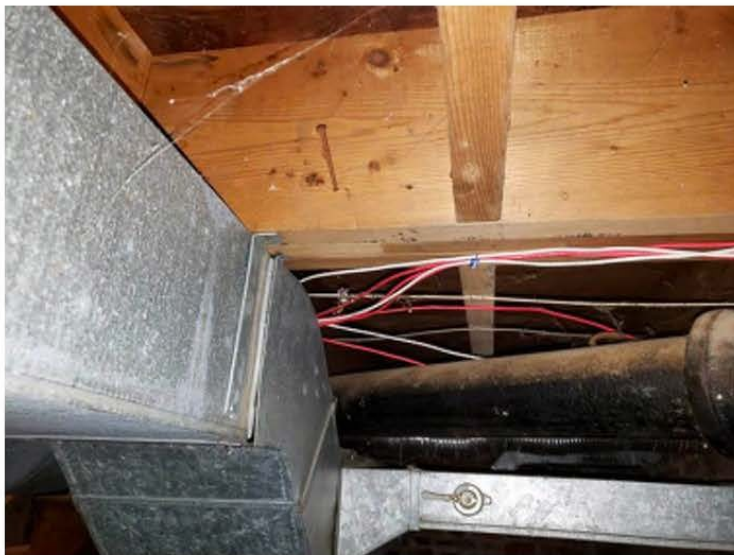
Photo 16
Reframed area at southwest corner of main house lacking hangers at common joists,
beam is improperly spliced
