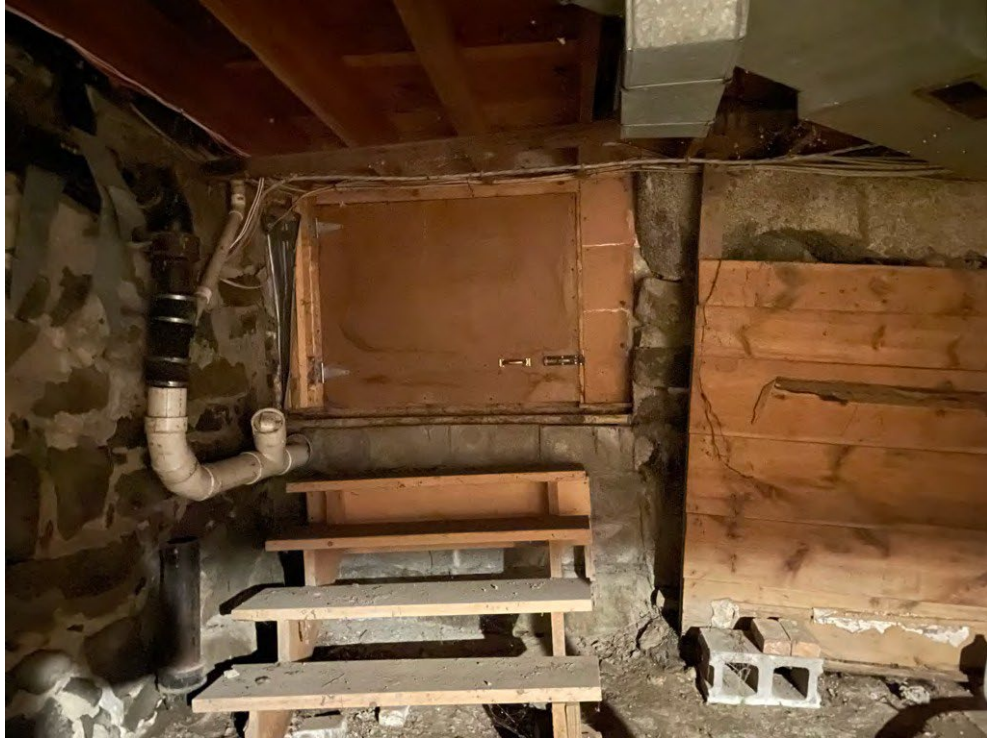
Image 33: View of basement, southwest corner looking west, showing replaced floor framing.

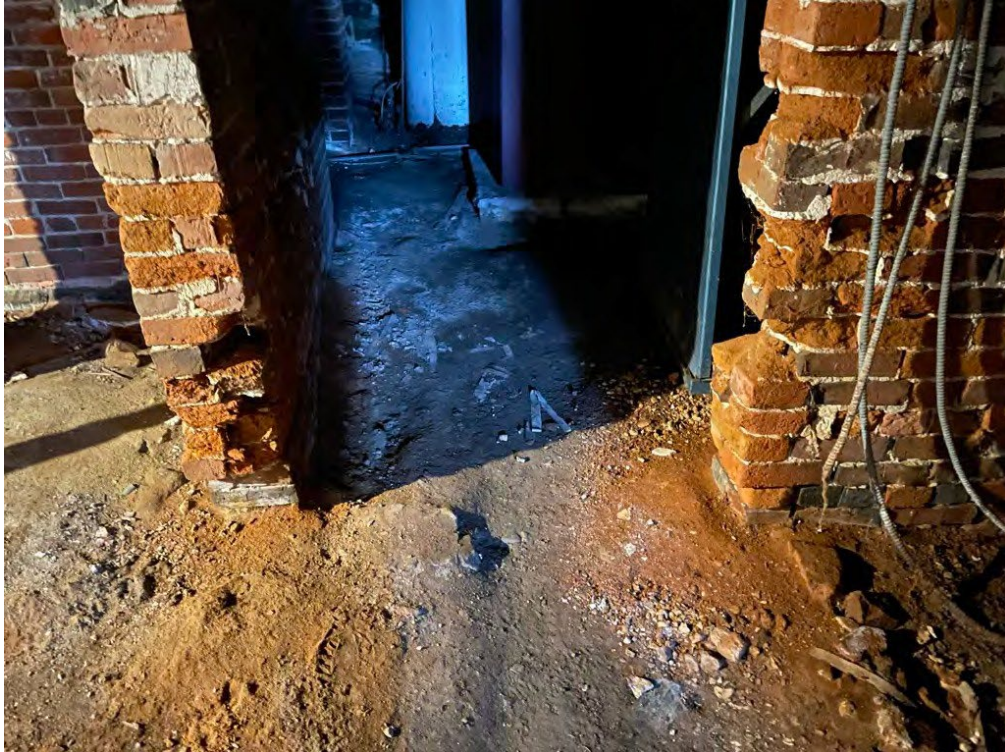
Image 34: View of typical rising damp in basement brick elements.

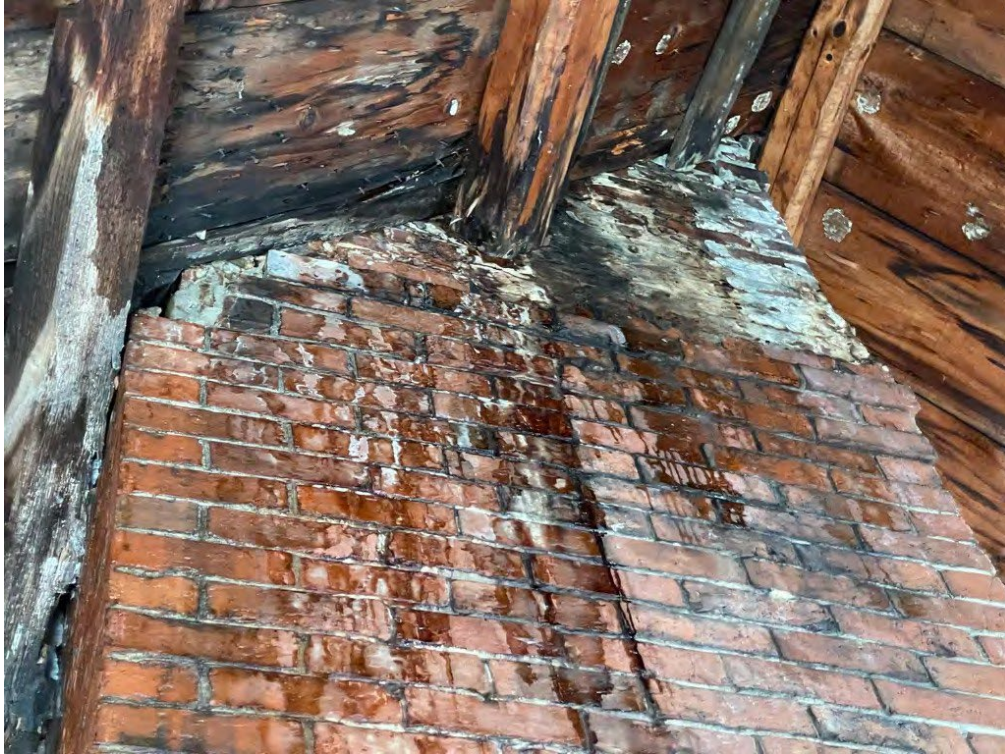
Image 35: Detail of east chimney showing the stack extension on top of the original corbel, and old water staining.

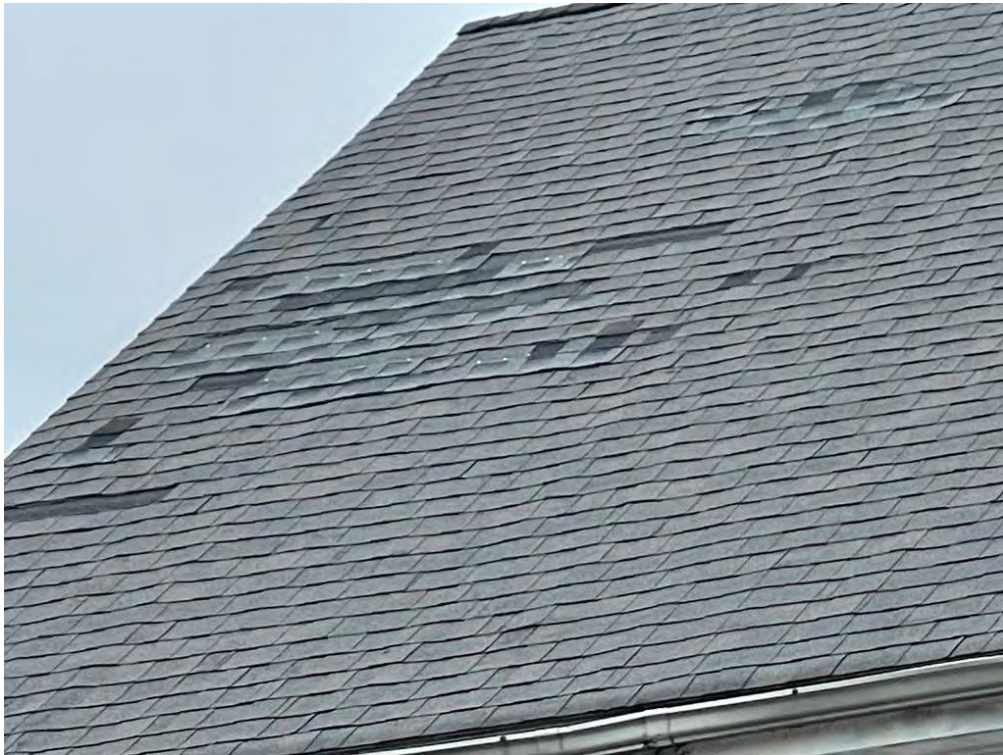
Image 36: Detail of the roof, main house, south elevation, showing shingle repairs.

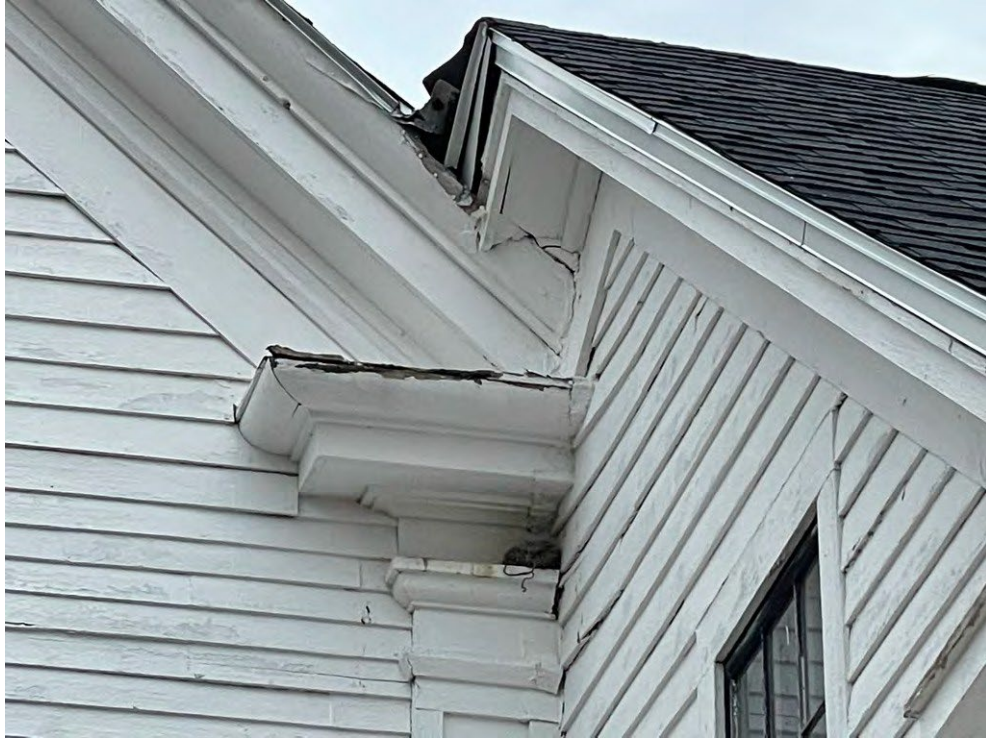
Image 37: Detail of cornice return and intersection of the main house to the ell, west elevation, showing water-related damage due to poor flashing and drainage.

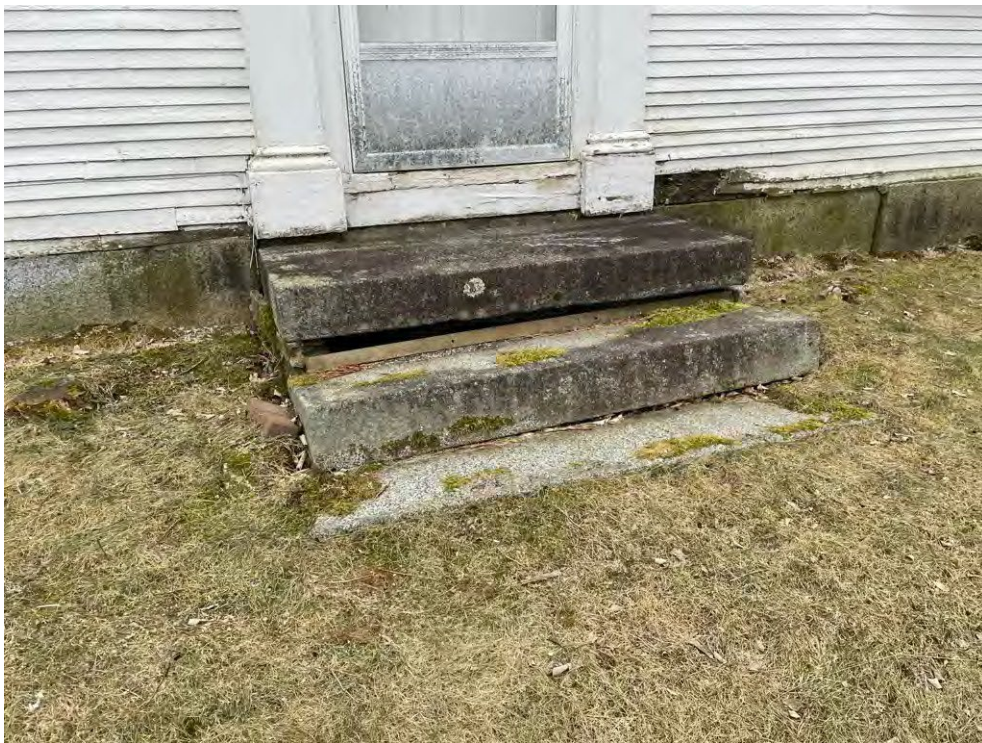
Image 38: Detail of the front entrance showing decay in original wooden elements and deflection of the stone steps.

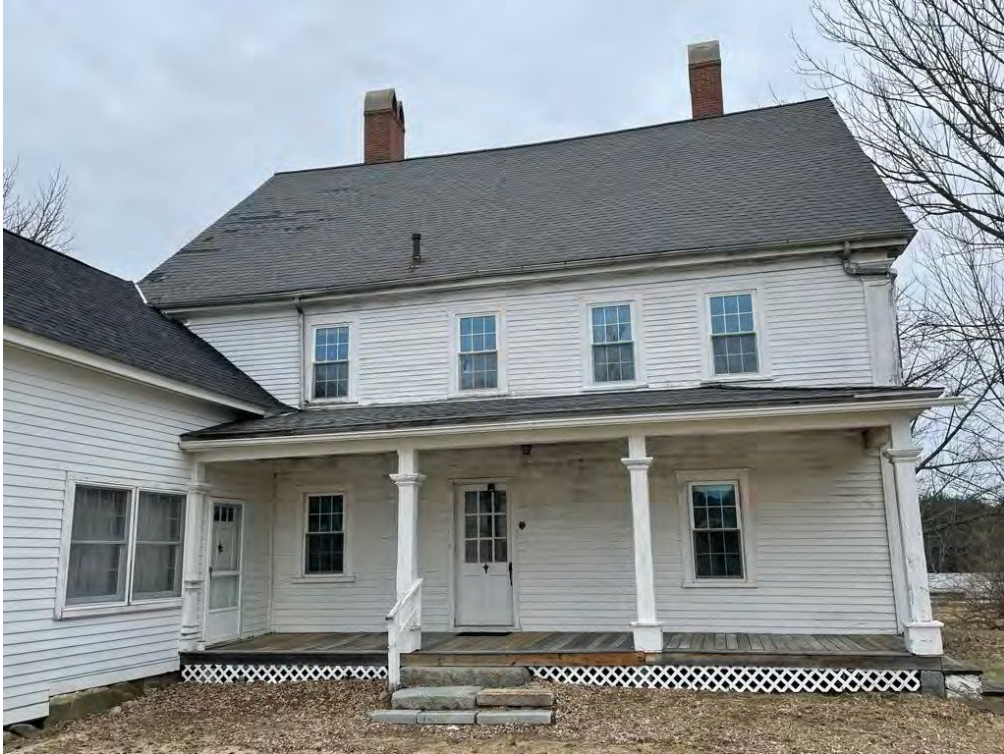
Image 39: View of the porch looking north, showing downward settling to the east.

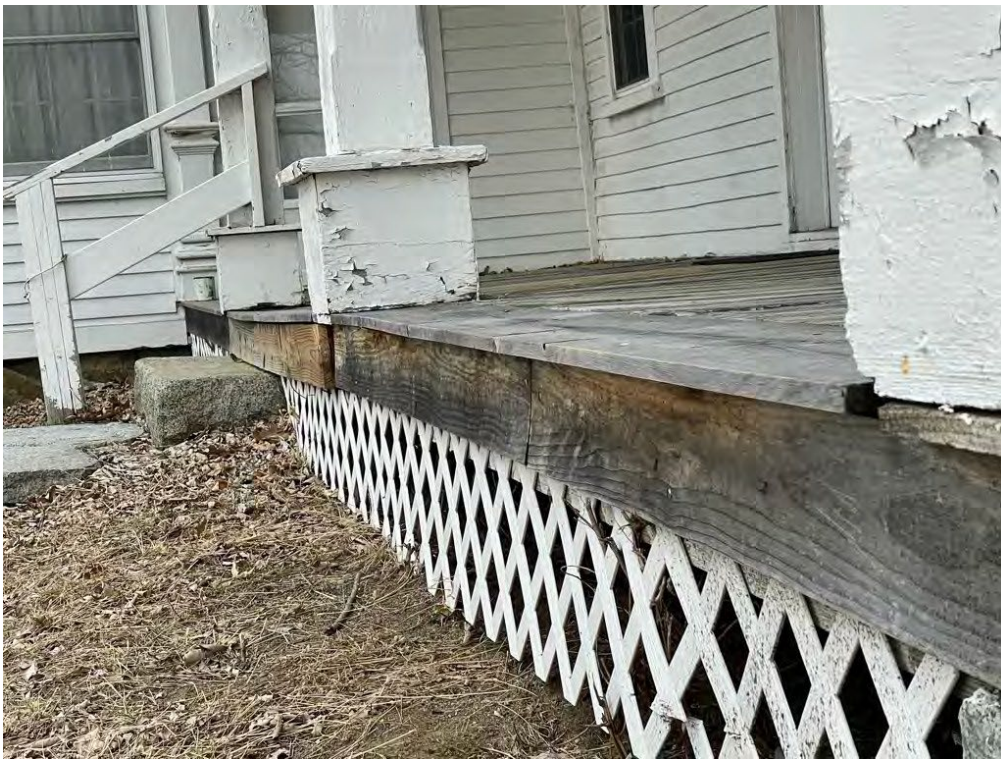
Image 40: Detail of the porch showing downward settling and decay of wooden elements.

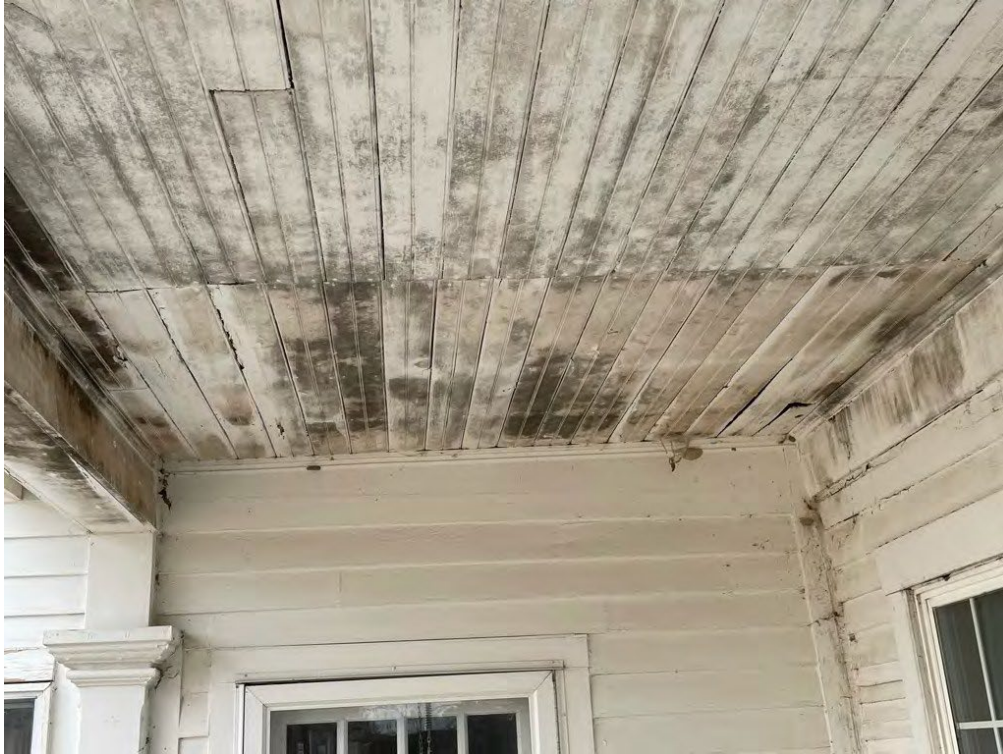
Image 41: Detail of the porch ceiling looking west, showing mold growth and warping due to past water infiltration.

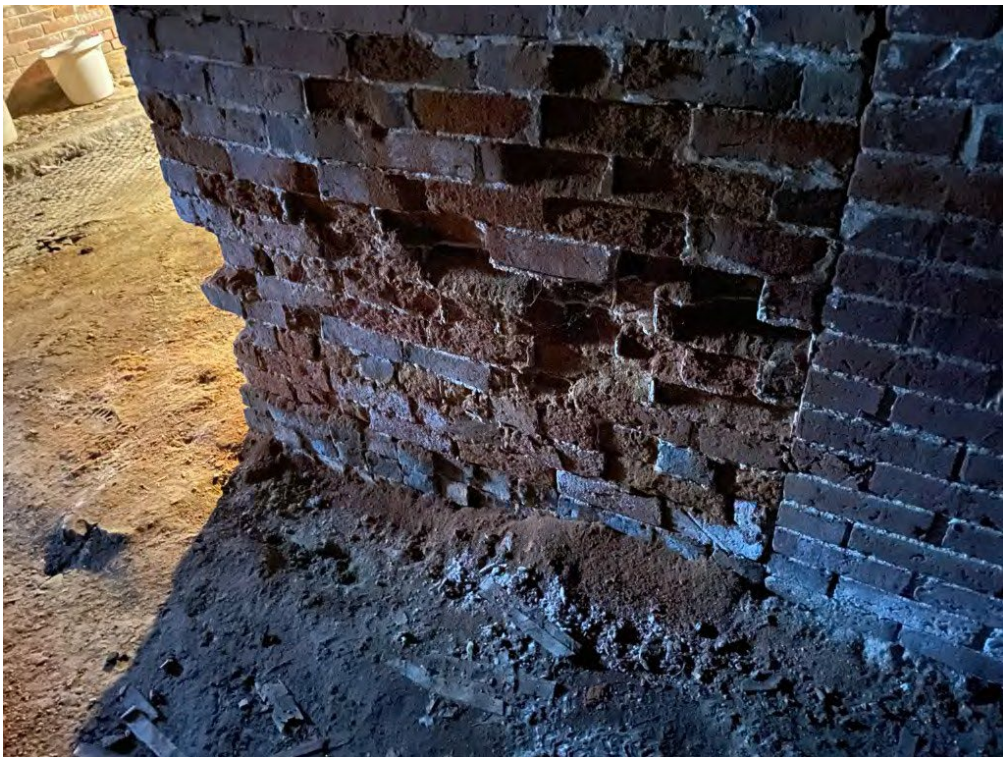
Image 42: Detail of the west chimney base in the basement showing typical brick deterioration from rising damp.

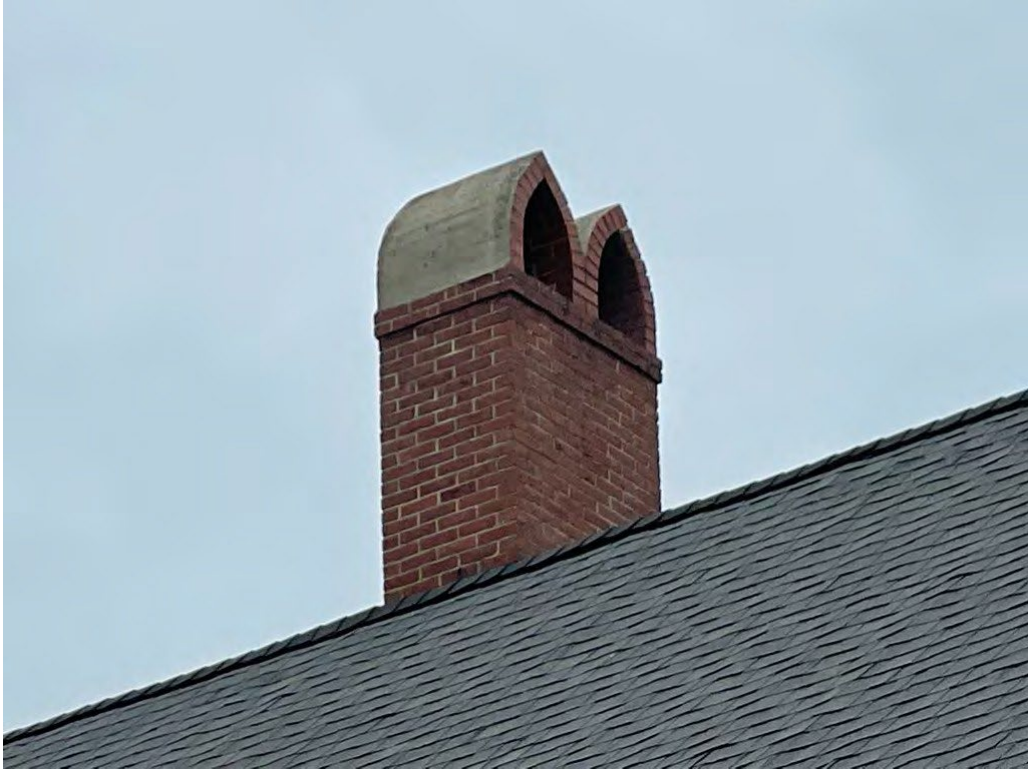
Image 43: View of the east chimney stack looking southwest, showing typical, minor mortar loss.

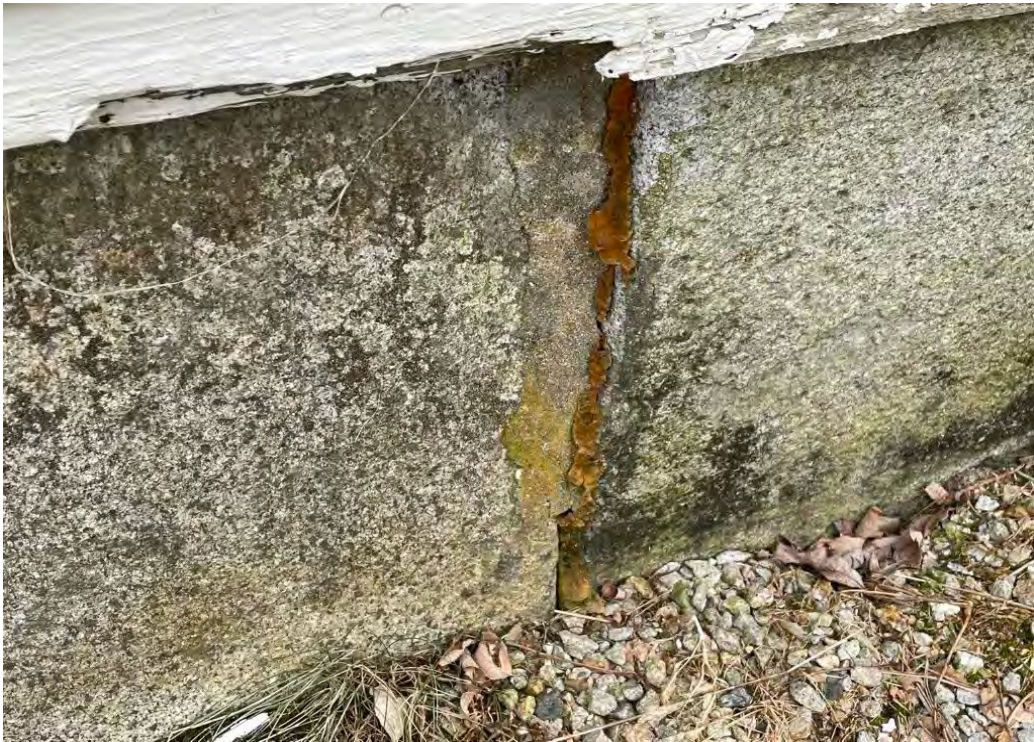
Image 44: Detail of foundation stone joint showing typical mortar loss and Spray foam repair.

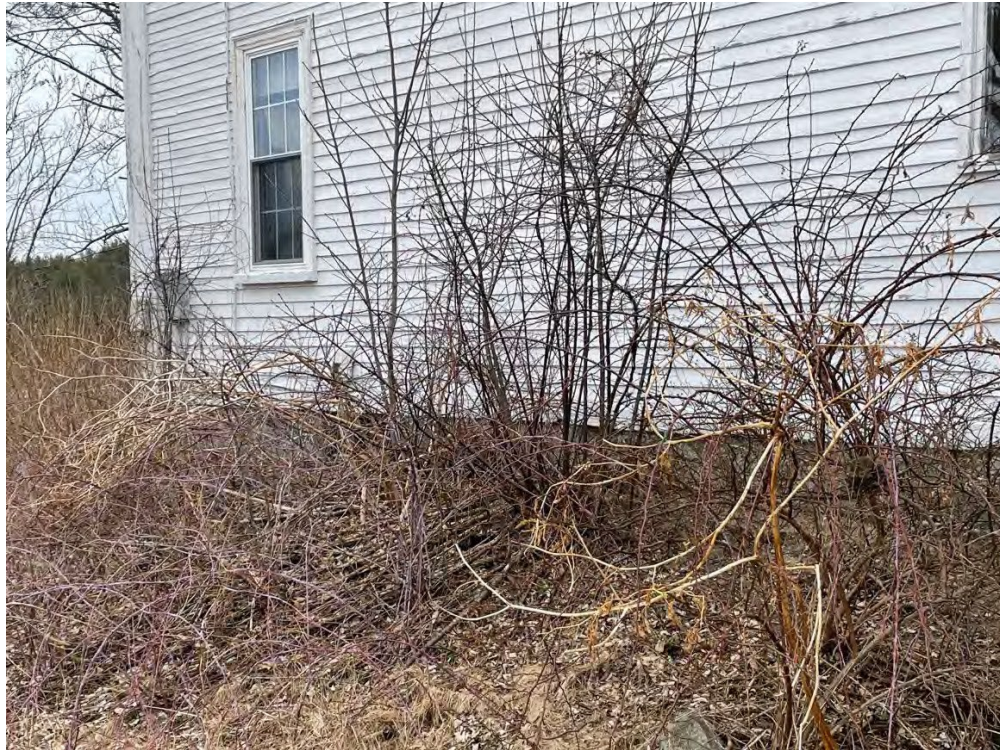
Image 45: View of the west elevation foundation, main house, showing overgrowth.

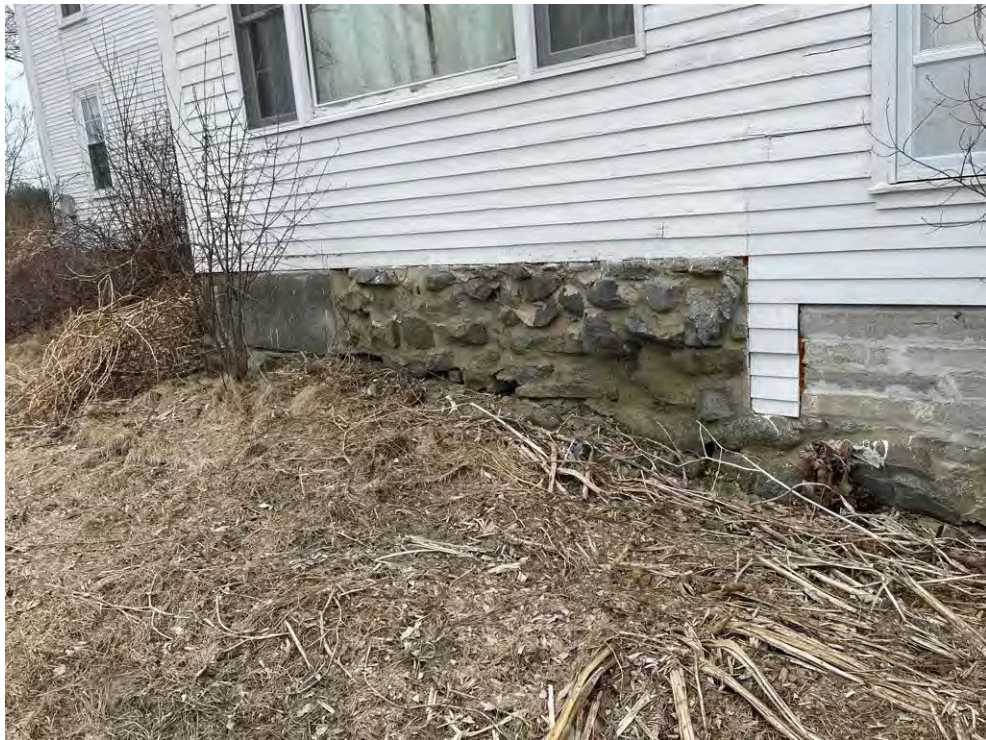
Image 48: View of the west elevation of the ell's foundation, showing variable materials and conditions.

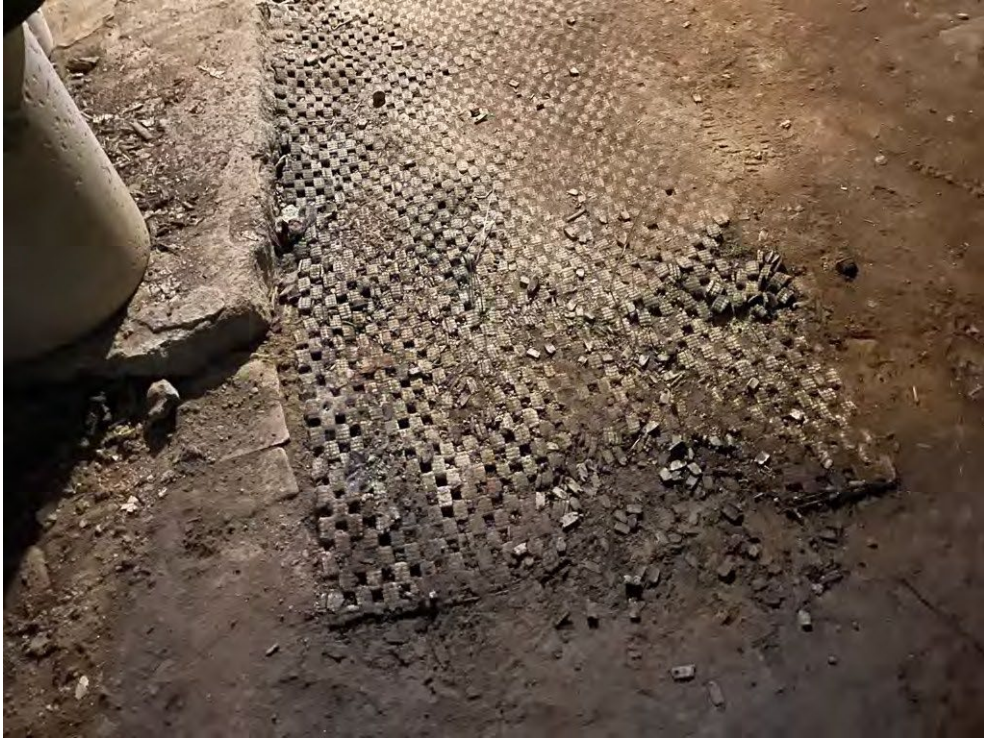
Image 49: Detail of the basement floor showing compacted soil from past water infiltration, and degraded floor mats.

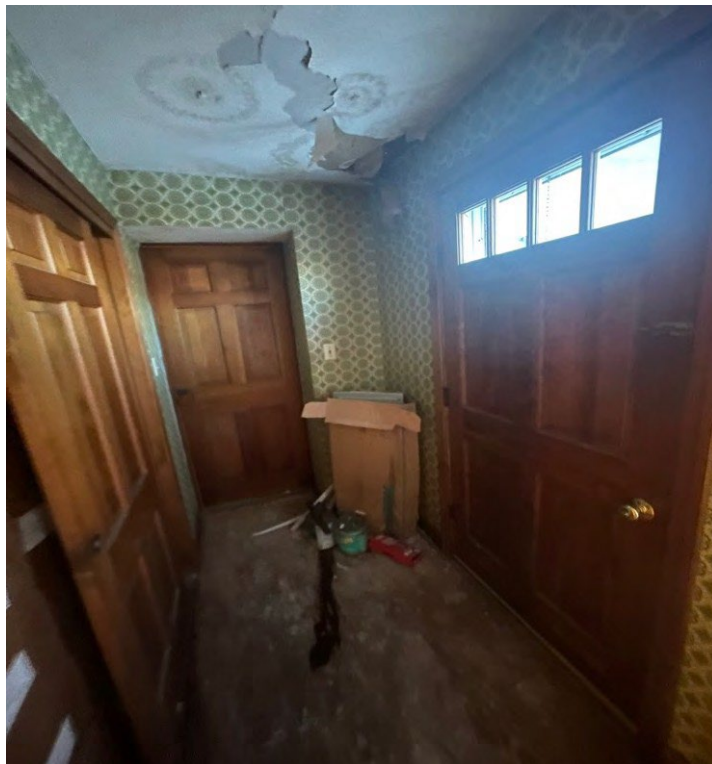
Image 50: View of the entrance to the ell apartment showing collapsed drywall from a past leak.

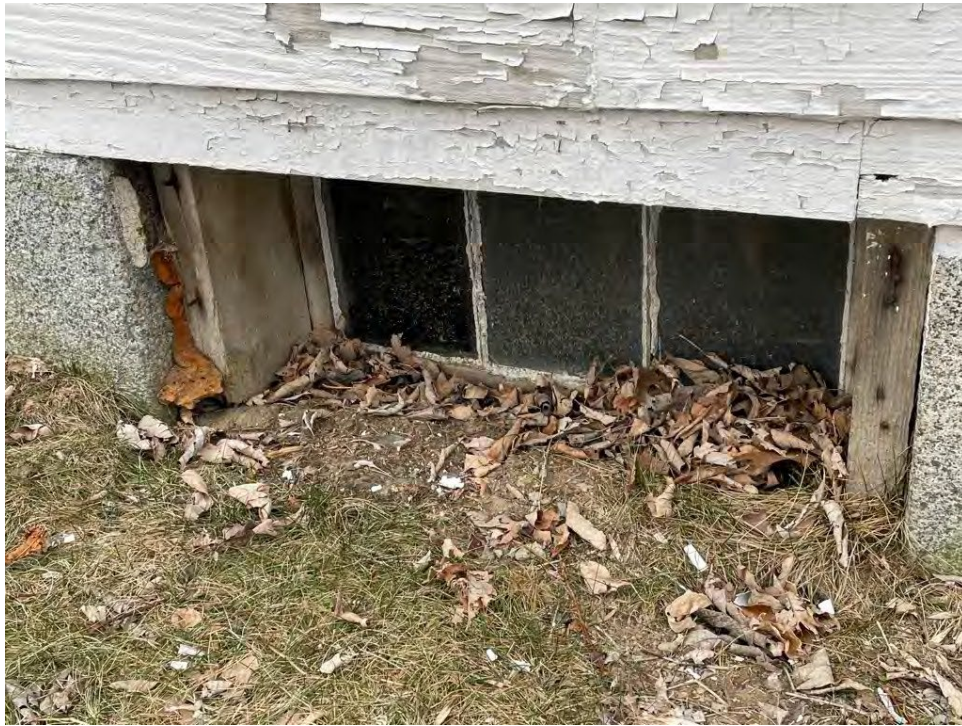
Image 51: Detail of a basement window, east elevation, showing encroaching grade and decay of the window elements.

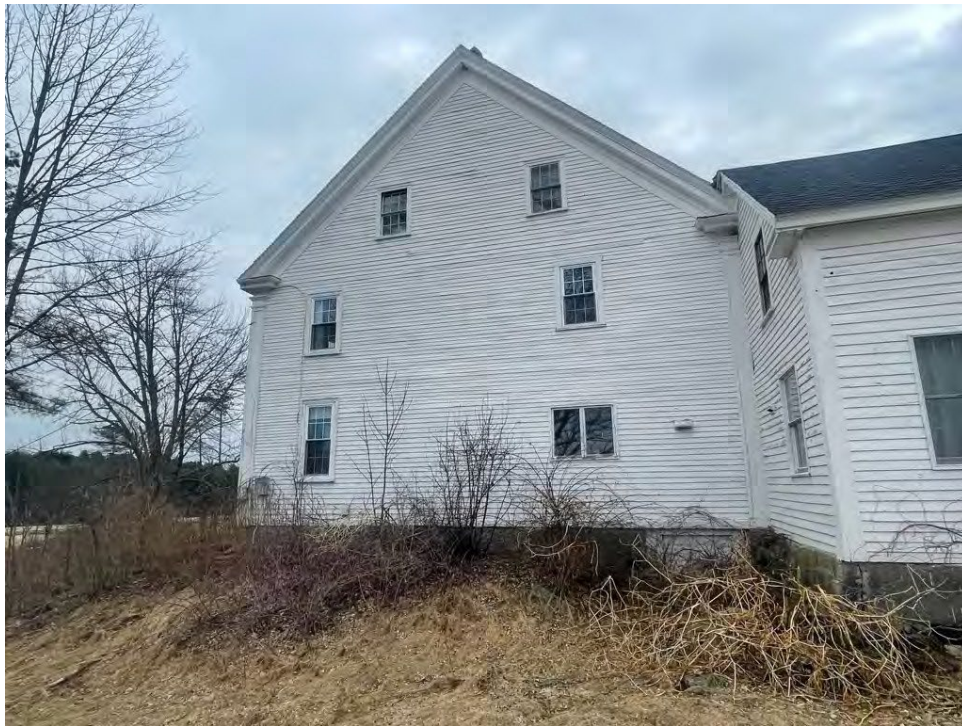
Image 52: View of the west elevation looking east, showing overgrowth.
