PRESERVATION TIMBER FRAMING
P.O. Box 28
Berwick, ME 03901
www.preservationtimberframing.com

Wagon Hill Existing Conditions Drawings
156 Piscataqua Rd
Durham, NH 03824

02.5.2020
Issue 001
Jessica MilNeil

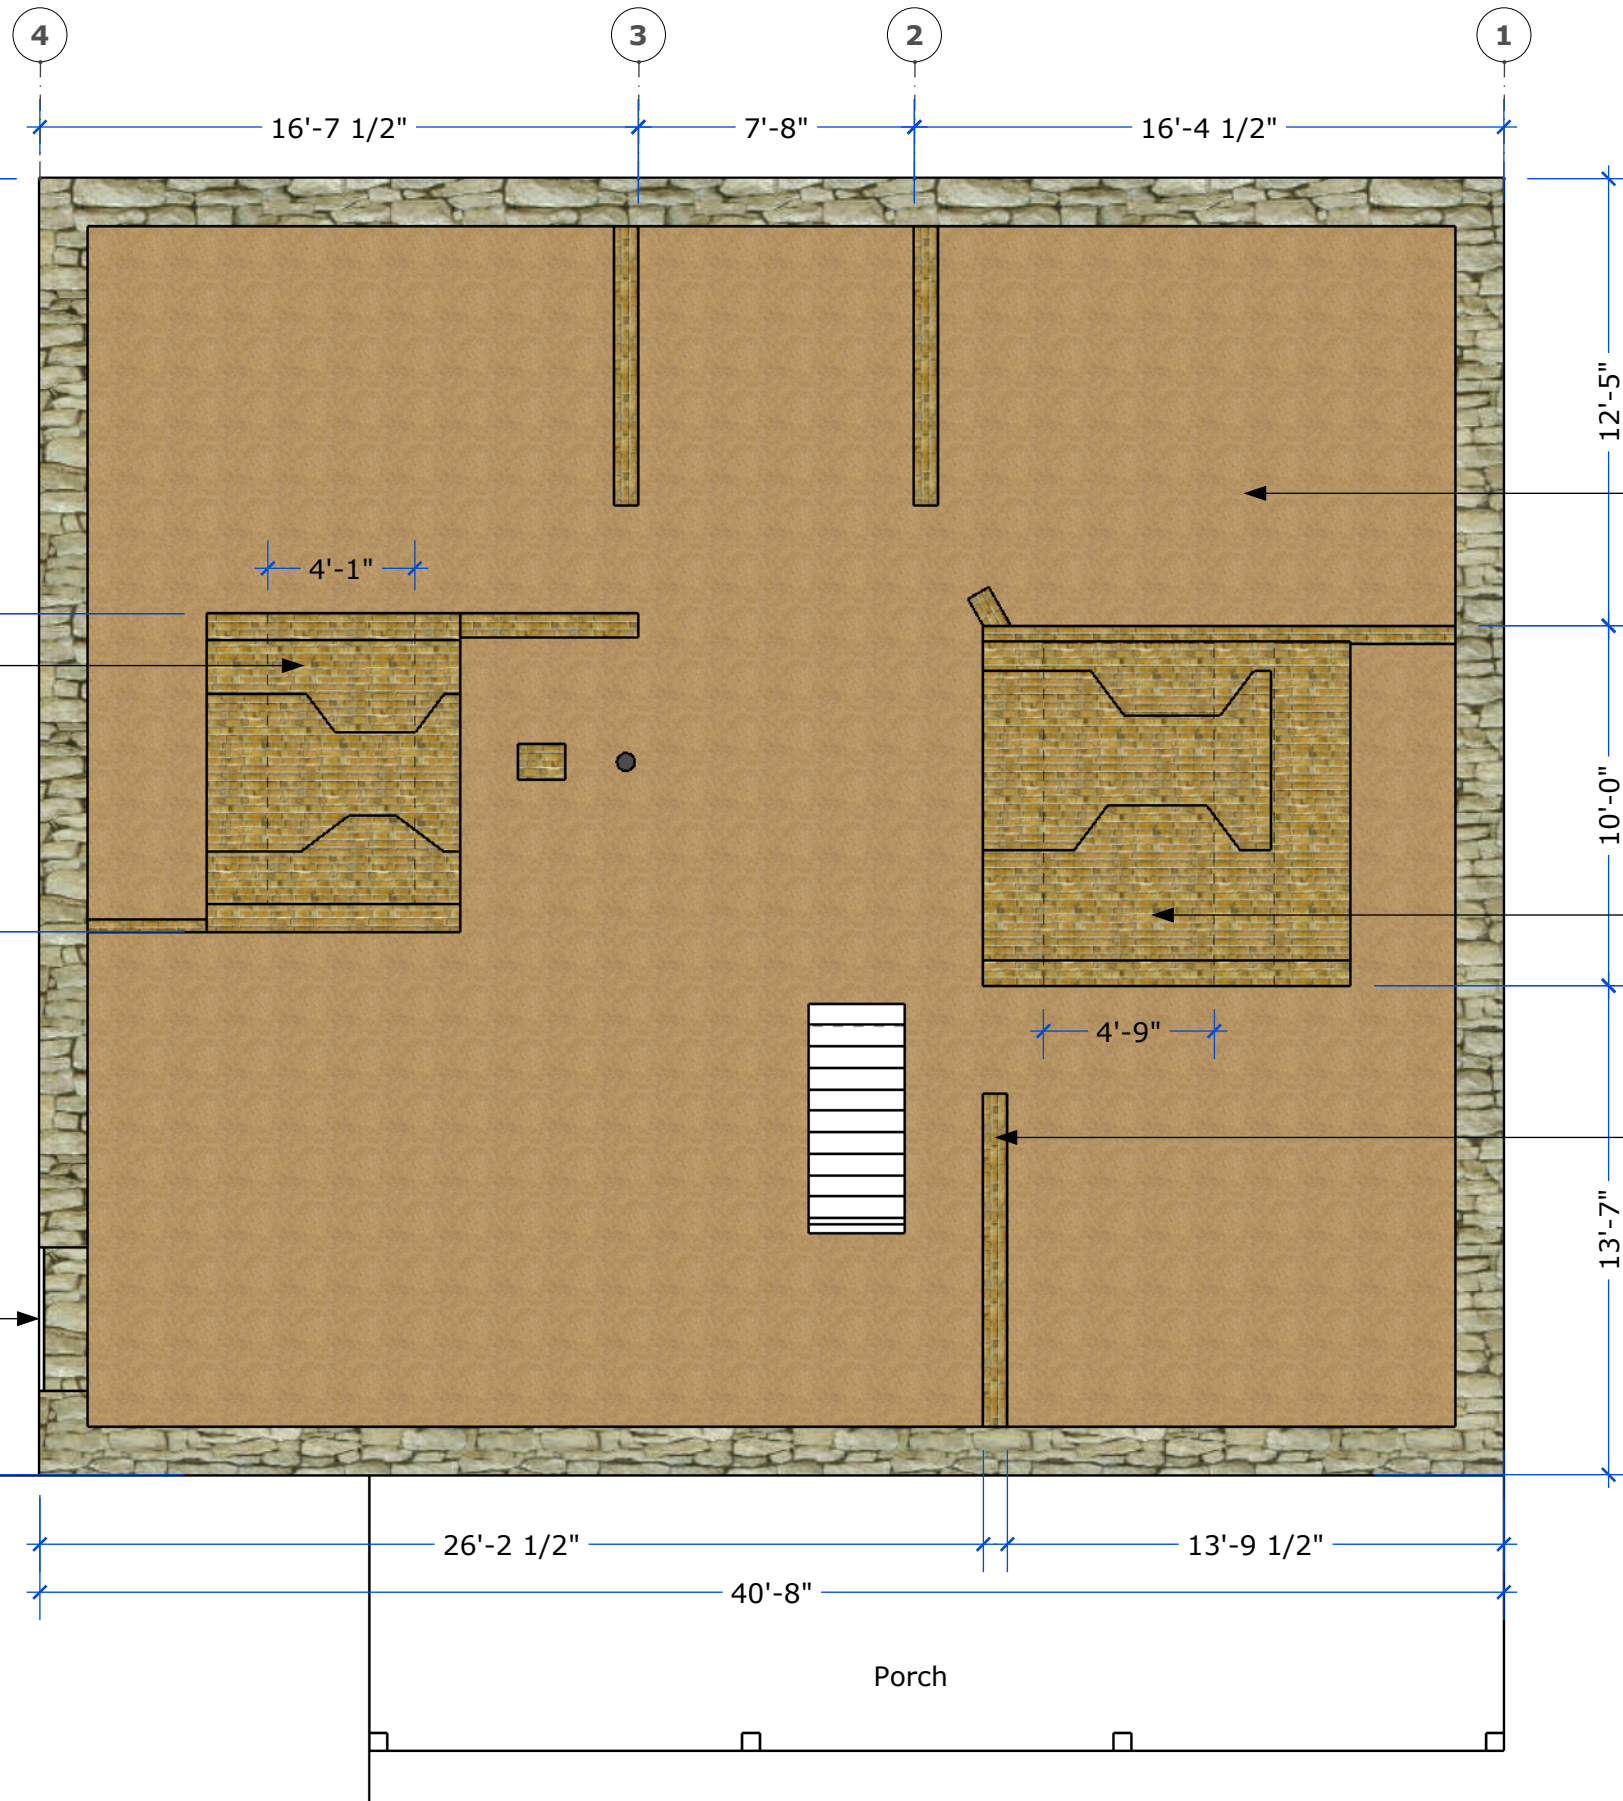
Foundation

Arch supports chimney mass

In this room, there is 8' 8" clearance from dirt to subfloor. Some partitions are trimmed and finished; much of the basement was once finished space. There was probably extensive storage for farm products.

Original floor girts are supported over brick partition walls. The undercarriage framing is remarkably well-supported.

Bulkhead has been closed off to prevent water infiltration. It should be opened, and furnaces removed. There are three furnaces and five unused water heaters in the basement

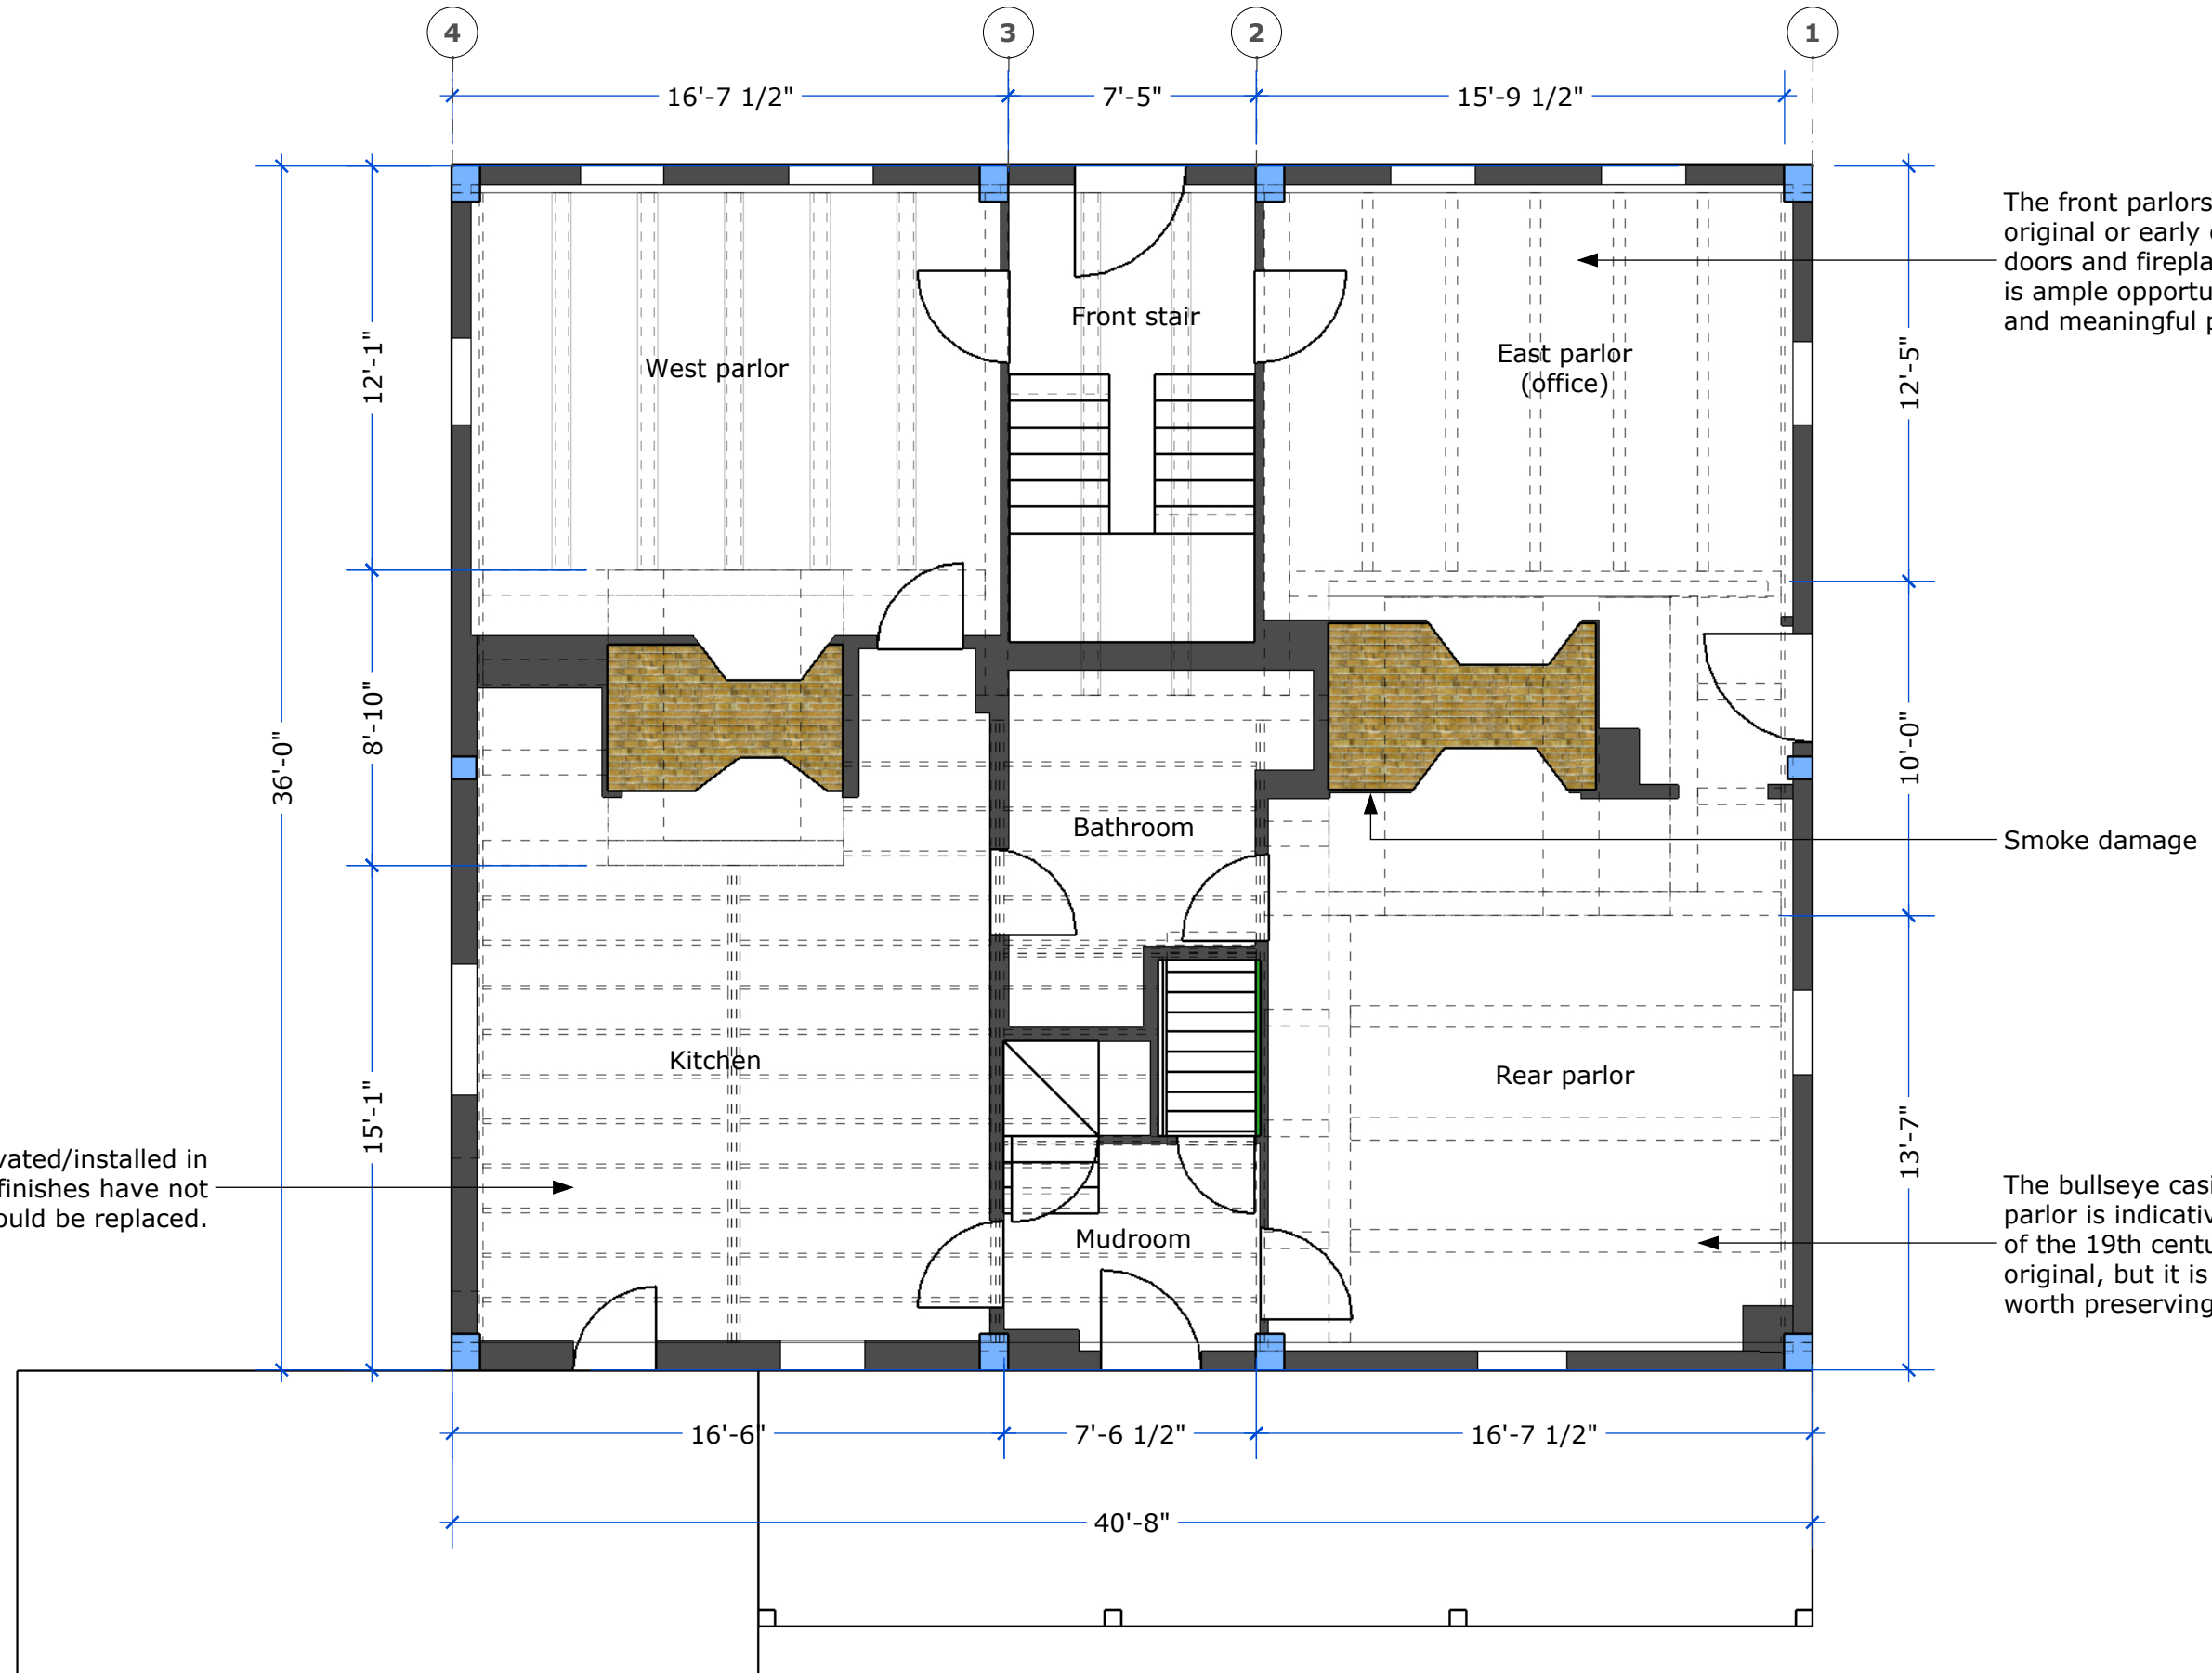
First Floor Plan

The front parlors and hall contain original or early casings, shutters, doors and fireplace surrounds. There is ample opportunity for authentic and meaningful preservation.

Smoke damage

The bullseye casing in the rear parlor is indicative of the latter half of the 19th century. It is not original, but it is significant and worth preserving.

Kitchen was renovated/installed in the 1970s. The finishes have not aged well, and should be replaced.

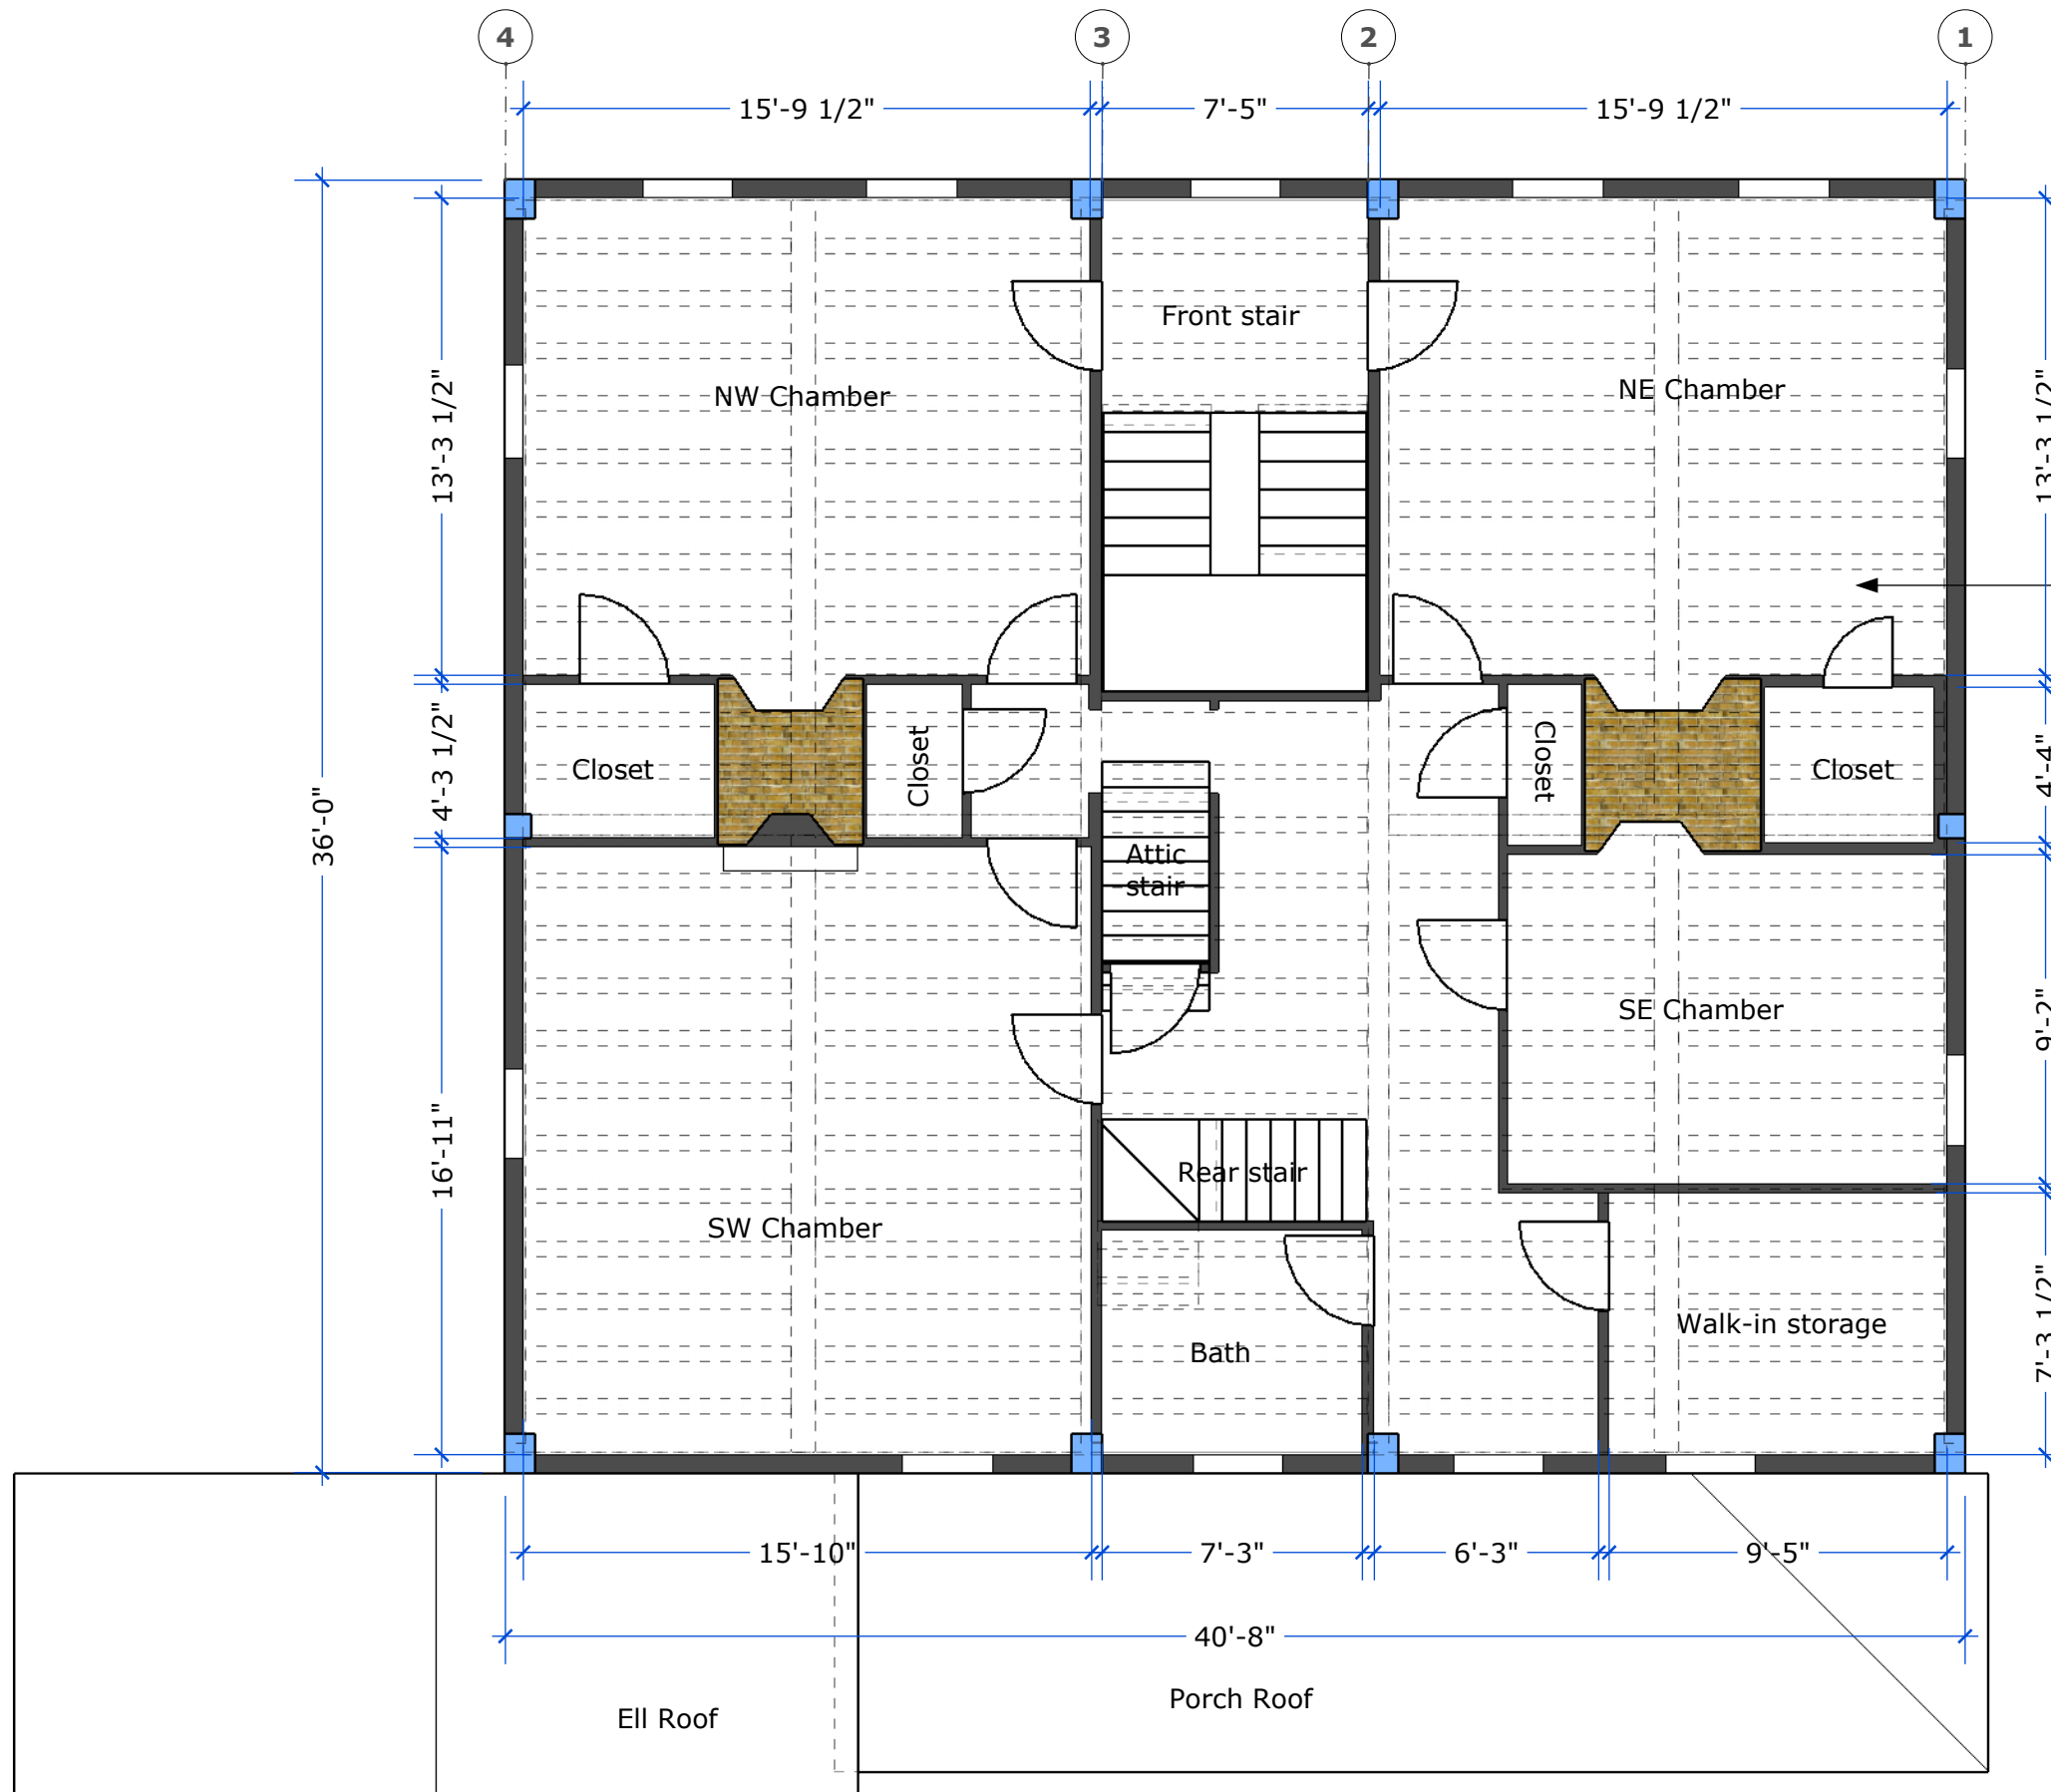
Second Floor Plan

Original or early trim, casings, fireplace surrounds, interior shutters, wall partitions located in every upstairs room except bathroom. This floor has excellent preservation and re-use potential.

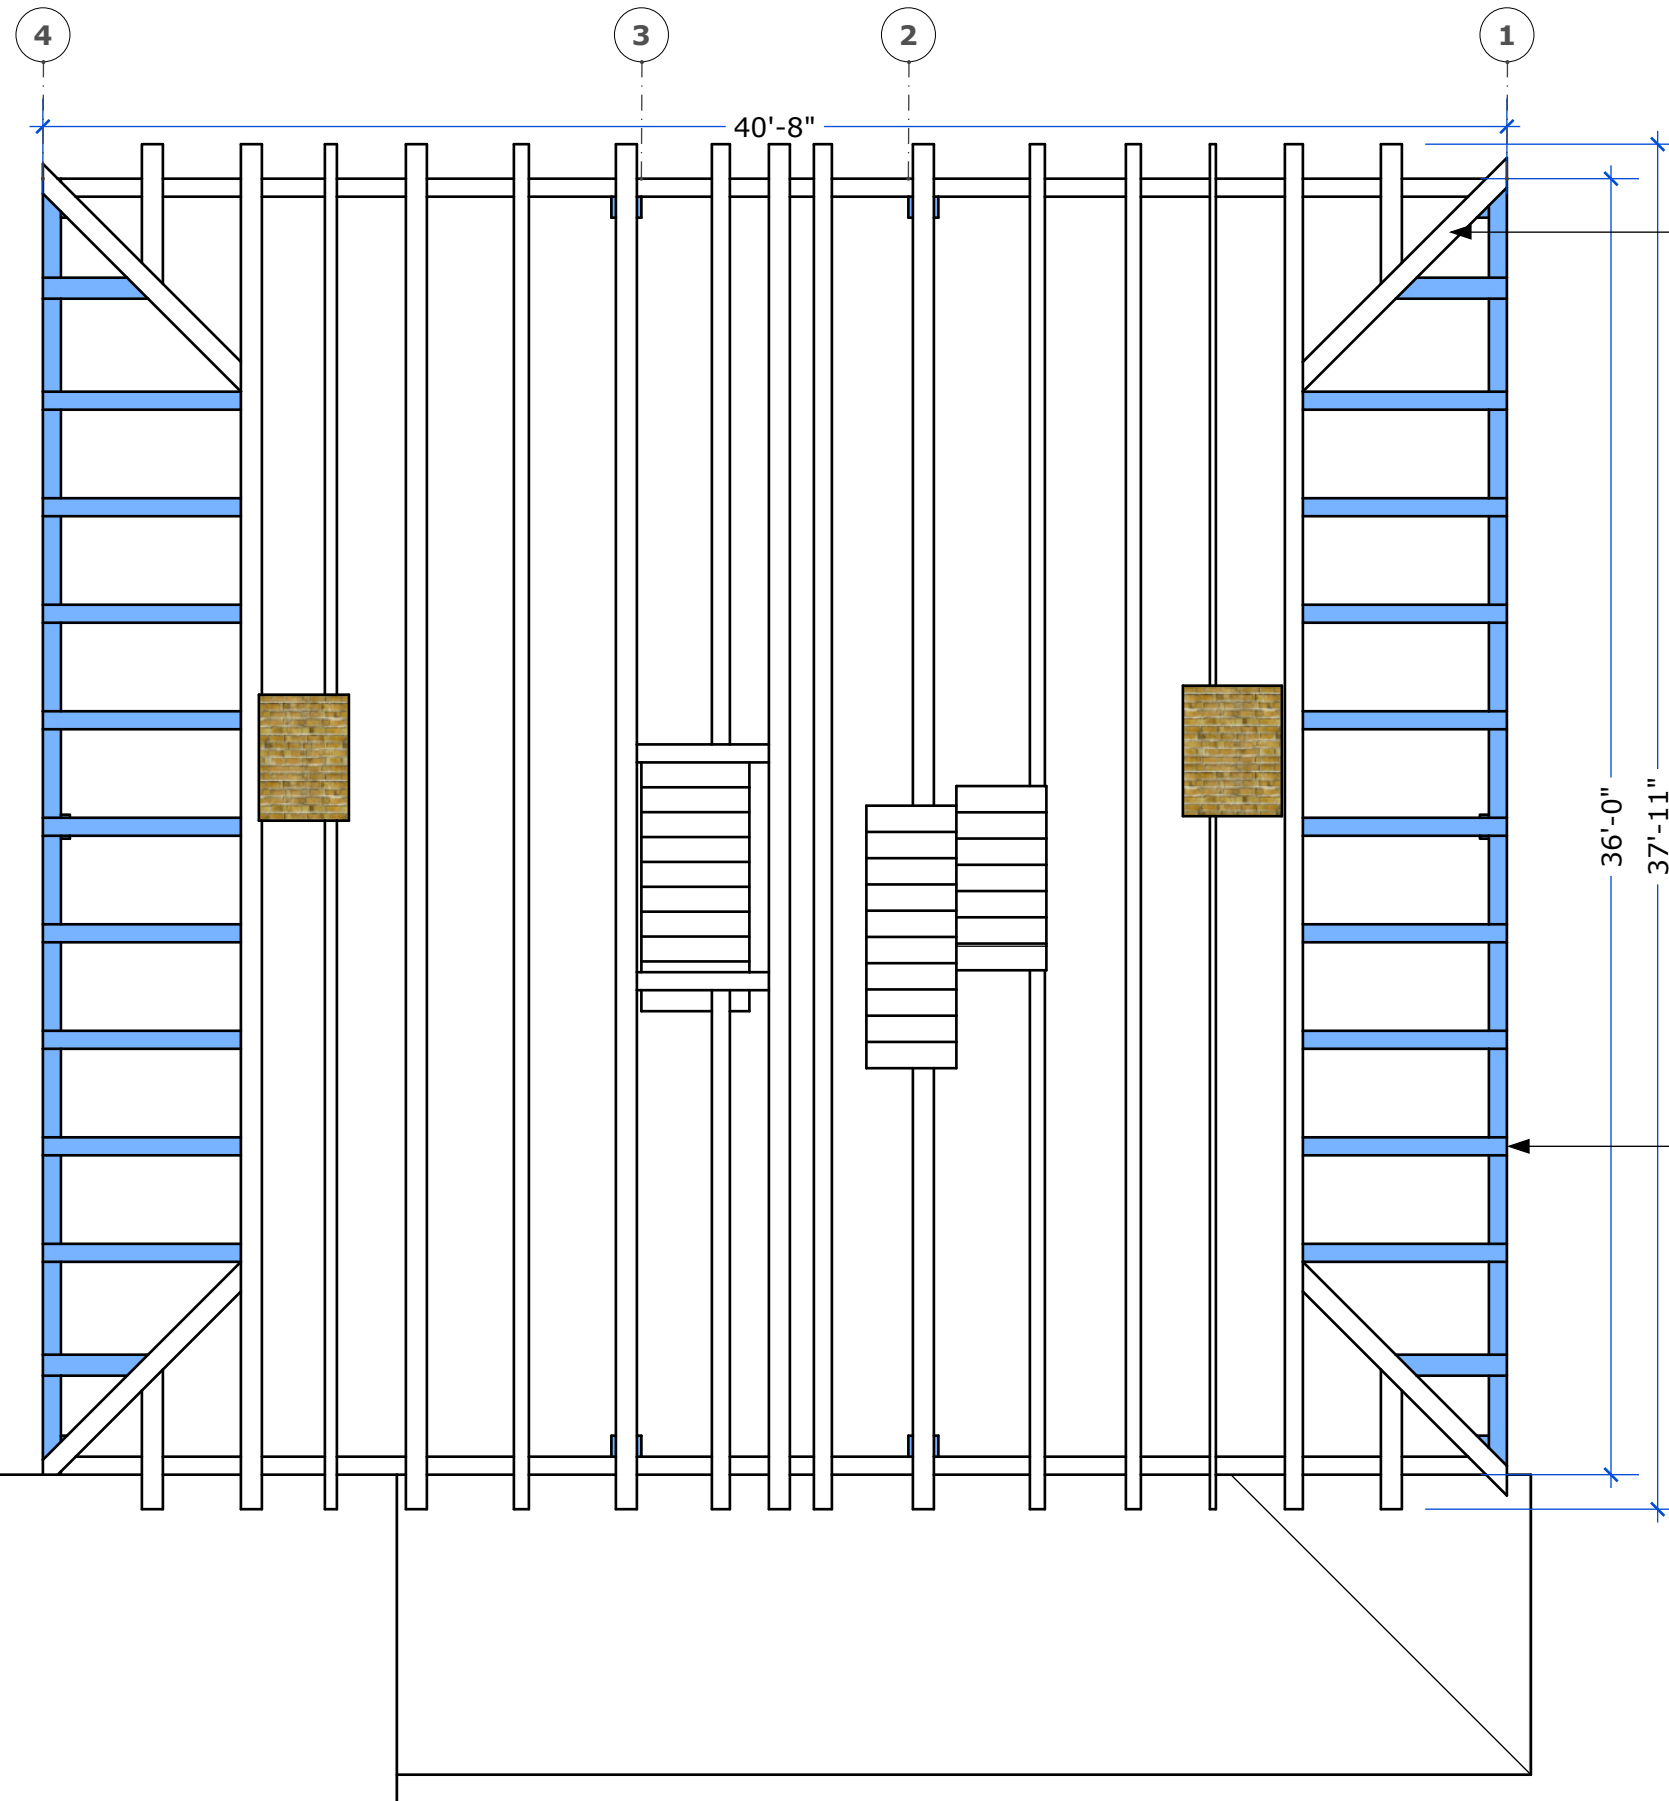
Tie Beam

Diagonal "dragon" braces

The attic floor is supported on a series of continuous tie beams. The roof was originally hipped, and was rebuilt as a gable roof in the first half of the 19th century. Diagonal braces in each corner once supported the hip rafters. The first and last tie beams are probably connected to the gable wall by a series of short ties that supported the ends of the east-west rafters.

From the building exterior, it appears that these short ties were cut flush with the gable framing when the roof was rebuilt

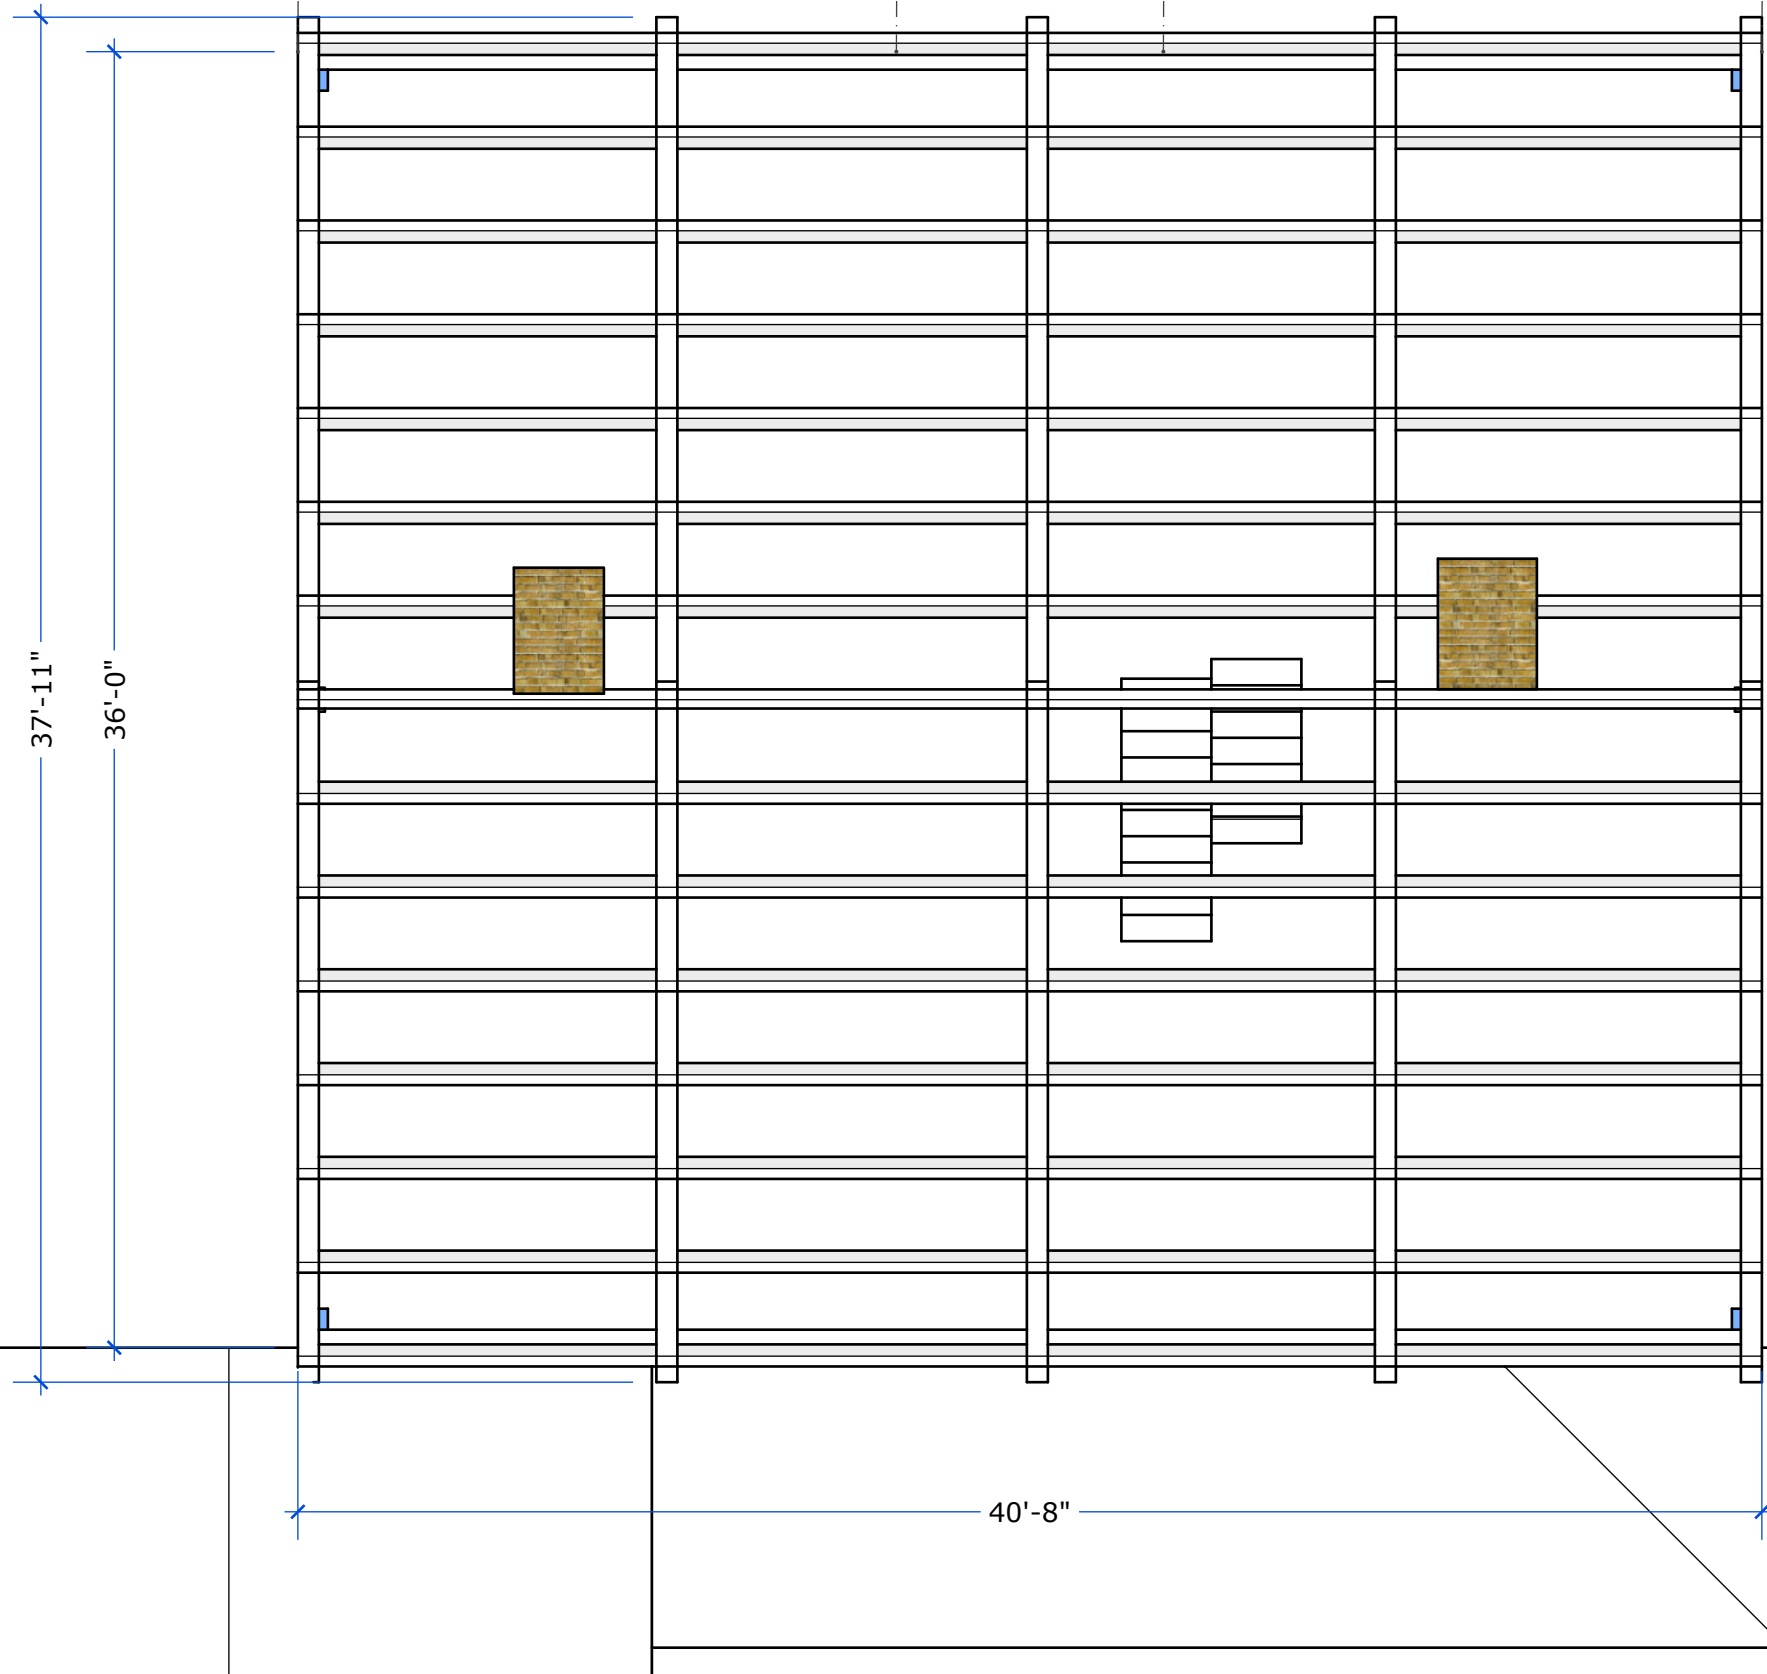
Roof Frame

The current gable roof is composed of five pairs of hewn principal rafters. These are connected longitudinally by common purlins. The bottom two rows of purlins on either pitch are continuous for the entire eave, and taper like the saplings from which they were cut. The upper purlins are continuous over three bays, with a short purlin in the last bay. The hewn surface and frame design were popular in this region until 1850.
