# Wagon Hill Farm

## Photo Report

By Jessica MilNeil | December 12, 2019

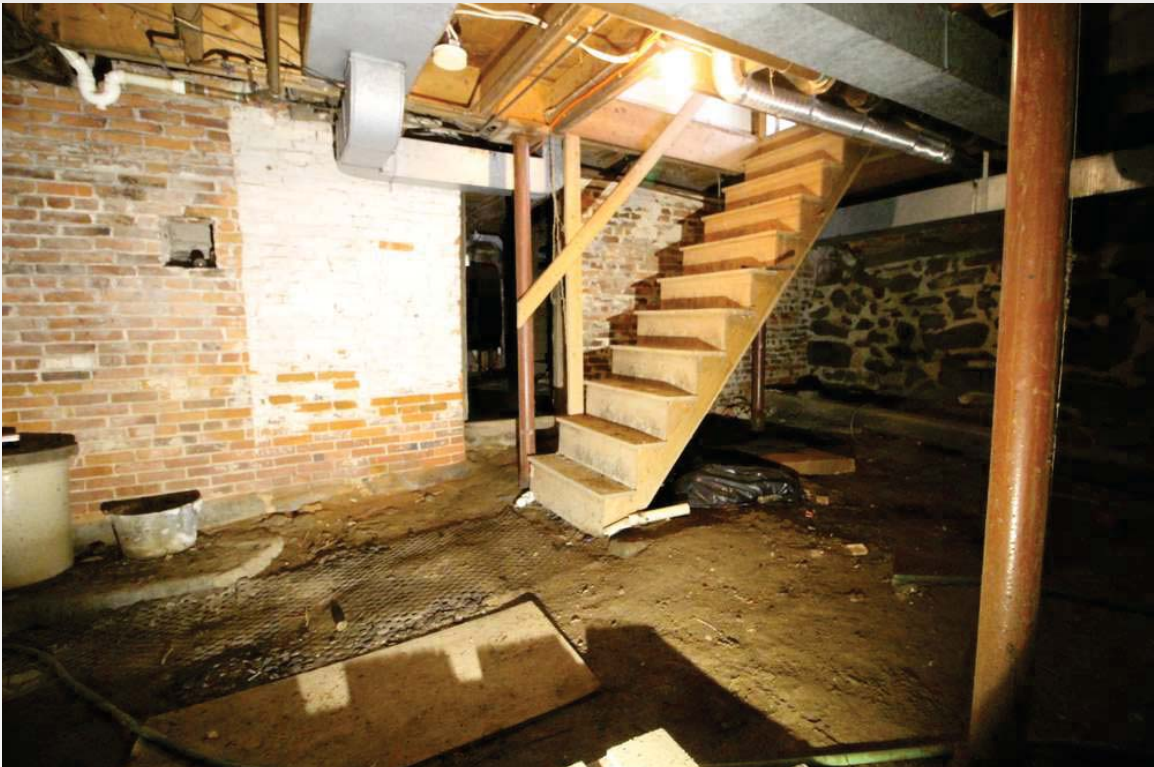
7

Basement, looking southeast. The dirt floor is uneven and allows a lot of ambient moisture to permeate up from the ground.

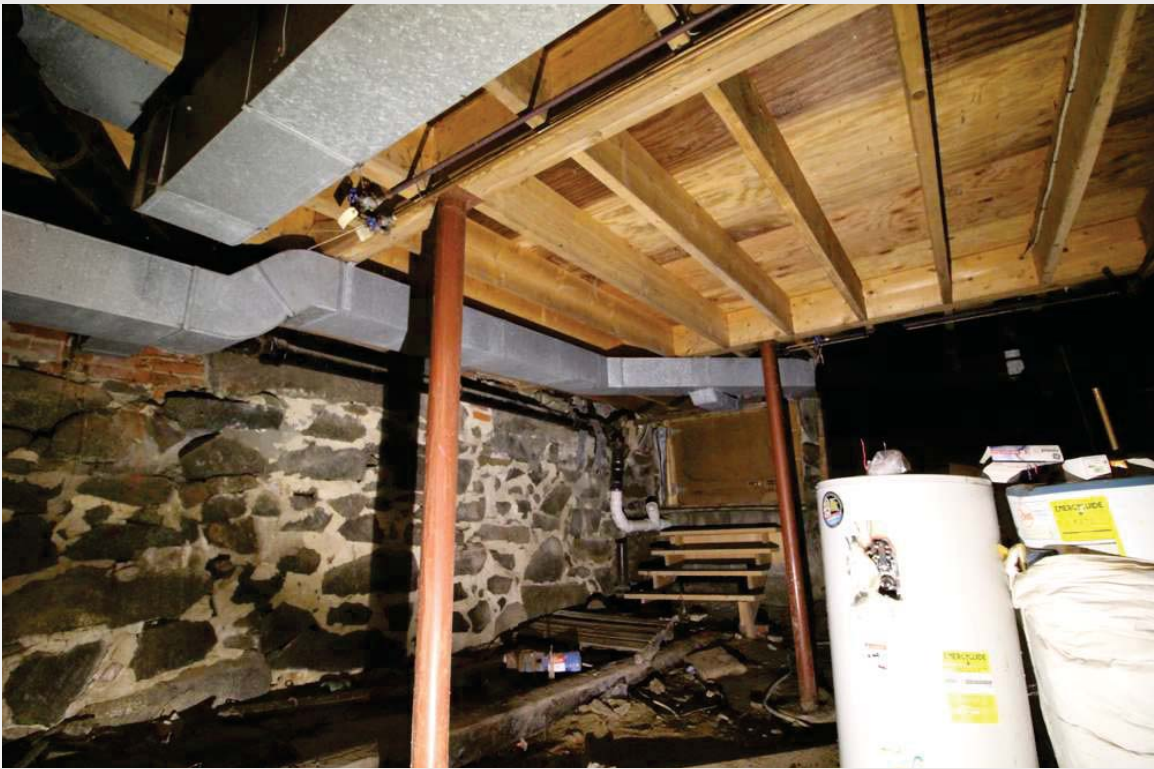
8

Basement, looking southwest. The framing under the southwest kitchen was completely removed and replaced with conventional lumber in the 1960s. The joists should be hung on hangers. Ambient moisture has already damaged the ends of a number of replacement joists.

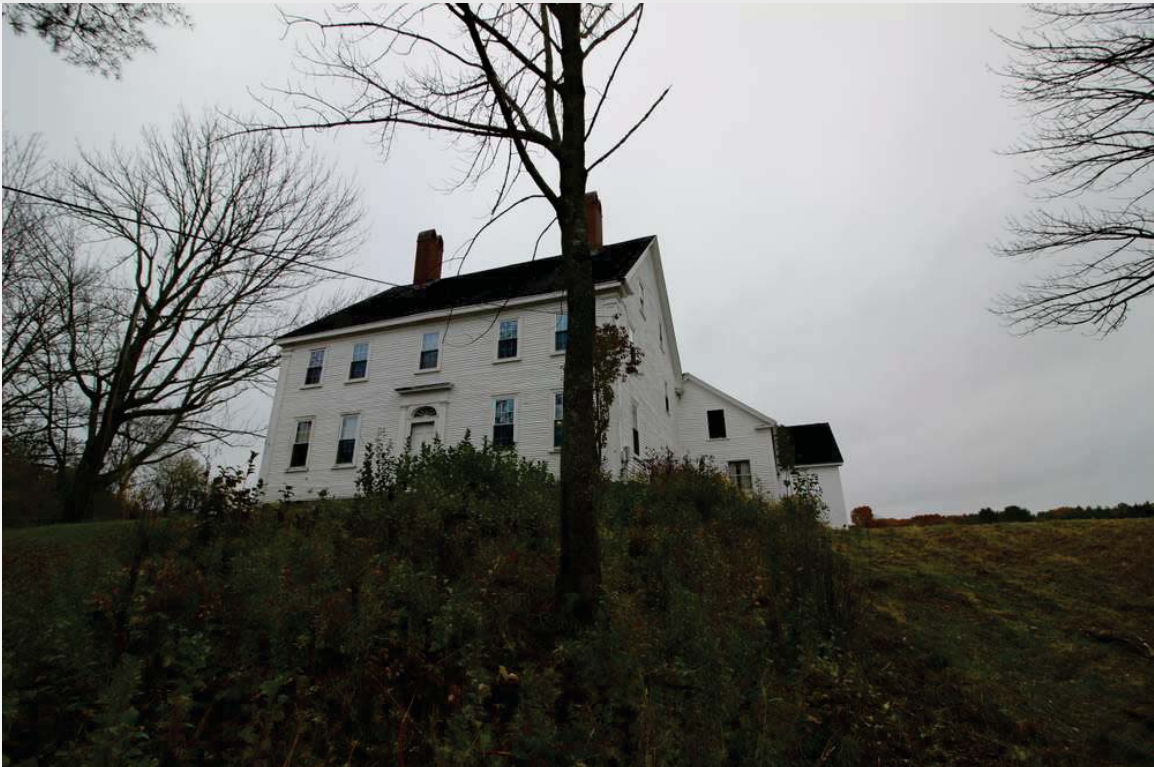
9

Despite being located on a rise, the basement is damp. Exterior drainage should be installed and vegetation removed to a distance of at least two feet.

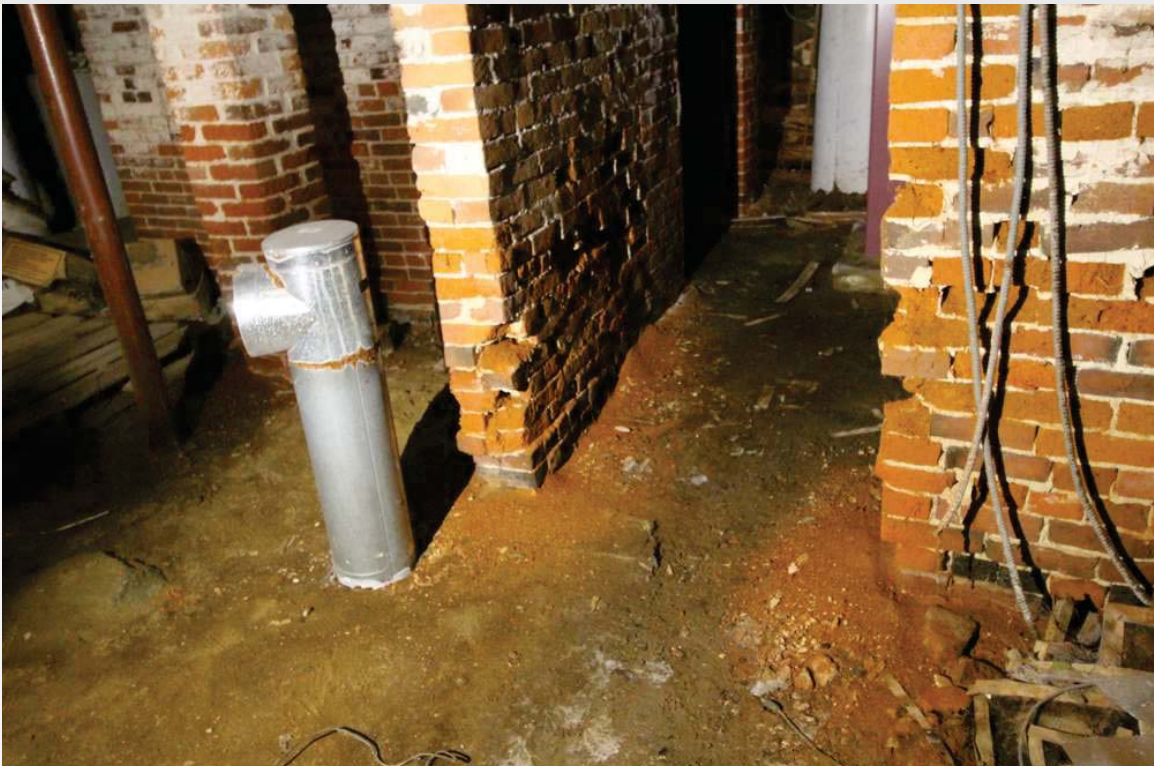
10

Brick partition walls pick up a lot of the first floor framing, which would otherwise be undersized. Unfortunately, ambient moisture has resulted in pervasive spalling, which should be assessed by a preservation mason.

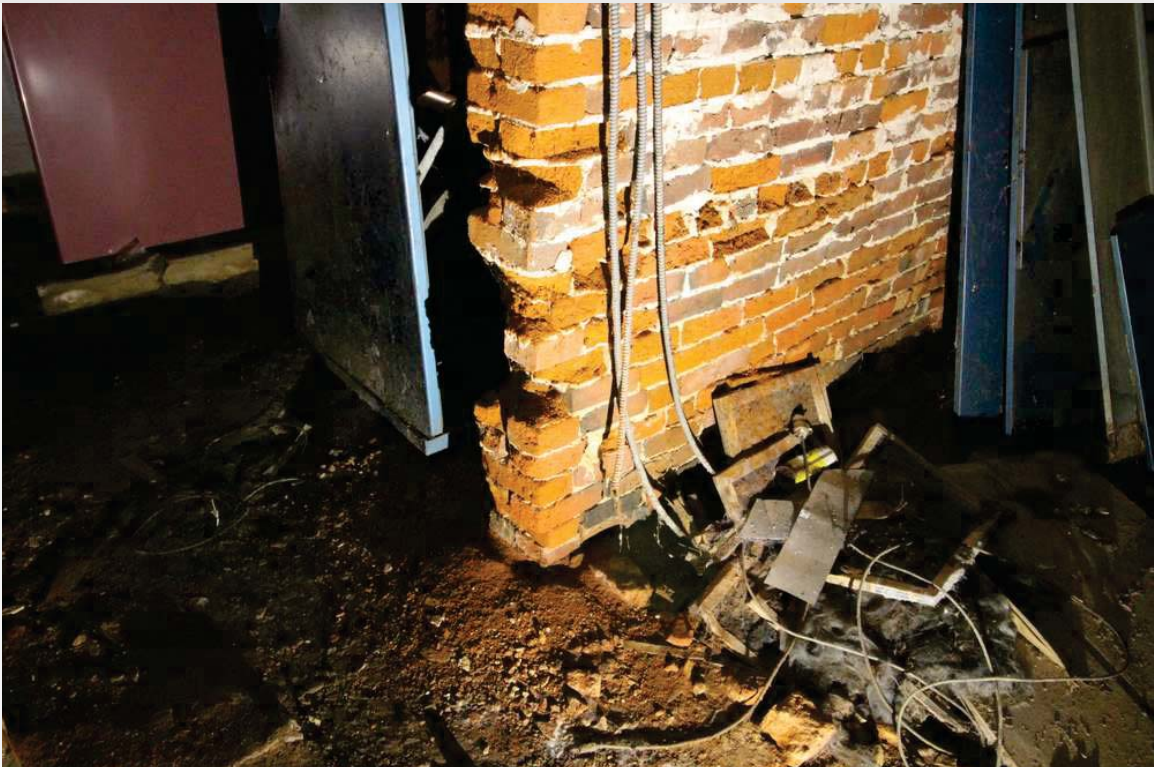
11

This is another view of the partition wall defining the northwest room downstairs. The spalling is particularly bad here.

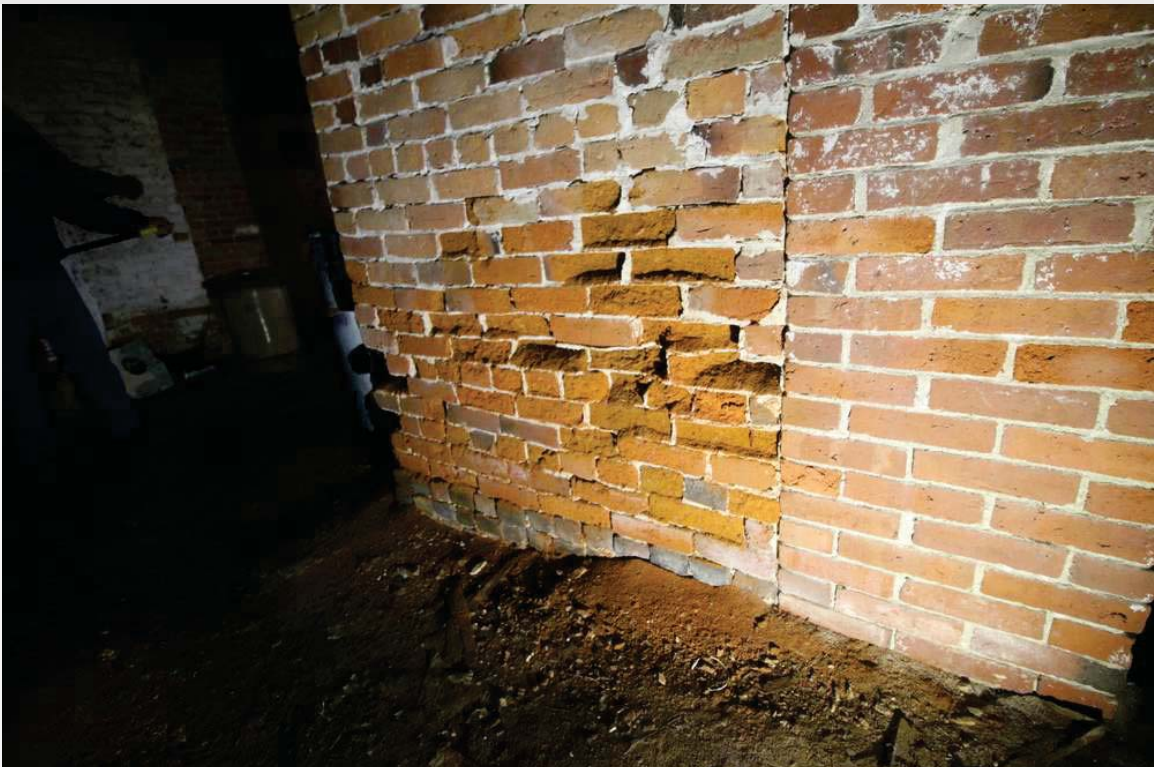
12

Brick spalling like this may require a complete rebuilding of the wall. Moisture must be managed to prevent future damage.

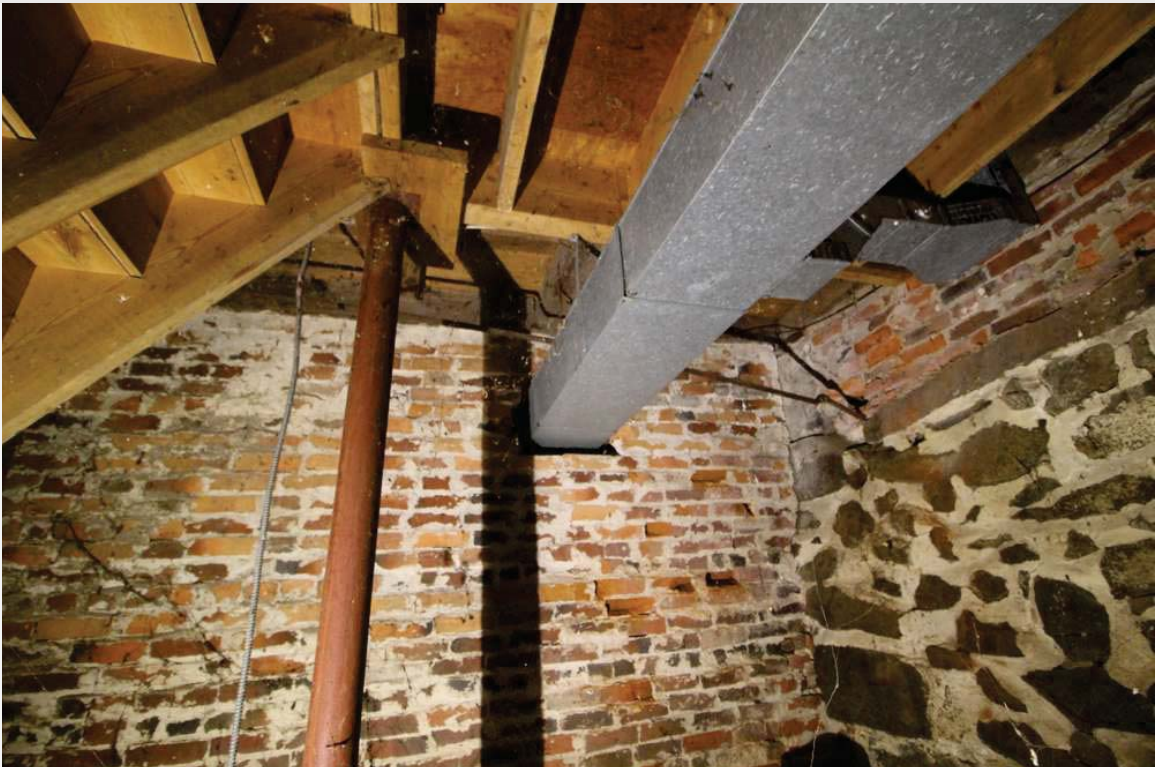
13

Elsewhere, spalling is limited and may be repaired brick by brick.

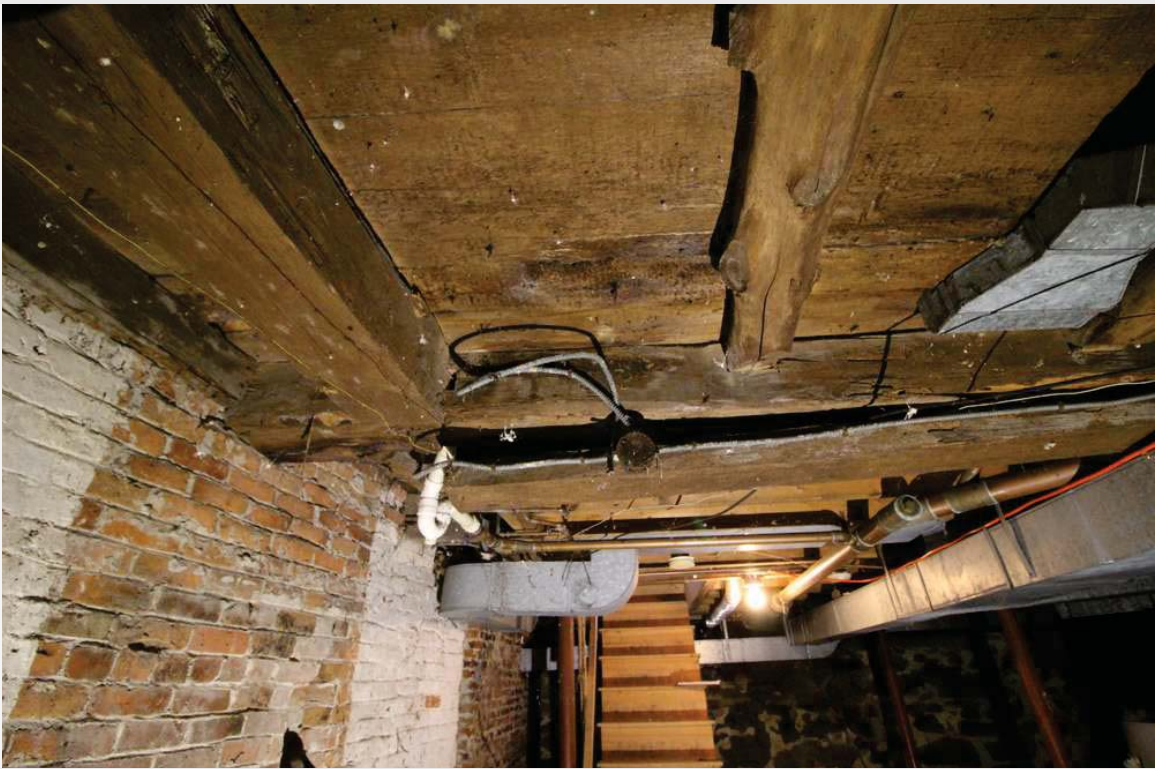
14

Center floor girt is badly rotted and a former repair attempt is falling away from the beam.

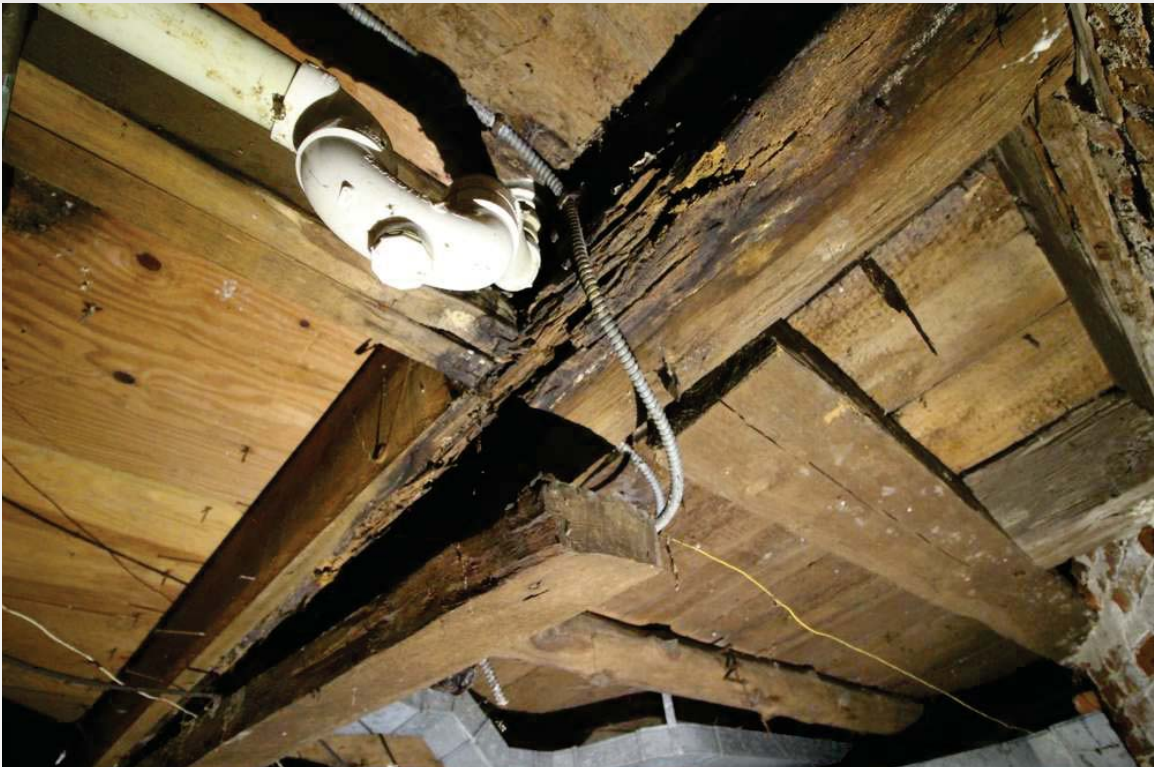
15

Close up picture of the same girt and damage.

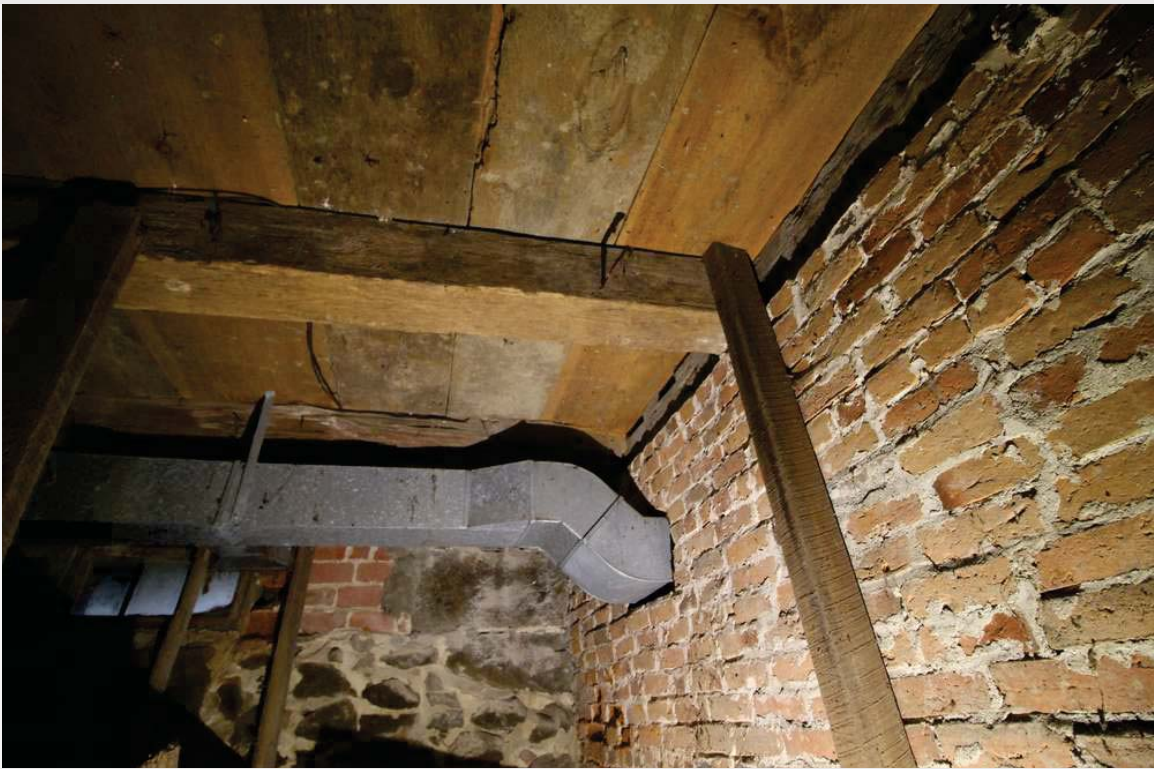
16

Most of the first floor framing lays directly upon the brick walls. With excessive moisture, vapor will condense against the cool masonry and be trapped against the wood, causing rot. We did not observe rot on the faces of these timbers, but there may be rot at the bottom and center of the beam.

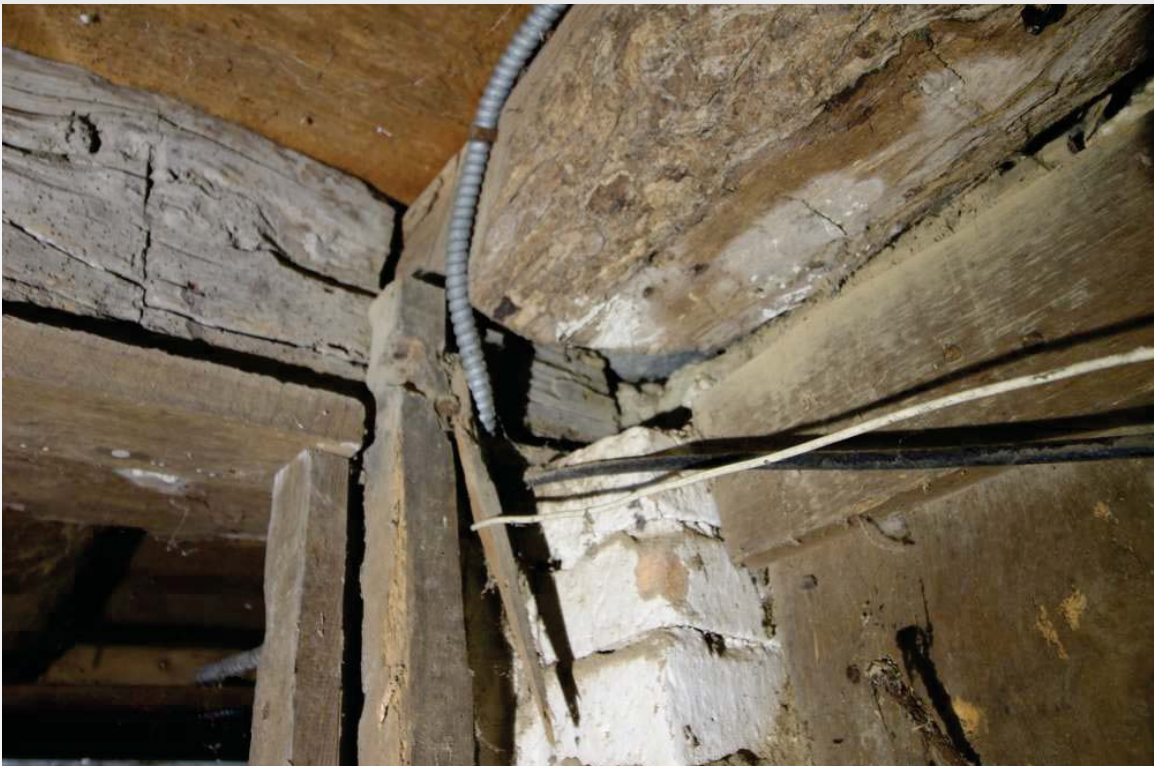
These two girts rest upon a brick partition and a brick vault. They show some mold but not major rot. It is unclear whether there is rot hidden on the underside of the beam and more invasive investigation is advised.

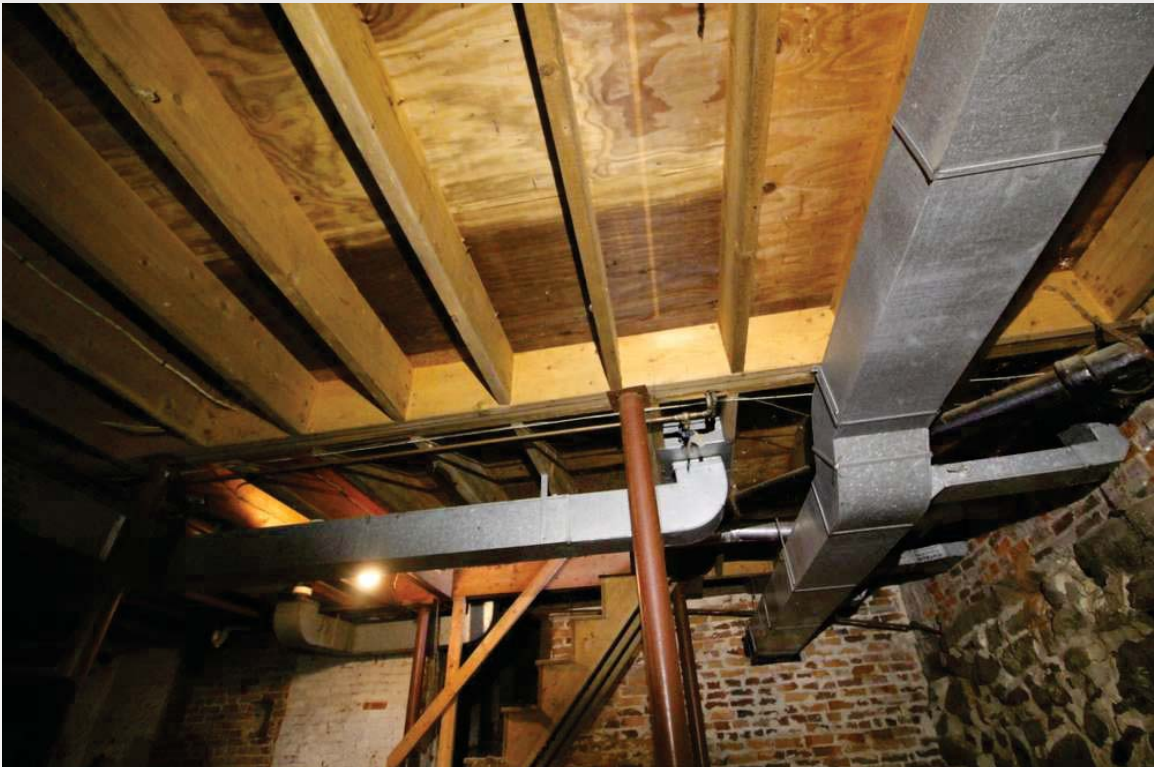
The framing beneath the southwest kitchen has been replaced fully, with conventional 2x10s. The joists were toe-nailed into the girders and should be reinforced with joist hangers.

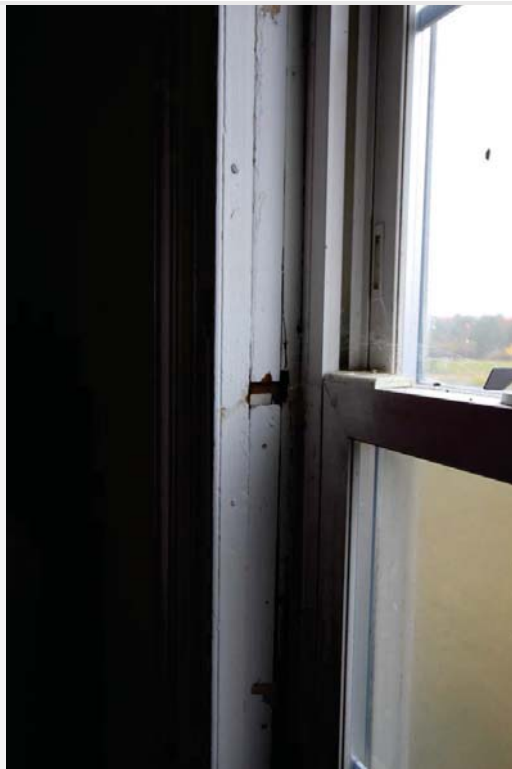
45

But the meeting rail was cut out when the vinyl replacement windows were installed. The meeting rail can and should be restored.

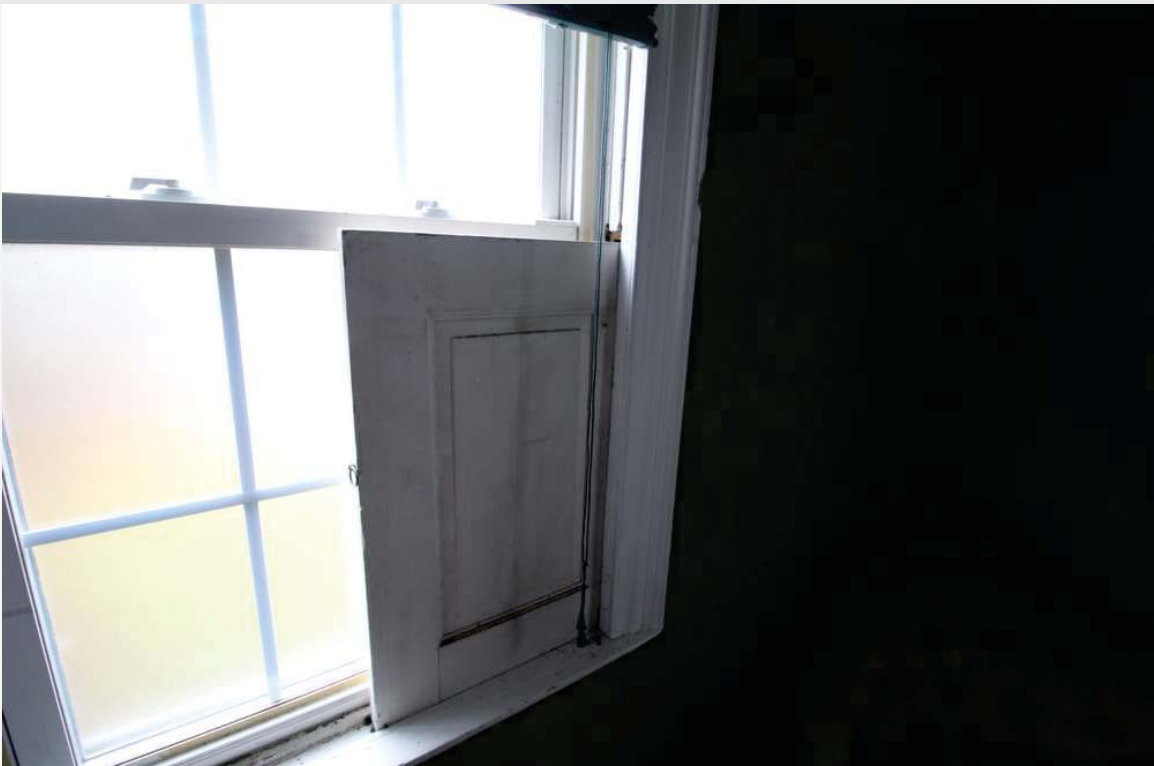
48

This room also retains its integrated shutters, and is also missing its meeting rails.

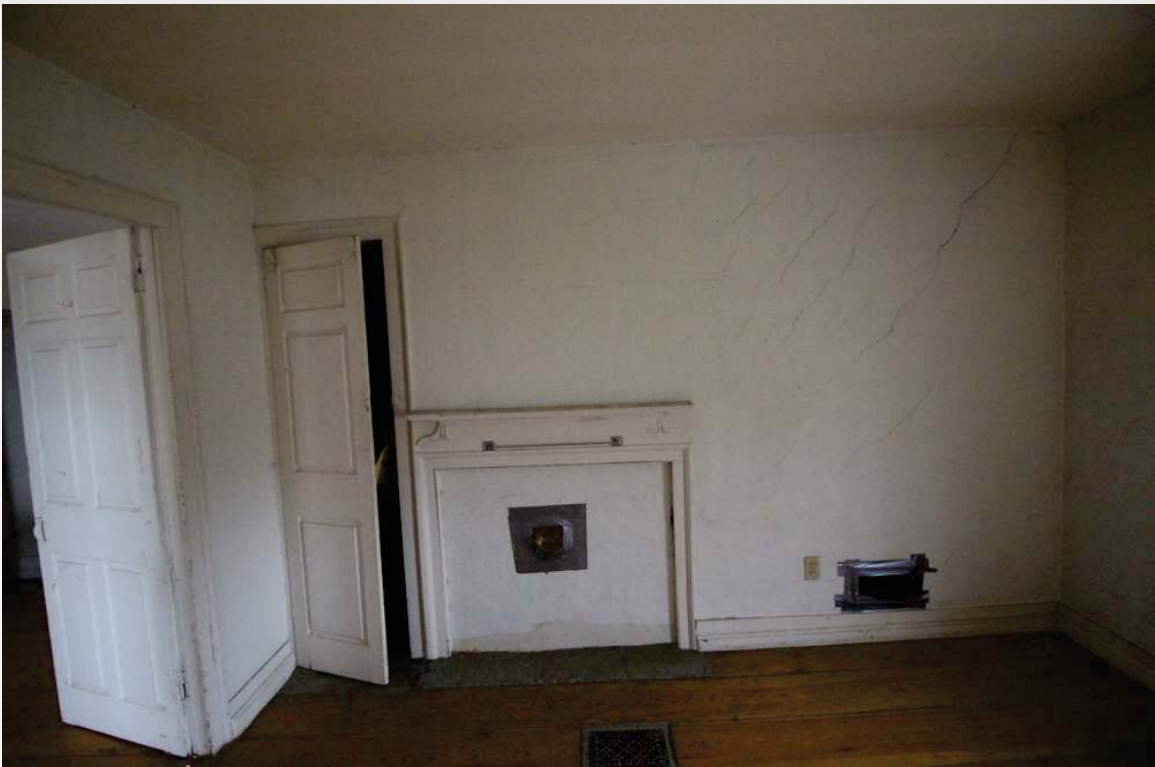
50

Middle chamber, east gable. This little room and its hearth are adorable. The fracturing in the plaster indicates some movement in the framing. It is reparable.

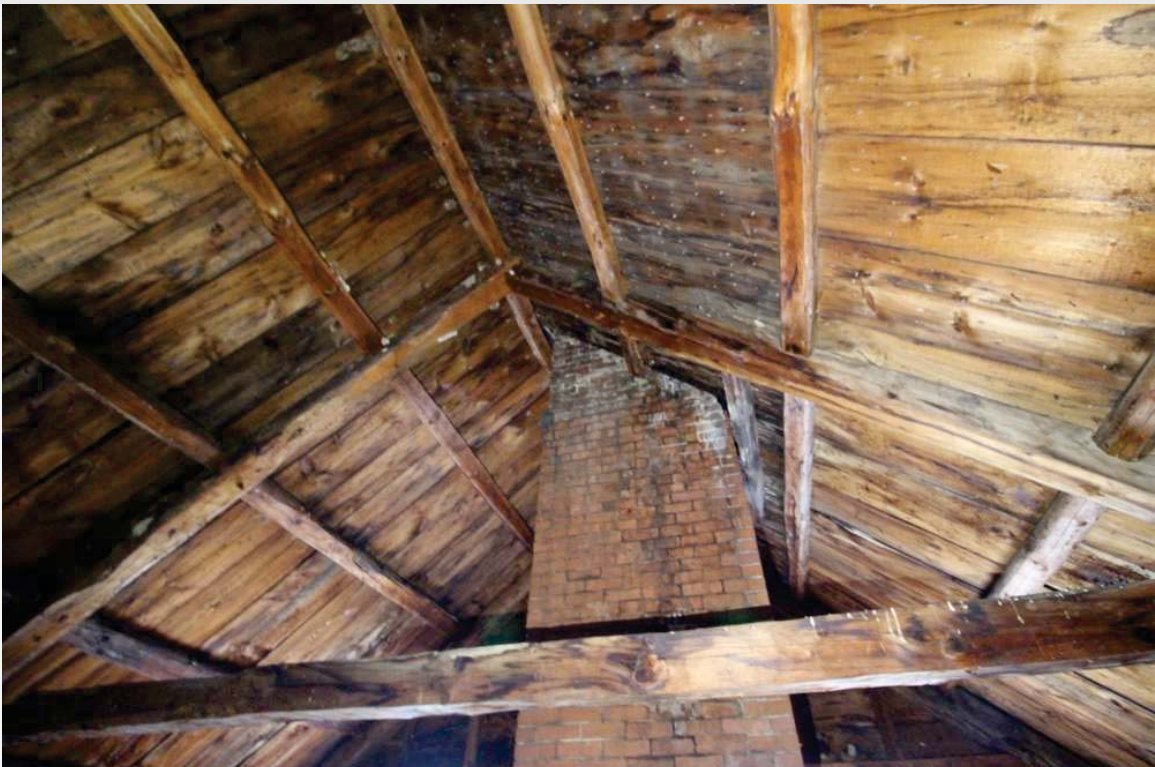
58

The chimneys do indicate some flashing failure. It is unclear whether this is ongoing, or a former leak since repaired.

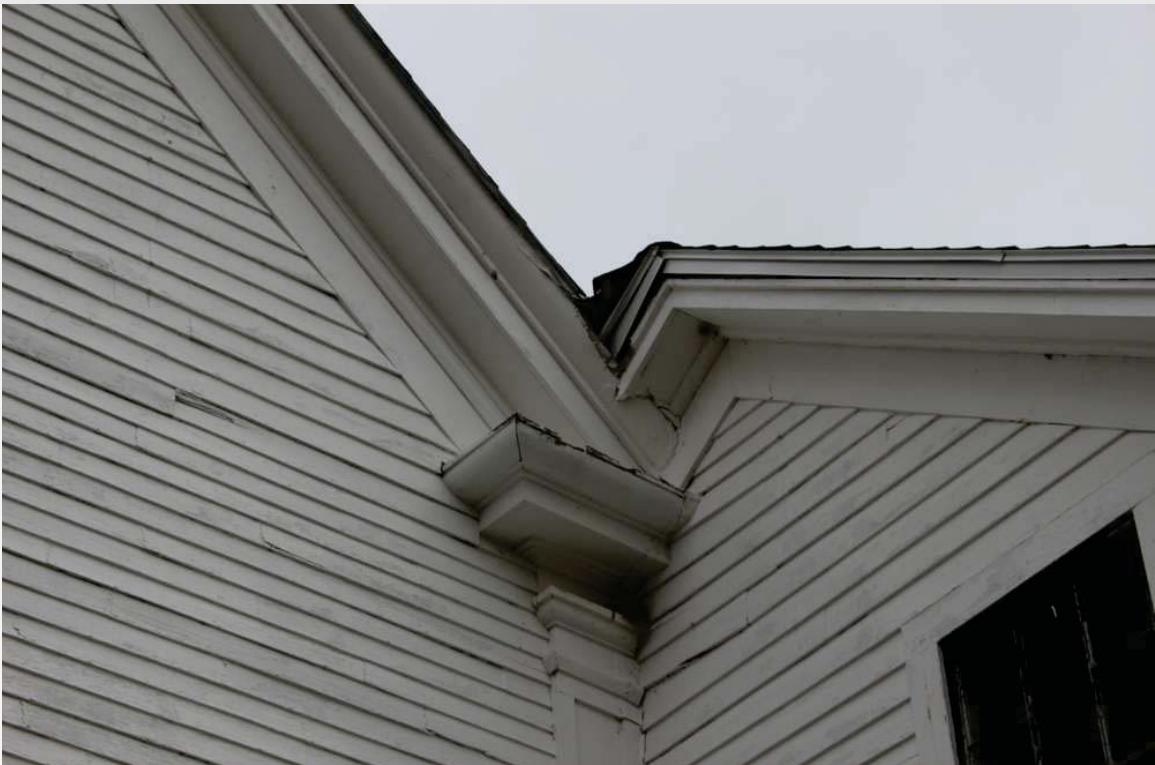
64

This intersection is very susceptible to water infiltration, and appears to have been leaking. It is essential to get the flashing right.

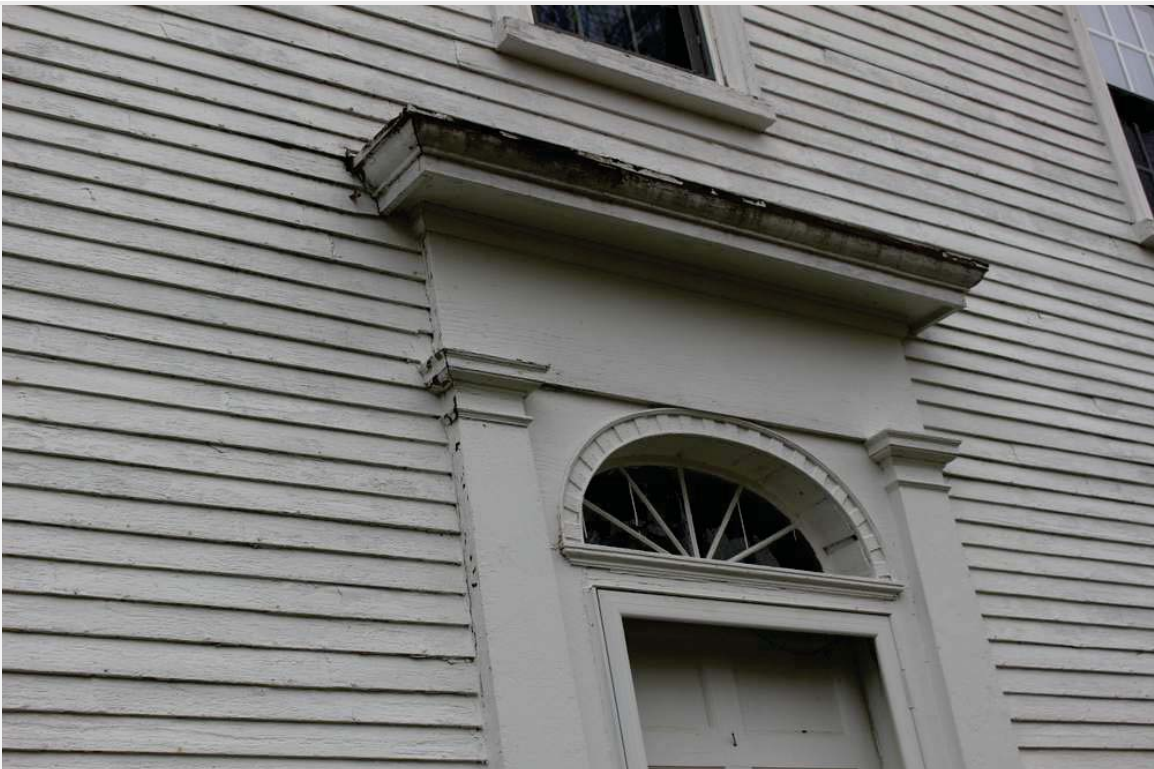
65

The front, north entrance, is a beautiful holdover from the building's Federal roots. The rooflet is showing signs of deterioration and should be repaired.

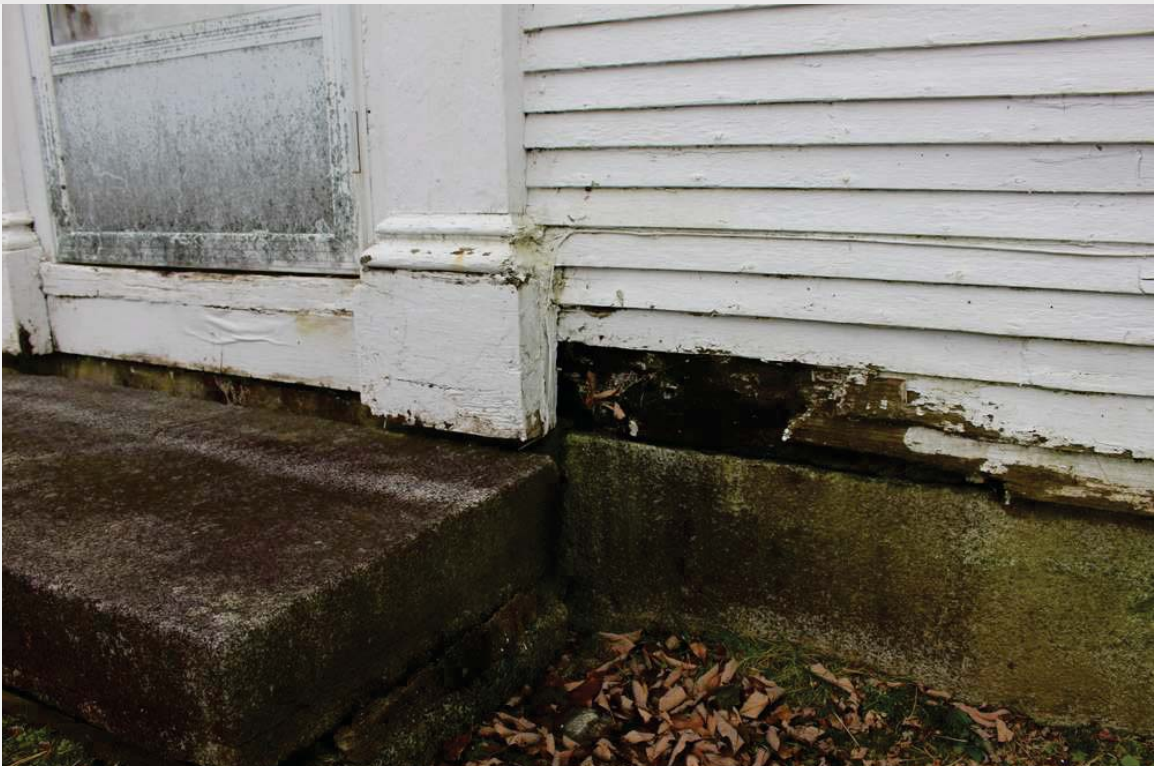
66

This rot extends through to the sill. It is extreme, and illustrates how a sill can look normal on an interior face while being hollowed out by rot from the exterior, or the bottom up.

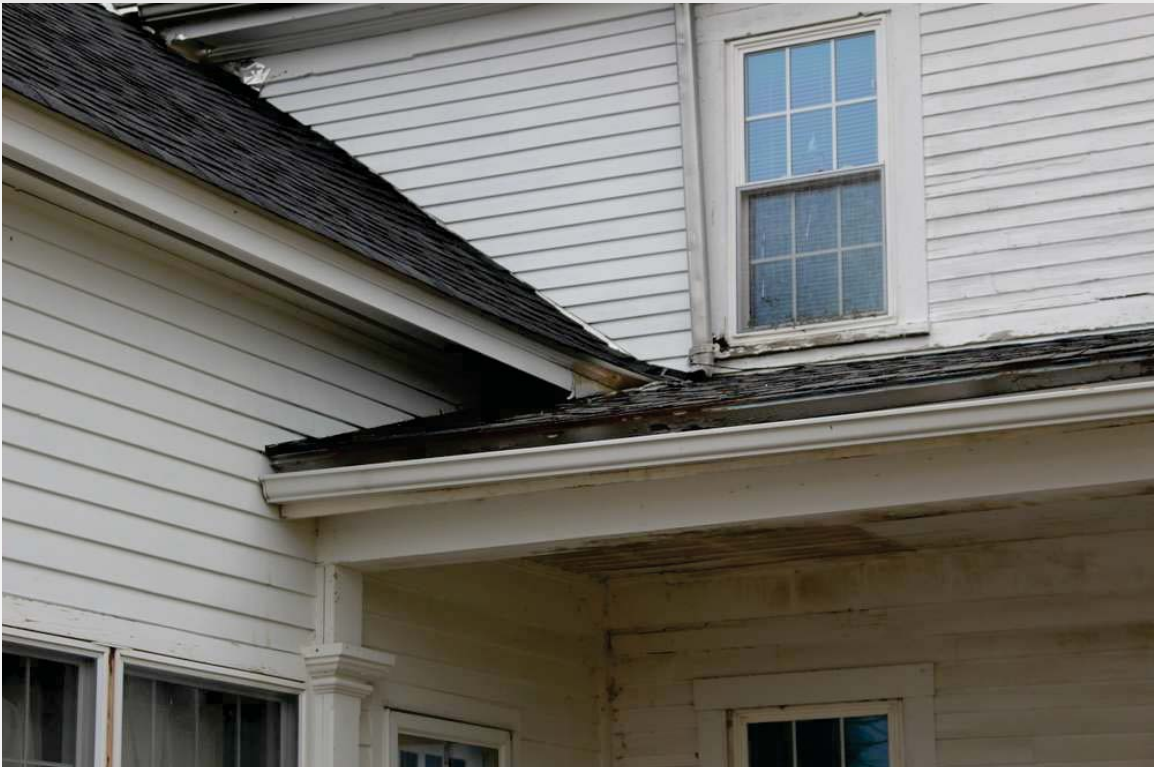
67

This intersection needs to be flashed properly. The main house is dumping water onto the ell roof, and that water is getting back into the main house through the south wall. There is a hole in the window casing.

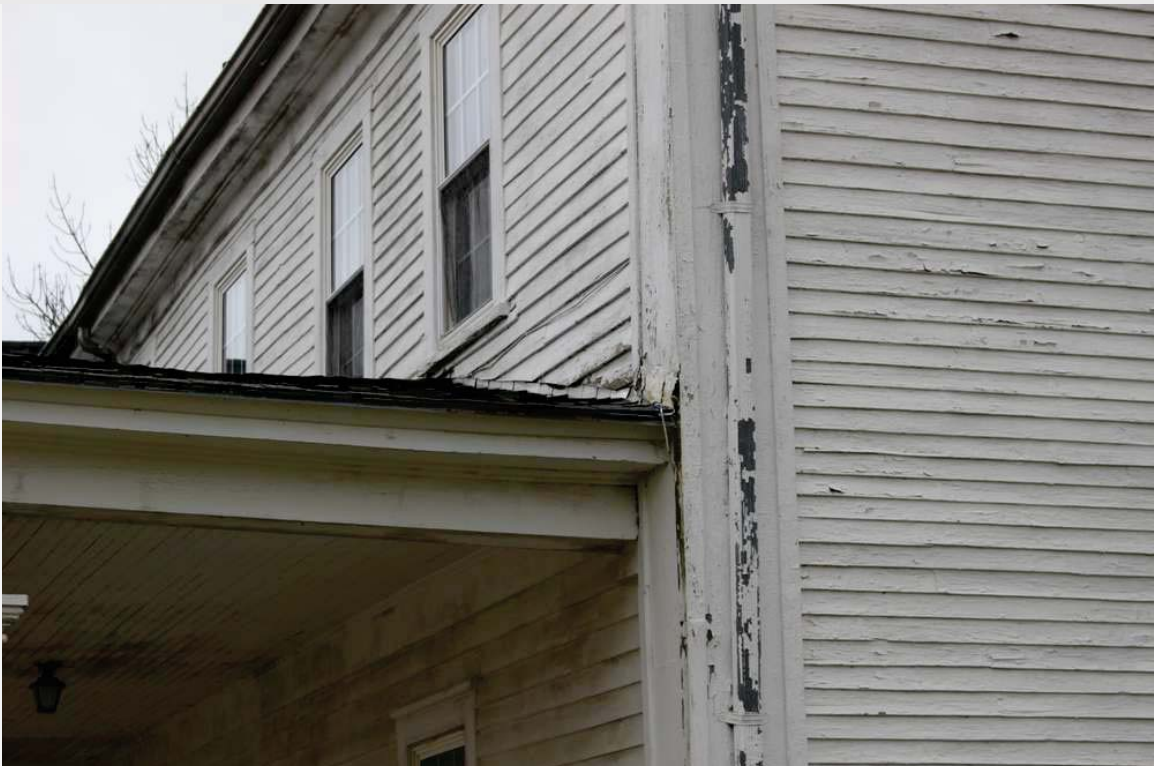
68

Here, too, the porch roof is shedding water into the corner board. Flashing needs to be inspected and improved, especially at the corner board.

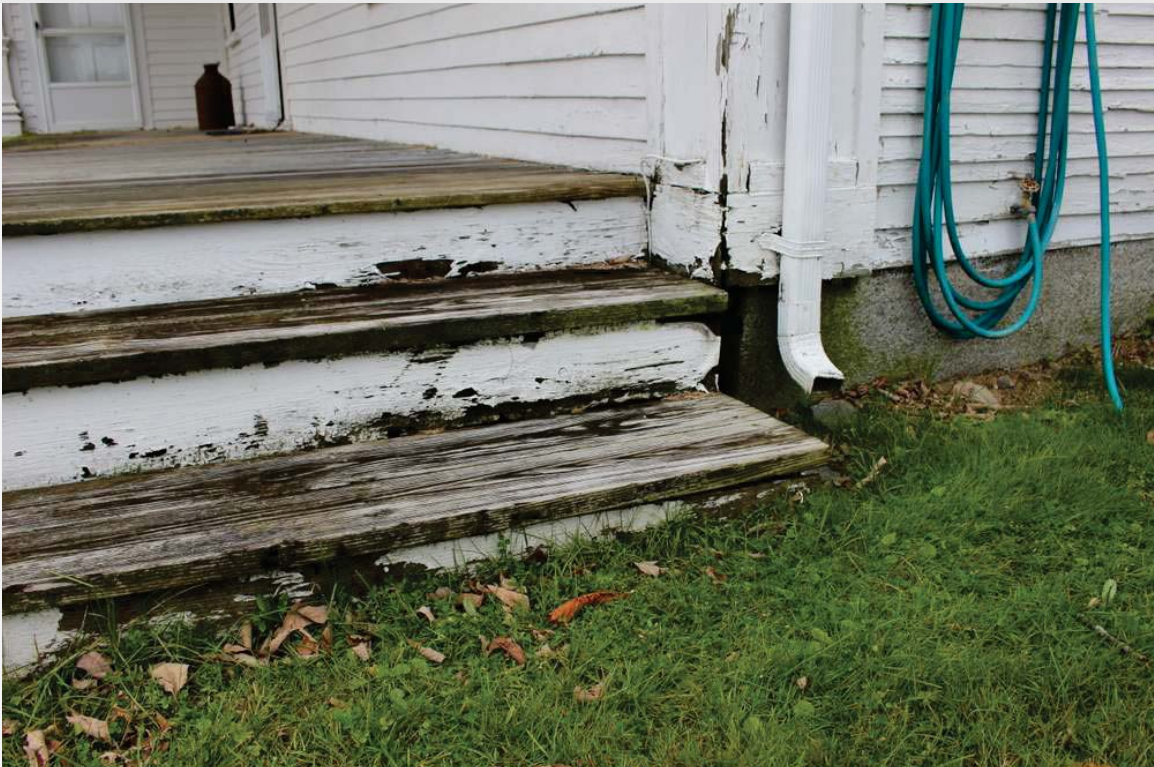
69

These steps are taking on a lot of water, and pitching it towards the main building.

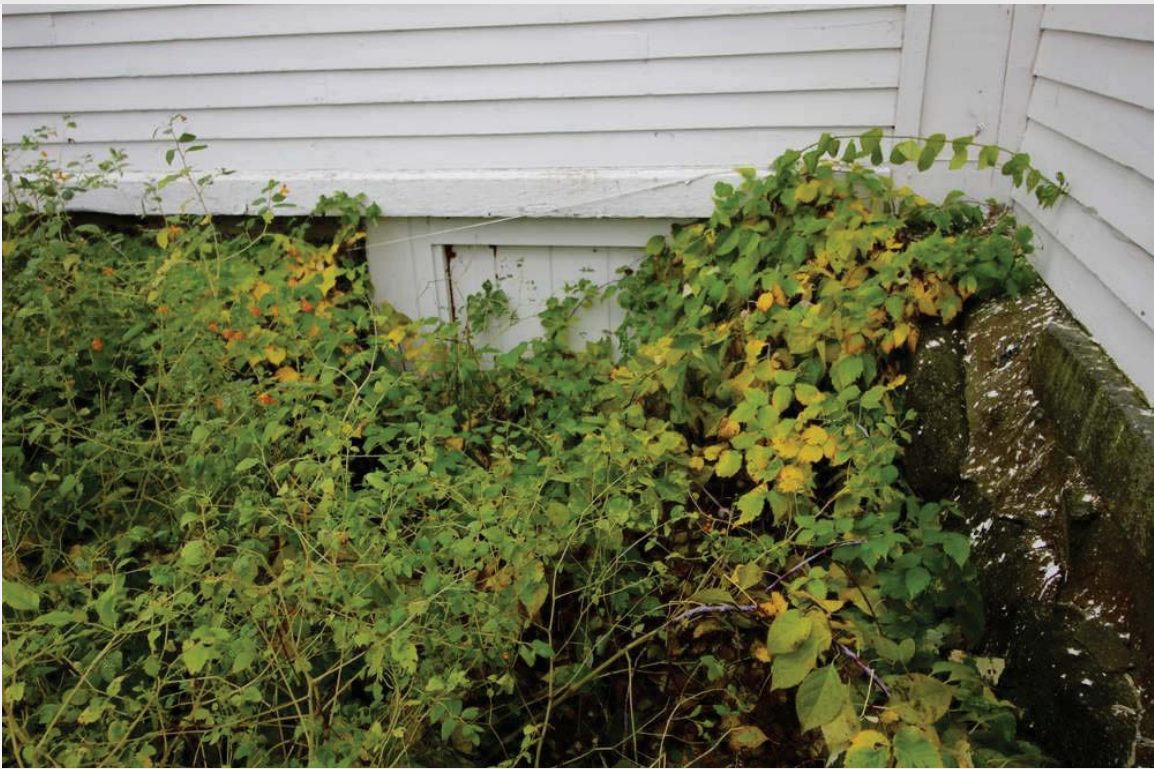
70

Vegetation surrounding the building must be cut back. Furnaces can be removed through this opening in the foundation.
