June 25, 2019

Re: Follow-up on Corrective Actions for Structure Installation in the Wetland Conservation and the Shoreland Protection Overlay District Buffers; Eversource Distribution Line Upgrade Project

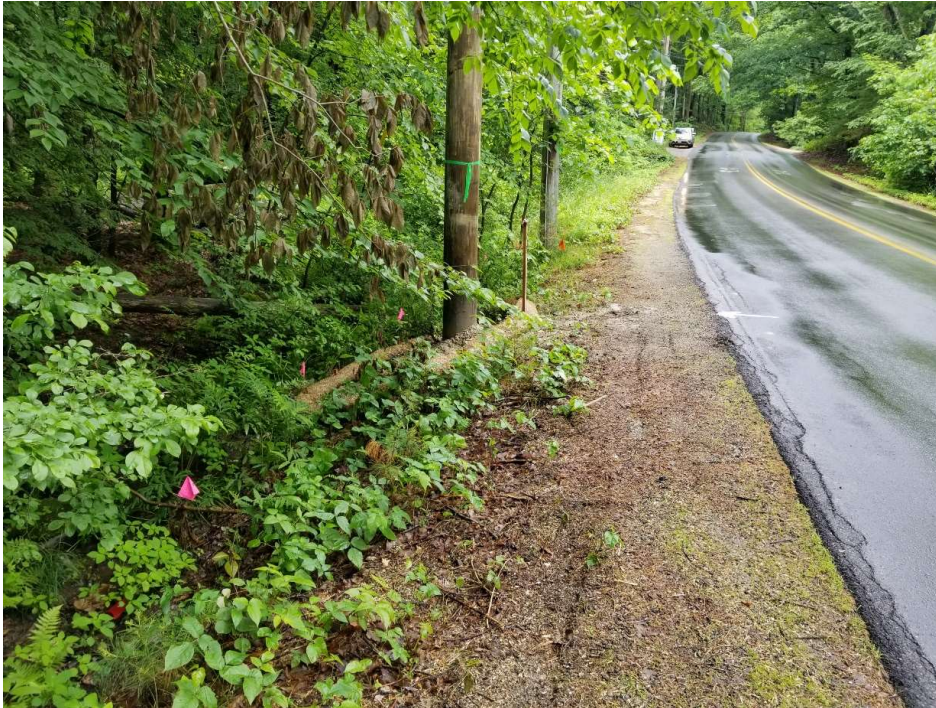
ATTACHMENT A: POLES SET IN WETLAND BUFFER
POLE: 21-54

- Pole 21-54 – Pole set between wetland and road within upland WCOD buffer
- Pole 21-58 – Pole set between wetland and road within upland WCOD and SPOD buffer
- Pole 21-59 – Pole set upslope of wetland within upland WCOD buffer

The pole setting crew, that inadvertently set the poles in the wetland buffers, has been removed from the project. Unique identifiers were installed at the ten poles located within WCOD and SPOD buffer locations to further represent the sensitivity at the location. Appropriate erosion prevention and sediment control (EPSC) measures were then deployed and will remain to prevent soil and other material from being mobilized into adjacent wetland or stream areas. The contractor has hired a compliance manager to monitor the remainder of work. Eversource has increased the number of construction supervisors assigned to monitoring the contractor's work. An environmental monitor has been hired to ensure environmental compliance on the entire distribution upgrade project and will provide authorization to proceed, for each structure, prior to the start of work. Contractor crews will be retrained with additional reinforcement of the importance of compliance relative to, environmental compliance, safety, community relations and construction protocols and we've instituted a construction checklist for every remaining pole for compliance with permitting, construction methods, mitigation measures, site conditions and documentation.

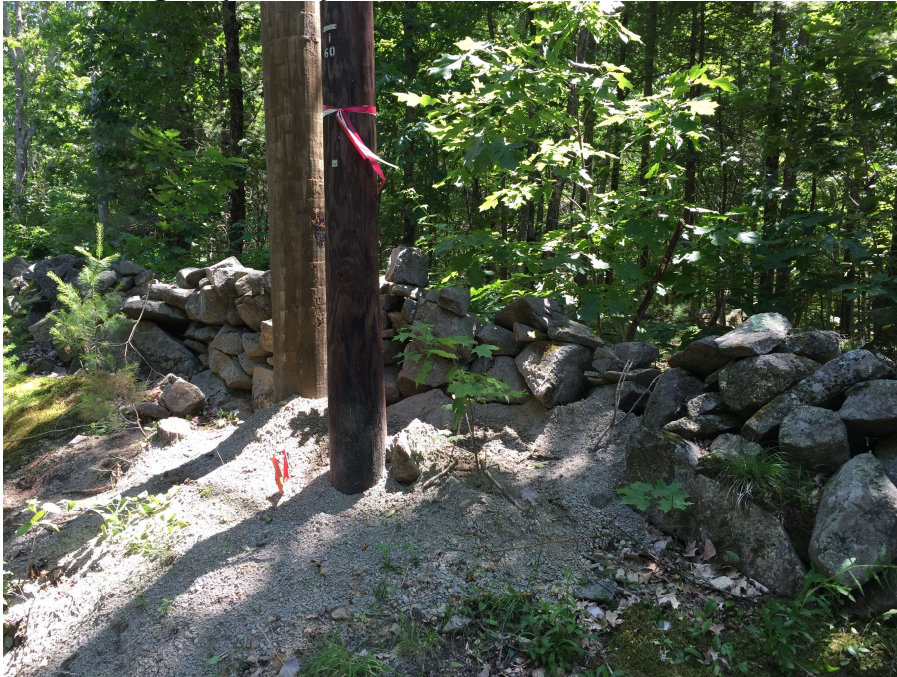
ATTACHMENT B: STONE WALLS
M. Sandberg #1 (Pole 60)

Stone Walls: While setting poles in ledge next to stone walls along Durham Point Road, the vibration from the drill caused small sections of some stone walls to shift. In total, there were seven locations along Durham Point Road where stone walls along two private property owners land experienced either shifting or an accumulation of soils near the stone wall.

- M. Sandberg #1 (Pole 60) Vibrations have caused portion of stone wall to shift/slump
- M. Sandberg #2 (Pole 62X) Vibrations have caused portion of stone wall to shift/slump
- M. Sandberg #3 (Pole 64X) Vibrations have caused portion of stone wall to shift/slump
- M. Sandberg #4 (Pole 64) Vibrations have caused portion of wall to shift/slump toward pole and stones from upper courses have fallen off the wall
- M. Sandberg #5 (Pole 65) Minor stone damage visible – Spoil dirt accumulation on wall
- D. Carson #1 (Pole 57) Vibrations have caused several stones to slide off wall away from pole
- D. Carson #2 (Pole 58) Wall is very low to the ground and is partially buried in this section. Crew encountered large stone when auguring the hole for the pole, removed the stone and set aside.

Once identified, the stone walls were documented, landowners were notified, a professional mason was hired, and site visits were scheduled to discuss restoration. The on-site meetings were held with both property owners on June 24 to develop a mutually agreeable restoration plan with a professional mason. Eversource will seek approval from the town on the restoration plans as well since one side of the wall is owned by a private landowner and the other is the town's road right of way. Upon agreement of a restoration plan and schedule with the landowner and the town and removal of the existing (old) pole, the mason will begin the work which is anticipated to take 1-2 days. Upon completion of the work Eversource will consult with the landowner and the town to confirm their satisfaction with the restoration.
