September 24, 2013

RE: Evaluation Phase Services – Summary Letter Report  
Durham Point Road over Crommet Creek  
NHDOT Bridge No. 150/065  
Hoyle, Tanner Project Number 902705

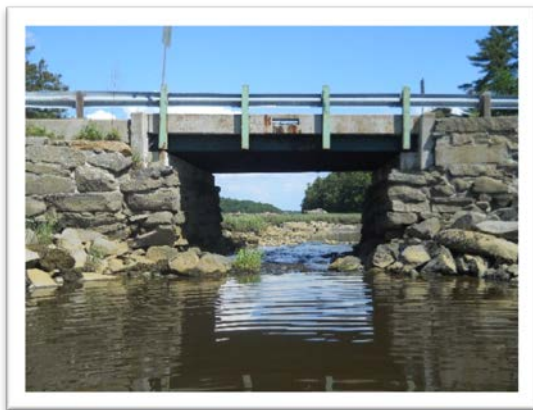
Upstream Elevation

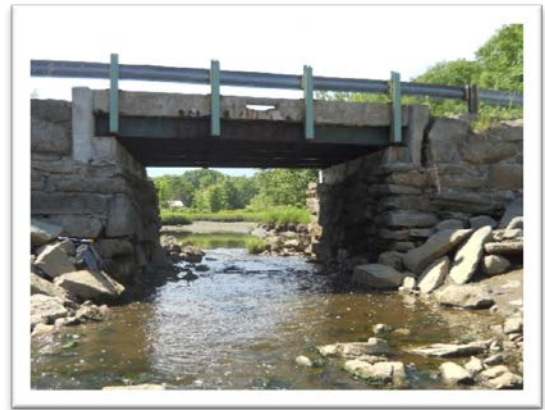
Downstream Elevation

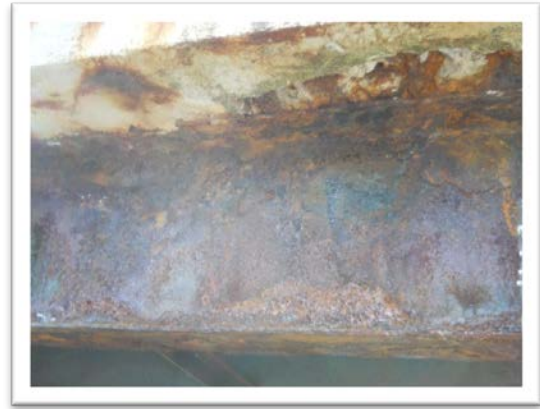
- All beams exhibit light rusting with light to moderate paint loss.
- Anchor rods at the west bearing plates are not vertical. It appears that the anchor rods may have been installed in this orientation.
- Downstream and upstream exterior beams have moderate deterioration at the scupper locations.
- West bearing plates exhibit heavy rusting.
- Rust pack formation prying the beam flanges off the west bearing plates.
- The underside of the deck exhibits light concrete spalling with exposed rebar. Concrete cover is minimal and varies from approximately  $\frac{1}{4}$ " to  $\frac{3}{8}$ ".

Downstream Exterior Girder

Hoyle, Tanner evaluated the structural capacity of the exterior beams at the deteriorated sections and determined that no repairs are required at this time to maintain the current weight limit posting. No visible cracks were observed in the stringers or bearings to suggest distress due to the anchor rods being off-vertical and deformation of the west bearing plates, therefore; no action is required. There are small localized areas of the deck underside that exhibit light concrete spalling. Due to the size and limited quantity of the spalls, patching is not required at this time.

- **SUPERSTRUCTURE**
  - Paint the middle section, between the two center rail posts, on both exterior beams, with lead barrier compound (LBC) paint to arrest future deterioration. Due to the age of the structure, it is assumed that the existing paint contains lead. The LBC provides a barrier between the lead-based paint and the environment and requires minimal surface prep. An acrylic rust inhibitive primer will be required to neutralize rust on the beams.

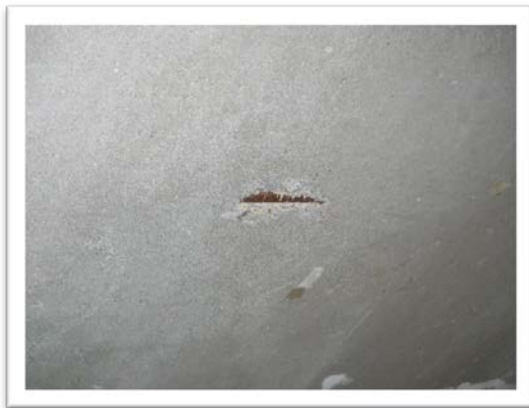
Concrete Spall at Underside of Deck

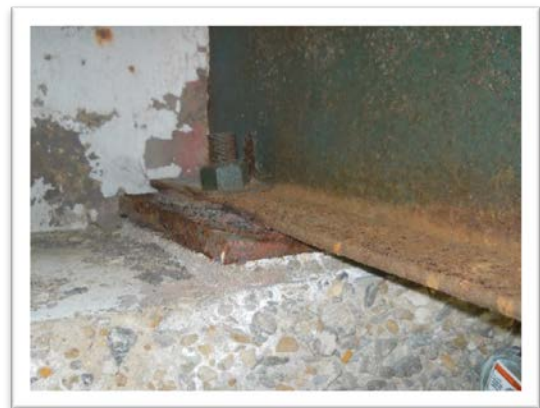
Typical West Bearing Plate

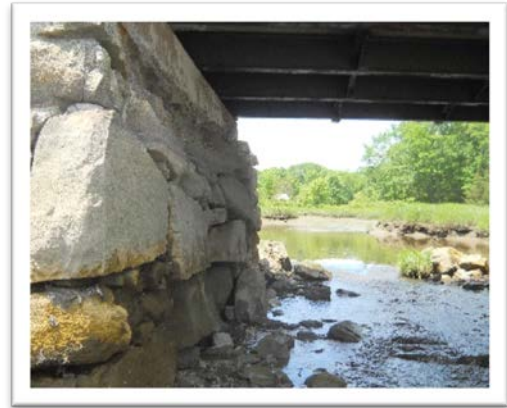
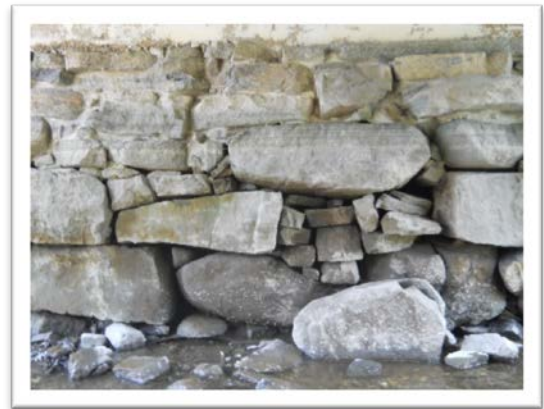
Bulging at West Abutment

The observed bulging of the abutments is believed to be due to settlement and movement of the structure. The bulging was first documented in the NHDOT Inspection report in 2010 when the condition of the substructure went from a condition rating of 5 to 4; however, Town representatives noted this bulging prior to this date. The settlement has caused cracking of the

stones within the bulging area. The loose small stones located in the bulging area appear to have been placed during the 1992 Durham Point Road Bridge Repair project.

- **SUBSTRUCTURE**
  - Long-term, annual monitoring of the abutments to supplement NHDOT inspections and ensure stability of the substructure should be completed. The stone bulging should be well documented with photographs and measurements. If any annual movement over 1/2" is detected, a qualified bridge engineer should be retained to evaluate the substructure.

- Chink stone face of abutment and wingwalls to the mudline. Replace missing stones in breastwall.
  - Remove and reconstruct the northwest corner of the concrete abutment cap.

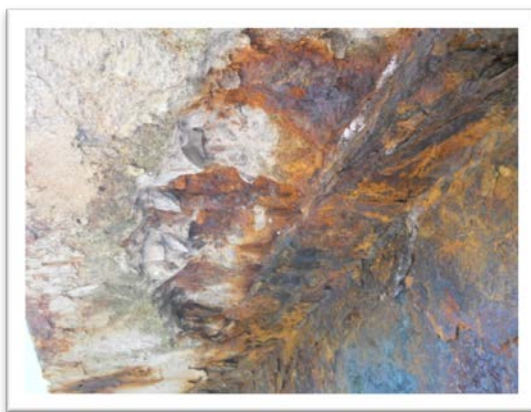
- The underside of the concrete curb within the limits of the downstream scupper exhibits concrete spalling.

Underside of Downstream Curb

The existing scuppers consist of 5" high x 2' wide voids in the concrete curb on both sides of the bridge. Water draining from the scuppers leaks onto the exterior beams and has caused deterioration in the exterior beams.

- **EXISTING SCUPPERS**
  - Install and grout a drainage pipe with a 90° elbow in the existing scuppers to direct water away from exterior stringers to prevent further damage.

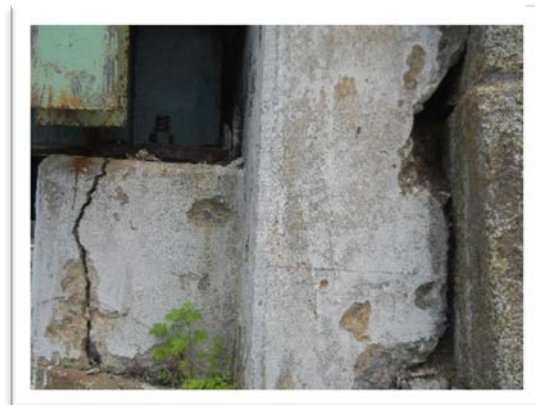
- Concrete beam seat coating is failing.
- Concrete beam seat at the northwest corner is cracked and the concrete is unsound at this location.
- West concrete backwall exhibits spalling behind the upstream exterior girder.
- Void with exposed rebar in the north corner of the west abutment backwall at the wingwall interface.
- Mortar in the stone is cracked at the abutment to wingwall interface at the northwest quadrant.
- Both abutments exhibit bulging in the center, approximately  $\frac{1}{3}$  the height from the channel bottom. Bulging is estimated to be 10" at the west abutment and 8" at the east abutment.
- Within the bulging area there are cracked and loose stones.
- At the west abutment within the bulging area there is a large stone that is hanging.
- Stones are located at the upstream corners of the abutments, which direct the creek flow towards the center of the channel.

North Corner of West Abutment

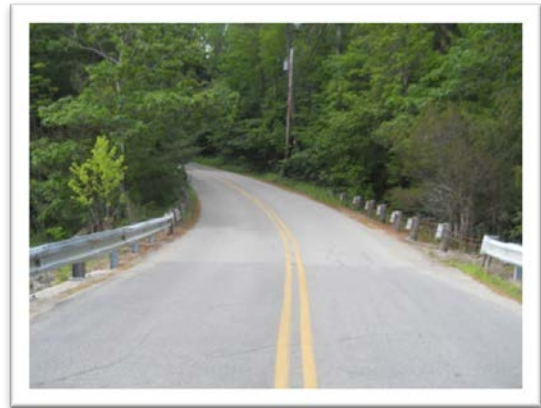
- The bridge rail is substandard.
- The approach rail is damaged at the northeast and southwest quadrants and lacks terminal units.

Damaged Approach Rail

It appears that there has been vehicular collision damage to the approach rails, which has damaged the w-beam rail. The slopes behind the guardrail posts are steep and provide little to no shelf for the posts.

- **BRIDGE AND APPROACH RAILS**
  - Double-nest the existing w-beam bridge rail and replace the cable guardrail with w-beam guardrail and terminal units. This will require slope improvements to secure the posts into the existing ground.
    - Another option would be to replace all w-beam guardrail and cable guardrail with steel-backed timber guardrail (FHWA standard). Existing bridge rail posts will be maintained and the approach posts will be replaced with wooden posts per the FHWA standard. The wooden posts are larger than the traditional steel w-beam posts, therefore; this option

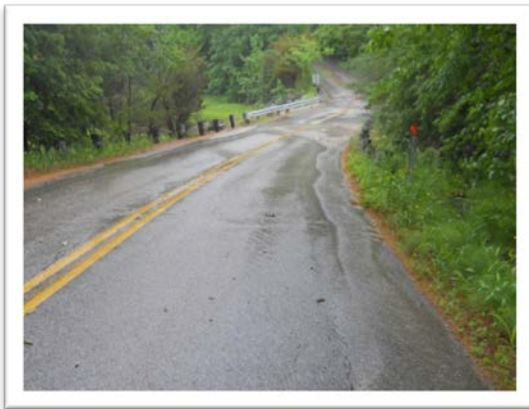
- Water at the east approach flows to the downstream scupper in the brush curb.
- Water at the west approach flows to a swale located at the guardrail at the northwest quadrant of the roadway.

Drainage Flow Looking East

During the June 17, 2013 site visit, Hoyle, Tanner representatives were present during heavy rainfall and observed the flow of water. As mentioned under Inspection Observations, the majority of the water flowing from the east approach crosses the road and drains to the downstream scupper. A small amount of water from the east approach drains to a swale located beyond the northeast concrete grade beam. Water flowing from the west approach crosses the road and drains to a swale located beyond the west abutment on the north side of the road. Little to no water from the west approach flows onto the bridge. Ponding was observed along both edges of the bridge deck.

- Pave the approach and bridge roadway, at the time of the "Durham Point Road South Paving" project. The roadway will be regraded to allow water to continue to flow to the downstream scupper and to the northwest swale without ponding at the bridge deck.

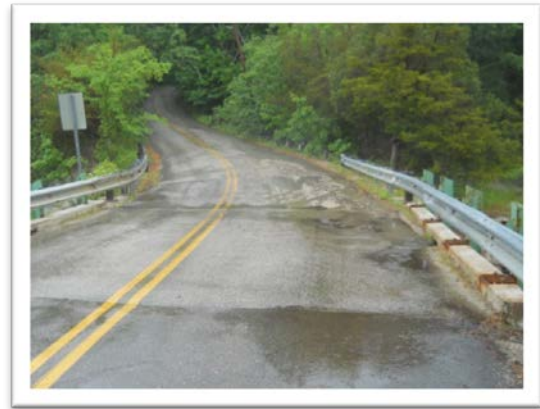
Drainage on Bridge Looking East
