PREPARED FOR: TOWN OF DURHAM, NH

**MILL POND DAM
VISUAL INSPECTION REPORT
DURHAM, NEW HAMPSHIRE
DAM #071.03**

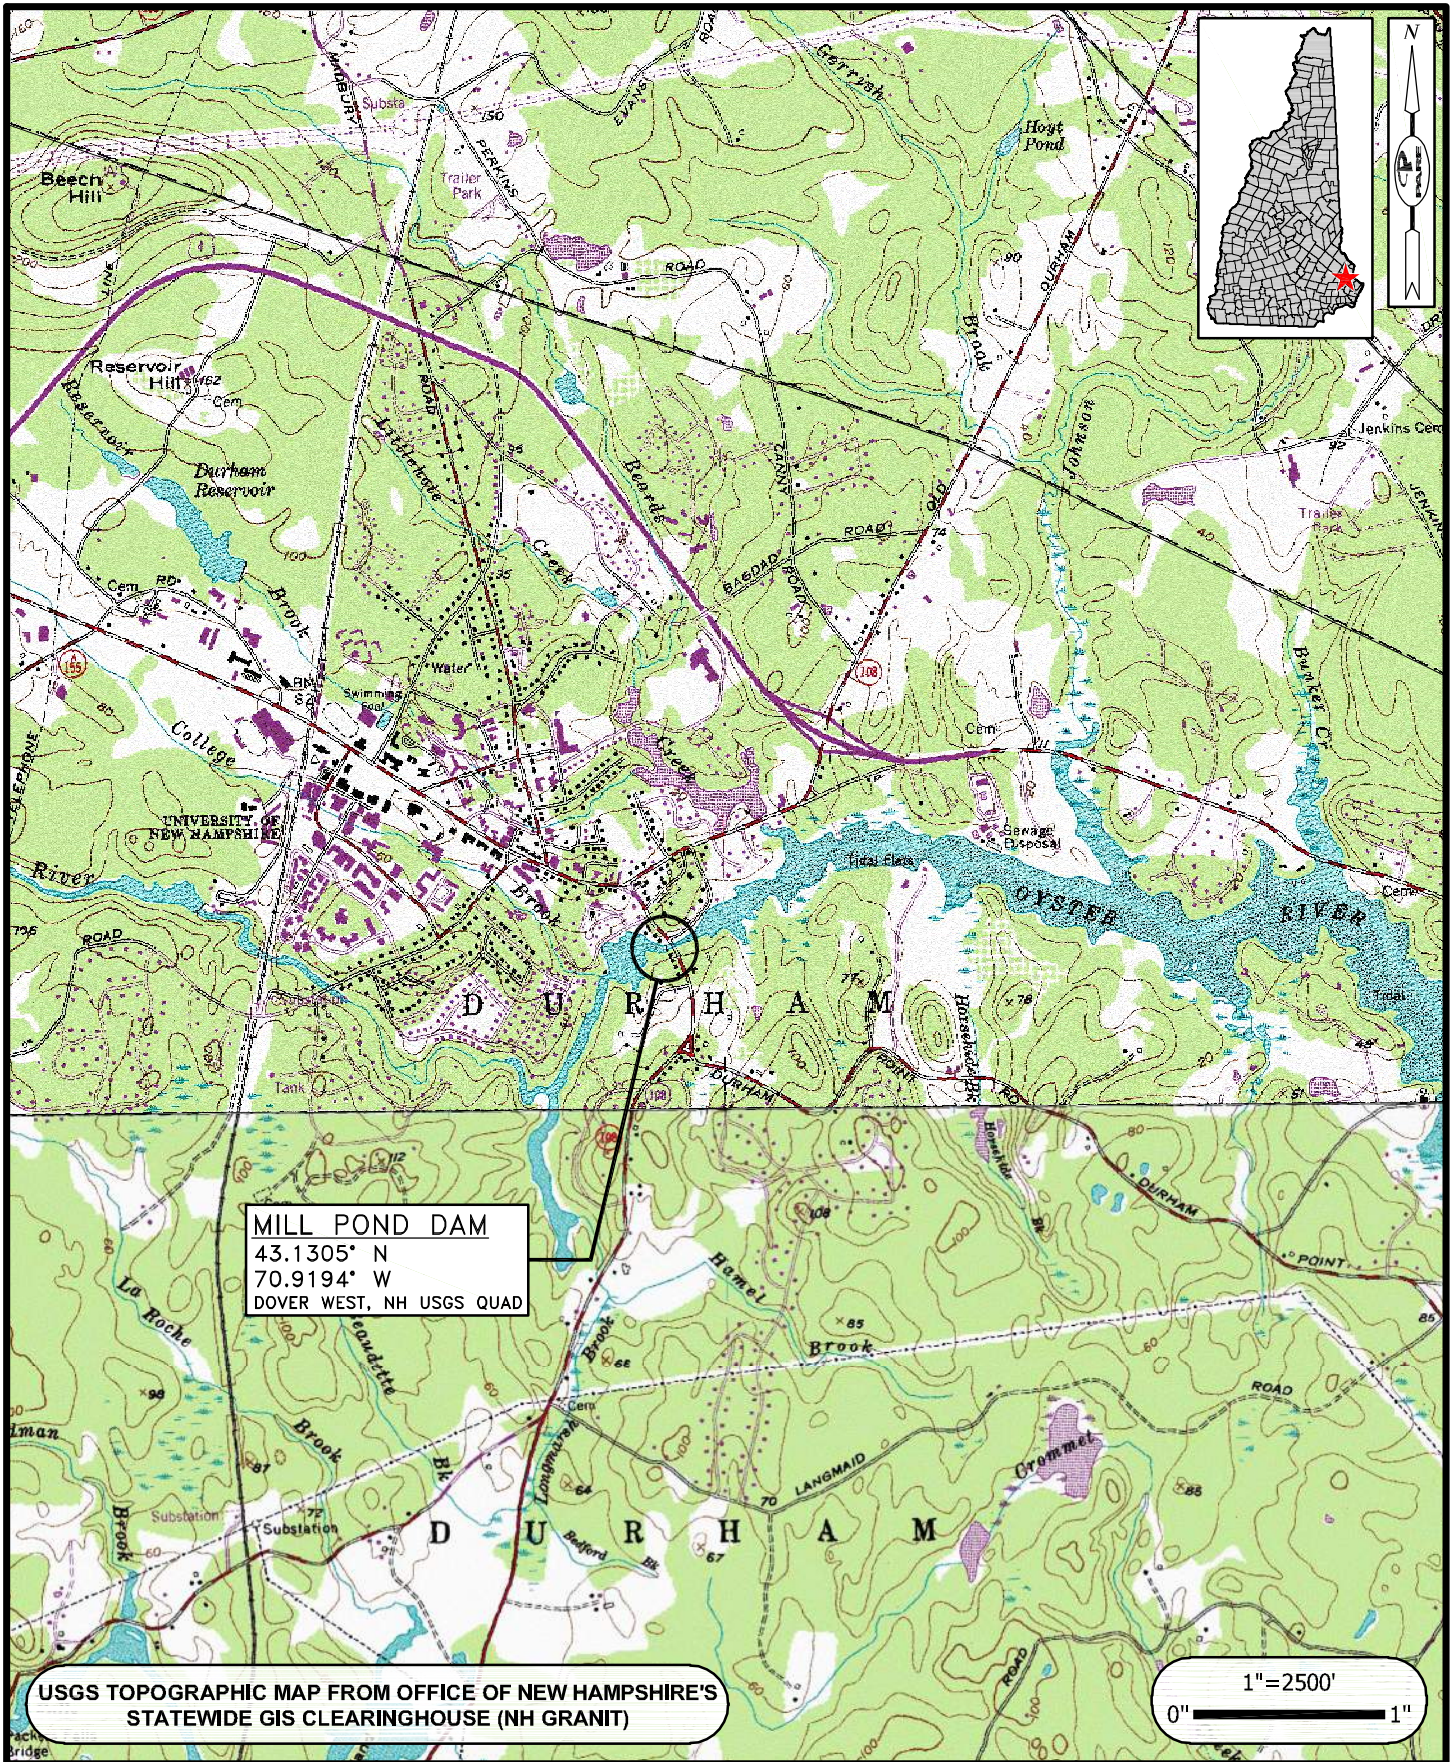
MILL POND DAM
 DAM #071.03
 DURHAM, NEW HAMPSHIRE

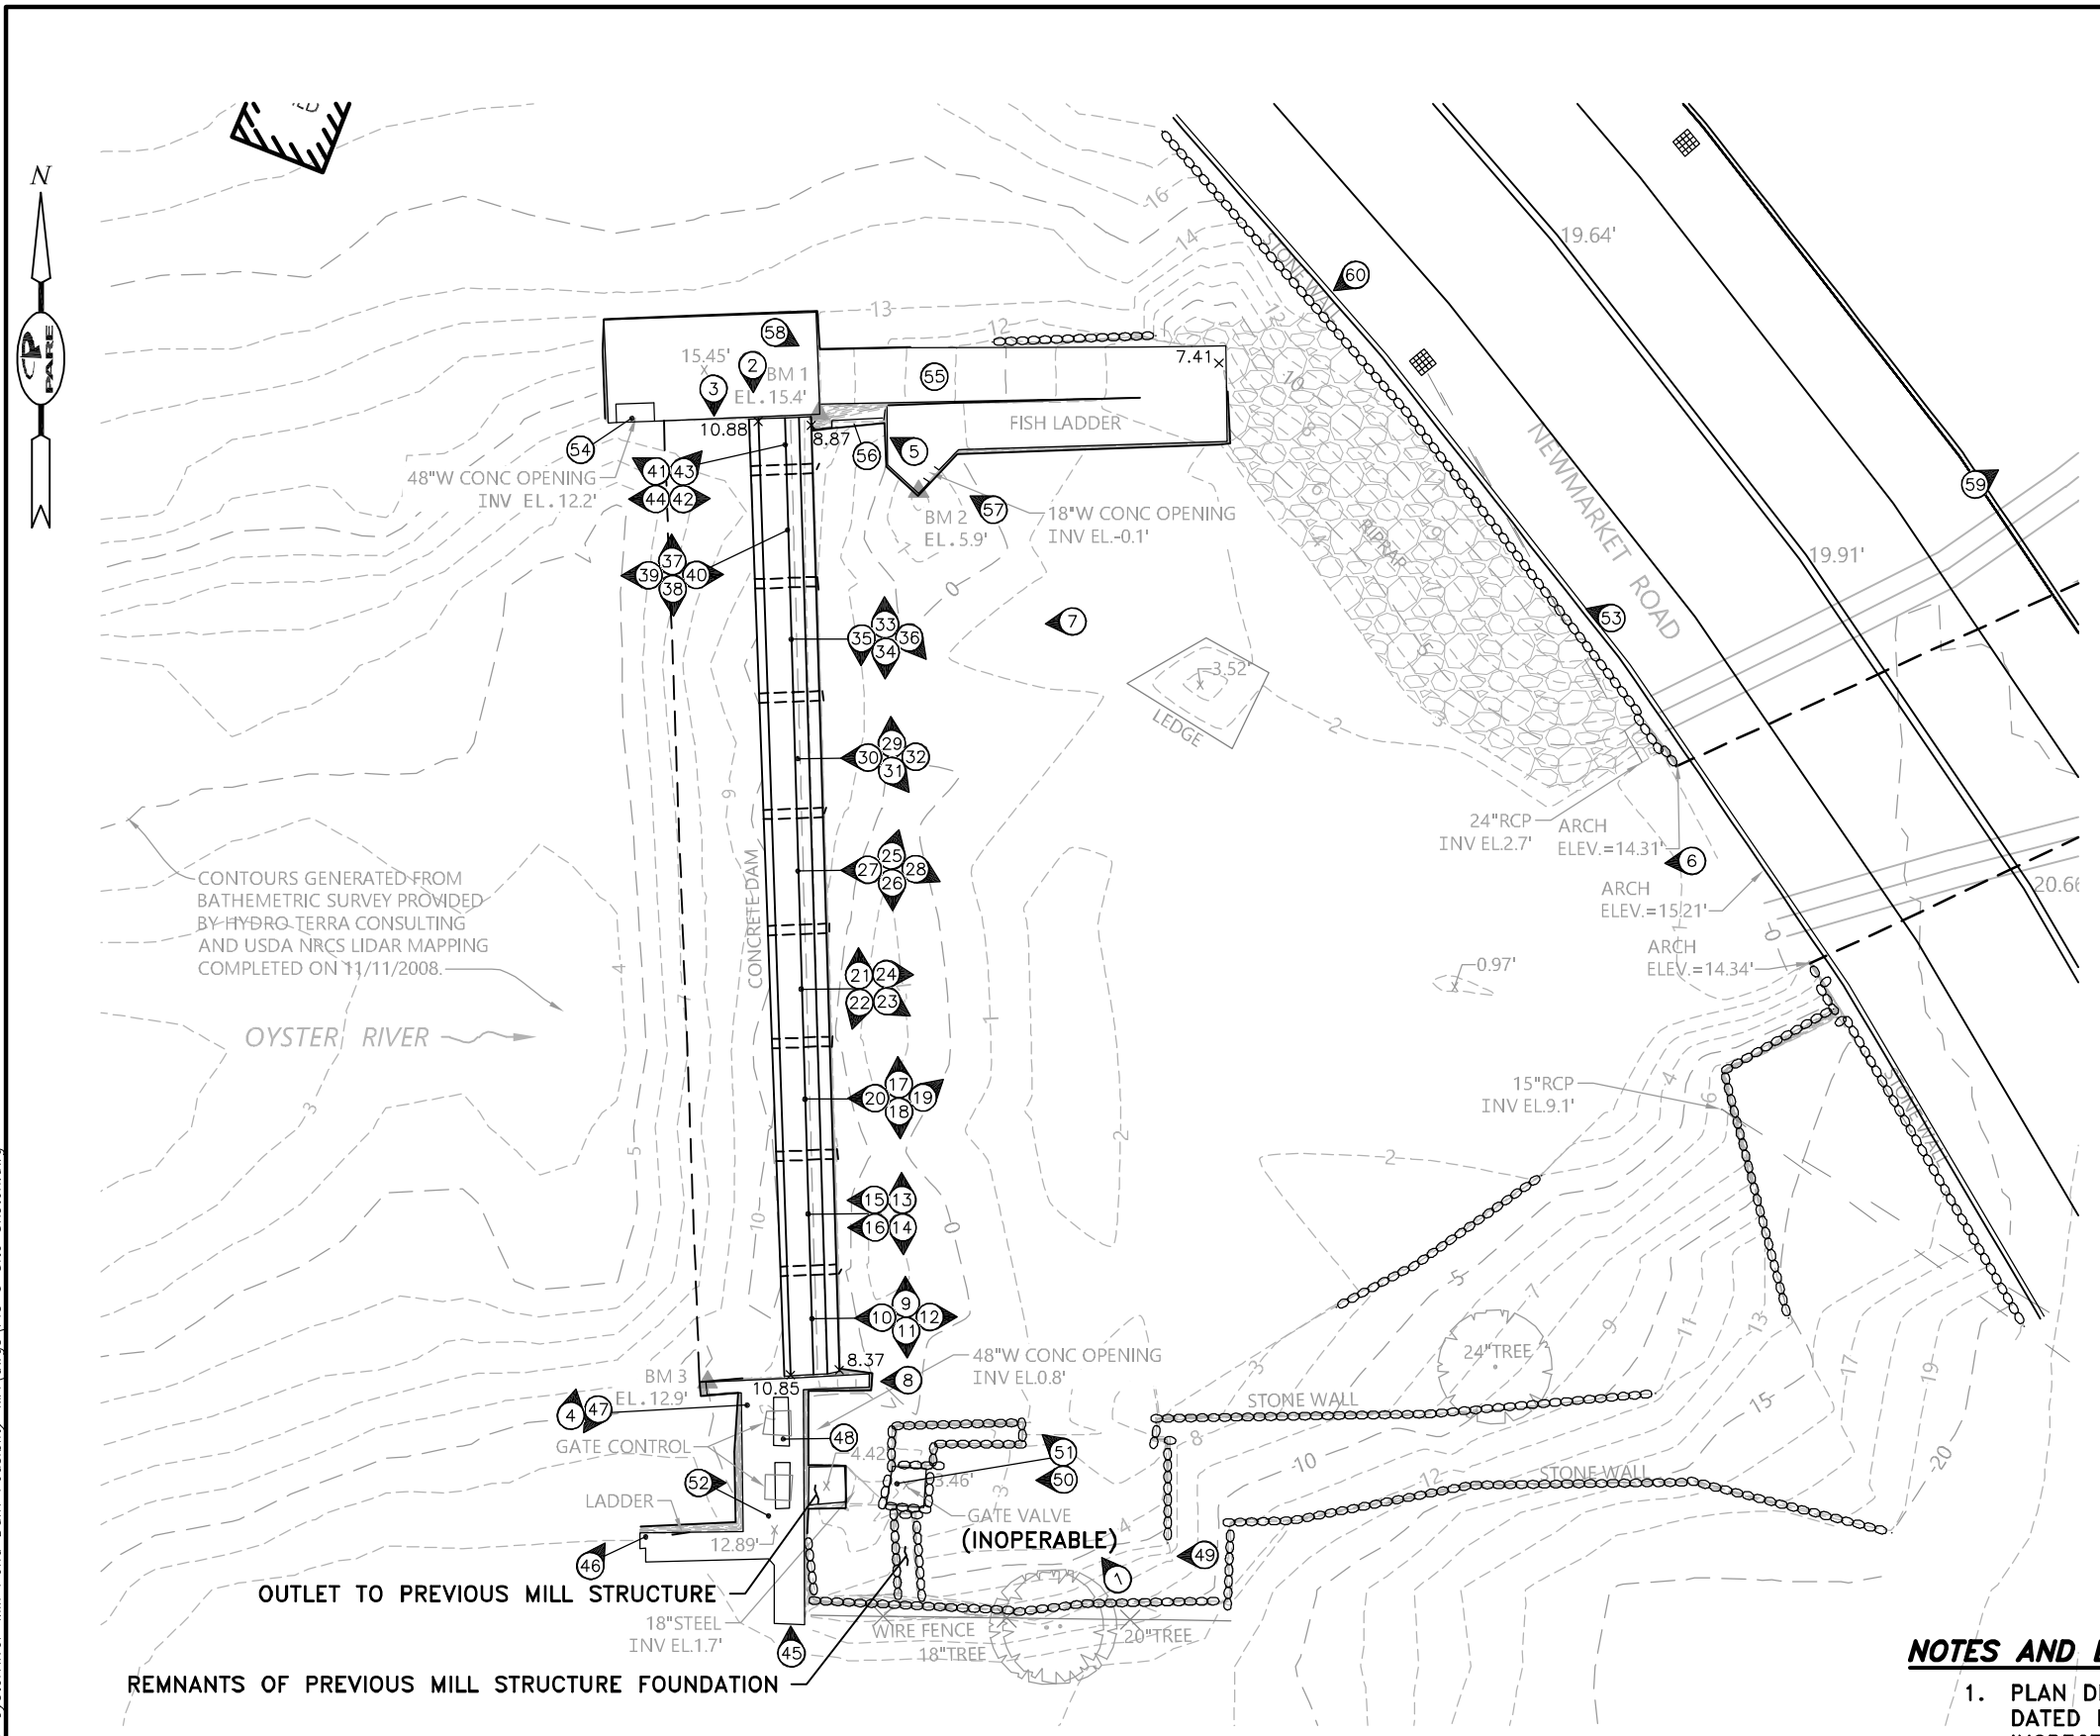
SITE SKETCH
 SCALE: 1"=20'±

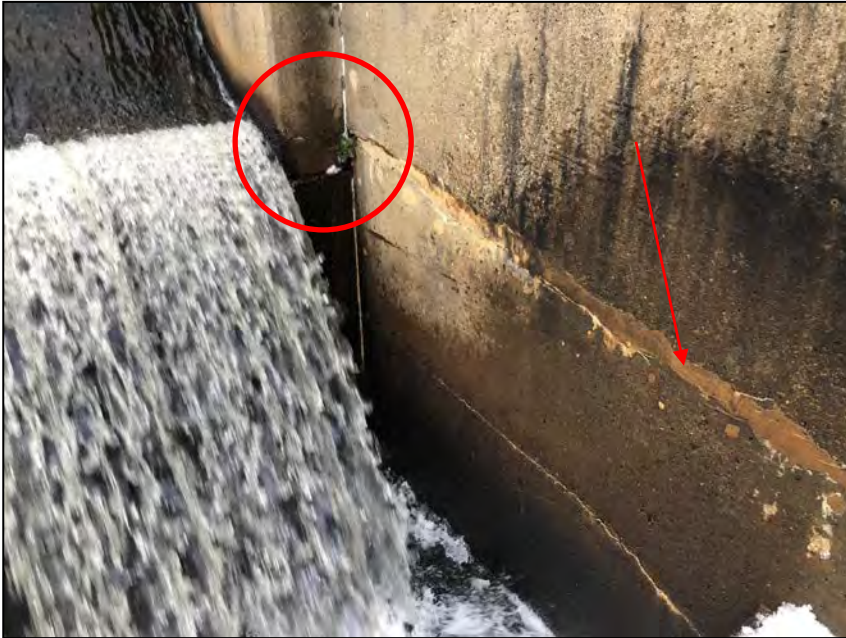
Photo No. 5: Area of the previously reported leakage from the left training wall. Note vegetation within the joint and repair along the wall.

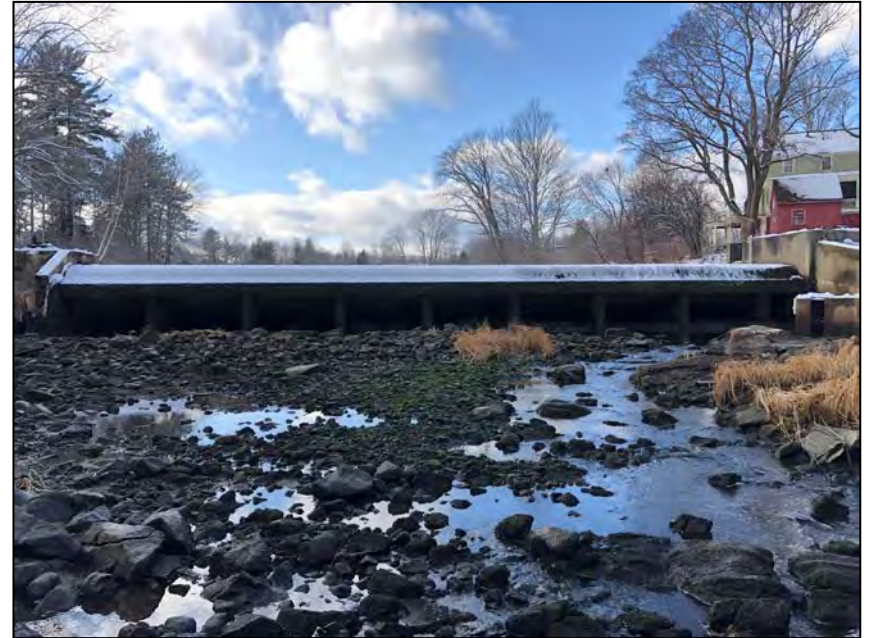
Photo No. 6: View of the downstream side of the dam with no flow over the spillway from under the bridge at Newmarket Road looking upstream.

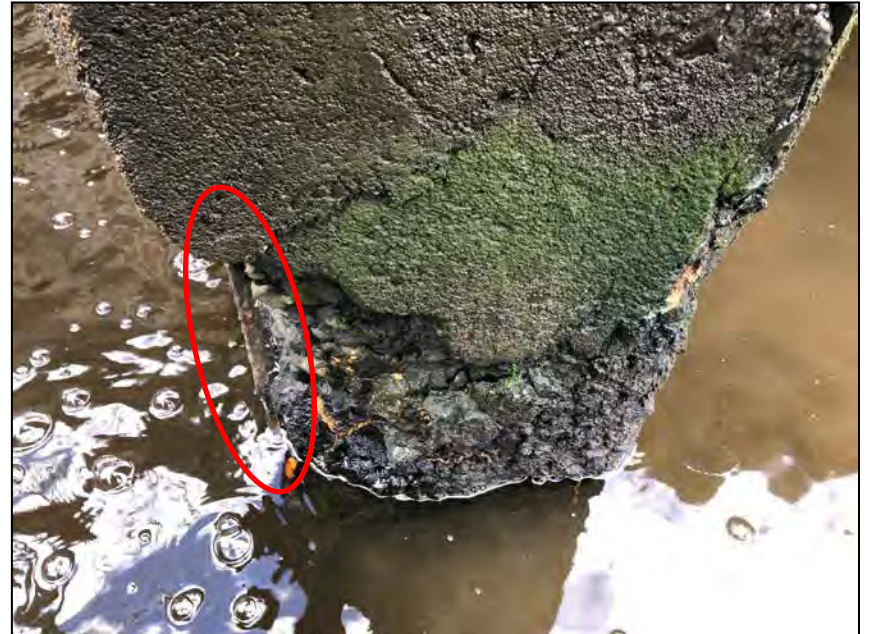
Photo No. 8: Scoured and severely deteriorated concrete with debonded rebar at the downstream side of the right training wall.

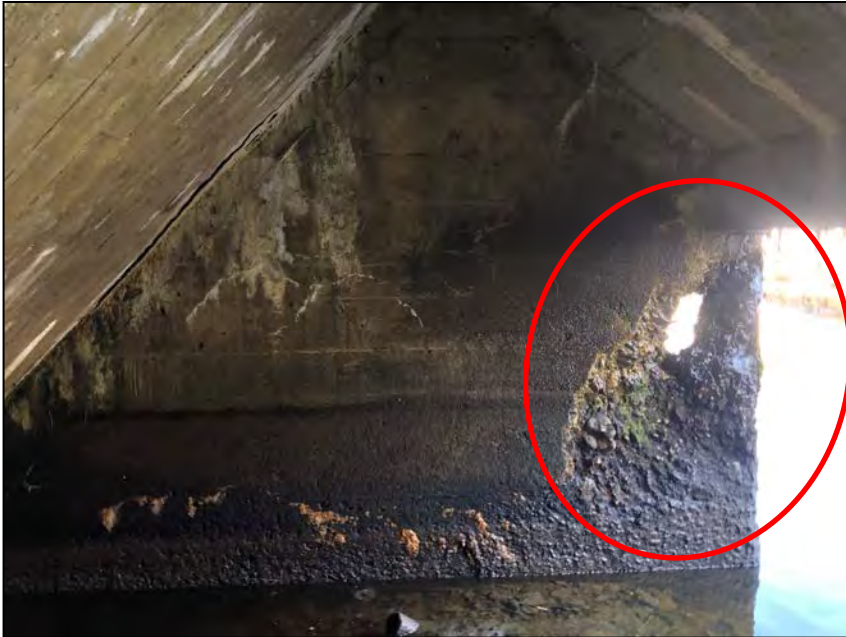
Photo No. 9: Left wall. Note section loss with spalling and scour on the downstream end.

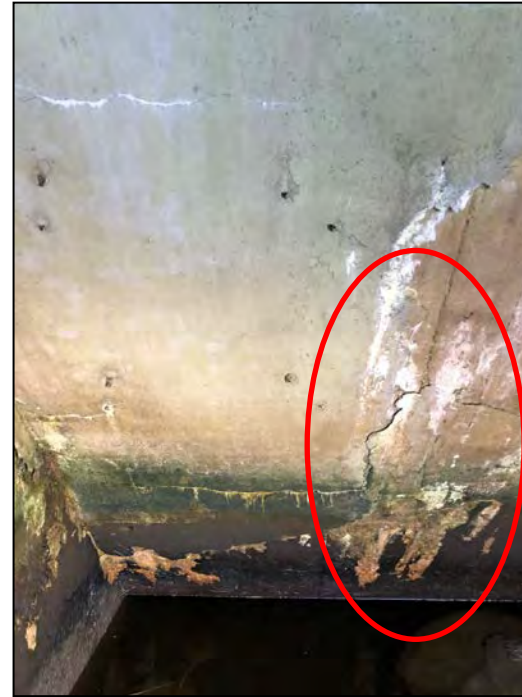
Photo No. 10: Right side of the upstream sloped ceiling. Note the delamination of the repairs.

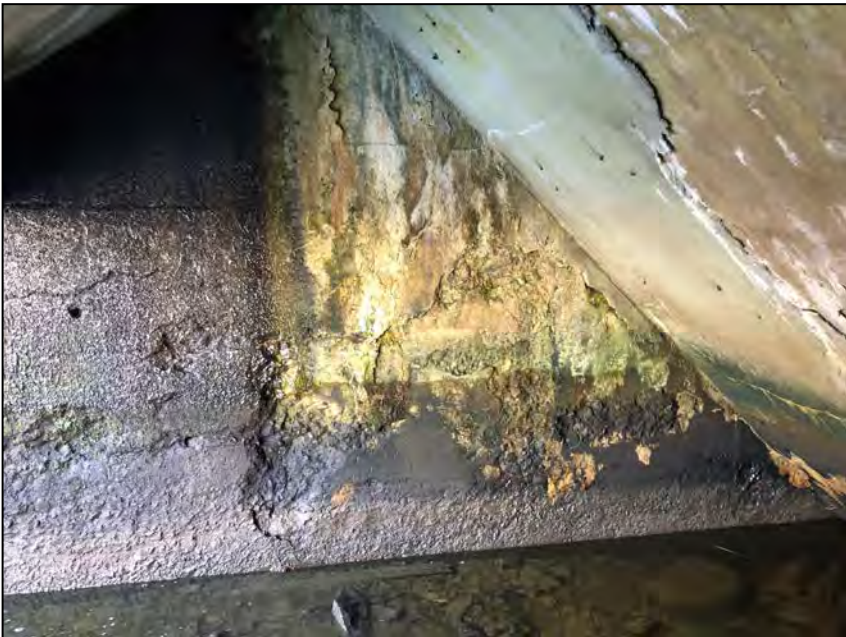
Photo No. 11: Right wall. Note spalling and delamination throughout the wall.

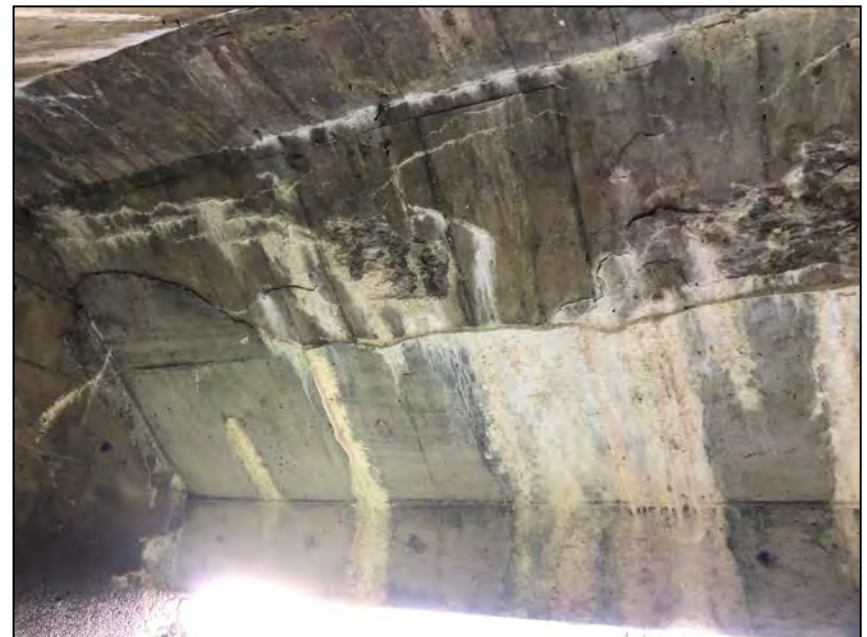
Photo No. 12: Repair on the downstream sloped ceiling section (ceiling face no.3). Note delamination above the repair and efflorescence.

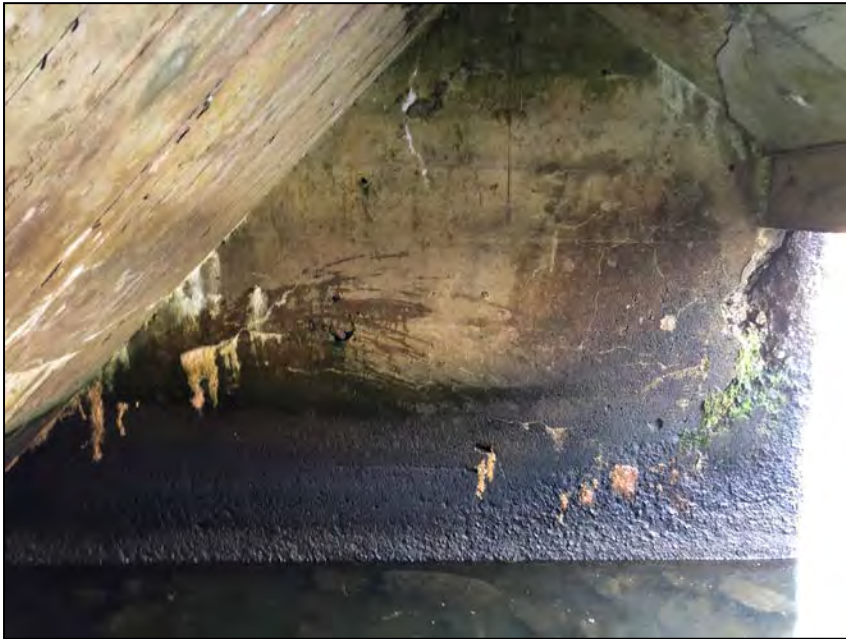
Photo No. 13: Left Wall. Note the scour and spalling on the downstream end.

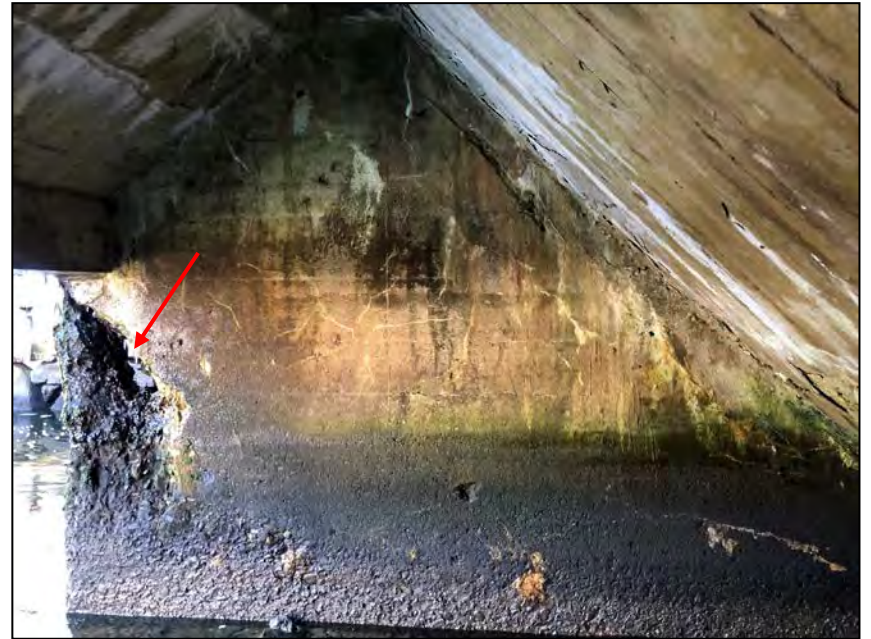
Photo No. 14: Right Wall. Note the section loss on the downstream end.

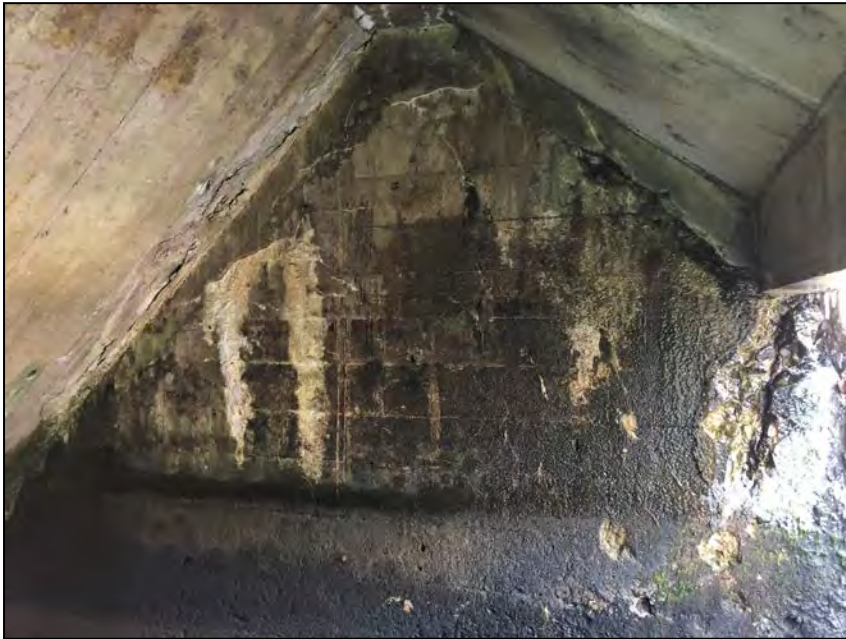
Photo No. 17: Left wall. Note scour and spalling on the downstream end and delamination on the upstream joint with the ceiling.

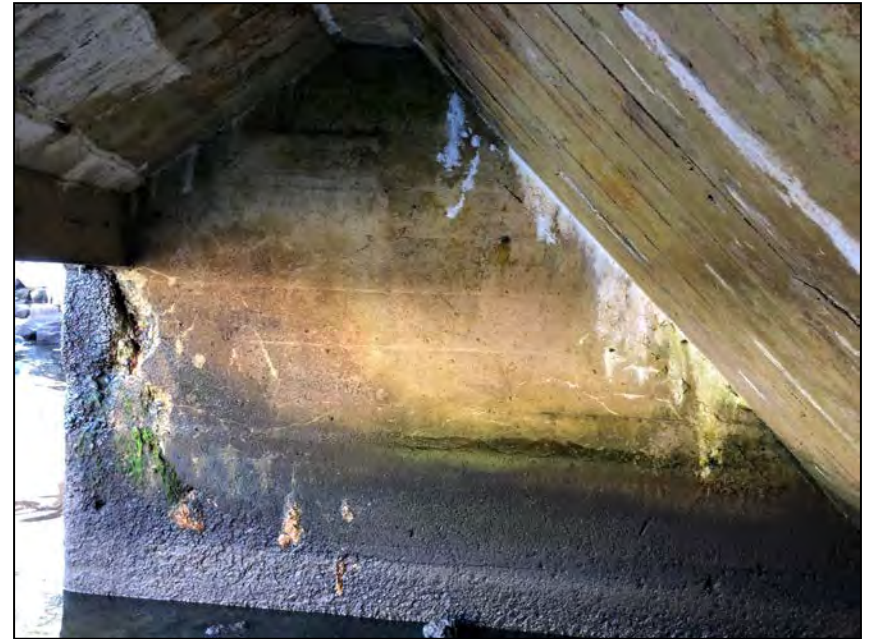
Photo No. 18: Right wall. Note scour and spalling on the downstream end.

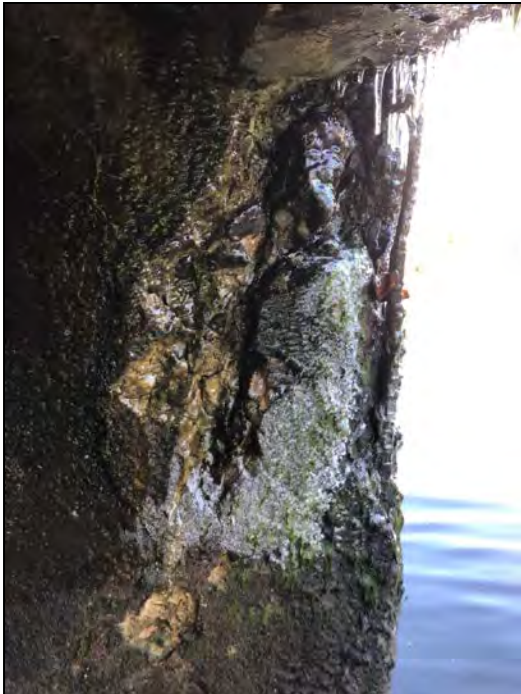
Photo No. 19: Delaminated rebar on the rib between Cell 3 and Cell 4.

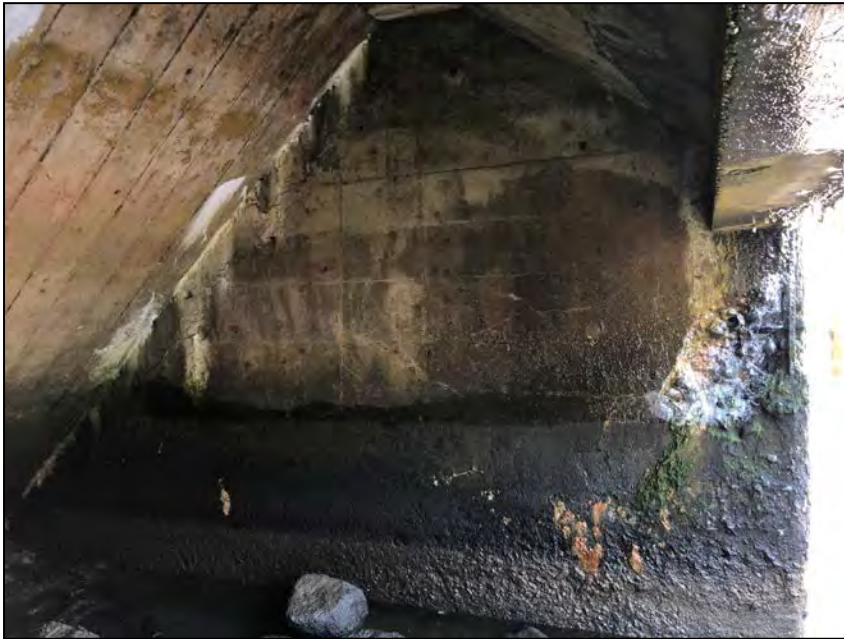
Photo No. 21: Left wall. Note debonded rebar and spalling on the downstream end.

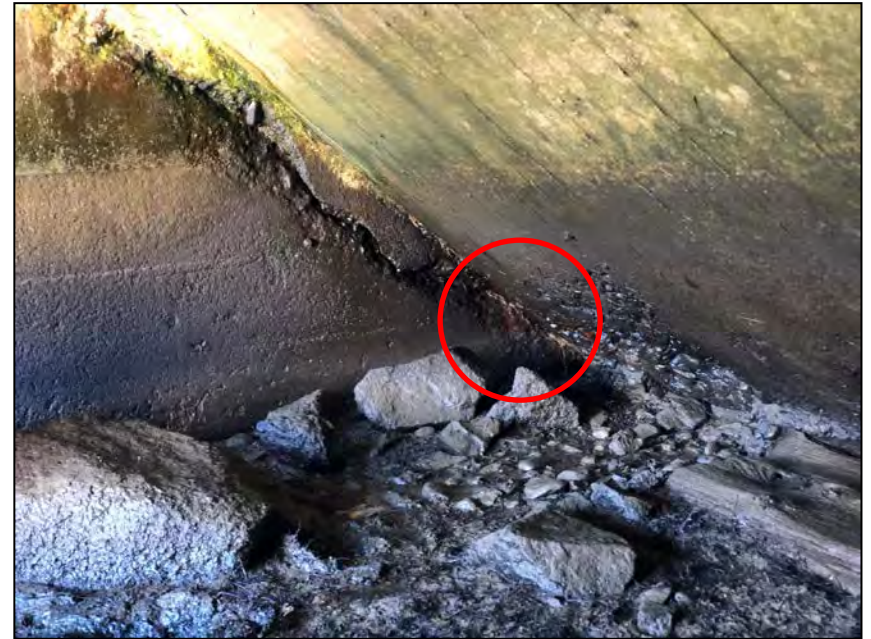
Photo No. 22: Large crack and spall along the right wall with iron oxide staining on the upstream end.

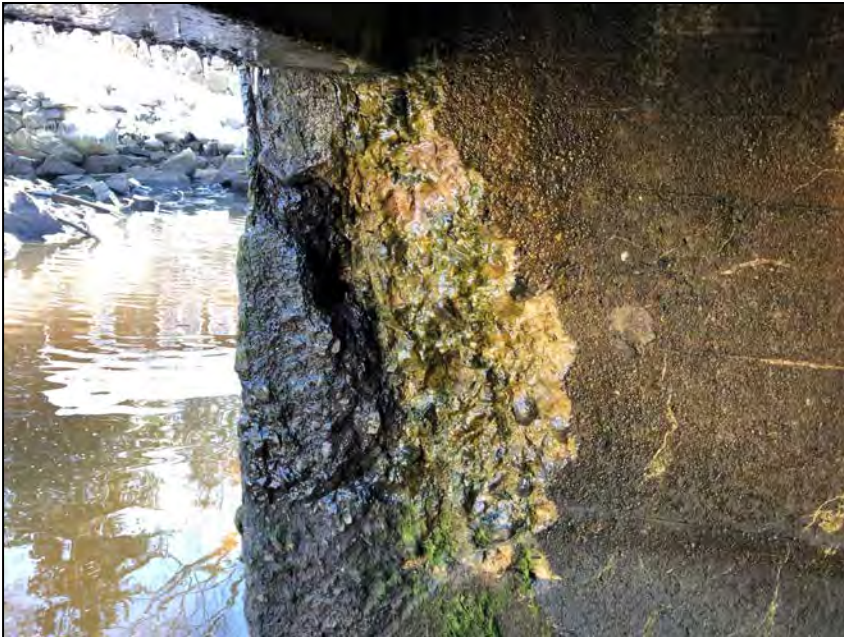
Photo No. 23: Spall with debonded rebar and 5-inch deep hole on the downstream end of the right wall.

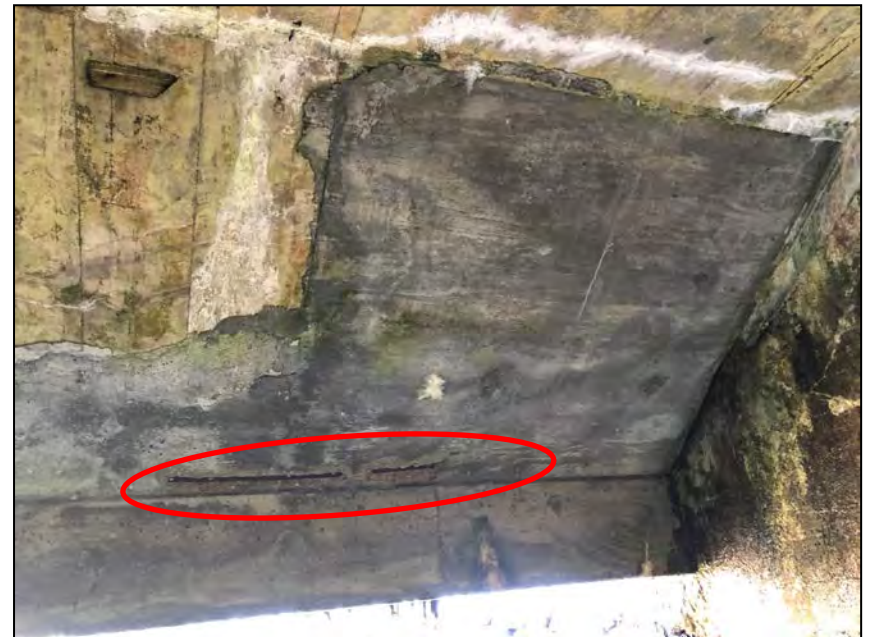
Photo No. 24: Downstream sloped ceiling with repair and exposed rebar.

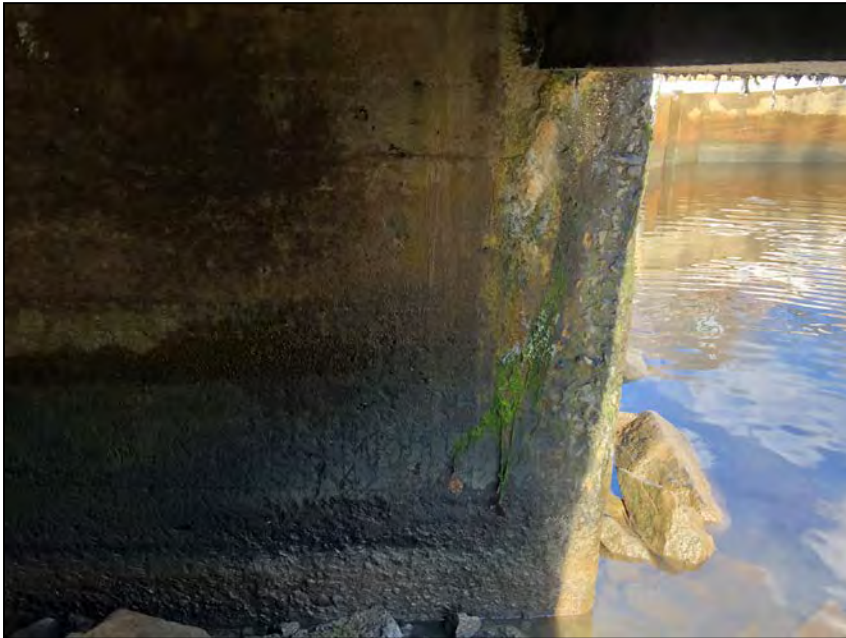
Photo No. 25: Left wall. Note scour and spalling on the downstream end approximately 1 foot above the waterline.

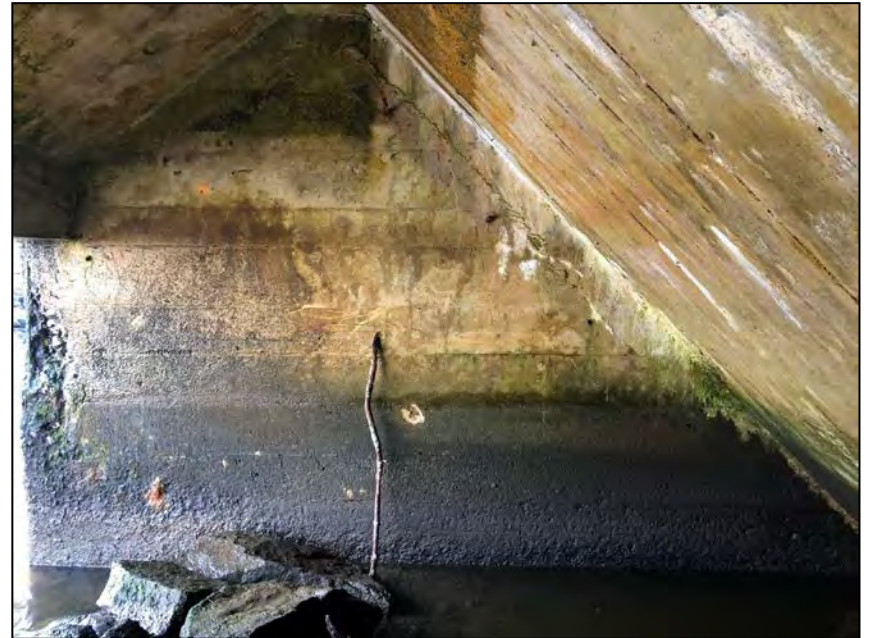
Photo No. 26: Right wall. Note debonded rebar and spalling on the downstream end.

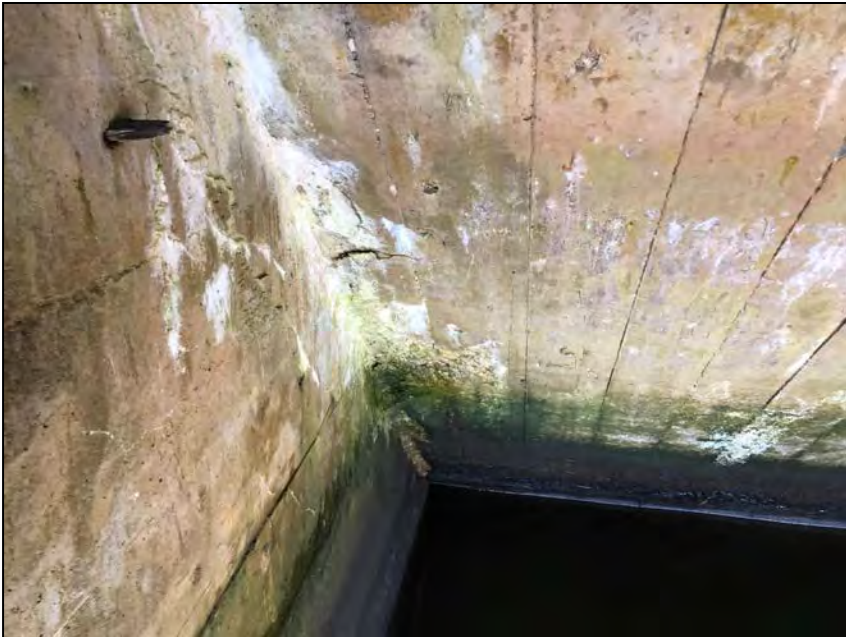
Photo No. 27: Efflorescent staining and delamination on the right side of the upstream sloped ceiling

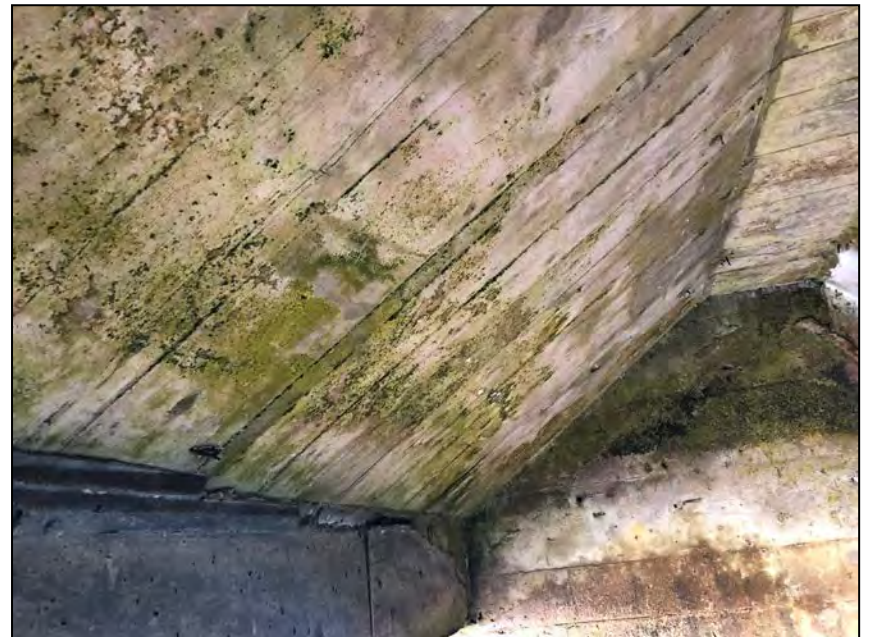
Photo No. 28: Downstream sloped ceiling (ceiling face no. 3).

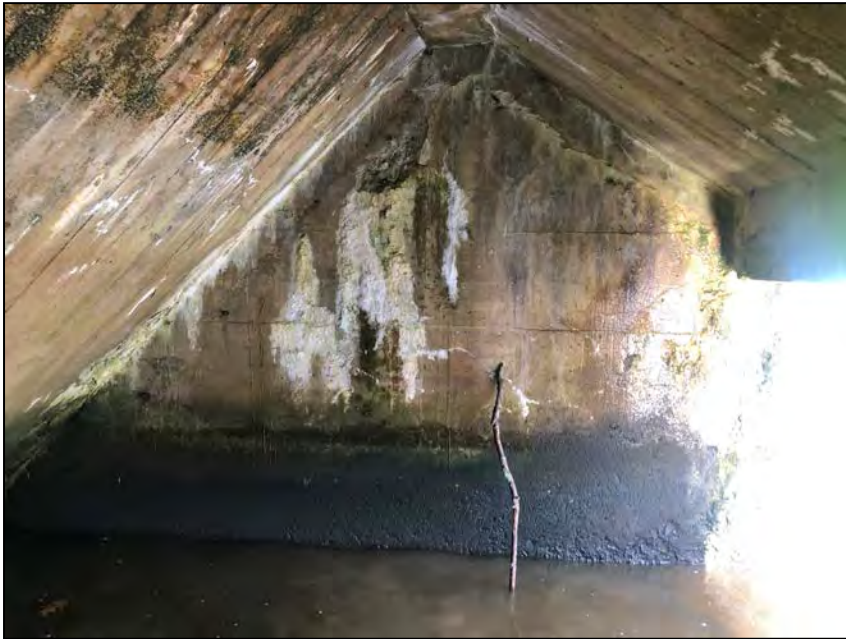
Photo No. 29: Left Wall. Note efflorescent staining and cracks.

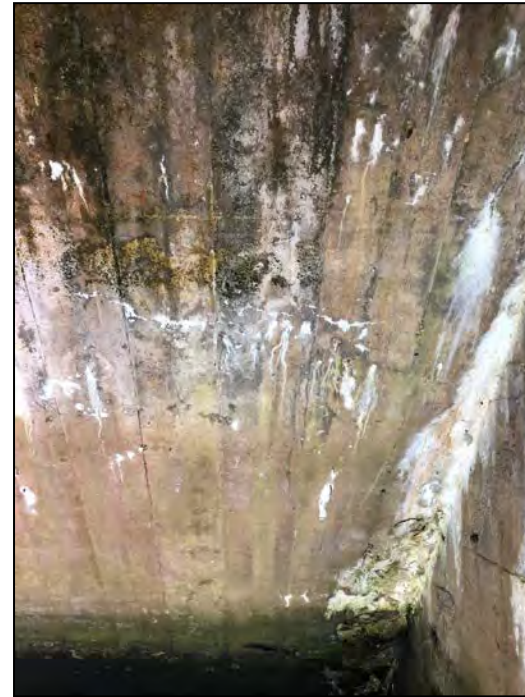
Photo No. 30: Delamination and staining along the joint between the ceiling and the left wall.

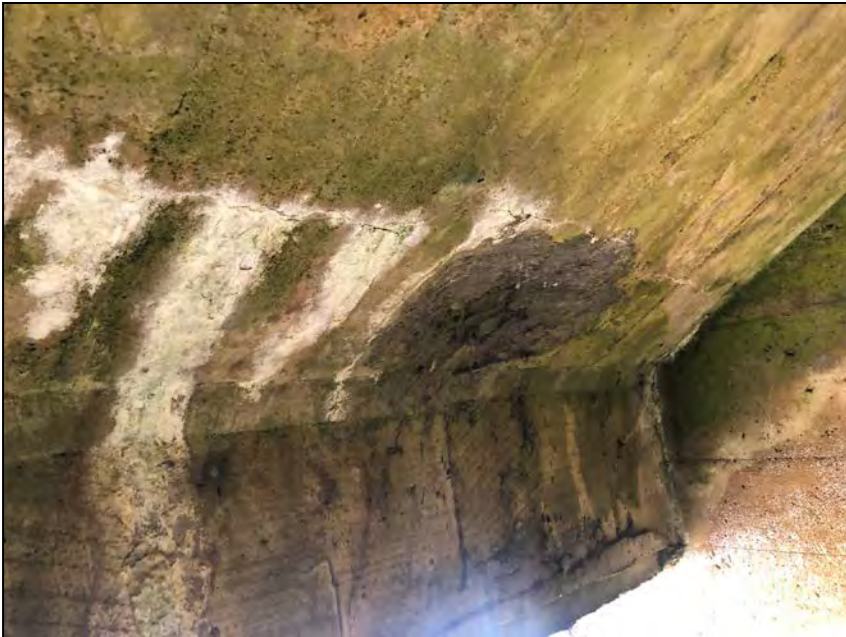
Photo No. 31: Repair on the right side of the downstream sloped ceiling,

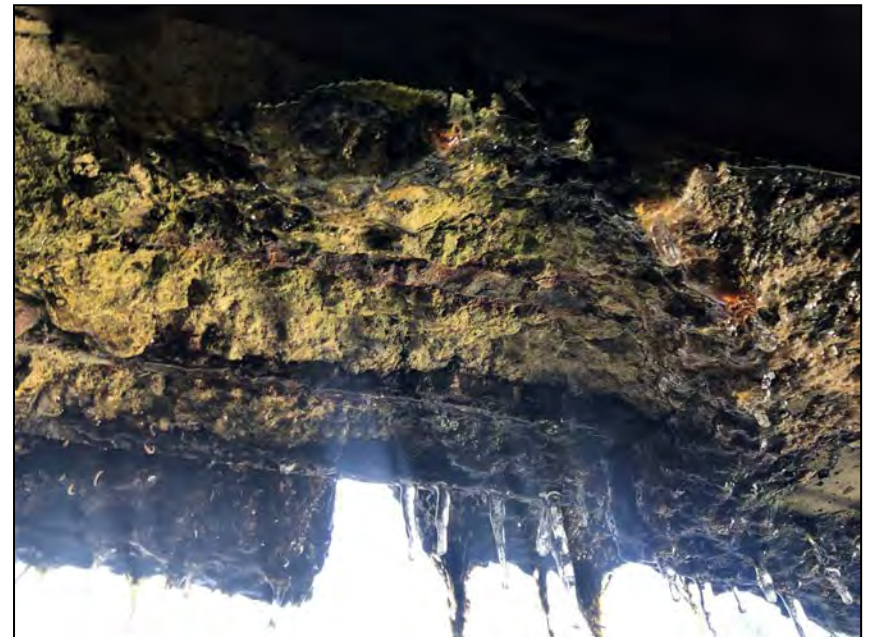
Photo No. 32: Spalling with debonded rebar on the underside of the downstream most ceiling (ceiling face no. 1).

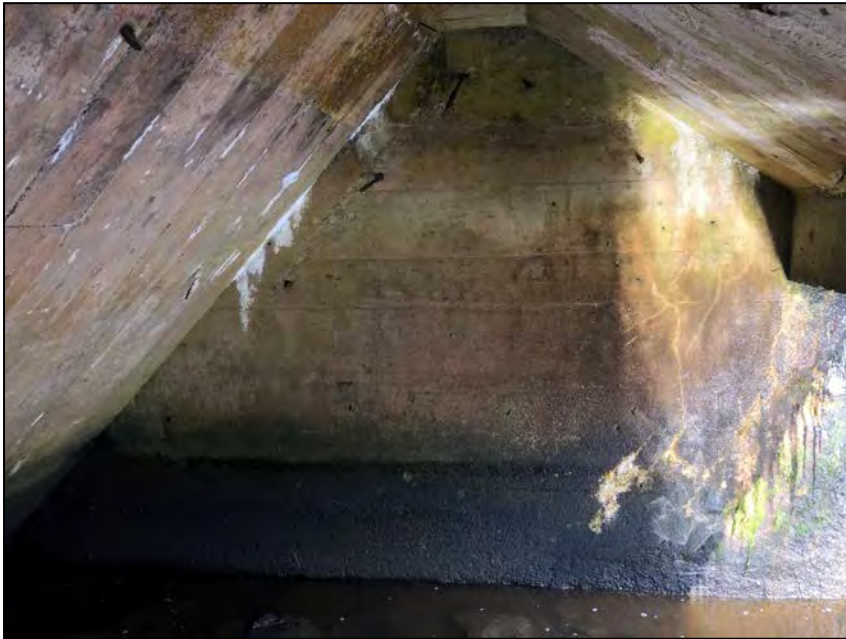
Photo No. 33: Left wall. Note efflorescent staining.

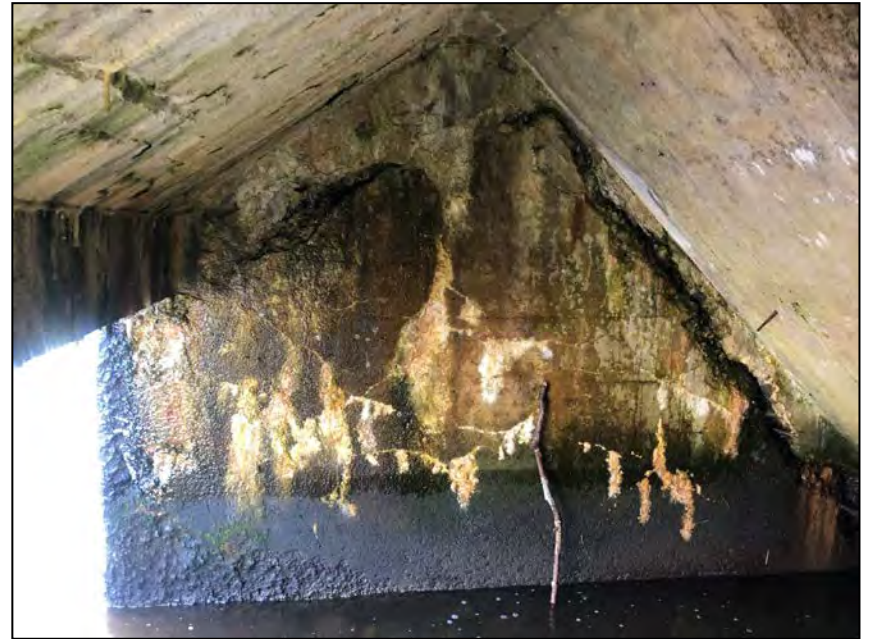
Photo No. 34: Right wall. Note crack and delamination extending along the upstream and upper side of the wall.

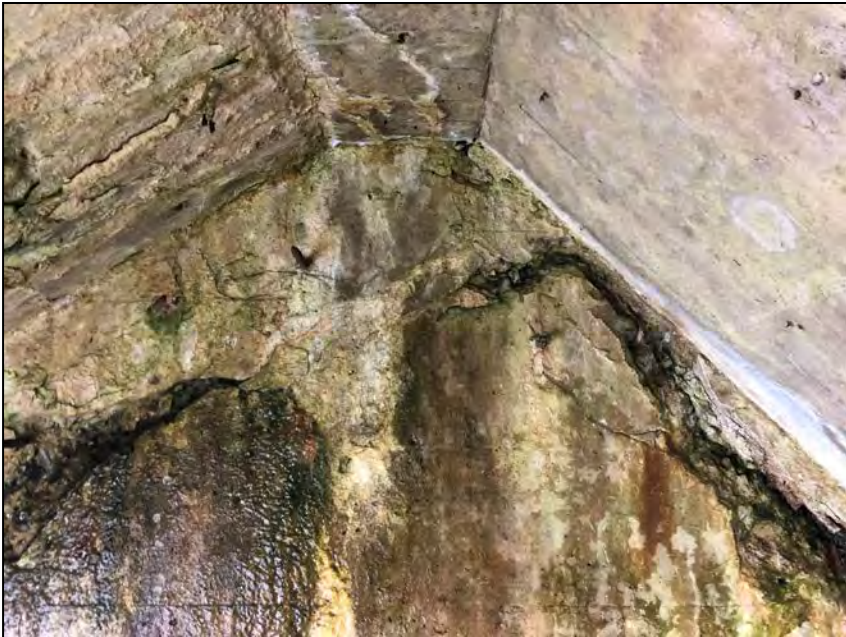
Photo No. 35: Delamination and crack with seepage below on the top of the right cell wall.

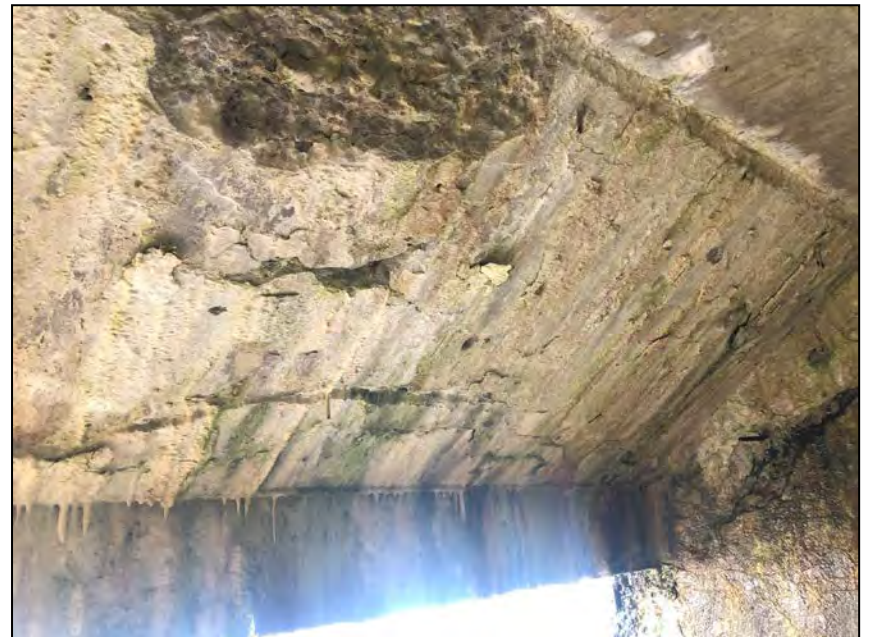
Photo No. 36: Delamination and efflorescence throughout the downstream sloped ceiling.

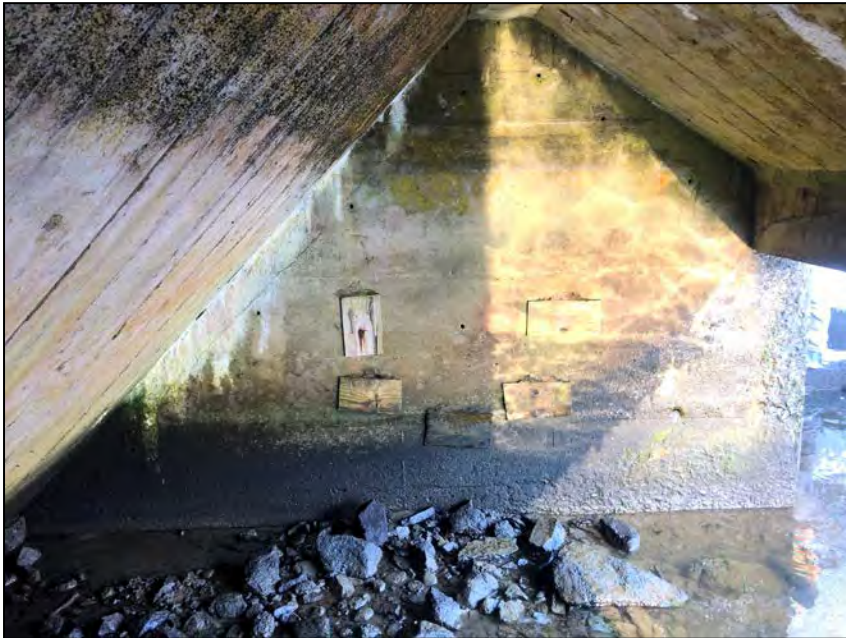
Photo No. 37: Left wall. Note repairs covered with timber falsework.

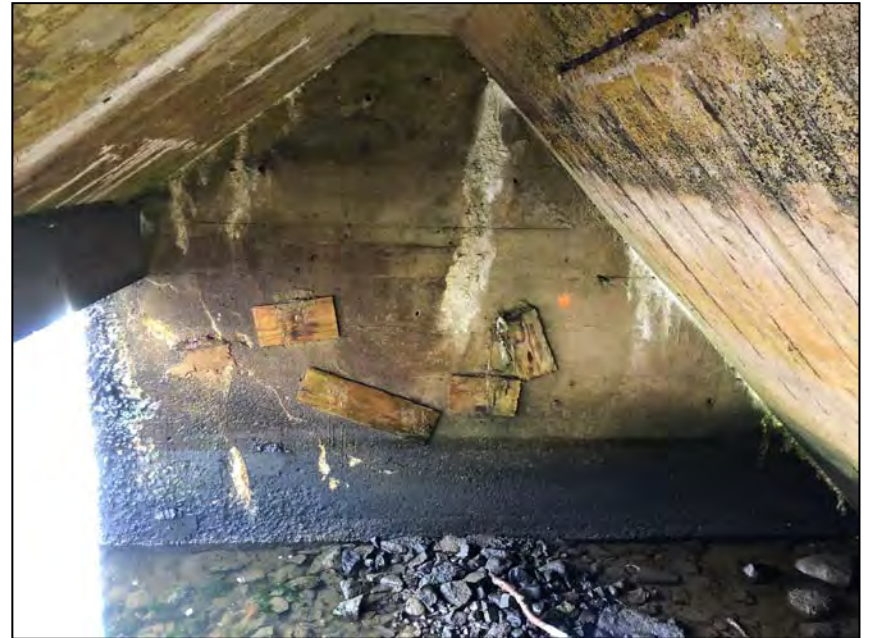
Photo No. 38: Right wall. Note repairs covered with timber falsework and spalling on the downstream end.
