PREPARED FOR: TOWN OF DURHAM, NH

**MILL POND DAM
VISUAL INSPECTION REPORT
DURHAM, NEW HAMPSHIRE
DAM #071.03**

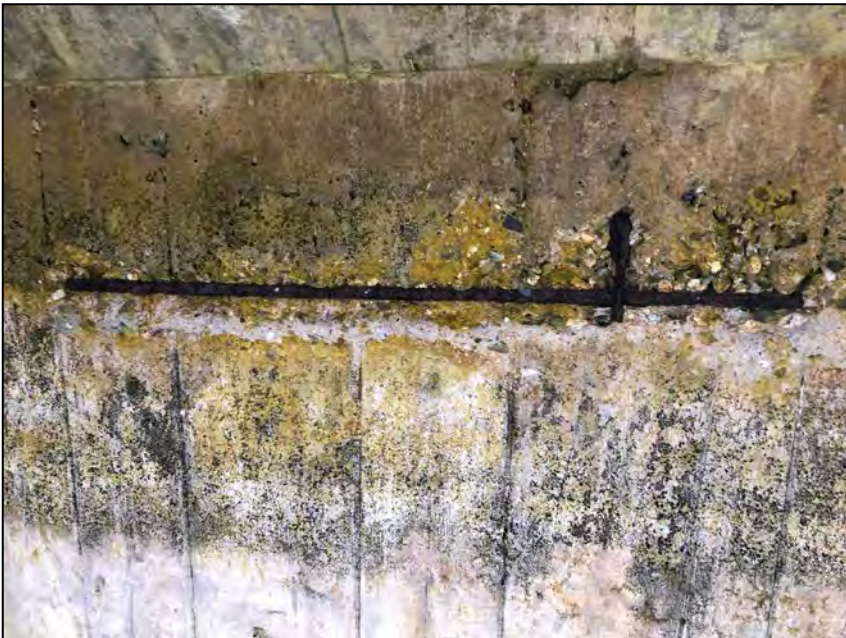
Photo No. 39: Exposed and deteriorated rebar on the upstream sloped ceiling.

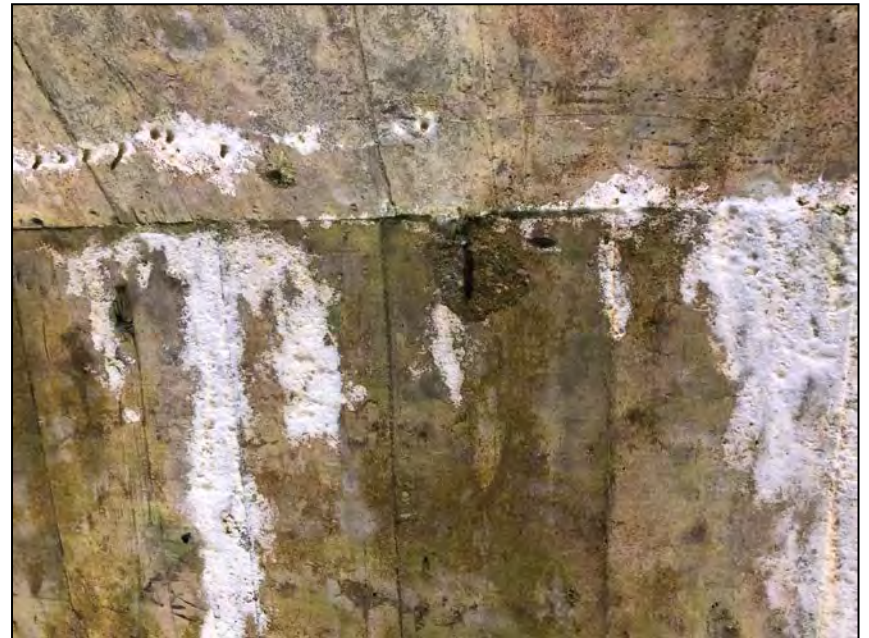
Photo No. 40: Area of exposed and deteriorated rebar on the downstream sloped ceiling.

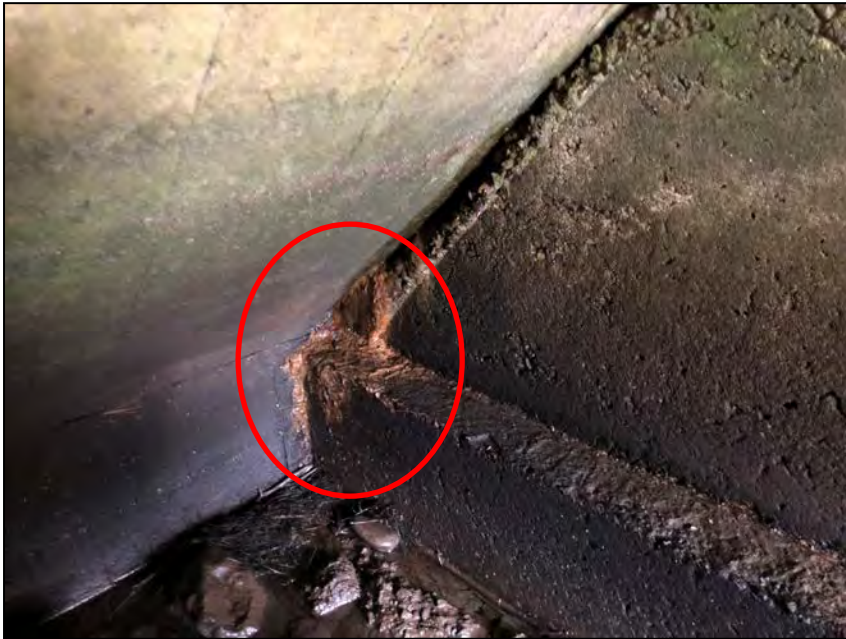
Photo No. 41: Upstream left corner of the cell with iron oxide staining.

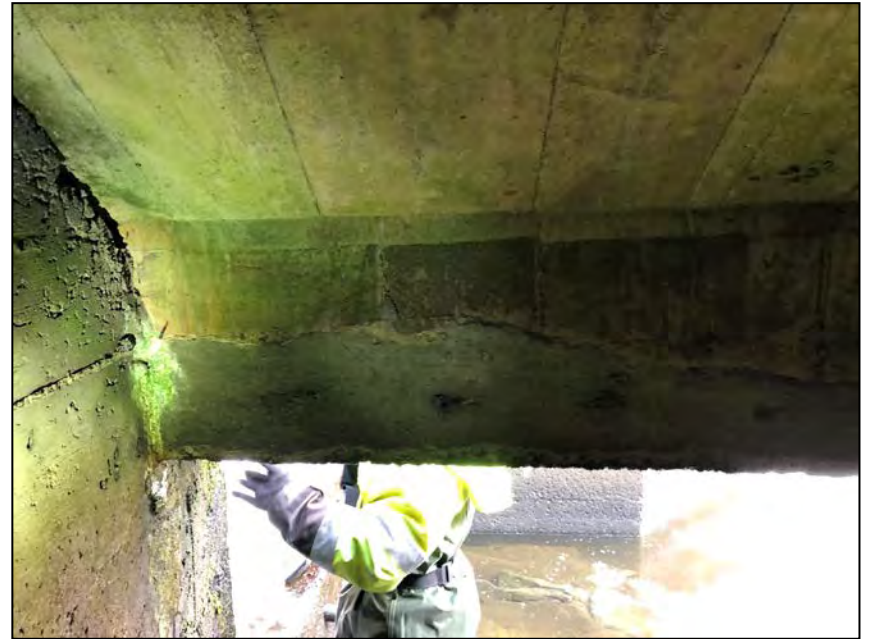
Photo No. 42: Repair on the downstream side of the cell (ceiling face no.2).

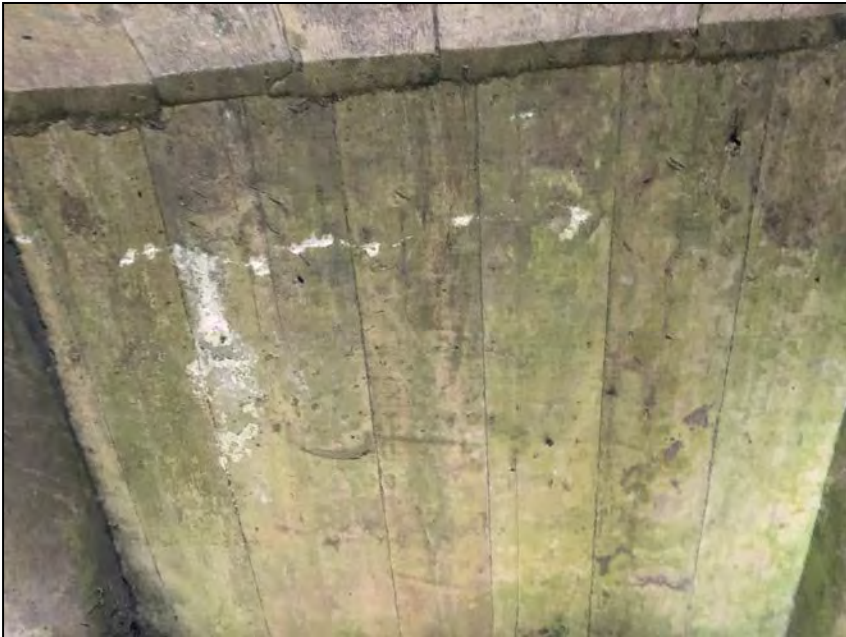
Photo No. 43: Downstream sloped ceiling.

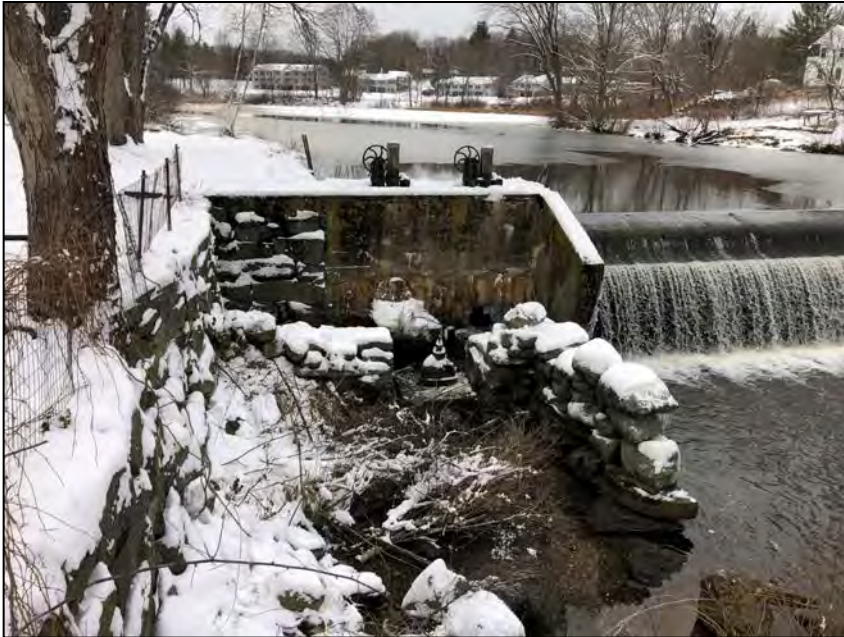
Photo No. 49: The gate structure and mill foundation from downstream of the dam looking upstream.

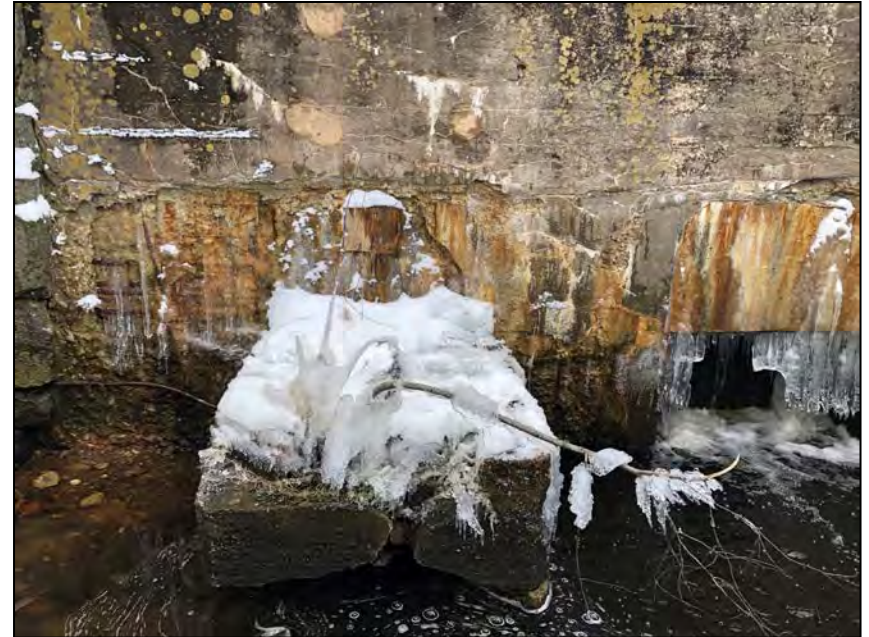
Photo No. 50: Left and right low-level outlets. Note the severe concrete deterioration and ice buildup throughout the downstream face of the structure.

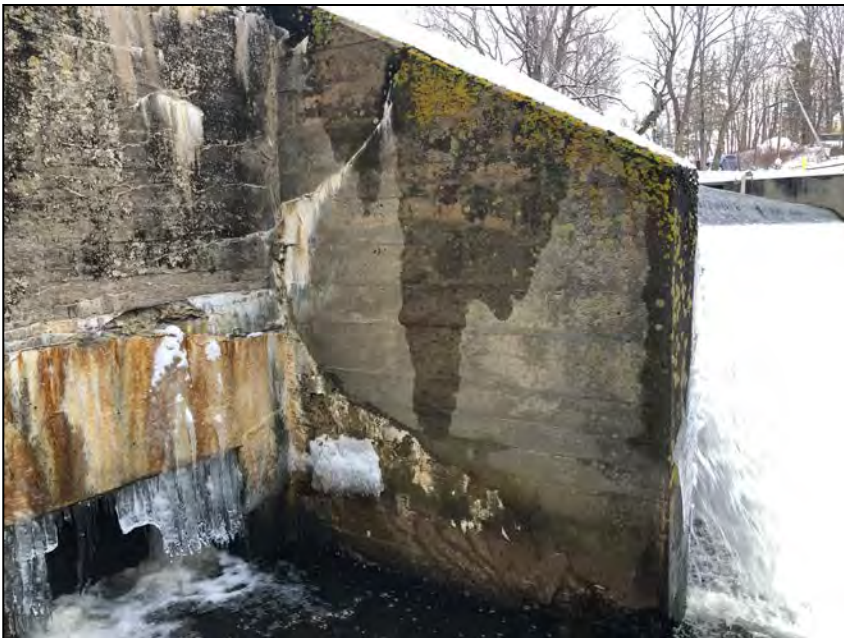
Photo No. 51: Right side of the right training wall and concrete downstream of the left gate. Note cracking with efflorescent staining and ice on the concrete. Additionally, note the leakage through the left gate.

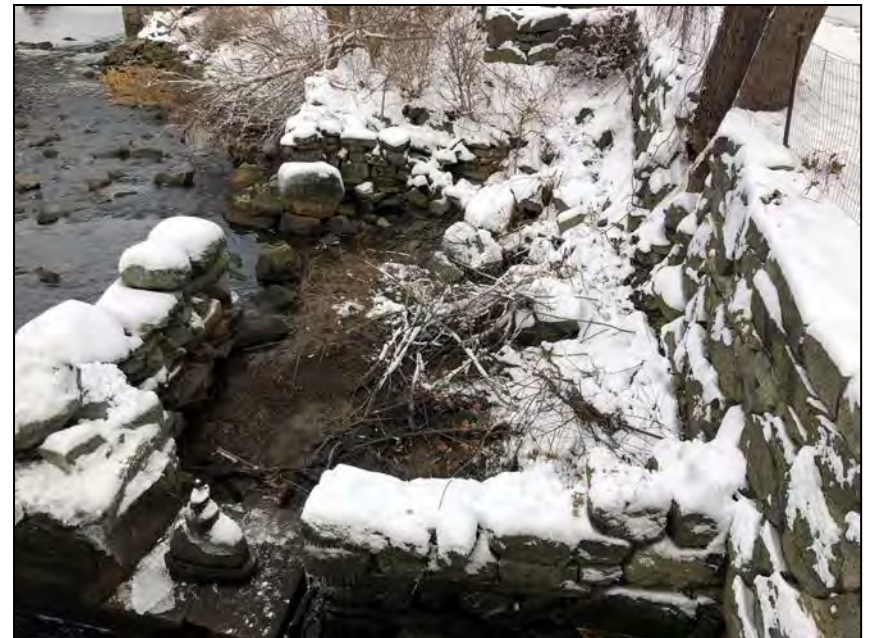
Photo No. 52: Remnants of the mill foundation downstream of the gate structure.

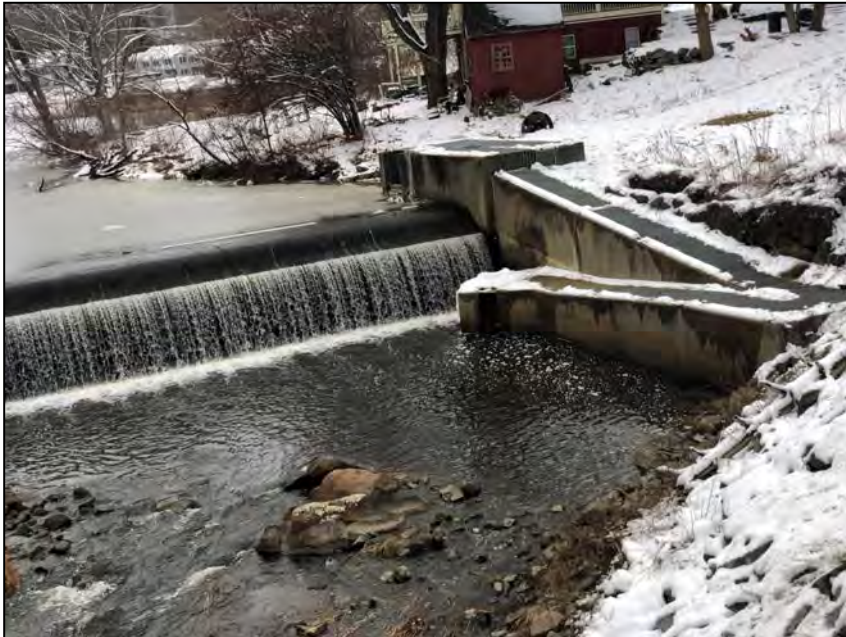
Photo No. 53: Overview of the fish ladder at the left end of the spillway..

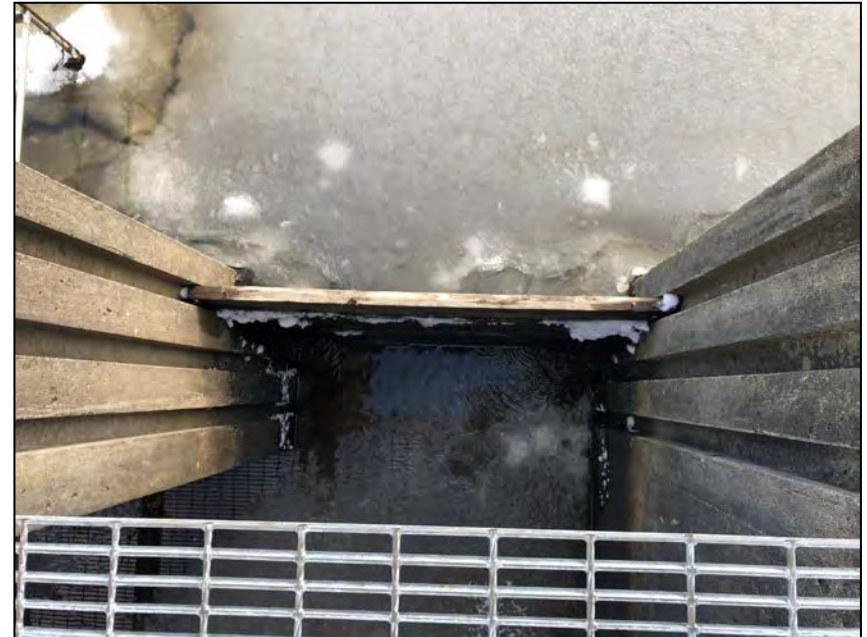
Photo No. 54: Fish ladder inlet with stop logs in. Note leakage from the stop logs.

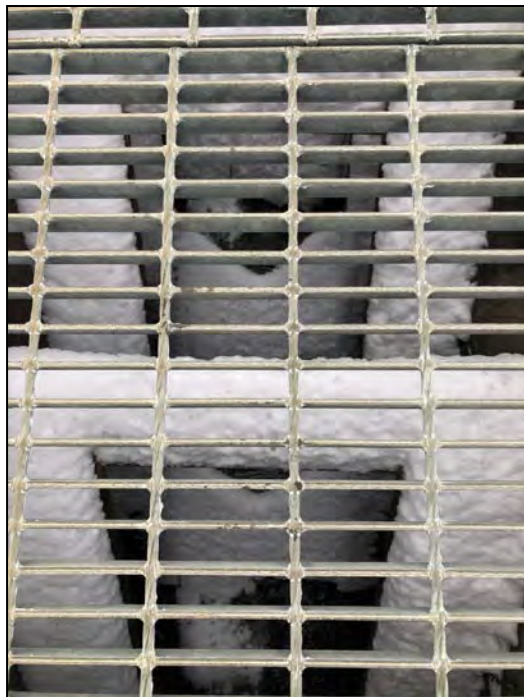
Photo No. 55: Inside of the fish ladder.
