# Mill Pond Dam

## Visual Inspection Report

Durham, New Hampshire

Dam #071.03

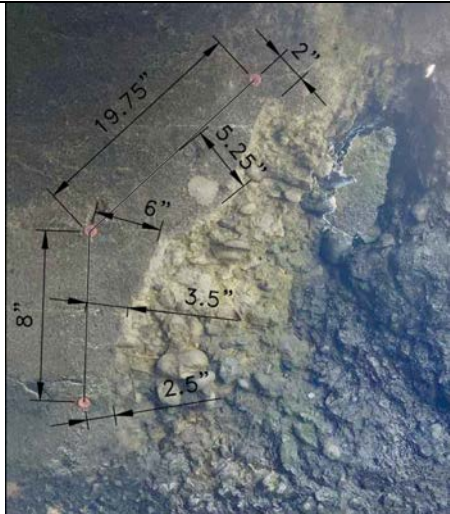
| | | <p>➤ The distance to the limits of deterioration on the left wall from the reference points are as follows:</p> <ul style="list-style-type: none"> <li>○ Top Reference: 2 inches</li> <li>○ Center between Top and Mid-References: 5.25 inches</li> <li>○ Middle Reference: 6 inches</li> <li>○ Center between Center and Bottom References: 3.5 inches</li> <li>○ Bottom Reference: 2.5 inches</li> </ul> |

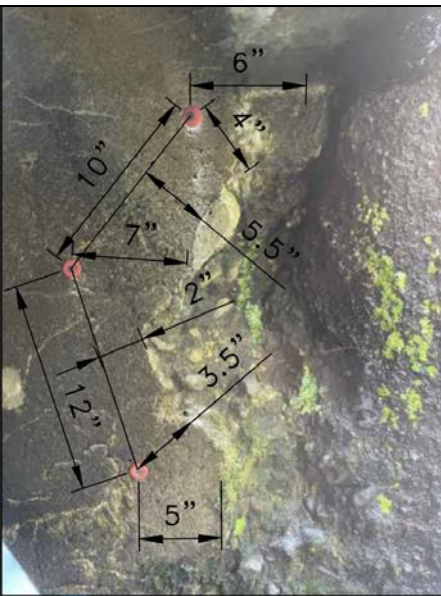
| | | <ul style="list-style-type: none"> <li>➤ The distance to the limits of deterioration on the left wall from the reference points are as follows: <ul style="list-style-type: none"> <li>○ Top Reference: 4 inches</li> <li>○ Center between Top and Mid-References: 5.5 inches</li> <li>○ Middle Reference: 7 inches</li> <li>○ Center between Center and Bottom References: 2 inches</li> <li>○ Bottom Reference: 3.5 inches</li> </ul> </li> </ul> |

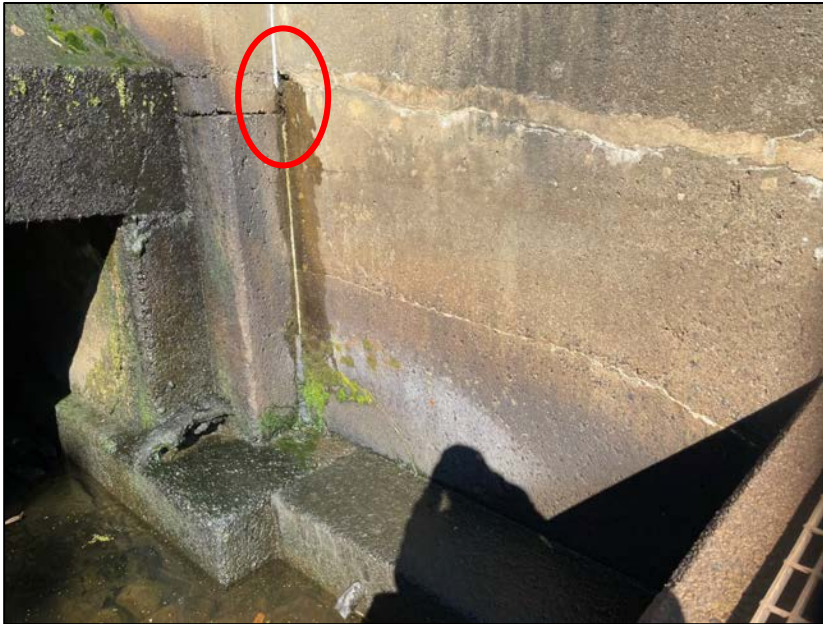
Photo No. 5.: Minor leakage between the left channel wall and the fish ladder wall.

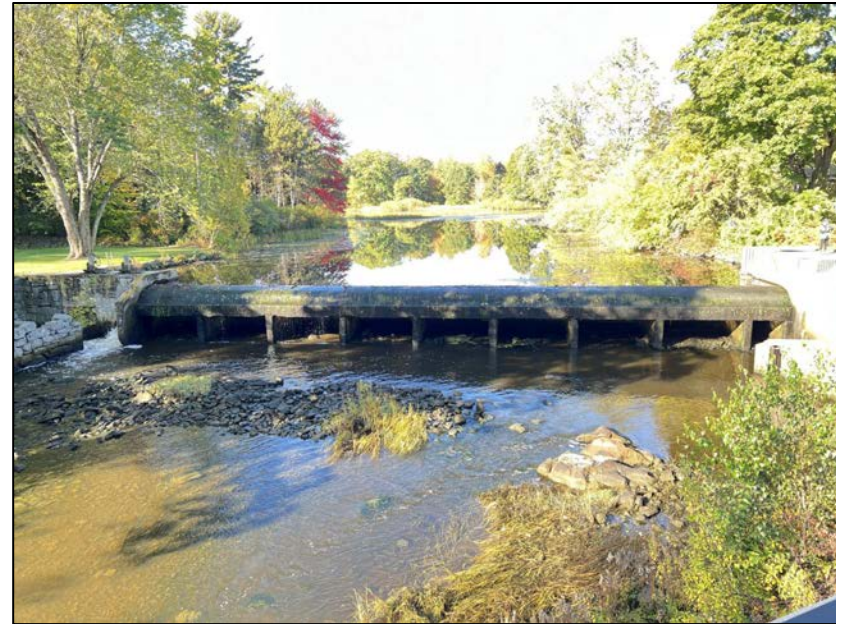
Photo No. 7.: Overview of the downstream side of the spillway.

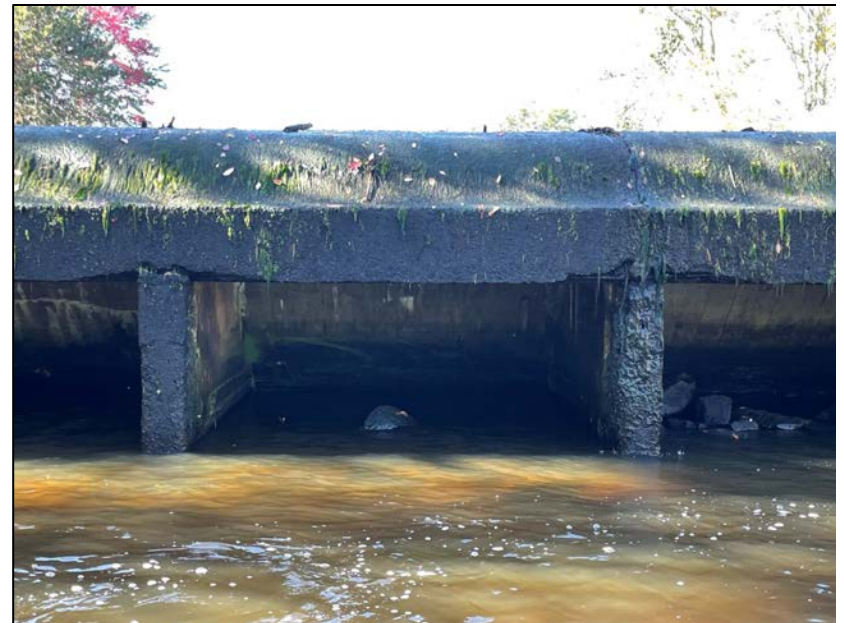
Photo No. 8.: Close-up view and typical downstream face conditions of the spillway cells.

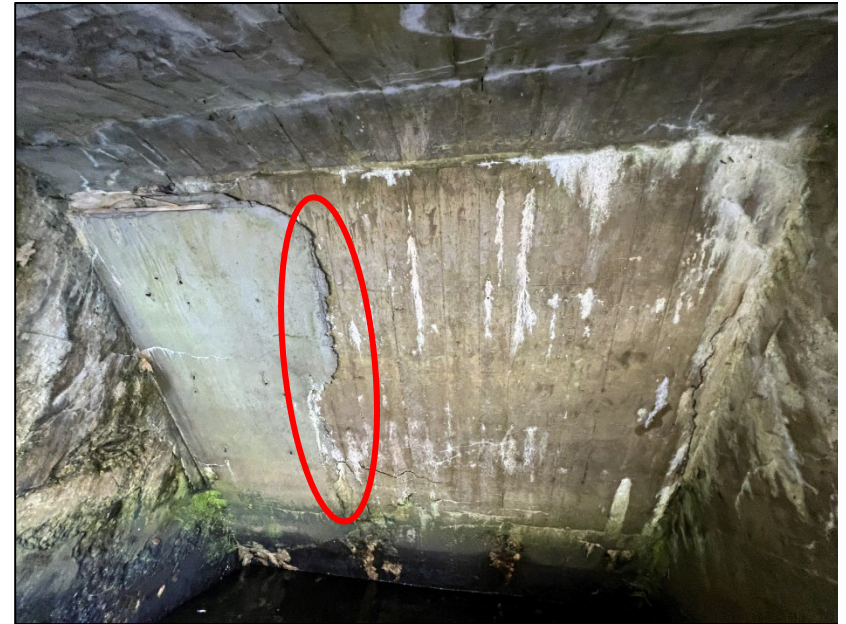
Photo No. 11.: Upstream sloped ceiling. Note location of delamination along repairs.

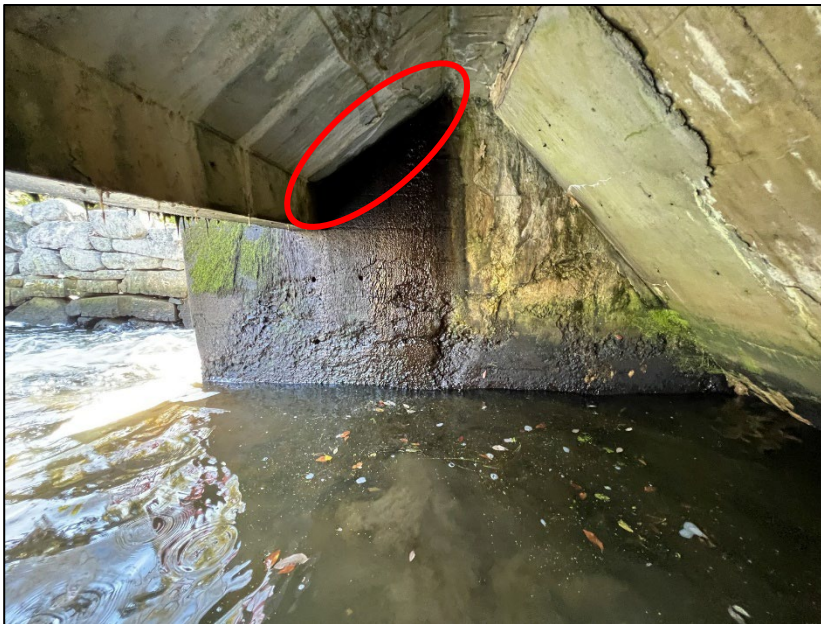
Photo No. 10.: Right wall. Note leakage along the interface between the ceiling and the right wall.

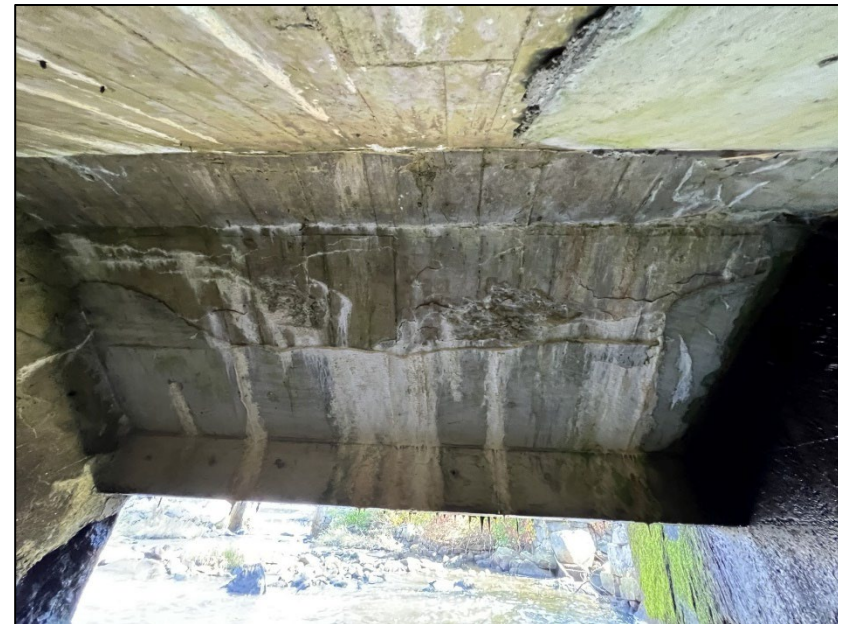
Photo No. 12.: Repair along the downstream sloped ceiling section (ceiling face No. 3). Note delamination above the repair with efflorescence staining.

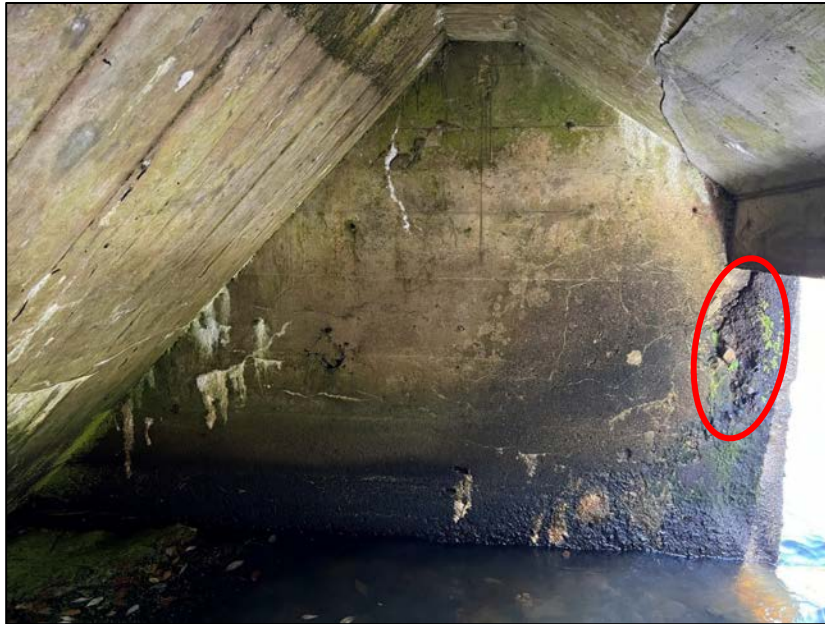
Photo No. 13.: left Wall. Note spalling and cracking beneath the downstream end of the spillway.

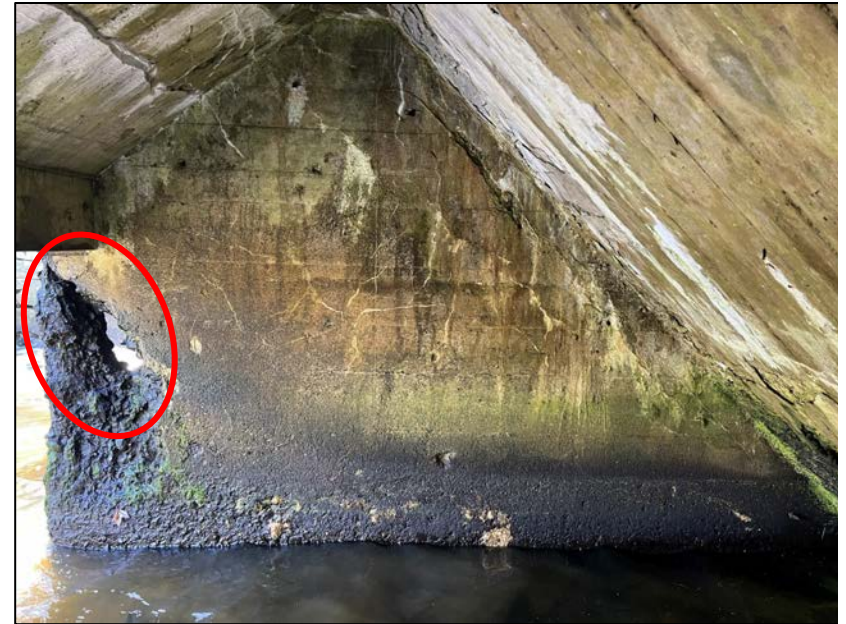
Photo No. 15.: Right wall. Note 100% section loss beneath the downstream end of the spillway. The hole pictured has continued to deteriorate since the previous inspection.

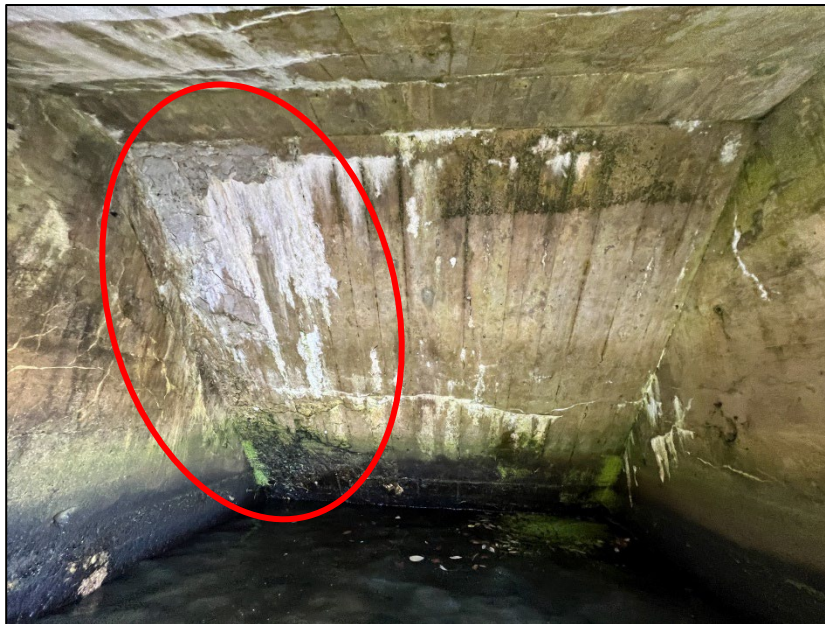
Photo No. 14.: Delamination and concrete deterioration along the right (photo left) portion of the upstream sloped ceiling (ceiling face no. 5).

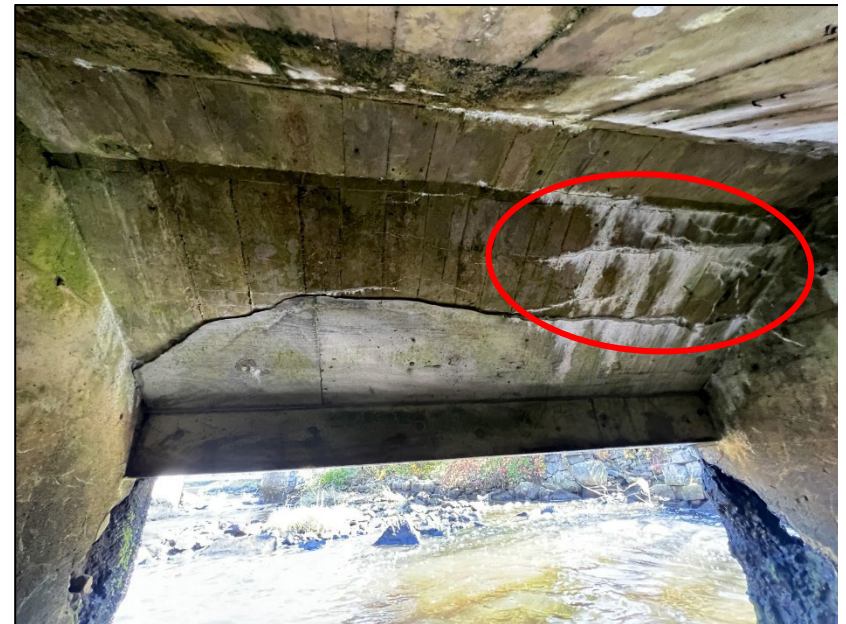
Photo No. 16.: Downstream sloped portion of the ceiling: Note delamination along the top of the concrete repair and cracking and efflorescence along the right side of the ceiling.

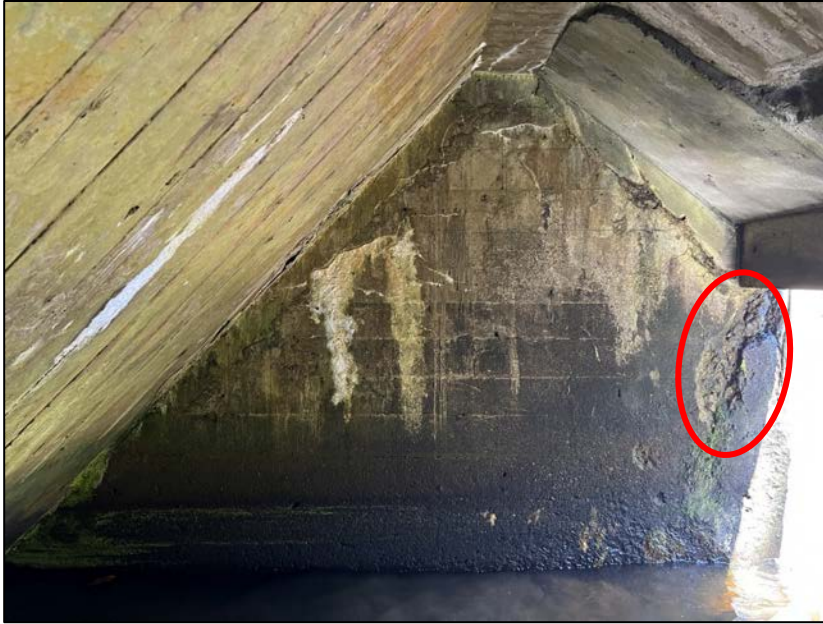
Photo No. 17.: Left Wall: Note concrete spalling on the downstream end of the wall beneath the spillway.

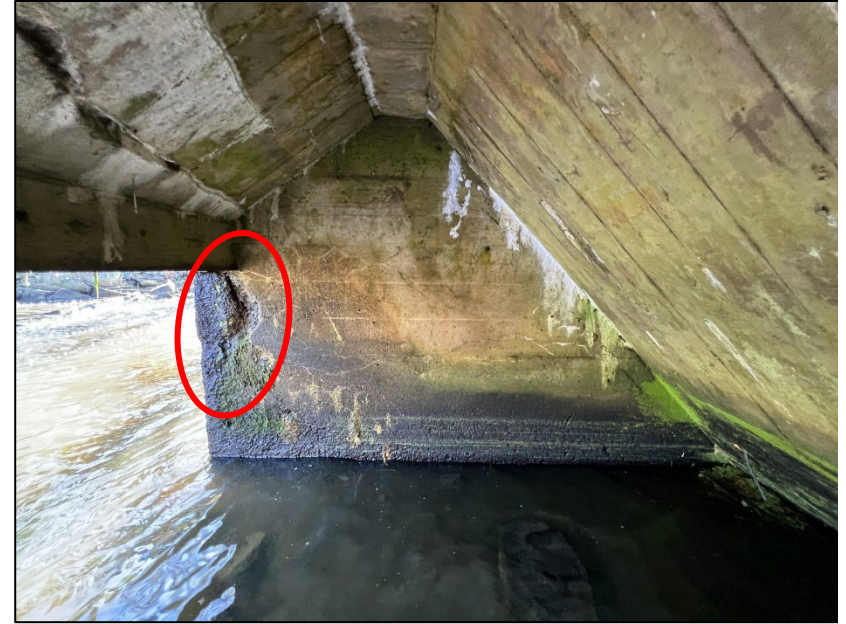
Photo No. 19.: Right wall. Note scour and spalling at the downstream end of the wall. Limited concrete deterioration was observed along ceiling face no. 5.

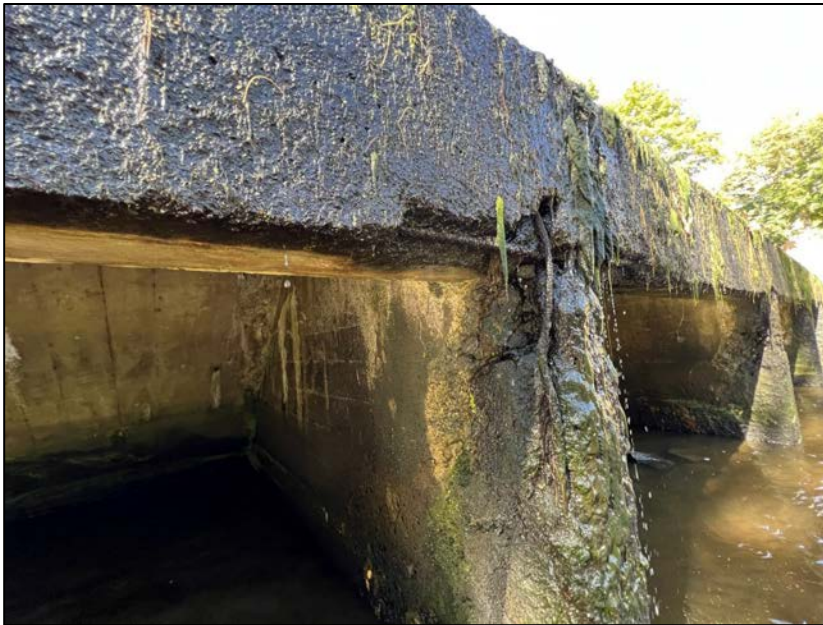
Photo No. 18.: Debonded rebar along the top of the rib between Cell 3 and Cell 4.

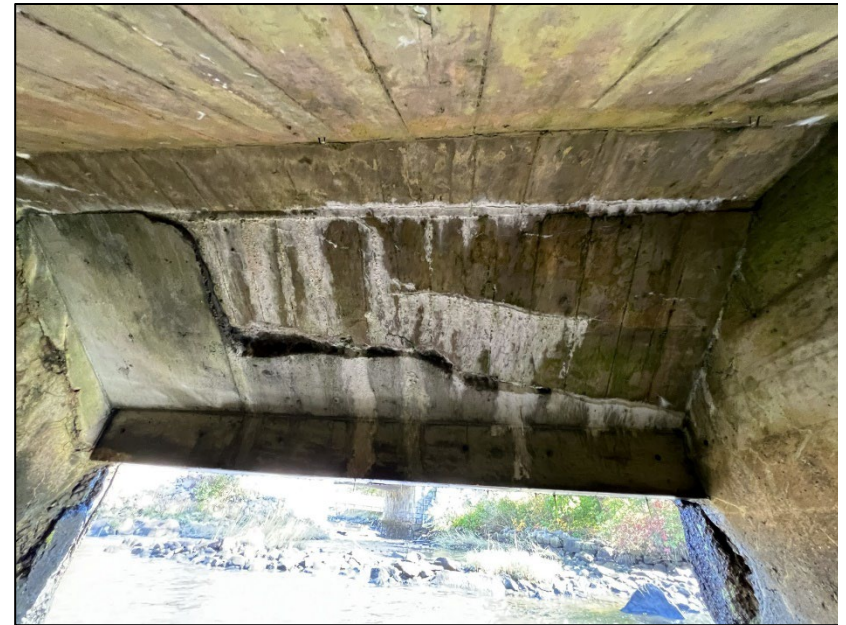
Photo No. 20.: Deterioration along the top of the concrete repair along downstream face of the ceiling (ceiling face No. 3).

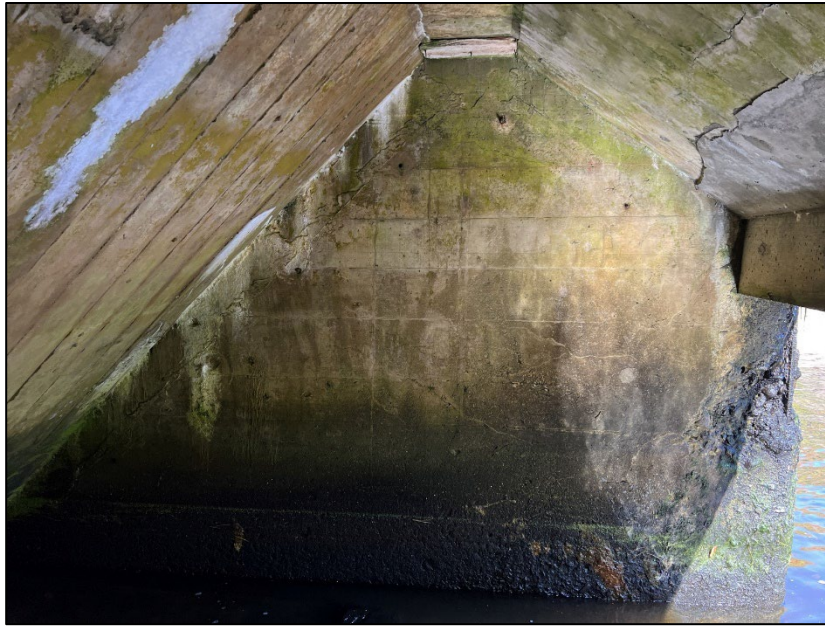
Photo No. 21.: Left Wall. Note debonded rebar and spalling on the downstream end of the wall.

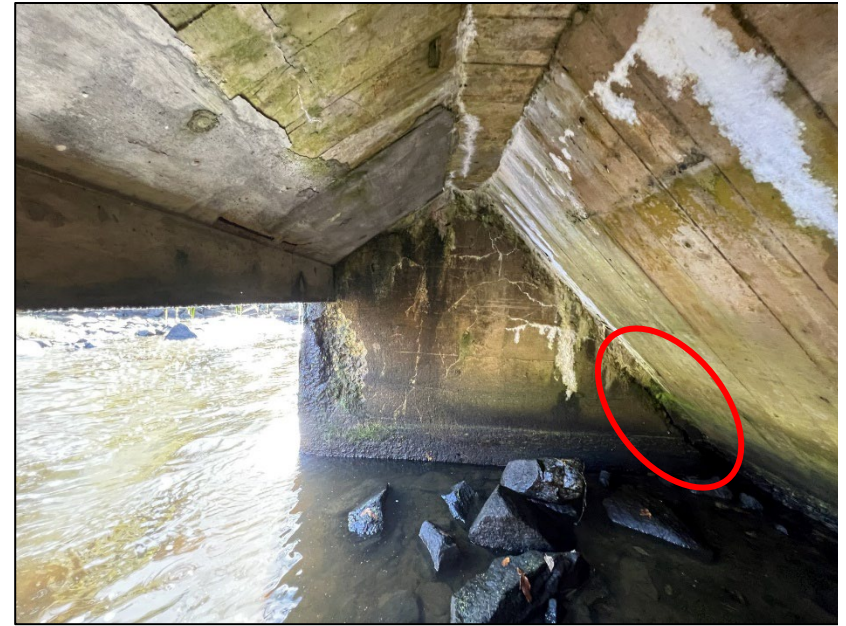
Photo No. 23.: Right wall. Note crack with 1/2" of left to right displacement.

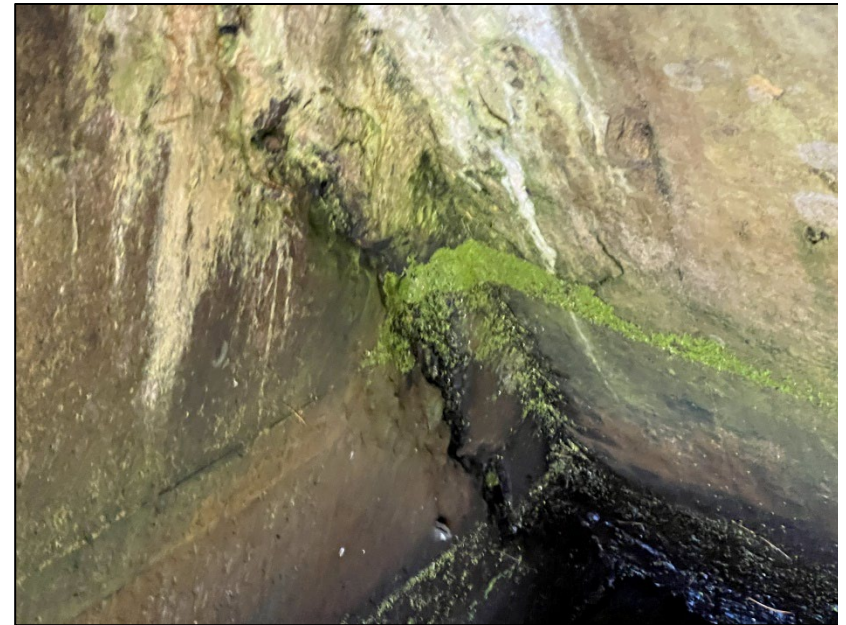
Photo No. 24.: Close-up view of the crack along the upstream side of right wall. Note iron oxide was previously observed within crack but not observed during this inspection.

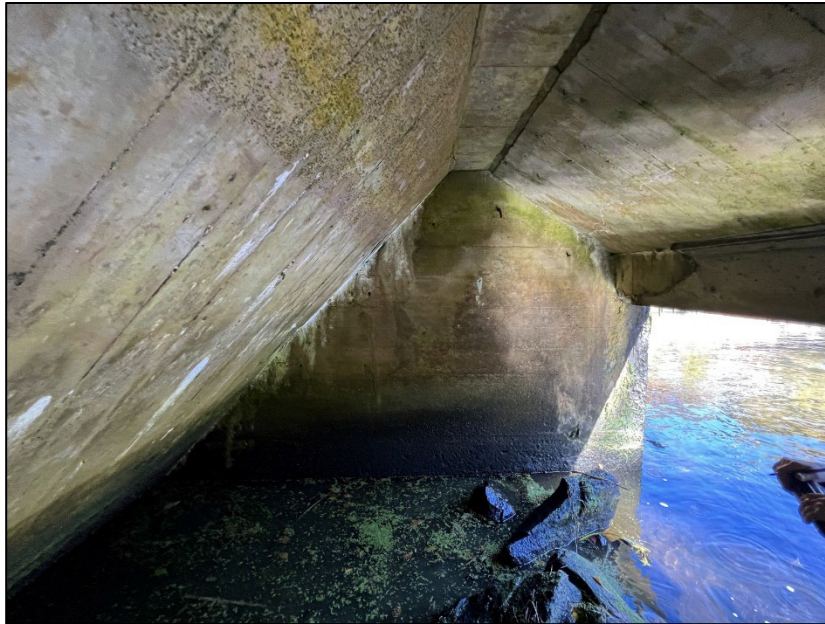
Photo No. 25.: Left Wall. Note scour and light spalling along the downstream end of the wall and approximately 1-foot above the waterline at the time the photo was taken.

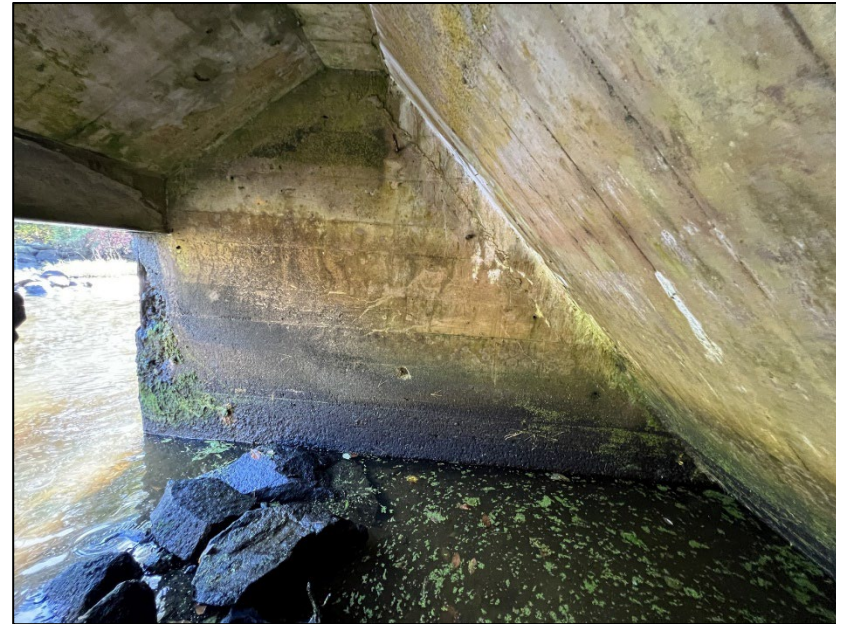
Photo No. 27.: Right Wall. Note debonded rebar and spalling at the downstream end of the wall.

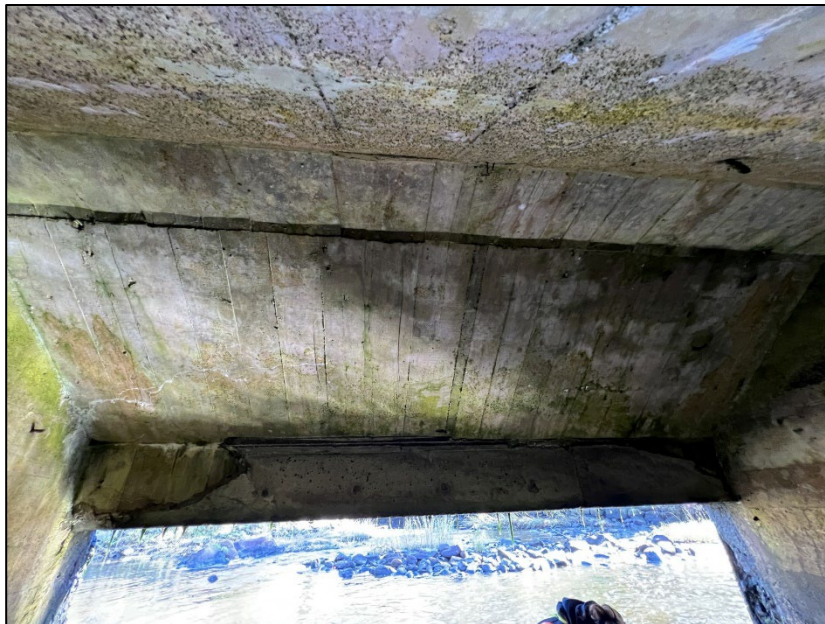
Photo No. 26.: Downstream portions of the ceiling. Note minor map cracking along ceiling face no. 3.

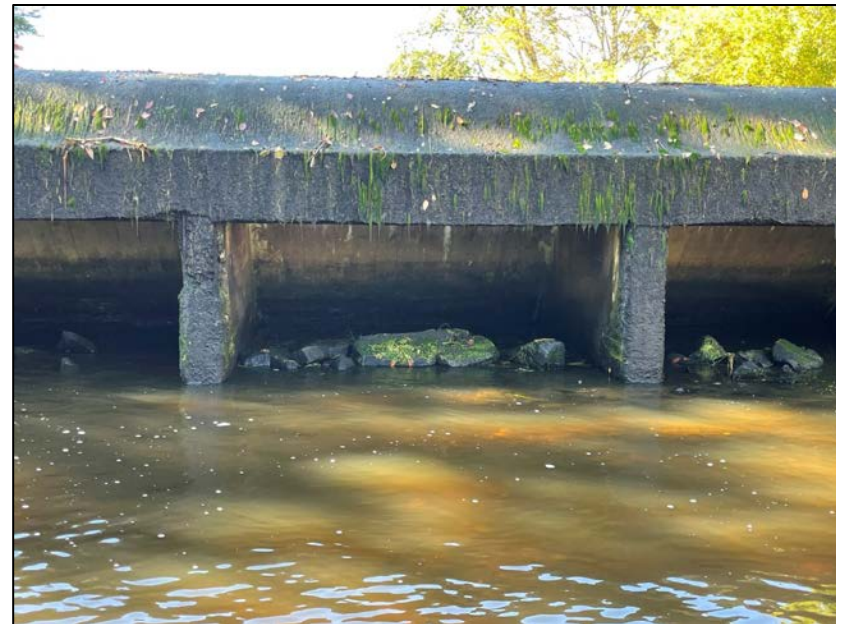
Photo No. 28.: Downstream face of the cell. Note the exposed rebar extending from the top of the stem between Cell 5 and Cell 4 to the mid-height of the stem.

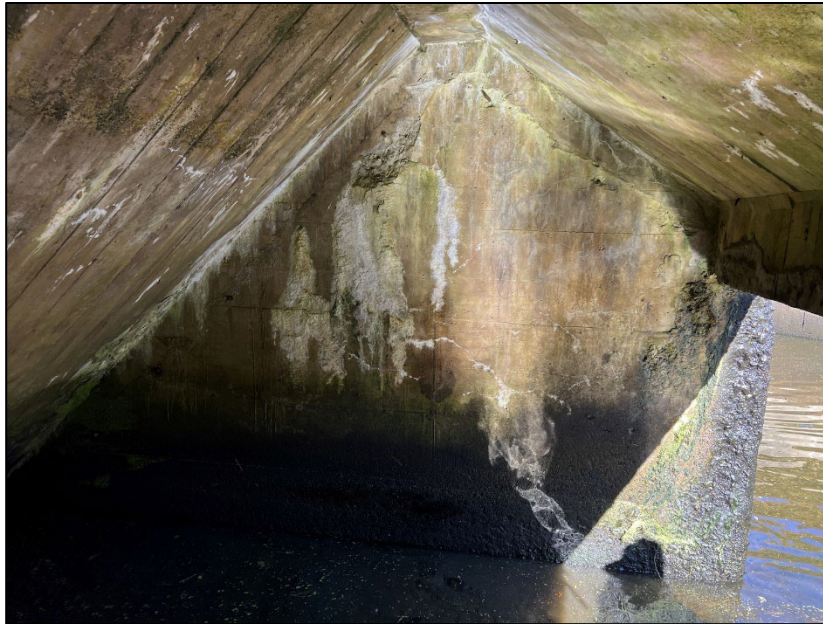
Photo No. 29.: Left Wall. Note efflorescent staining and cracking.

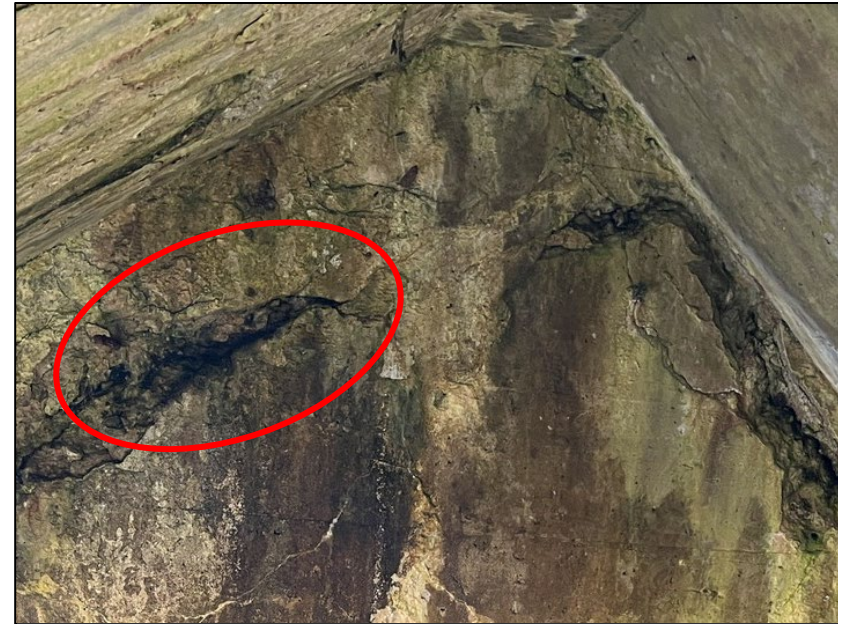
Photo No. 35.: Close-up view of the top of the deterioration of the right wall. Note location of previously noted leakage not observed during this inspection.

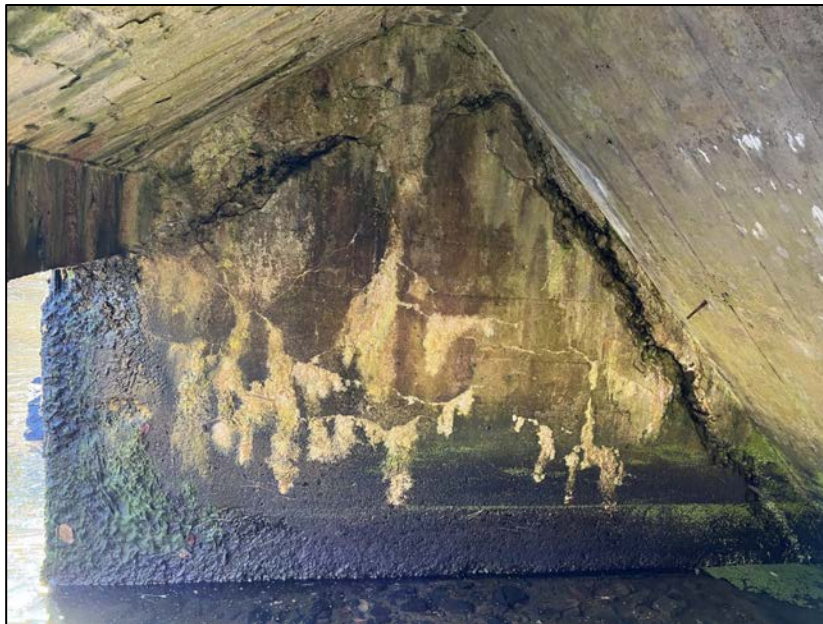
Photo No. 34.: Right Wall. Note cracking and spalling throughout the right wall and the upstream slope of the right wall.

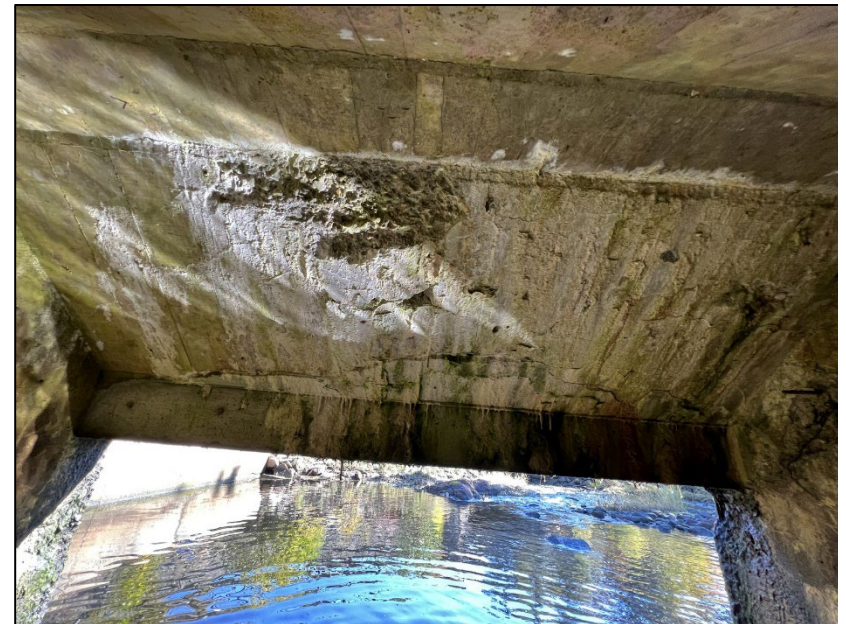
Photo No. 36.: Delamination, spalling, and efflorescence throughout the downstream sloped portion of the ceiling.

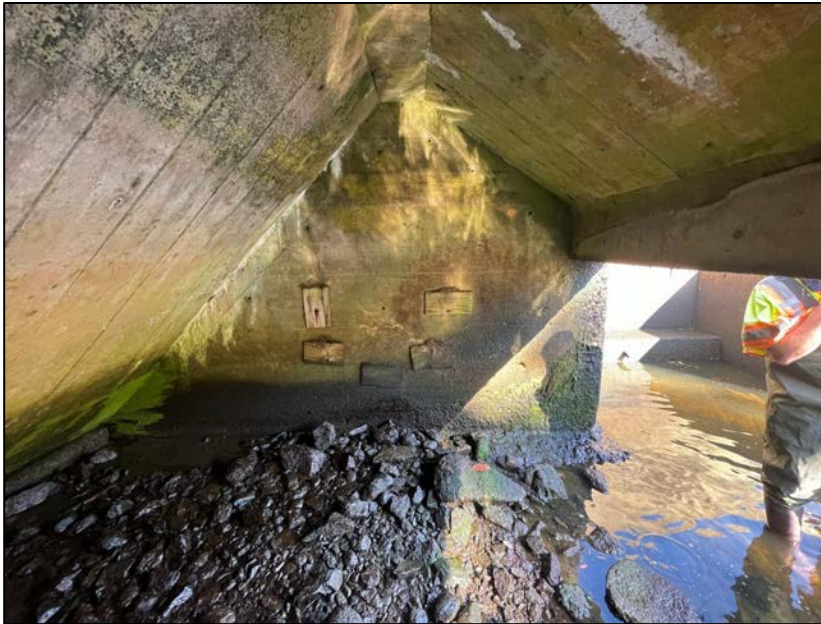
Photo No. 37.: Left Wall: Note repairs covered with timber falsework.

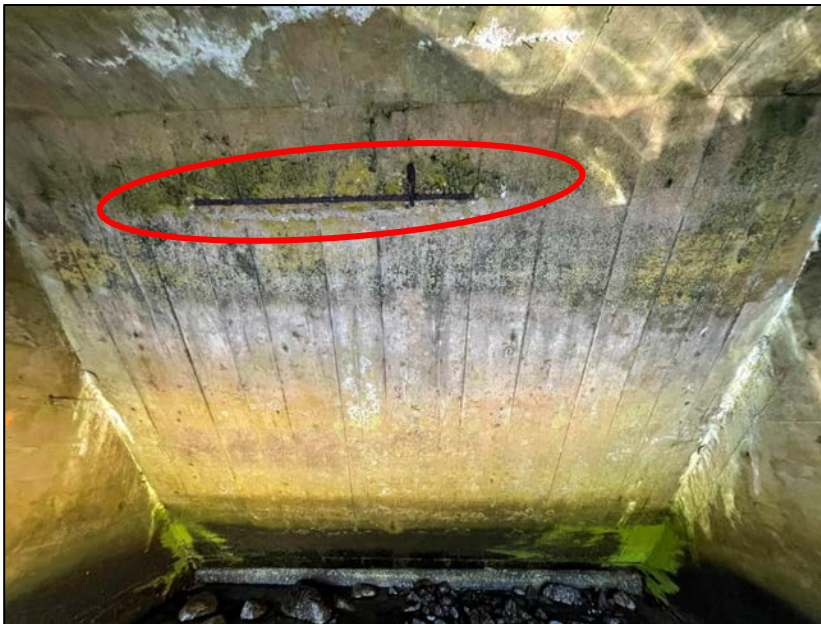
Photo No. 38.: Exposed deteriorated rebar near the top of the upstream portion of the ceiling.

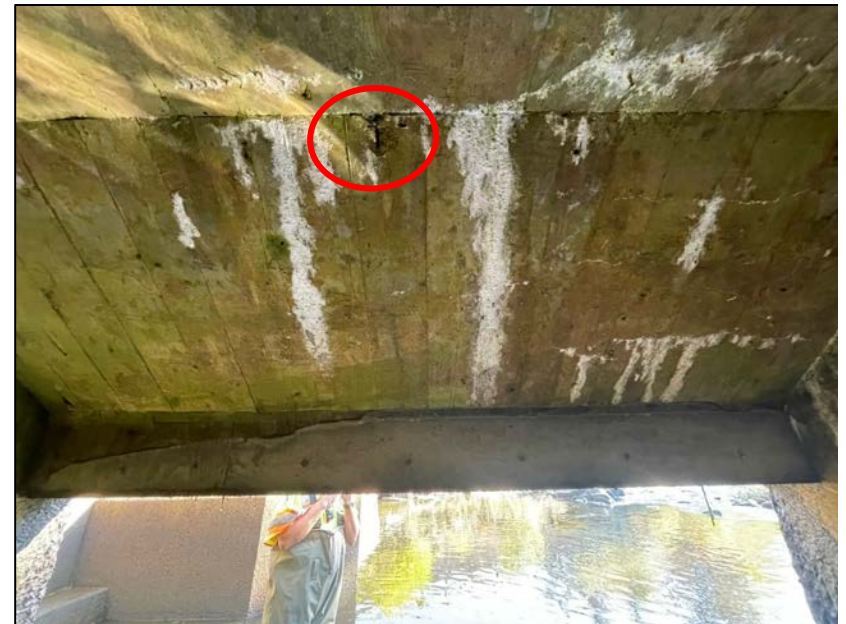
Photo No. 40.: Exposed deteriorated rebar and concrete spall on the downstream sloped portion of the ceiling.

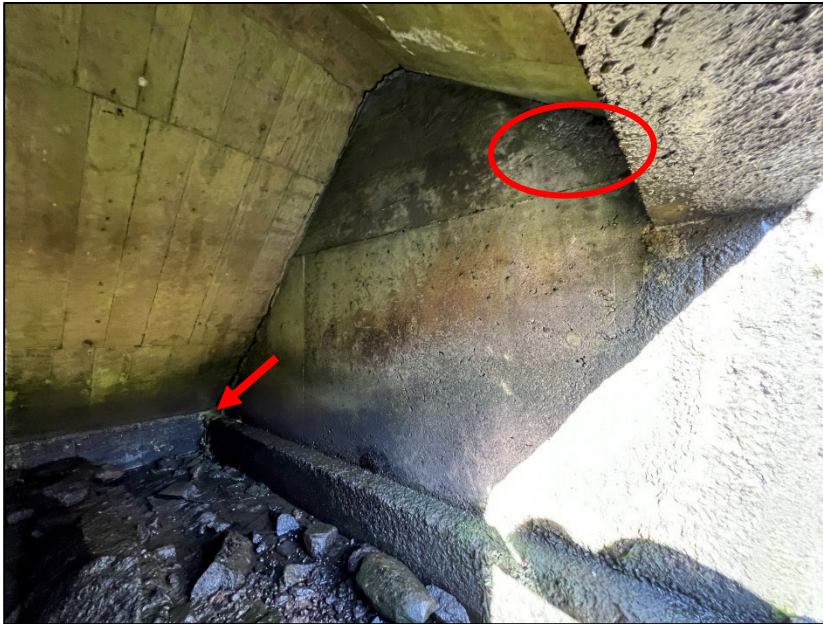
Photo No. 41.: Left Wall. Note evidence of poor concrete consolidation along the top of the wall at ceiling face no. 3 (circle). Previous location of iron oxide staining (arrow)

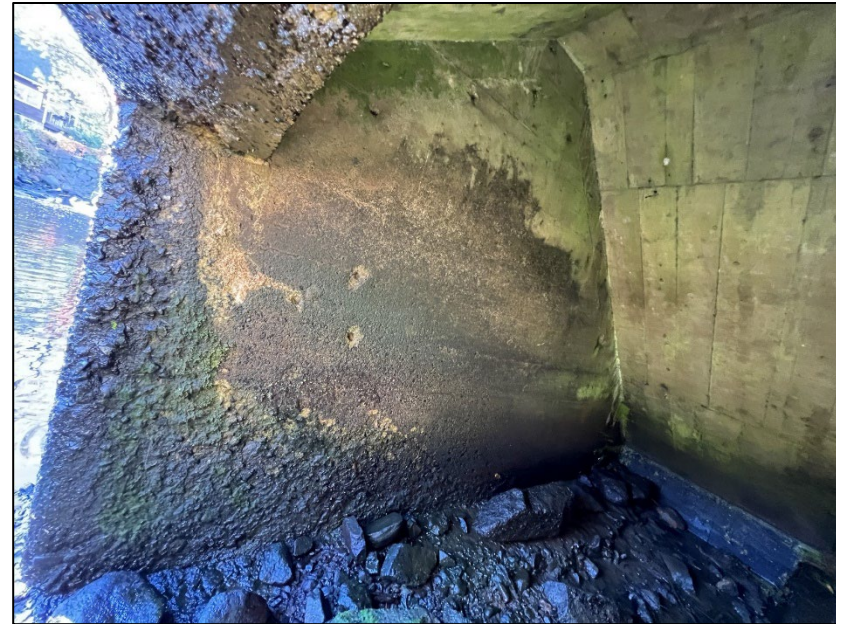
Photo No. 43.: Right wall. Note scour and concrete deterioration at the downstream end of the wall.

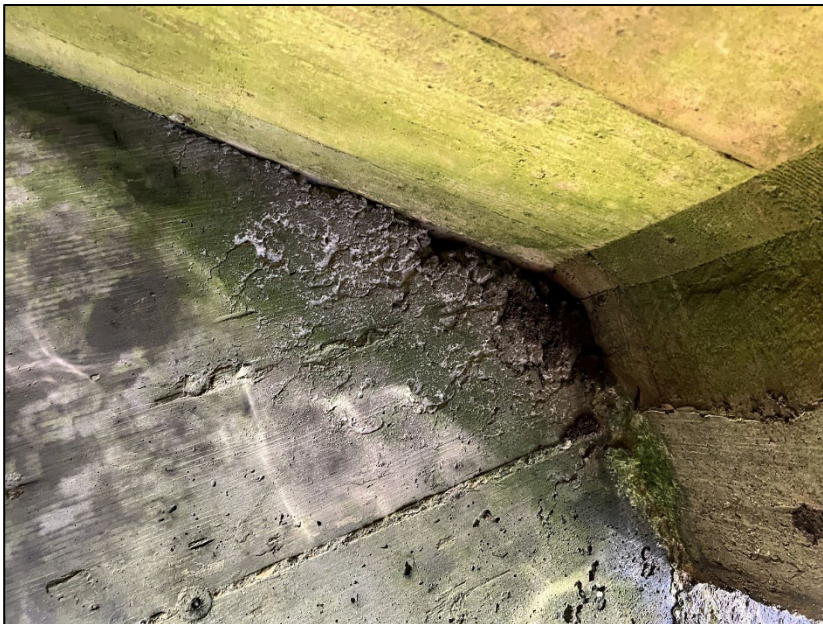
Photo No. 42.: Poor concrete consolidation at the downstream end of the left wall.

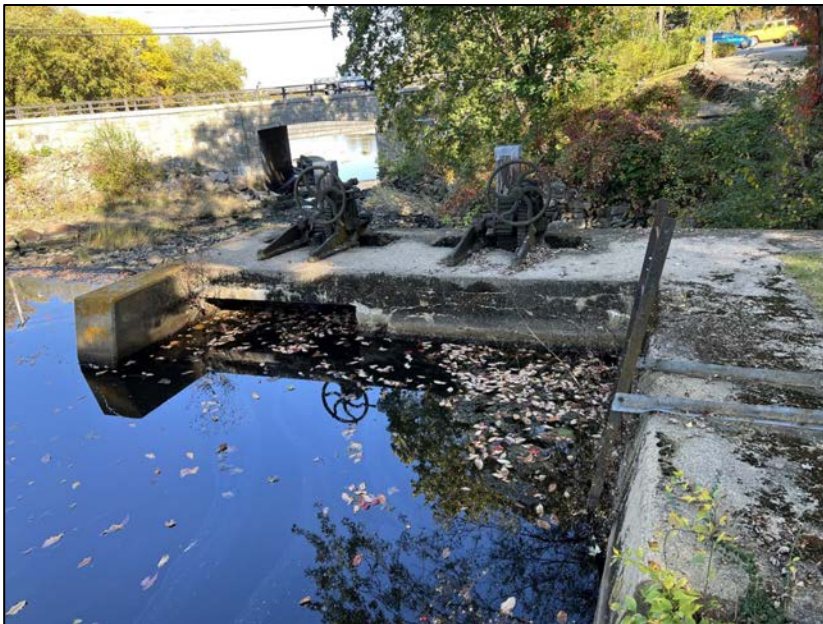
Photo No. 46.: Overview of the upstream side of the low-level outlets. Note concrete deterioration along the upstream face of the concrete wall.

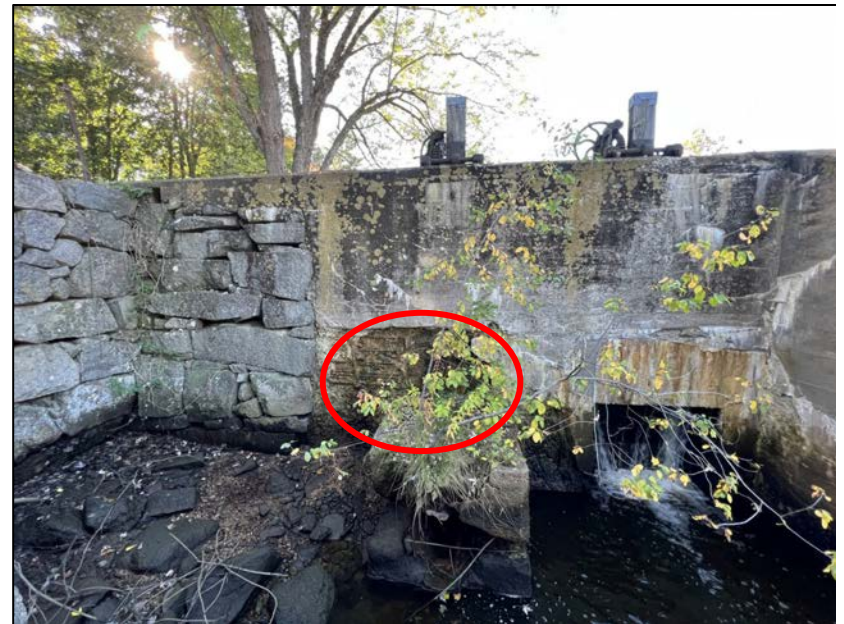
Photo No. 48.: Downstream face of the low-level outlet structure. Note further concrete smalling noted when compared to 2019 inspection report.

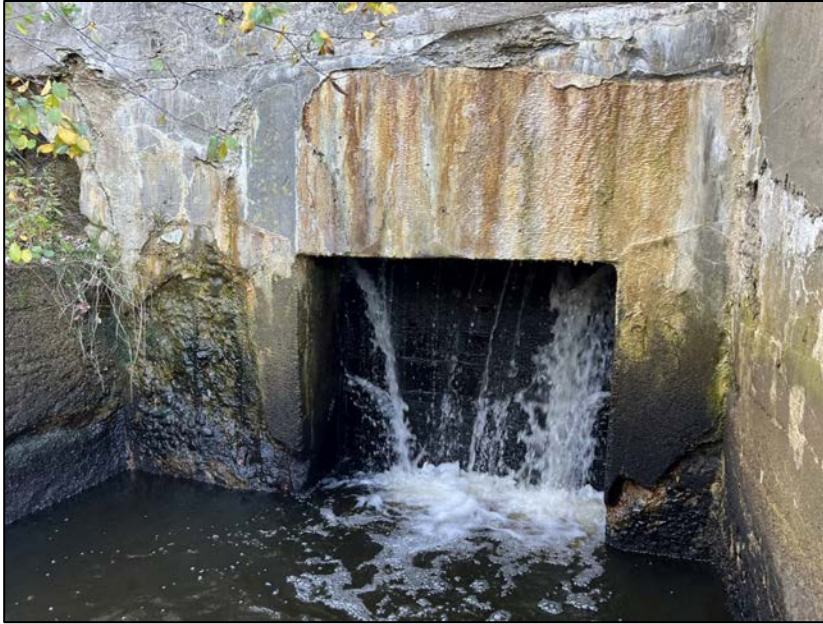
Photo No. 49.: Leakage through the low-level outlet timber gates. Note concrete deterioration throughout the downstream wall.
