Site Inspection Form

Dam Name: Oyster River Dam **Dam No.:#** 71.03 **Town:** Durham
Date Inspected: 09/18/07 **Owner:** Durham Public Works

Oyster River Mill Dam #71.03 Durham, NH

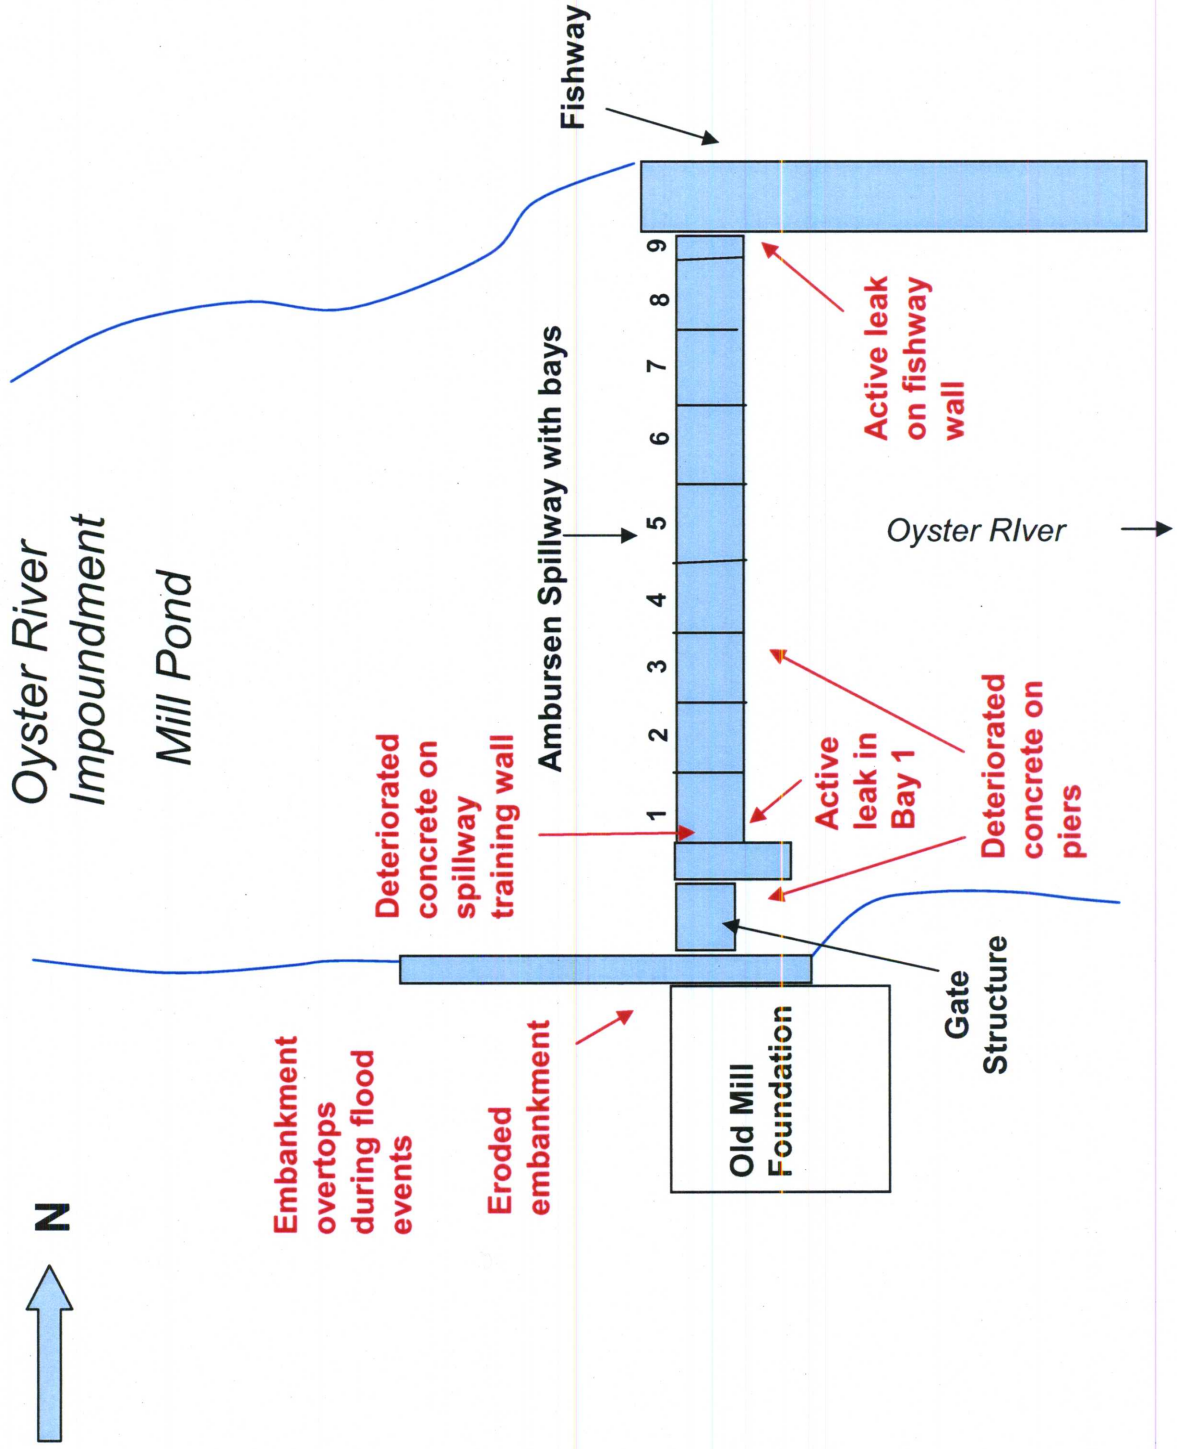
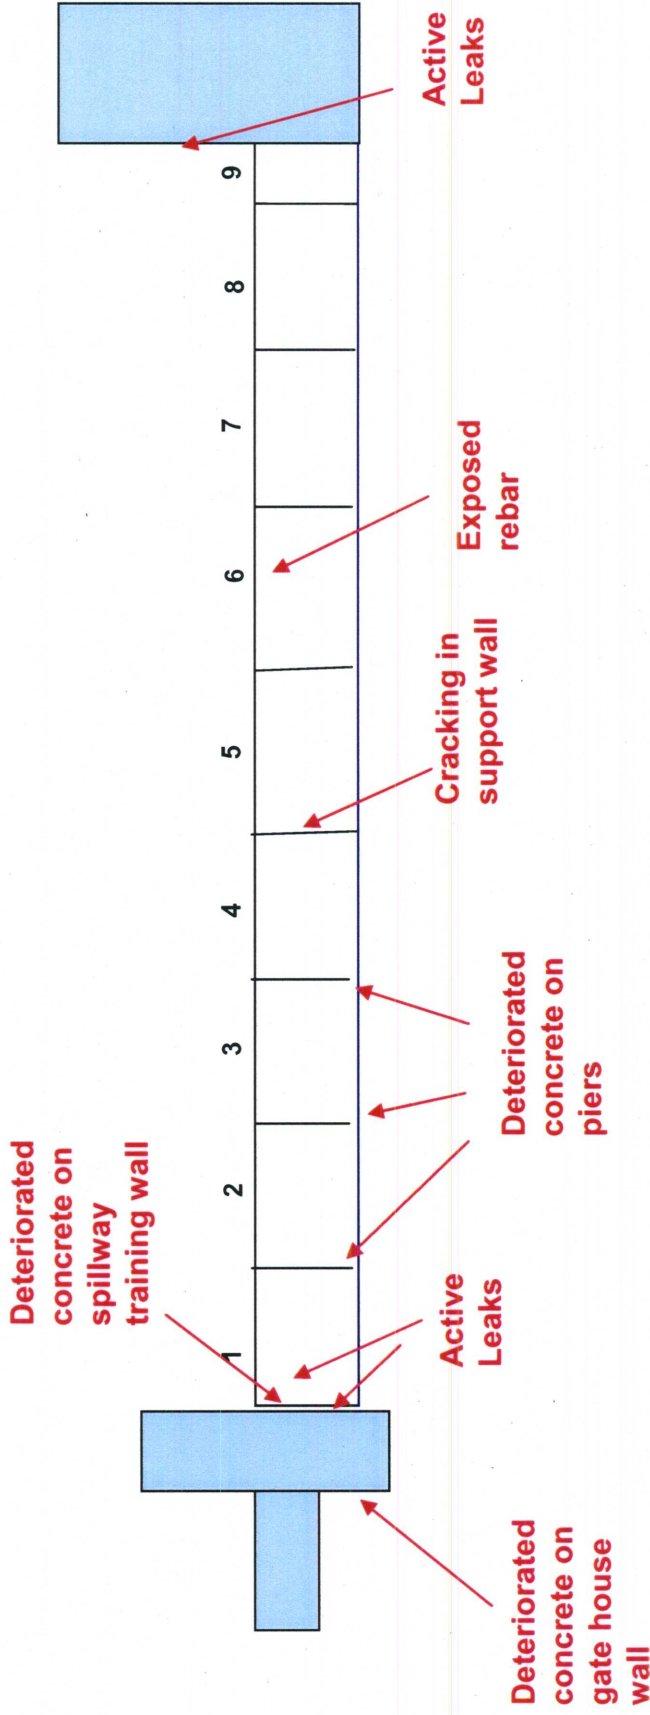
- 2) There was an active leak noted from a construction joint on the fishway that forms the left spillway training wall.
- 3) Deteriorated concrete was noted in the following locations (refer to enclosed sketch):

- On the gate house structure/spillway training wall. An eroded section of the right concrete spillway training wall measured 6" deep.
 - The upper and lower portions of the eight concrete piers supporting the spillway slab. Along the base of the left abutment wall of the gate structure/right spillway training wall. Rebar was also exposed in this area.

- To the right of the low level gate at the base of the downstream face.
 - On the interior ceiling of bay 6 (counting from right end). Rebar was also exposed.

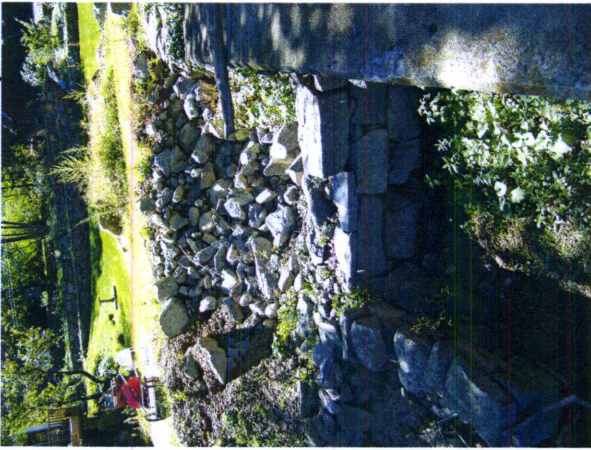
- 1) There was damage to the right abutment from the past two flood events. Soil had settled and eroded from the right earthen embankment adjacent to the concrete/stone training wall. The old mill foundation had suffered extensive damage from the floods. Some repairs have been made by the property owner on the right bank.

Failed mill foundation - stone was added to stabilize area

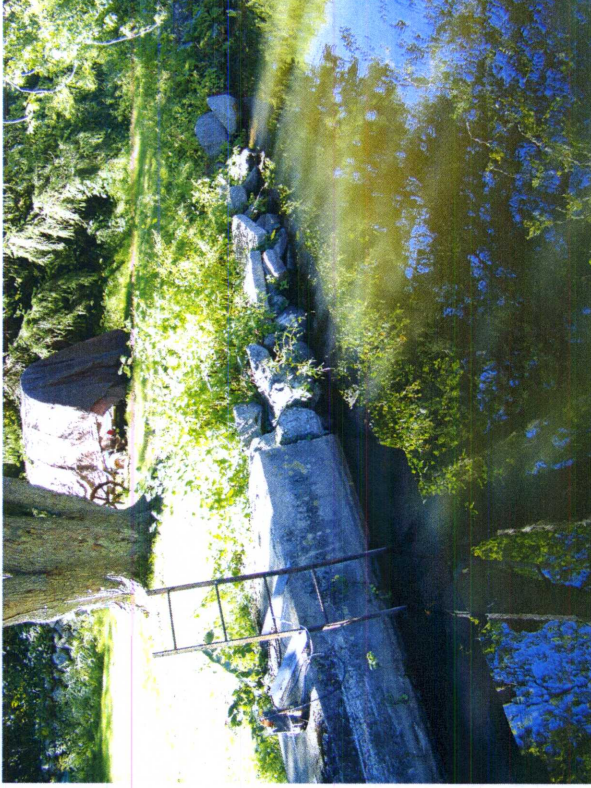
Area that overtopped during 4/16/07 flood event

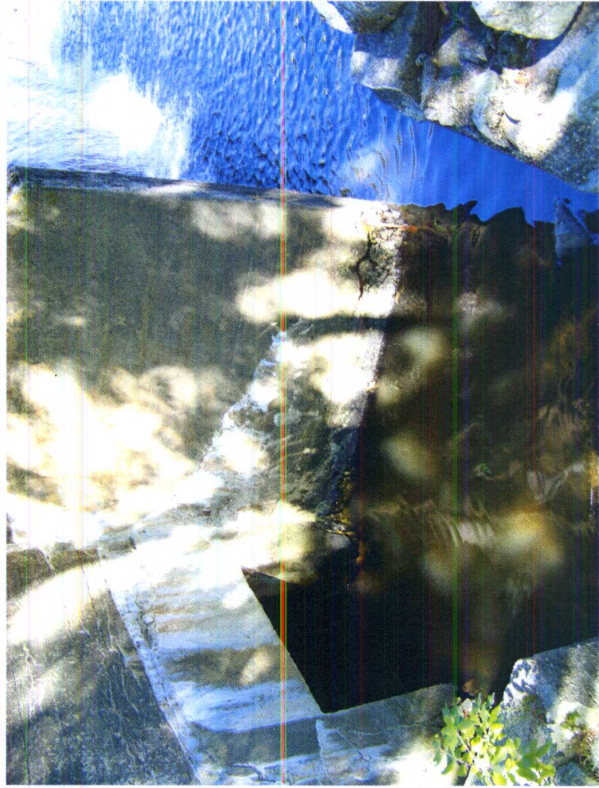
Deteriorated concrete at base of pier serving as left gate housing

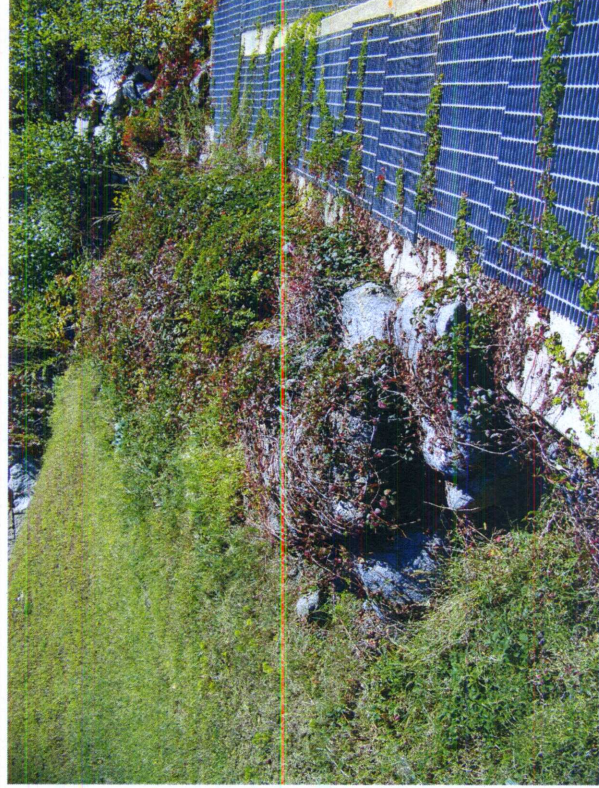
Some settlement of left embankment near fishway

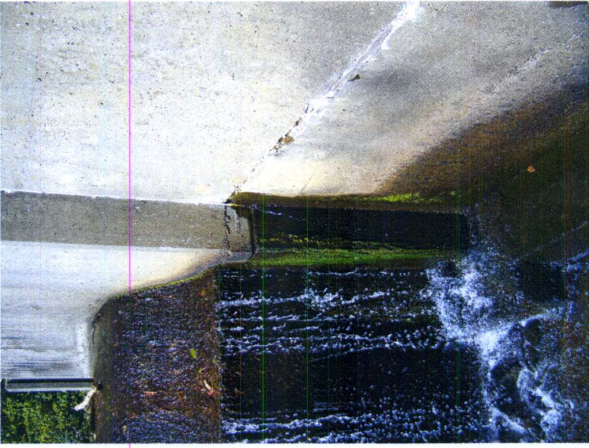
Leak in left spillway training wall at fishway

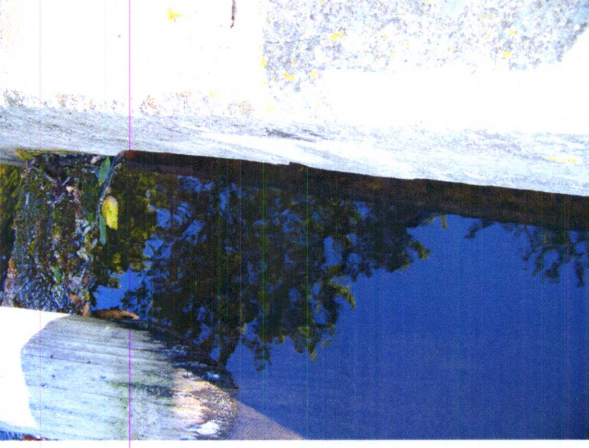
Right spillway training wall - 6" deep deterioration on wall at water

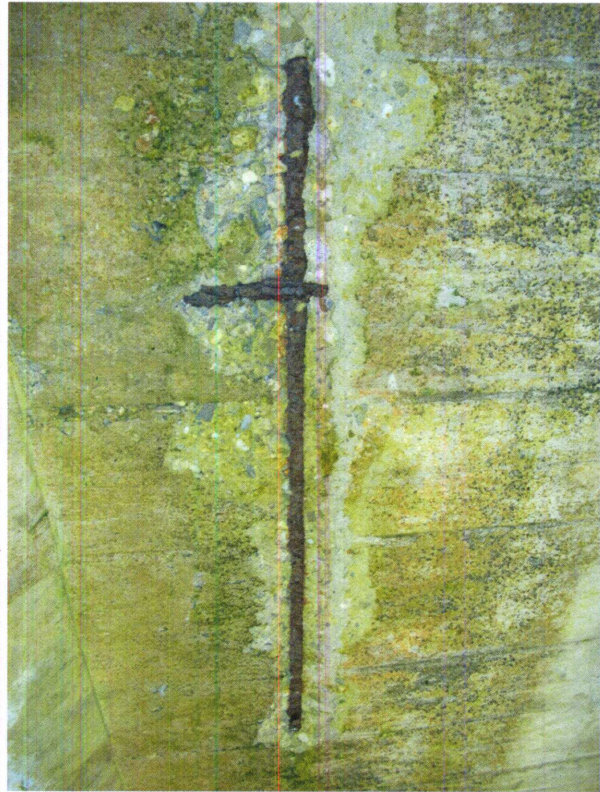
Bay 6 - exposed rebar on ceiling

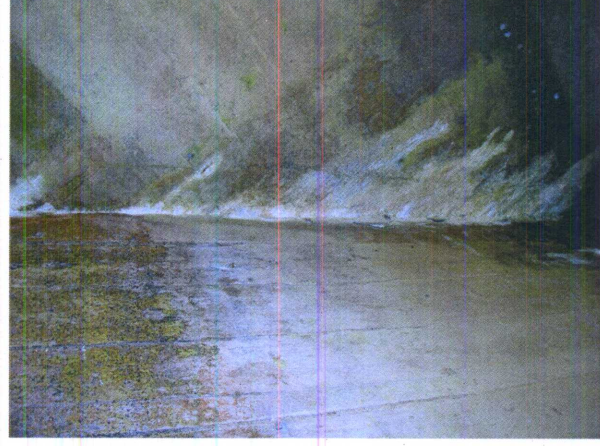
Bay 6 - efflorescence

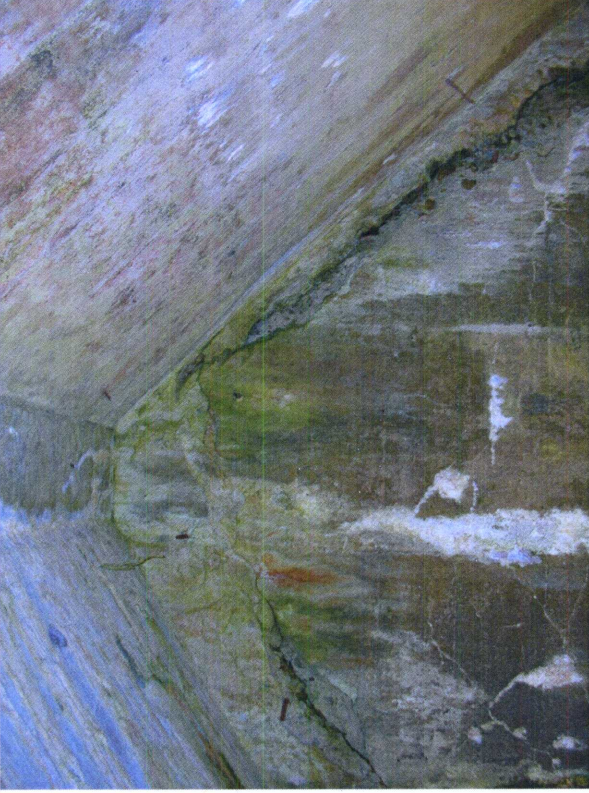
- There was concrete cracking in the support wall of Bay 4 & 5 (Refer to attached photo).
- 4) There was active leakage noted in Bay 1 along the ceiling at the spillway slab and spillway training wall junction. Leakage was also noted at the upstream toe of the right spillway training wall inside Bay 1 (refer to photos).

Bay 5 - cracking in bay 5/4 support wall

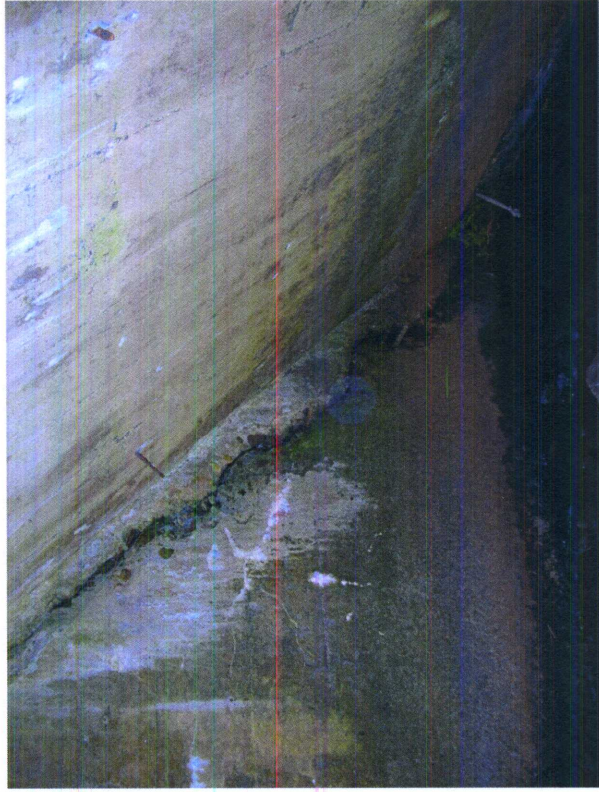
bay 5 - Cracking in Bay 5/4 support wall

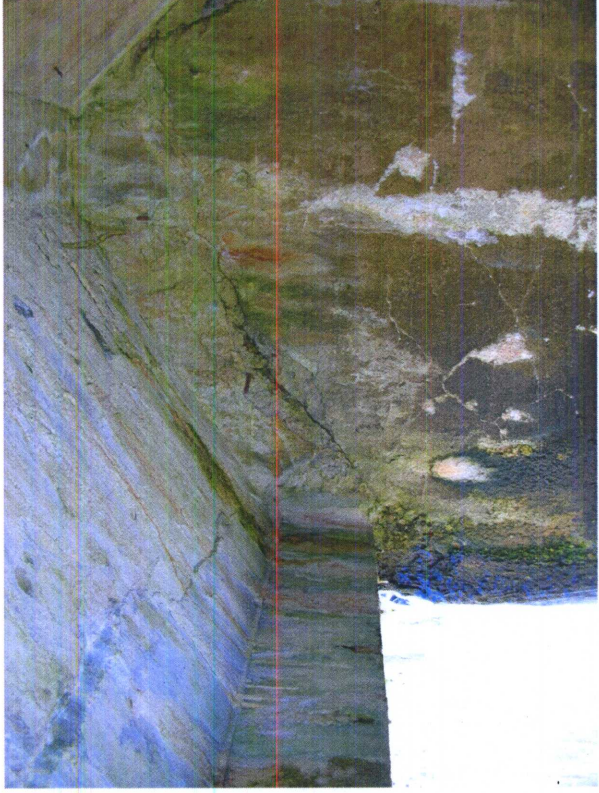
Bay 5 - Crack in Bay 5/4 support wall

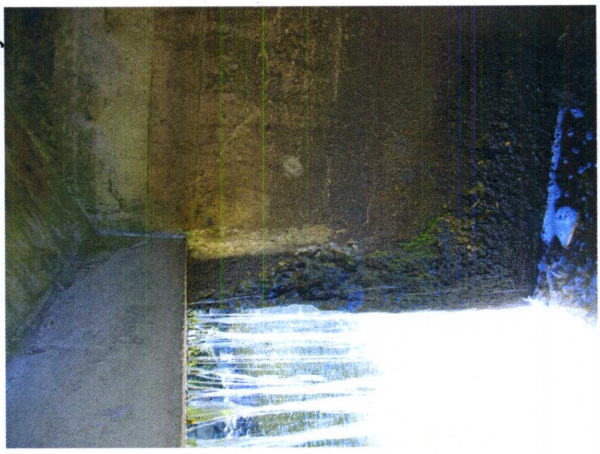
Bay 4 - Deterioration on Bay 4/3 pier

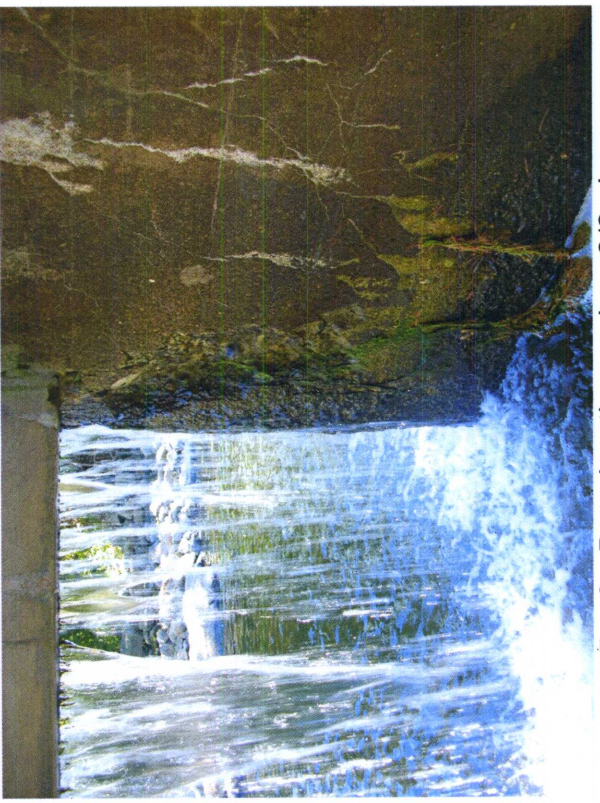
Bay3 - Deterioration on bay 3/2 pier

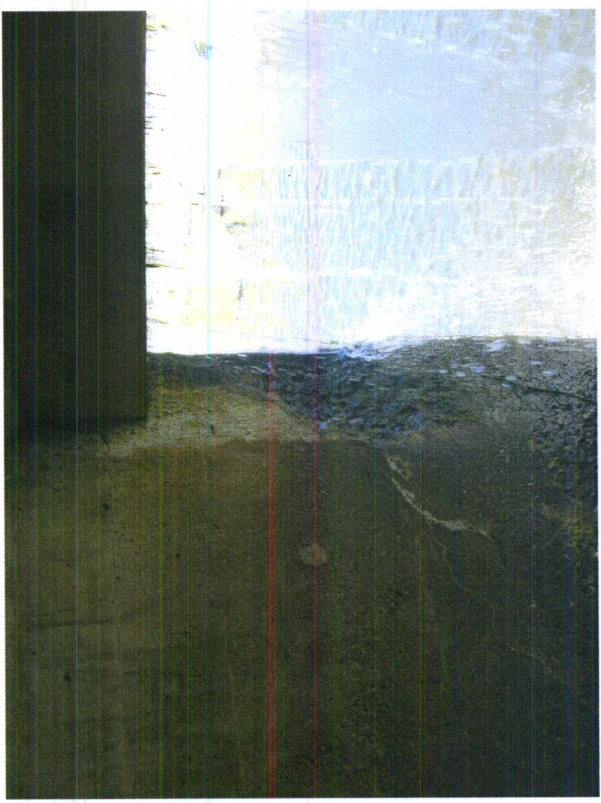
Bay 3 - Deterioration on Pier 3/4

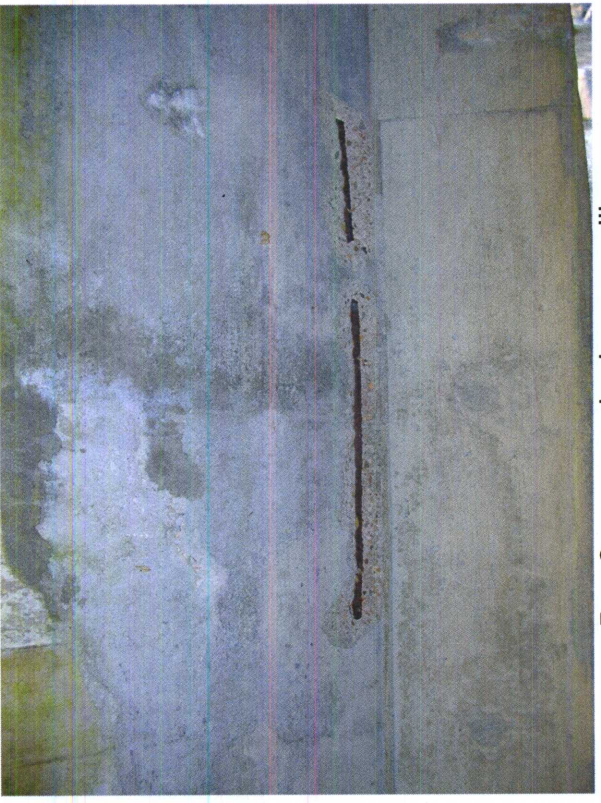
Bay 2 - exposed rebar on ceiling

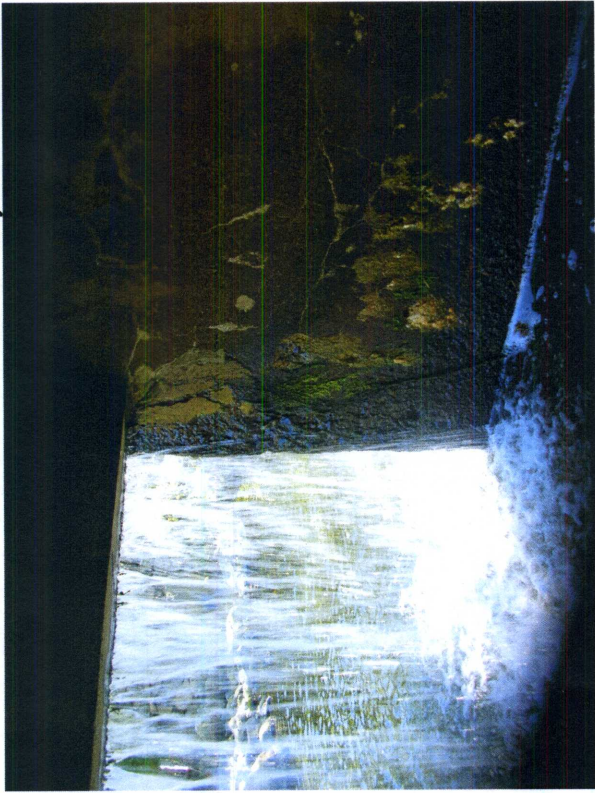
Bay 2 - deterioration on pier 2/1

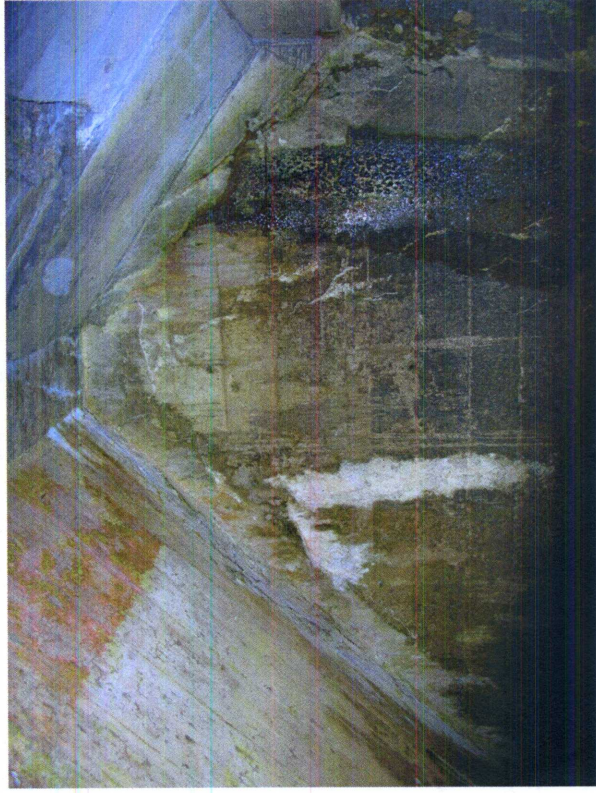
Bay 2 - leaking on pier 2/3

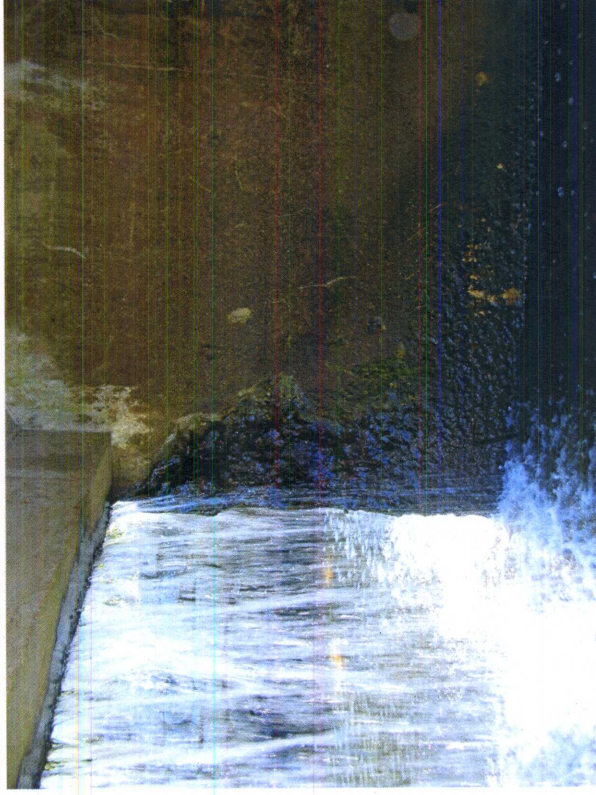
Bay 2 - concrete deterioration pier 2/1

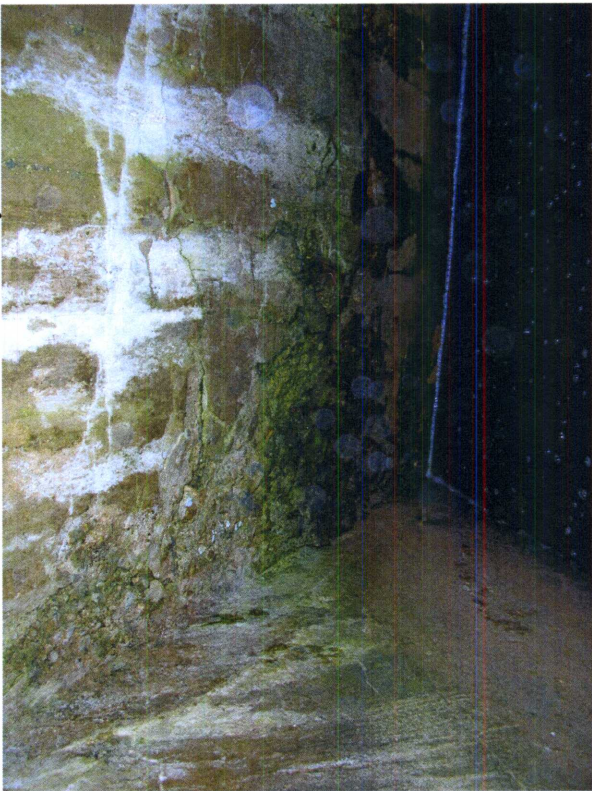
Bay 2 - concrete deterioration

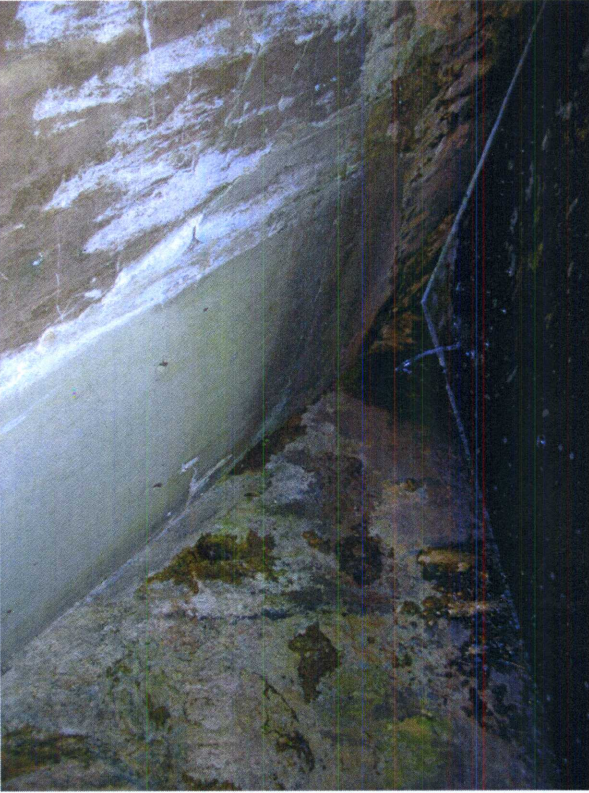
Bay 1 - active leak on connecting gate house wall

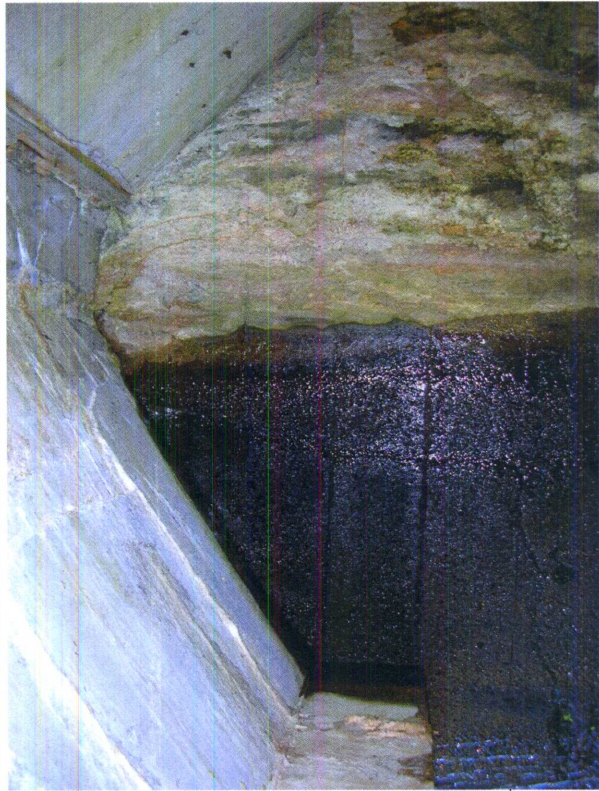
Bay 1 - active leakage from spillway slab adjacent to gate chamber

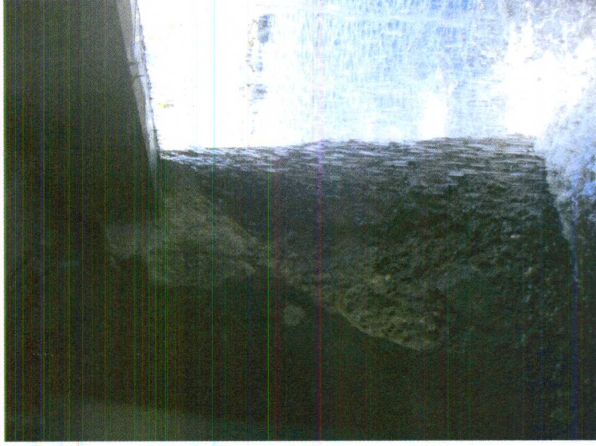
Bay 1 - concrete deterioration on Pier 1/2
