**Re: Concrete Evaluation Report  
Oyster River (aka Mill Pond) Dam #071.03  
Durham, New Hampshire  
SA Project No. 075-07-003**

**CONCRETE EVALUATION REPORT  
OYSTER RIVER DAM #071.03  
aka Mill Pond Dam, aka Durham Falls Dam  
DURHAM, NEW HAMPSHIRE  
SA PROJECT NO. 075-07-003  
MARCH 31, 2010**

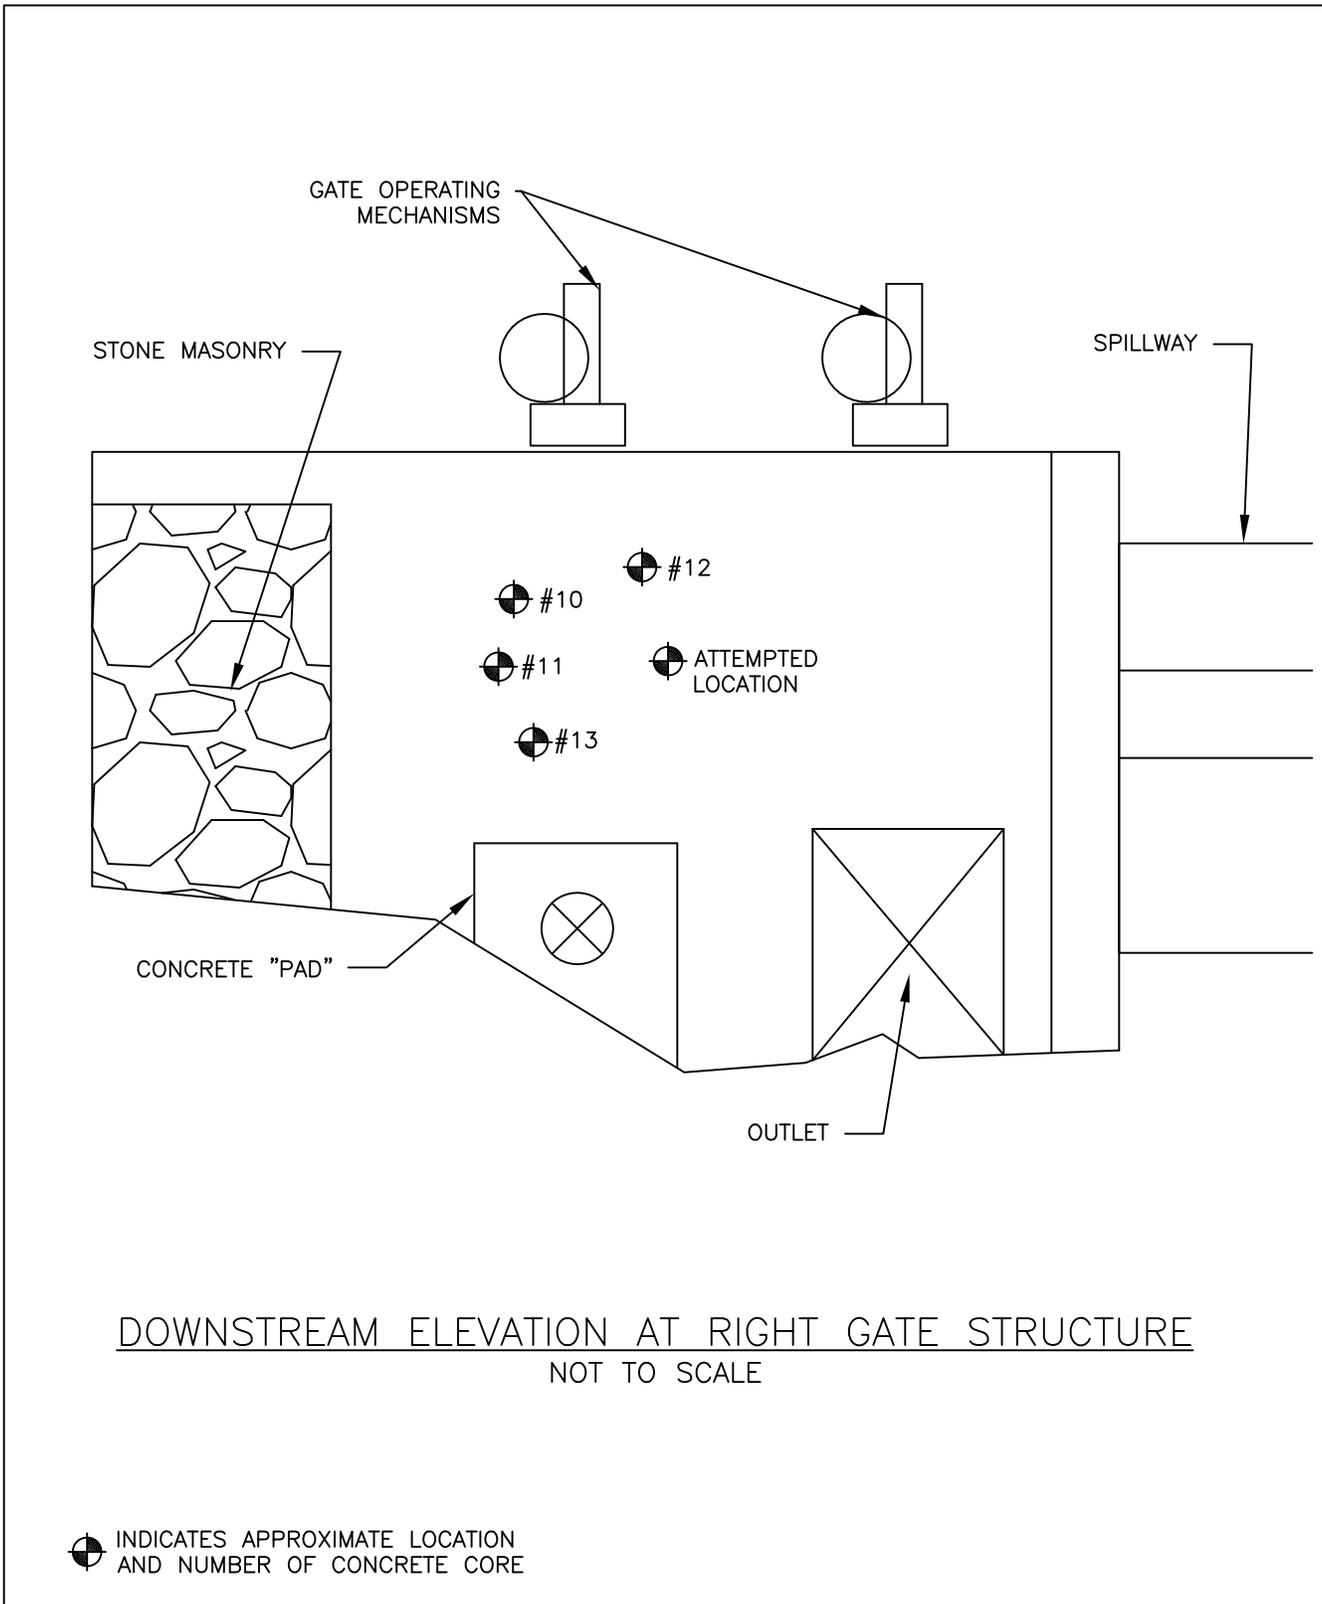
Approximate Locations - Cores #10 - #13

Cores #10 and #12 had significant cracking parallel to the face of the Dam, which SA observed both in the cores and in the core holes. Core #11 was in fragments and contained a piece of square reinforcing steel about 3 inches from the concrete surface. SA observed brown staining of the concrete in the plane of the steel, but the bar appeared relatively free of corrosion. We observed several significant cracks, up to 1/8-inch wide and parallel to the face of the Dam, inside the core hole, as well as a couple of small cracks perpendicular to the face extending about 3 inches into the Dam from the surface.

Core #13 came from just below a visible horizontal line between the original concrete (above) and a concrete patch (below) through an area of the wall that sounded delaminated. The outer 7 inches of 1974 concrete came out of the core hole intact with no visible cracking. The concrete scanner had indicated that the concrete in this area appeared to be delaminated. SA observed space between the original and 1974 concrete, about ¼-inch-wide, at the back of the core hole. We observed a horizontal square steel bar in the core about 3 ½ inches from the surface. The gap we observed between the 1974 and original concretes at the back of the Core #13 hole indicates that the patch is likely being held in place by the existing reinforcing steel.

DOWNSTREAM ELEVATION AT RIGHT GATE STRUCTURE  
NOT TO SCALE

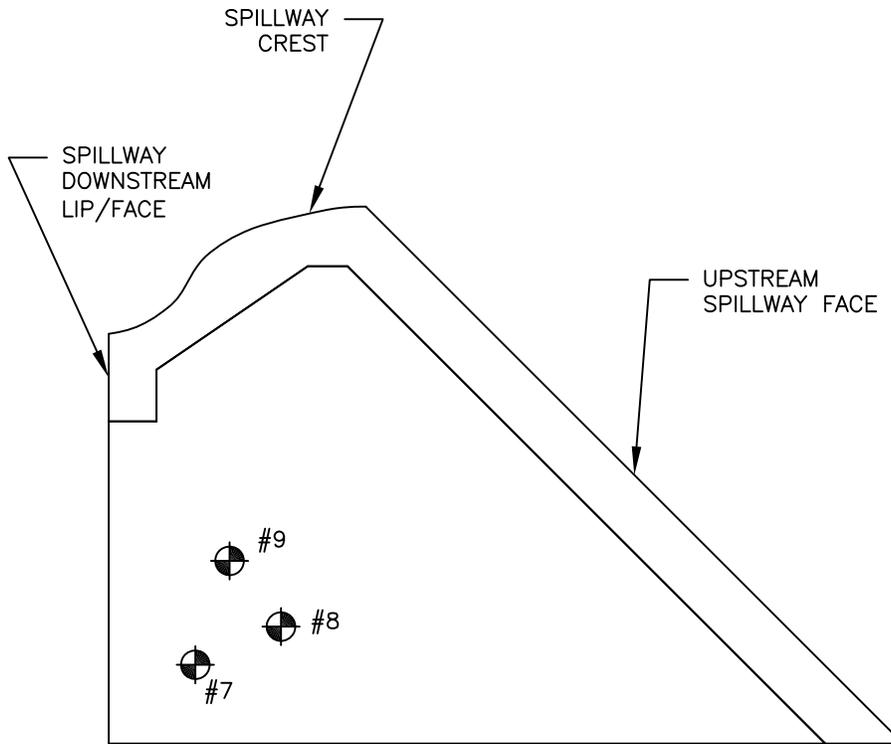
Approximate Locations - Cores #7 - #9

Proscanning scanned the majority of the rib between Cells 7 and 8 as representative of the structure and accessible to scanning and coring equipment. The ground penetrating radar only detected reinforcing steel at the downstream vertical edges of the rib. Procut took three 6-inch-diameter cores (Cores #7, #8 and #9) horizontally through the rib between Cells 7 and 8. The cores were intact (no visible cracking and no steel) and were about 12 inches long. The aggregate appeared to be well distributed throughout the cores, appearing mostly rounded with maximum size close to 3 inches in diameter.

SPILLWAY SECTION  
PIER/RIB BETWEEN CELLS 7 AND 8  
NOT TO SCALE

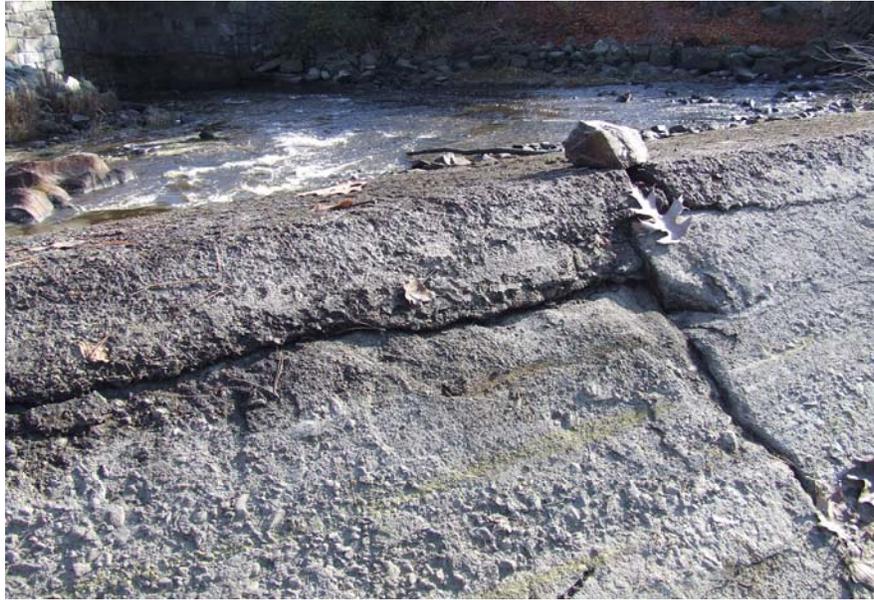
Sounding indicated a possible delamination along the joint between Cells 5 and 6 along the crest. At the joint above the rib located between Cells 6 and 7, the corner of the repair material over Cell 6 sounded delaminated. We also noted a hollow sounding area extended from the joint up to 4 feet over Cell 7.

Photo Number: 5 Upstream spillway face and crest above Cells 7 and 6. Note visible separation of repair concrete at crest.  
Description:

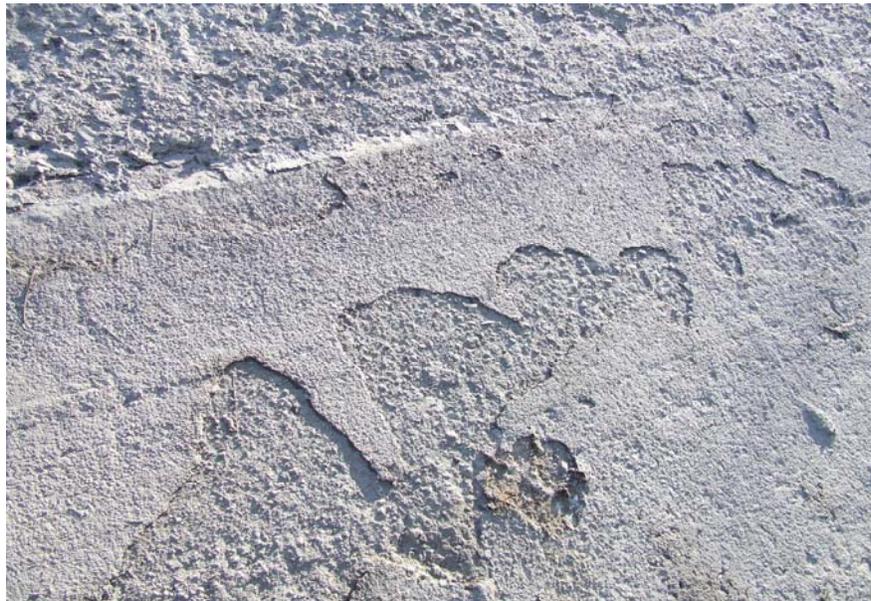
Photo Number: 6 Typical surface deterioration of upstream face of spillway.  
Description:

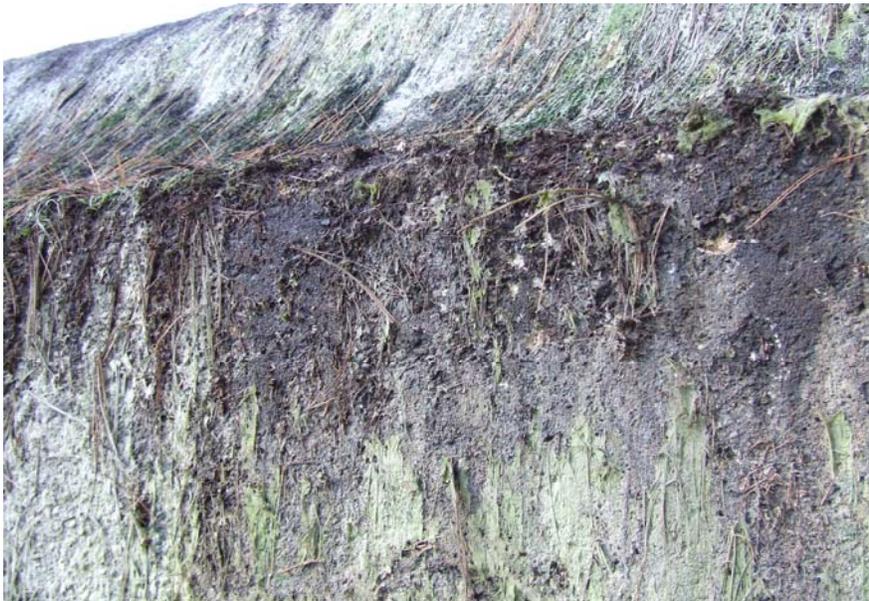
Photo Number: **8**

Description: Moss and algae growth on downstream face of spillway.

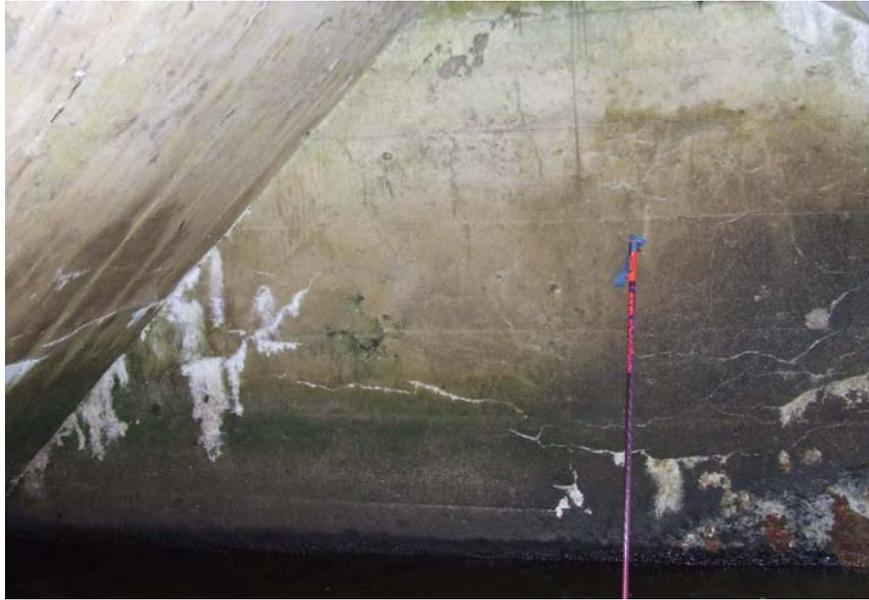
Photo Number: **9**

Description: Cracking and efflorescence on Rib in Cell 2.

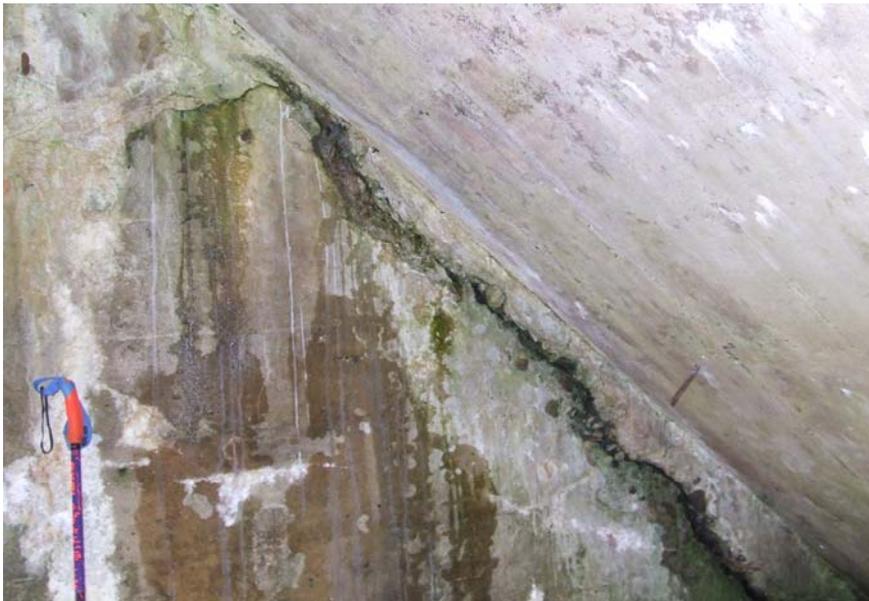
Photo Number: **12**

Description: Crack and delamination at joint between rib and ceiling slab in Cell 7.

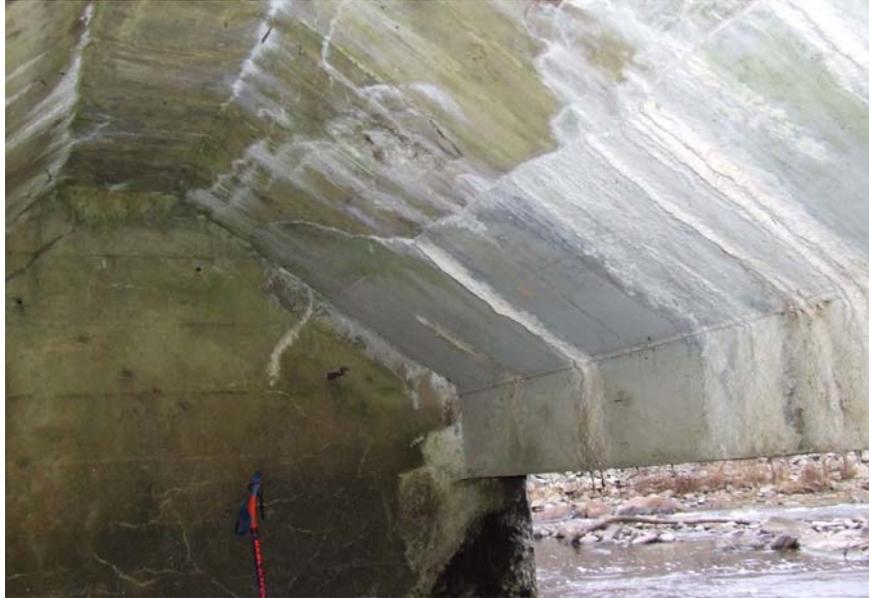
Photo Number: **13**

Sounding revealed that Cell 1 contained delaminated areas of patch material, and of the original concrete adjacent to the patch material, over a significant area of the upstream ceiling/slab. Five of the cells had significant delaminated areas in the downstream ceiling or along the lip. Some cells had delaminations of what appears to be the repair concrete, while other delaminated areas were directly adjacent to the patches in the original concrete.

Description: Interior of Cell 1.

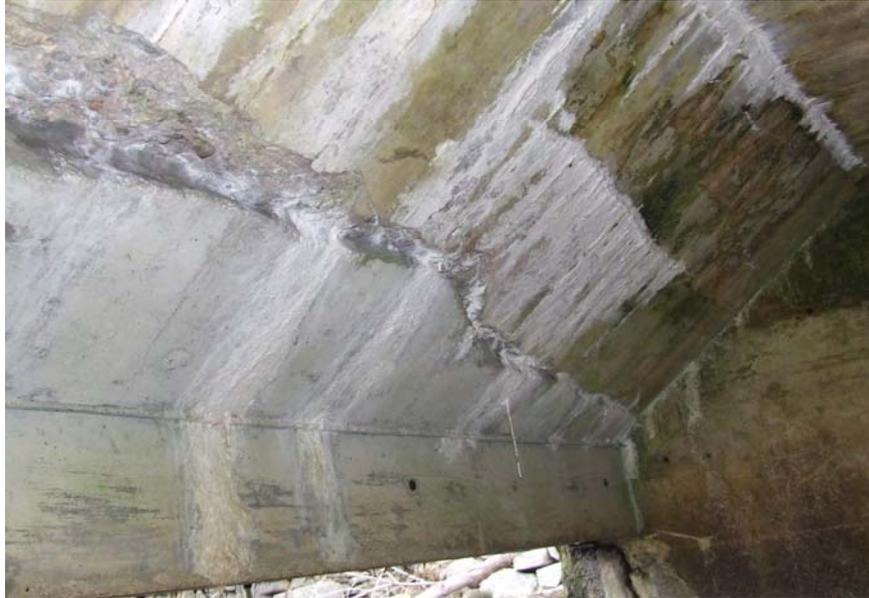
Photo Number: **13**

Description: Cracking spalling and efflorescence at downstream ceiling of Cell 3.

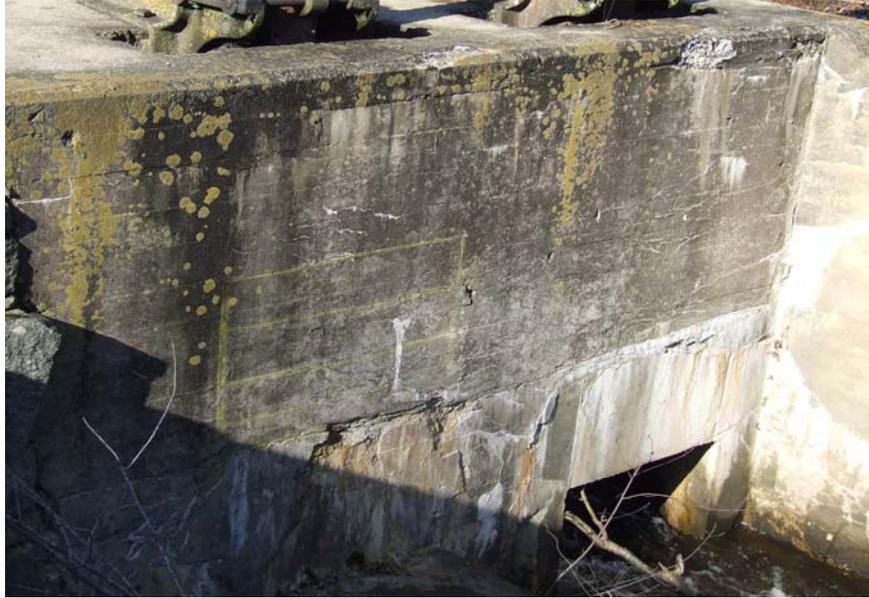
Photo Number: **19**

The concrete at downstream face of the gate structure near the right abutment exhibited the most severe damage and deterioration. The extensive cracking in the cores from this area made the cores unusable for strength testing. The abutment is exposed to water from the pond and river surface, rain and splashing, but unlike the spillway, which is protected from freezing by the water flowing over it, the downstream face concrete is continually exposed and thus much more susceptible to freeze-thaw damage. SA observed water infiltrating the cracks in the core hole from Core #13. This indicates that water from behind the Dam may be infiltrating the extensive cracks in the gate structure, which may freeze leading to more severe deterioration.

Description: Downstream face of gate structure near right abutment.

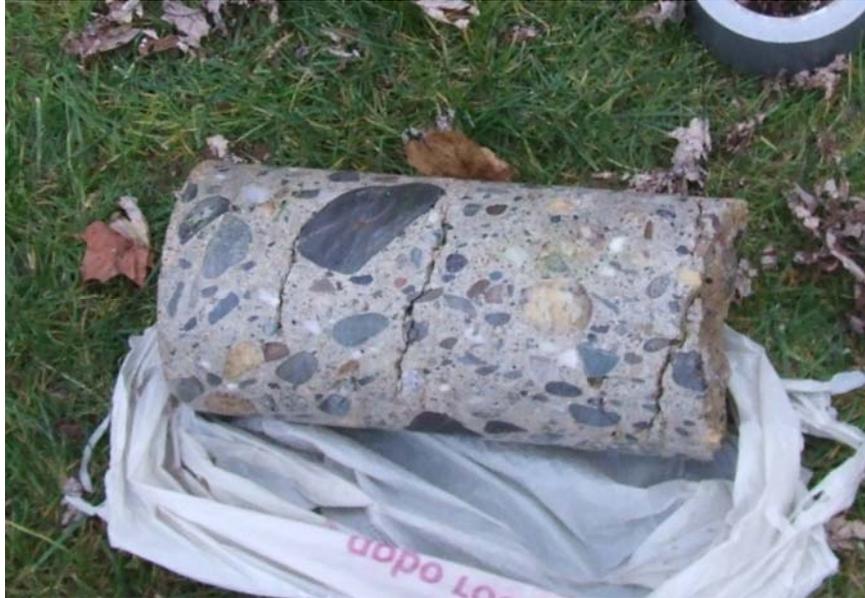
Photo Number: 25

Thin sections were made of Core #10, from the downstream face of the gate structure at the right abutment, for viewing with a petrographic microscope. Petrographic analysis revealed evidence of ASR and extensive cracking in both the aggregate and the cement paste. Multiple layers of ASR products indicate that the reaction has likely been active for a long time period.

Description: Core #10.

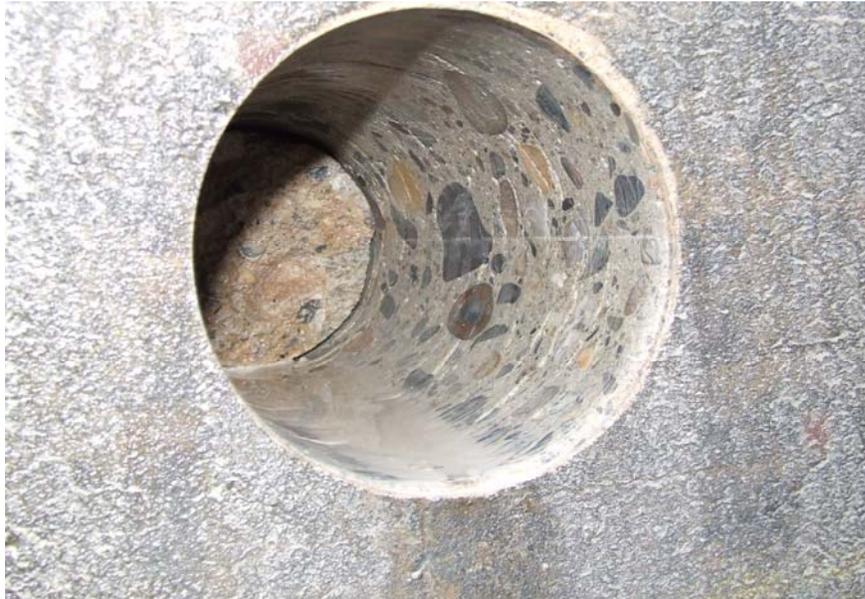
Photo Number: 26

Description: Cracking in core hole #10.

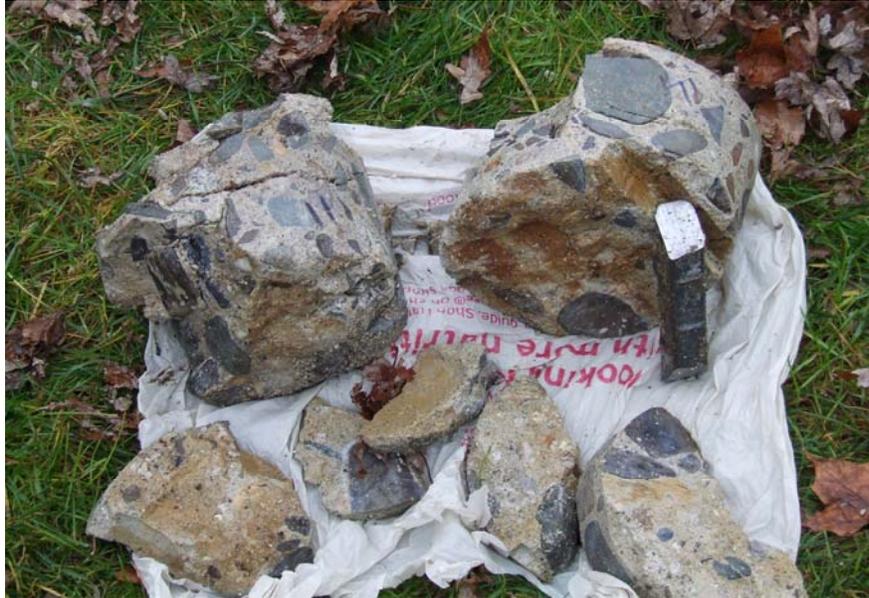
Photo Number: 27

Description: Core #11 pieces.

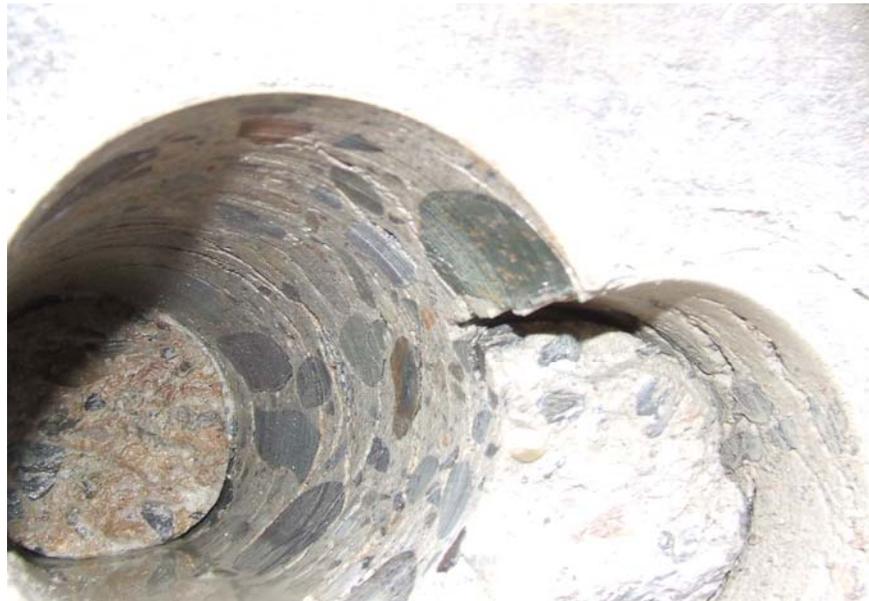
Photo Number: 28

Description: Cracking in core hole #11.

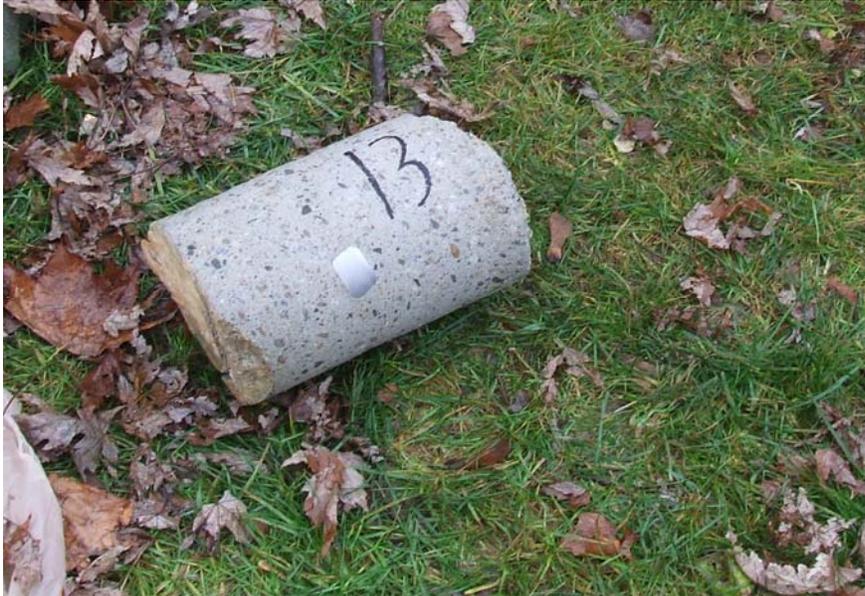
Photo Number: **29**

Description: Core #13.

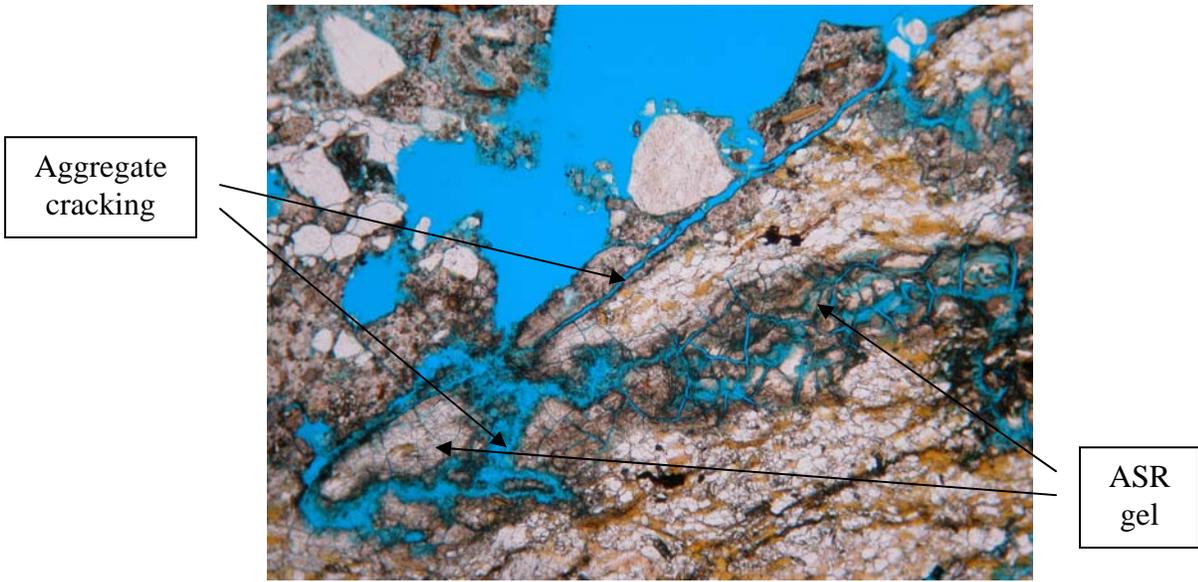
Figure 29 Core 13 vertical section showing ASR gel inside cracked granite coarse aggregate

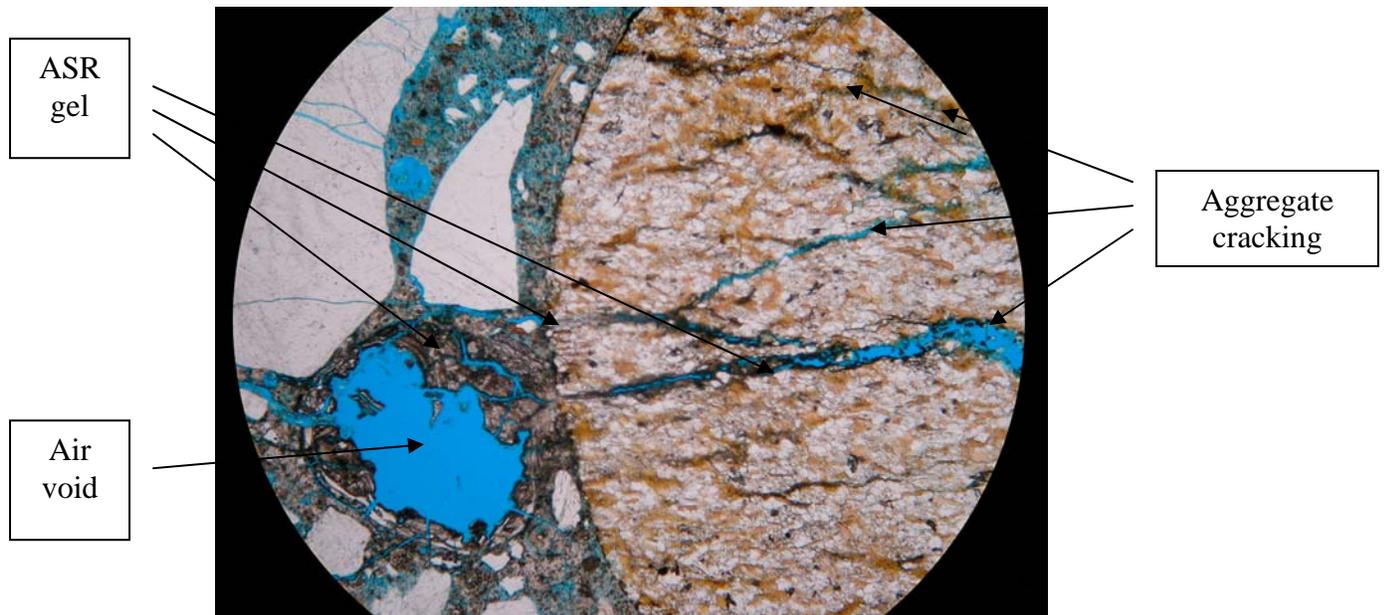
Figure 34 Core 13 vertical section showing aggregate cracking, ASR gel

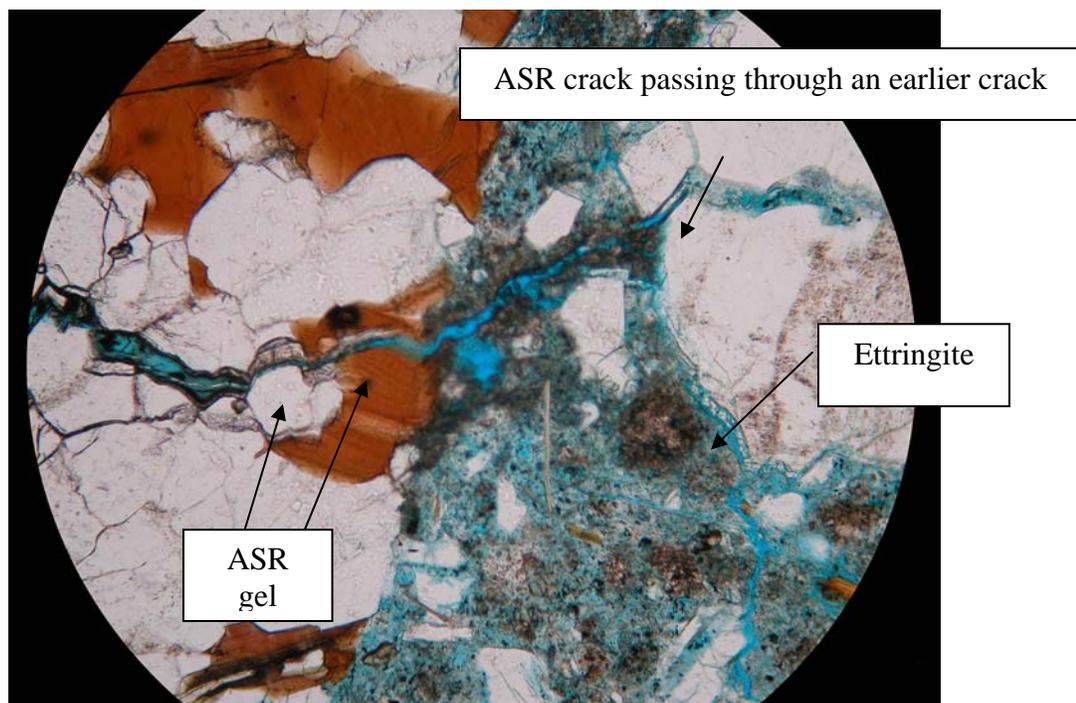
Figure 40 Core 13 horizontal section showing ASR and DEF in the same place

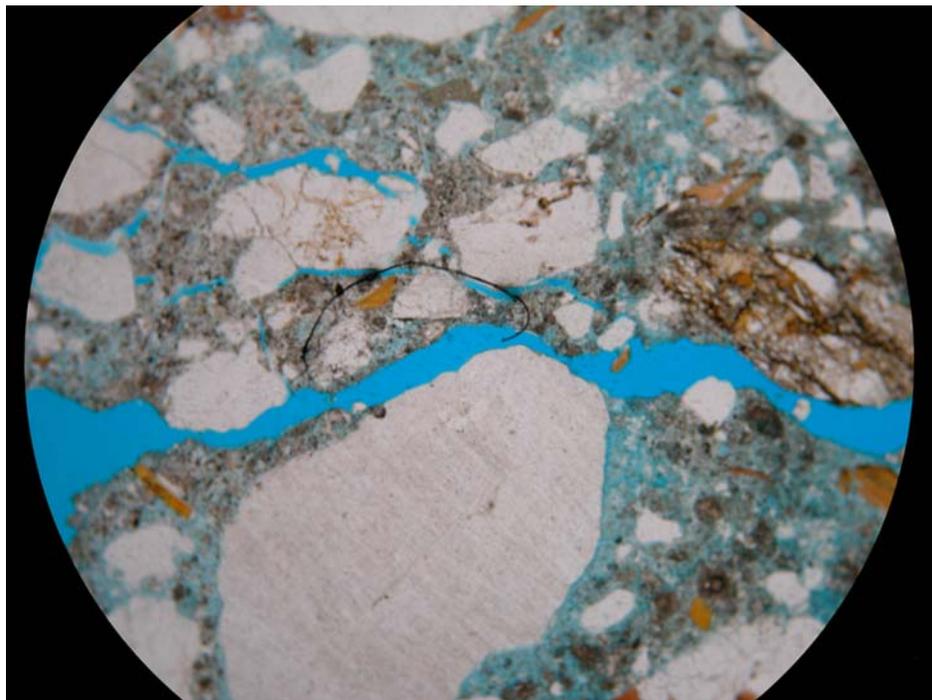
Figure 42 Core 13 horizontal section showing Typical crack pattern
