Evaluation of the Concrete of the Oyster River Durham Falls Dam Concrete

Final Report

Dr. David Gress Ph.D., P.E.

March 25, 2010

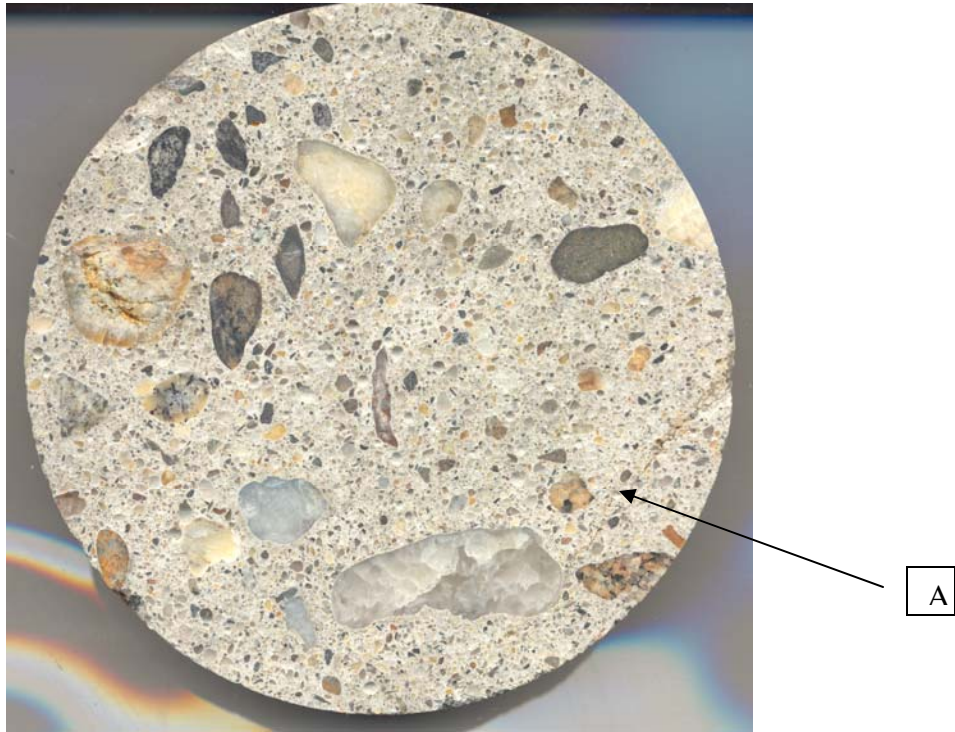
Selected cores were cut using a diamond blade then polished on a lapidary wheel using various grit sizes. Figure 1 shows the upper portion of the concrete from the 1974 rehabilitation. Cracking of the concrete is shown in a close up of section A in Figure 2. Micro cracks were apparent in Figure 3, the same sample as in Figure 1, after epoxy was applied with the Ultra Violet (UV) pigment. The surface was repolished to enhance the presence of cracks when viewed under UV light. These cracks are most likely due to Freeze Thaw damage.

Figure 1 Core # 1 polished surface of top

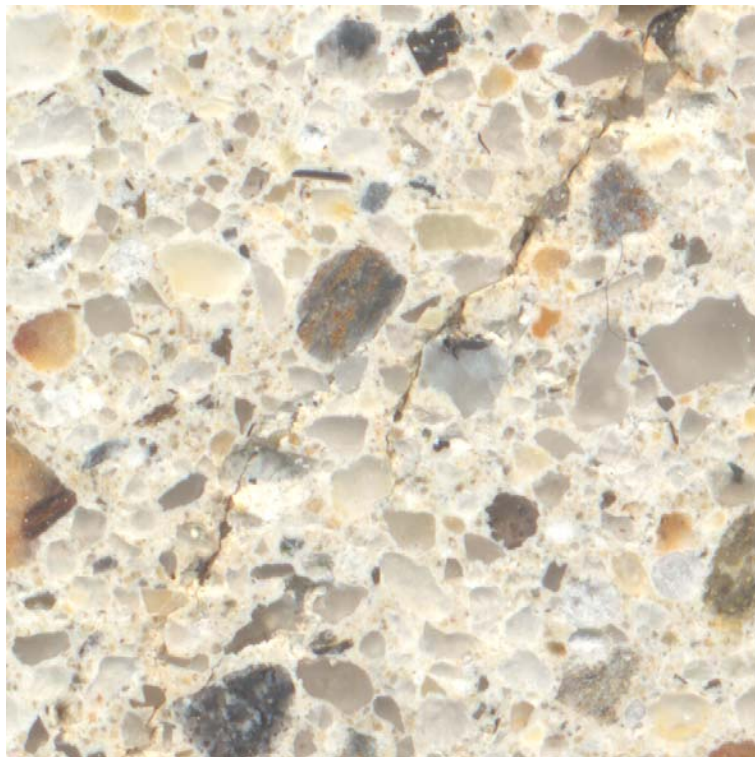
Figure 2 Section A close up of Figure 1 core #1

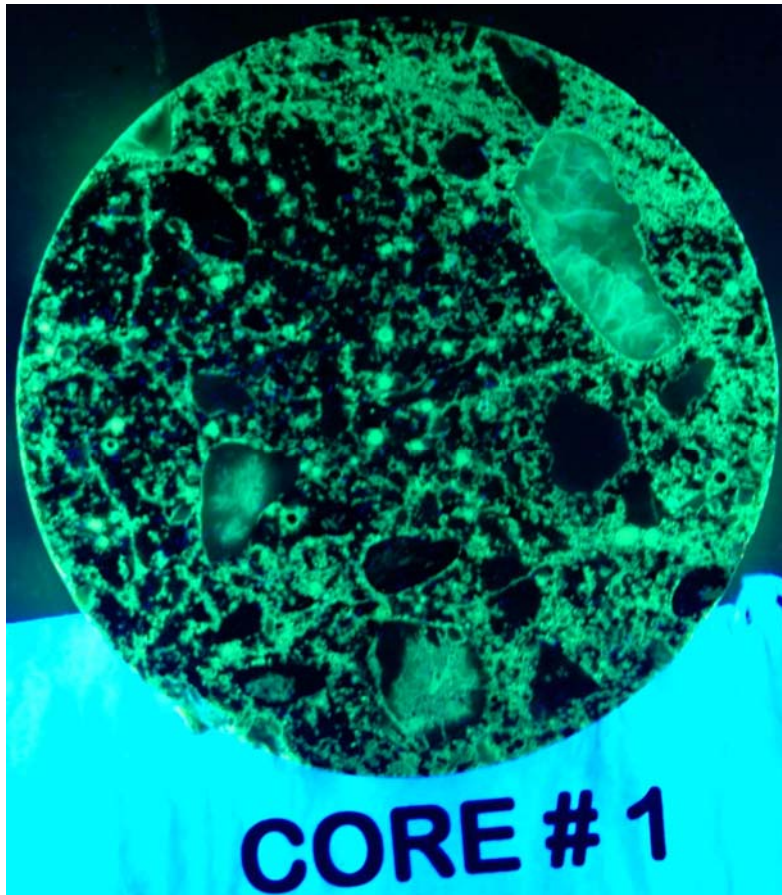
Figure 3 Core #1 polished and coated with impregnated epoxy under UV to enhance microcracks

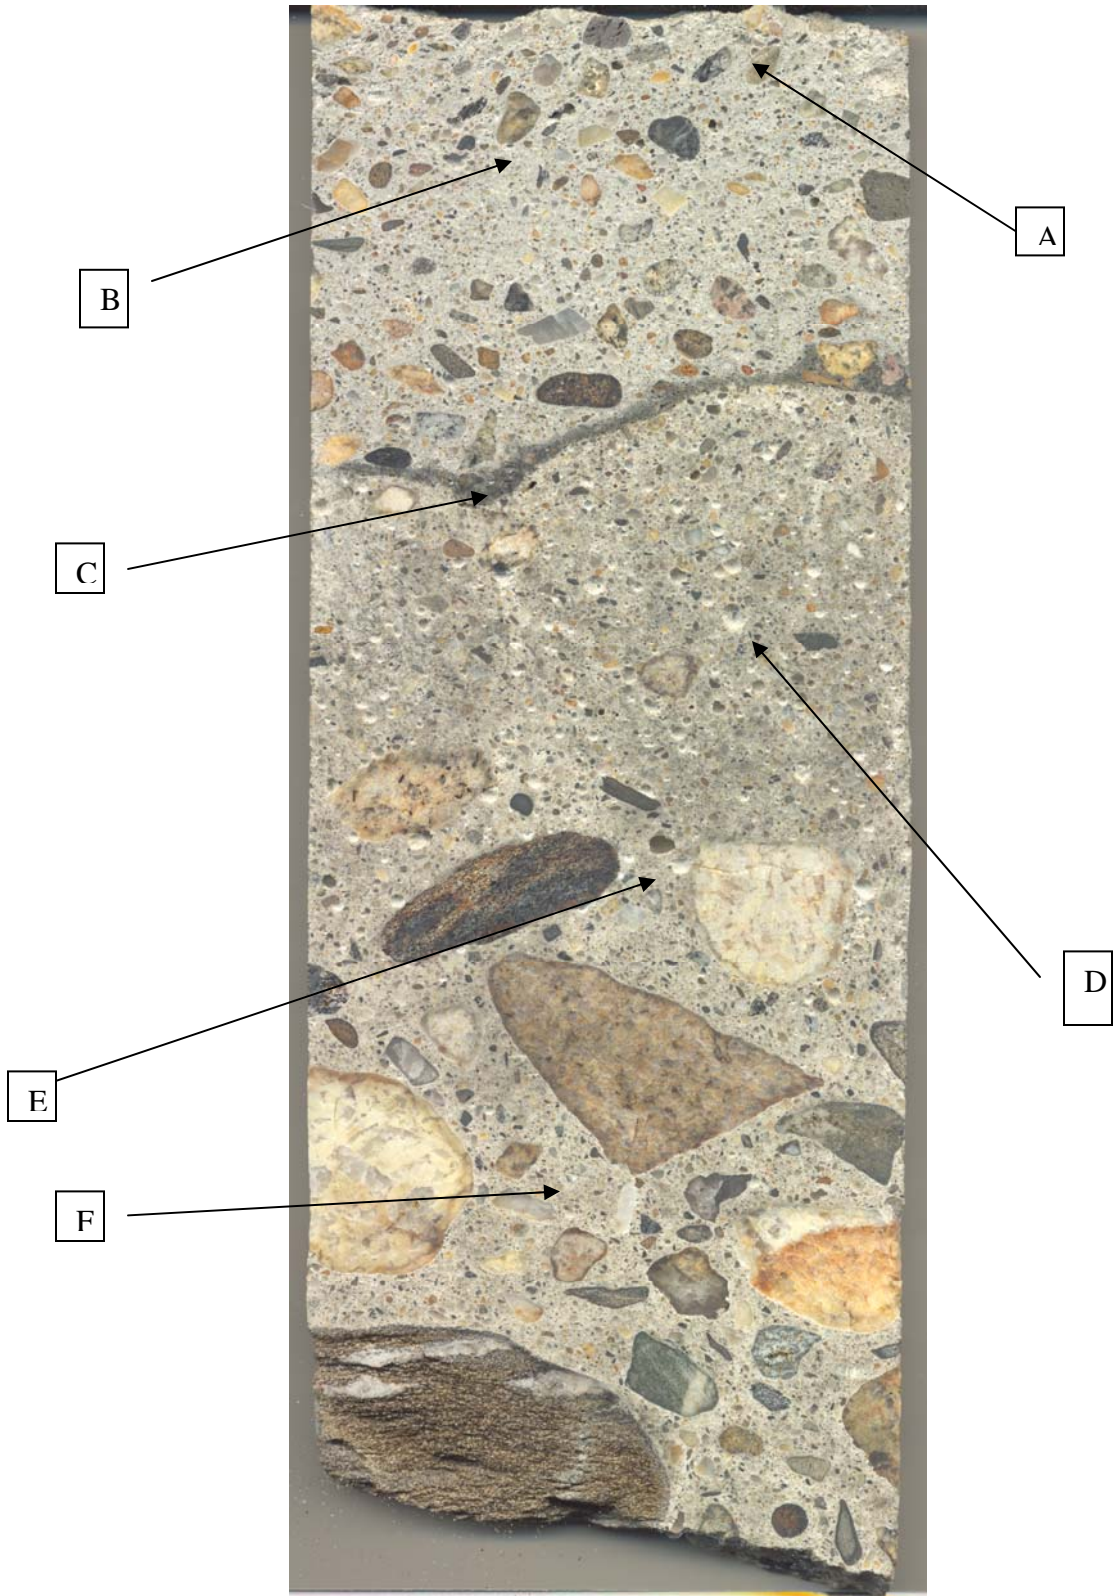
Figure 4 shows the concrete of the spillway crest obtained in core # 5. Sections B, C, D, and F show four different concretes. Section B is the 1974 repair concrete, C is a layer of mortar that was applied to achieve a bond between the old original concrete shown in section D and the new concrete in section B. The lower portion shown by section F contains very large aggregate and is well compacted compared to the concrete of section D which has little coarse aggregate and shows poor compaction. This concrete was apparently mixed on site and hand placed which would be the expected procedure in 1913. The original concrete as seen on the lower portion consists of a natural glacial gravel material most likely obtained in the near vicinity of the Dam. It contains various minerals mostly of igneous origin with a maximum aggregate size of approximately 2." Several of the large aggregate pieces consisted of a deteriorated granite that was so weak it came apart during the polishing process as noted by the small pieces of mica scattered throughout the concrete. Figure 5 shows a close up of section A which contains a crack, most likely from freeze thaw damage. It also contains several pores filled with a white powder deposit. Figure 6 shows a close up of the mortar applied to enhance the bond at the old and new

Figure 4 Core # 5 polished surface

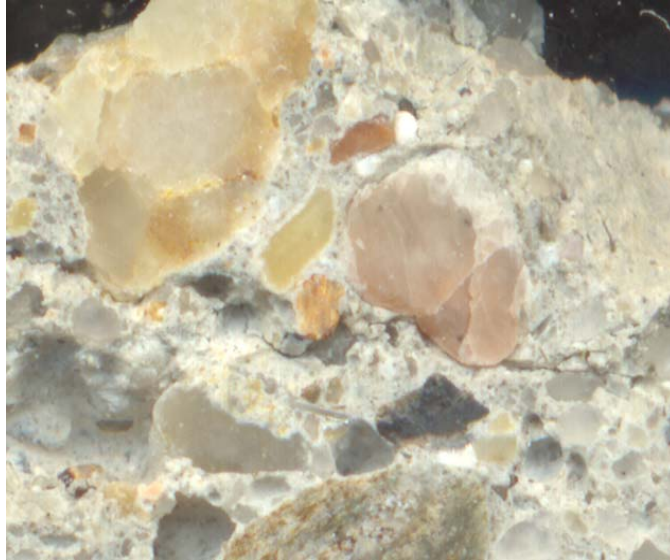
Figure 5 Section A close up of Figure 4 core #5

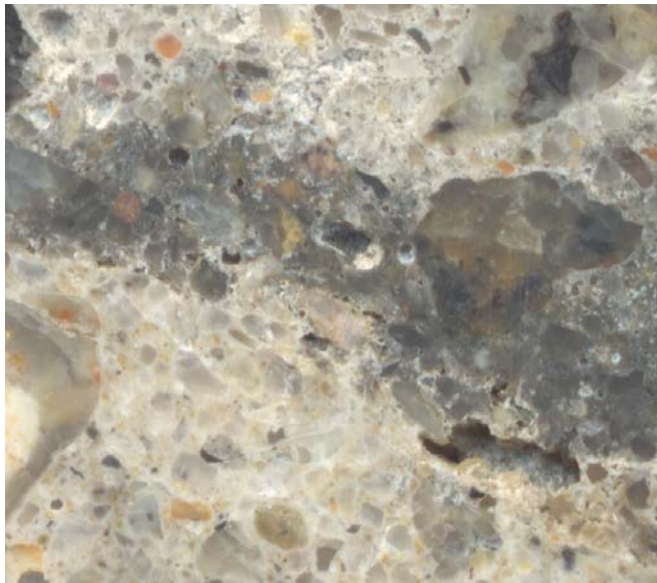
interface. This layer was poorly compacted as shown by the voids at the old interface as well as in the matrix of the layer. Several other voids containing the white powder are shown on the close up view of section E in Figure 7. These voids appear to be interconnected by a crack that initiated in the aggregate particle on the right side of figure 7.

Figure 6 Section C close up of Figure 4 core #5

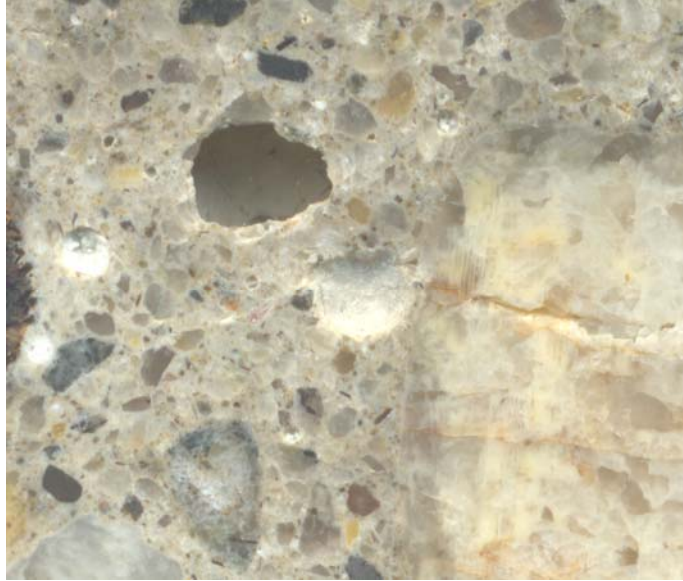
Figure 7 Section E close up of Figure 4 core #5

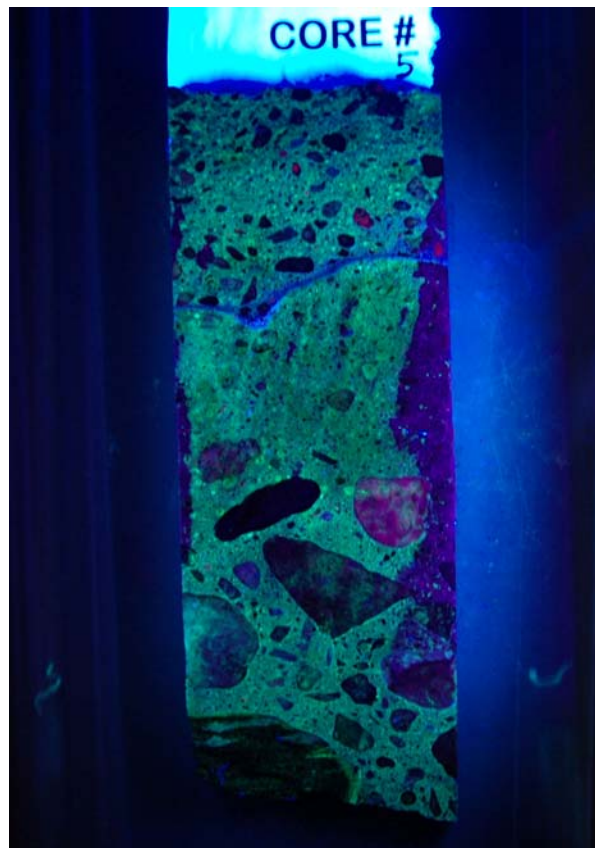
The polished section of Core #5 was coated with a low viscosity epoxy that was impregnated with an UV fluorescing pigment and repolished so as to visually enhance the micro cracks. Figure 8 shows the polished section coated with the epoxy under UV light. A view of the mid section of the epoxy coated Core #5 under UV light is shown in Figure 9. Micro cracks are visible within the aggregate as well as the paste matrix. Reaction rims are also emphasized by the dark areas on the on the edge of most of the aggregates.

Figure 8 Core 5 polished section coated with impregnated epoxy and viewed under UV

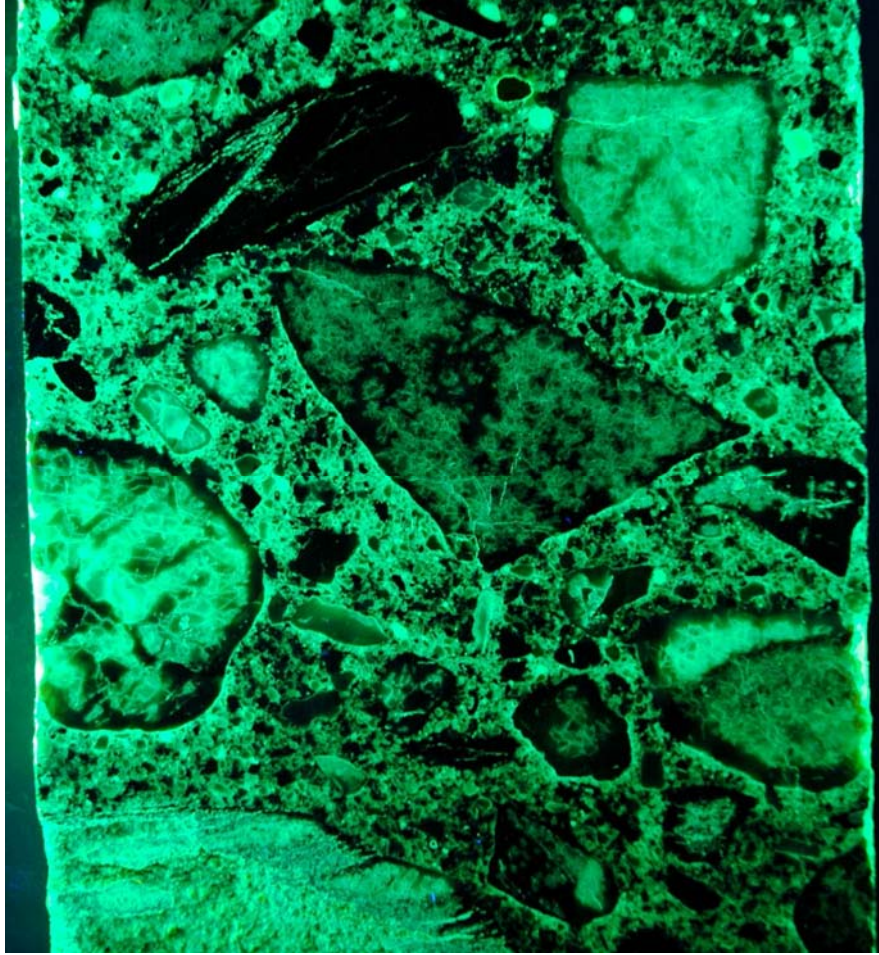
Figure 9 Core 5 polished mid section coated with impregnated epoxy under UV to emphasize micro cracks (see Figures 4, 7 and 8)

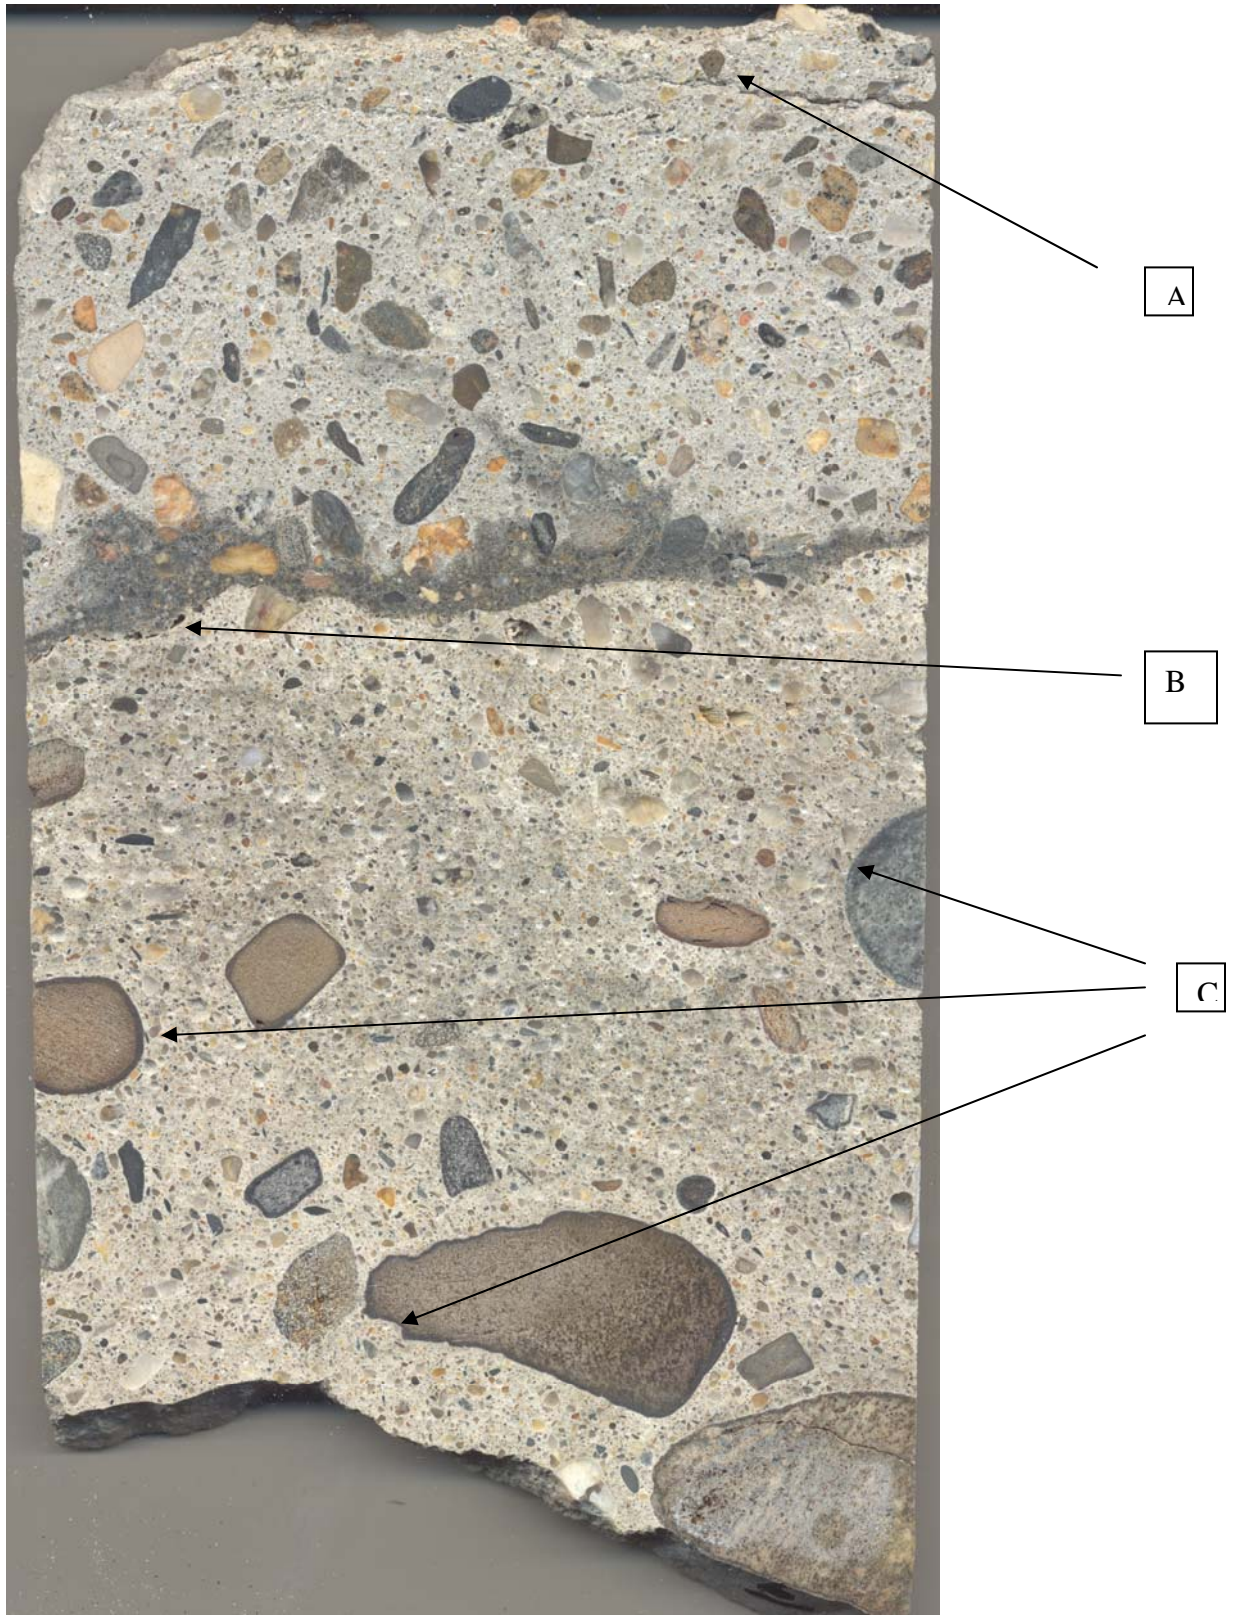
An overall view of the polished section of Core #6 is shown on Figure 10. This shows four different concretes the 1974 repair concrete, the interface mortar, a high entrapped air concrete with little aggregate, and the typical original described above. The surface concrete shows signs of freeze thaw damage as noted by the parallel cracks as shown in the close up view of section a in Figure 11. The mortar interface layer is poorly consolidated and is delaminating at the old concrete interface as shown by Figure 12. Aggregate internal cracking and matrix cracking are shown on the close up view of section C on Figure 13.

Figure 10 Core # 6 showing polished surface

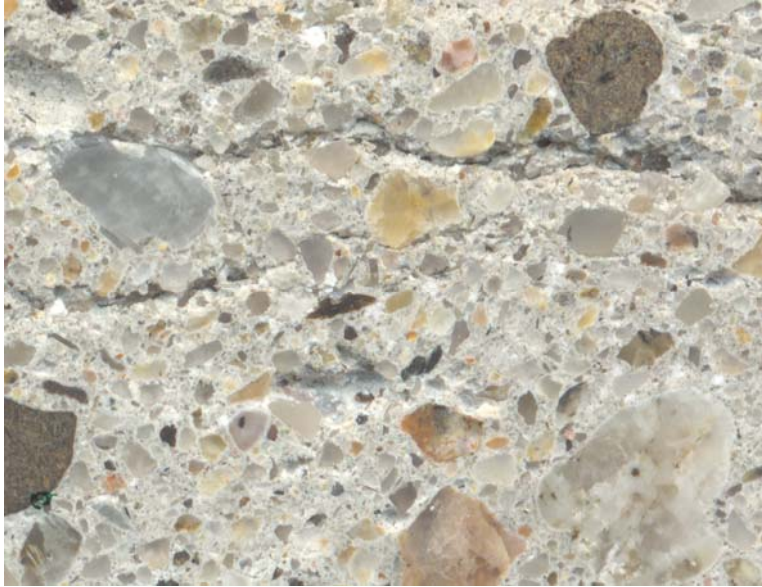
Figure 11 Section A of Figure 10 of Core # 6

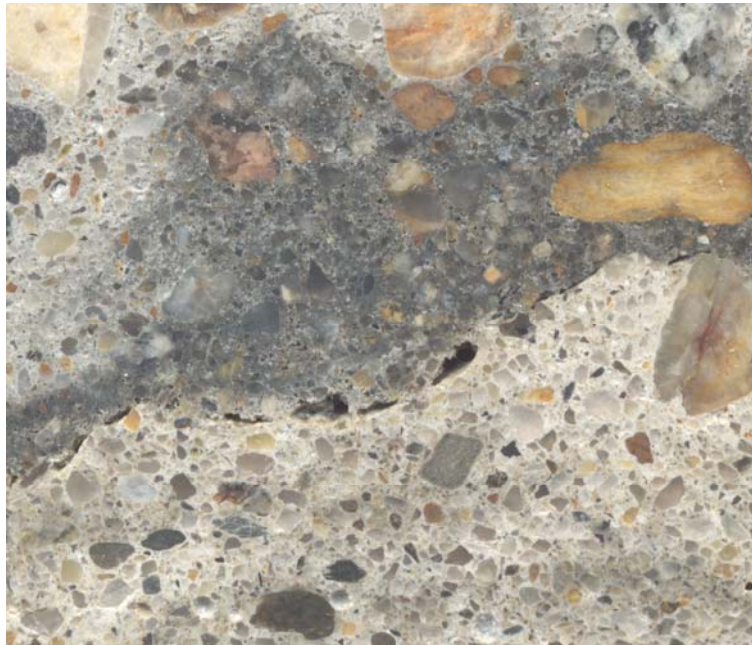
Figure 12 Section B of Figure 10 Core # 6

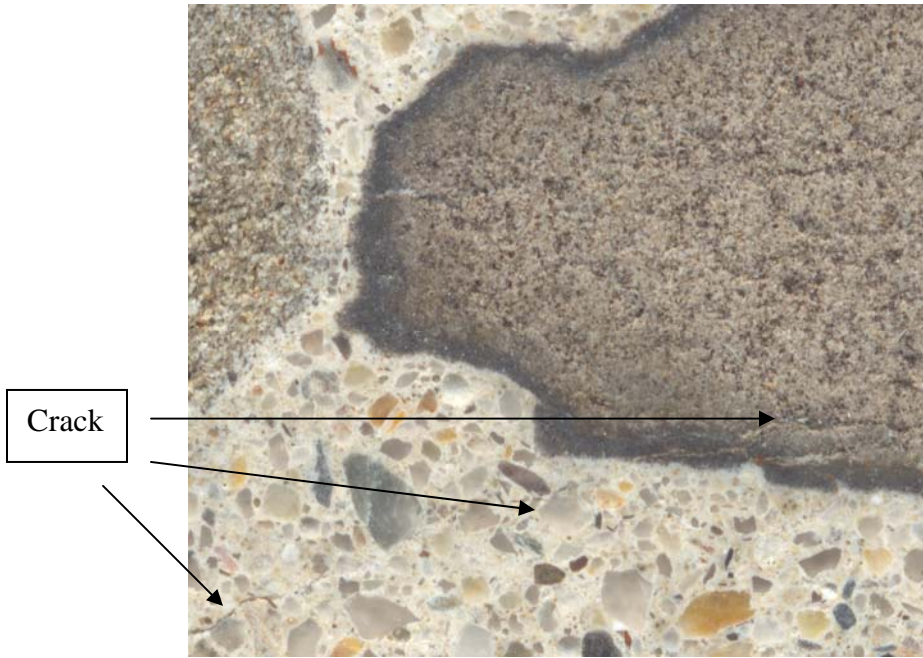
Figure 13 Section C of Figure 10 Core # 6

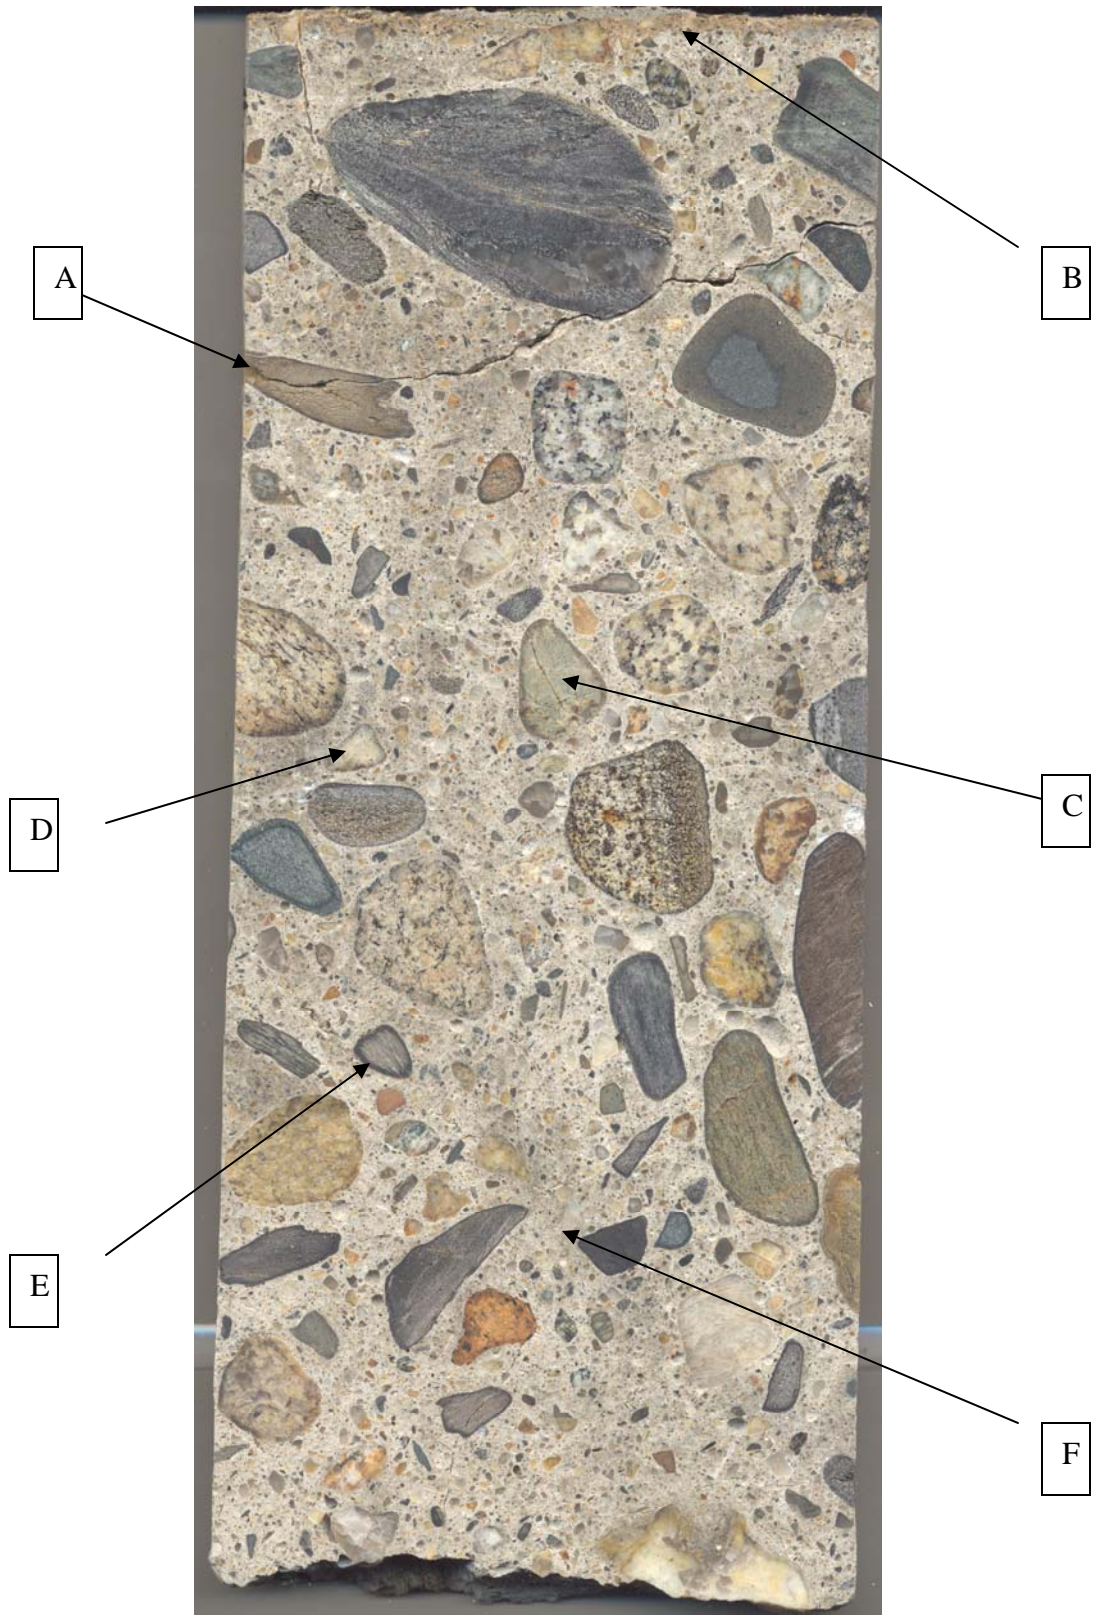
Core # 9 obtained horizontally from the rib is shown on Figure 14. This concrete appears more uniform because the core was taken horizontally. If the core was obtained vertically as the previous cores then it would be expected that several placements would be viewed showing variable mixes. Overall this concrete shows cracking and reaction rims as the previous original concrete. Figure 5 shows a close up of section A with cracking within the aggregate particle as well as around it. Figure 14 shows a crack radiating up towards the surface of the concrete originating from an aggregate particle that has expanded as shown in the close up view in Figure 16. Another aggregate particle that has expanded is shown in Figure 17, a close up view of section C. This aggregate is severely cracked due to internal expansion. Reaction rims are also visible on the outside surface of the aggregate. The aggregate particle of section D, shown in Figure 18 has micro cracks. The interface of the aggregate and the paste also shows cracking. The flat like dark line near the right top side of the aggregate particle is a sliver of mica. These small slivers are randomly dispersed throughout the concrete and most likely came from the very weak granite particles that degraded during the mixing and placement of the concrete. A severely cracked aggregate particle is shown in the close up view of section E in Figure 19. This aggregate particle also has a very dark reaction rim. An advanced crack matrix is shown in the close up view of section F of Figure 20.

Figure 14 Polished section of Core # 9

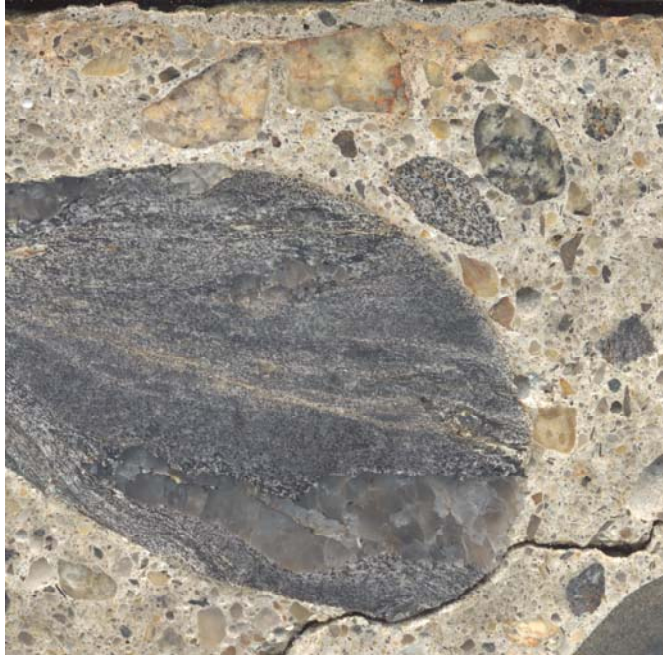
Figure 15 Section A close up of Figure 14 Core #9

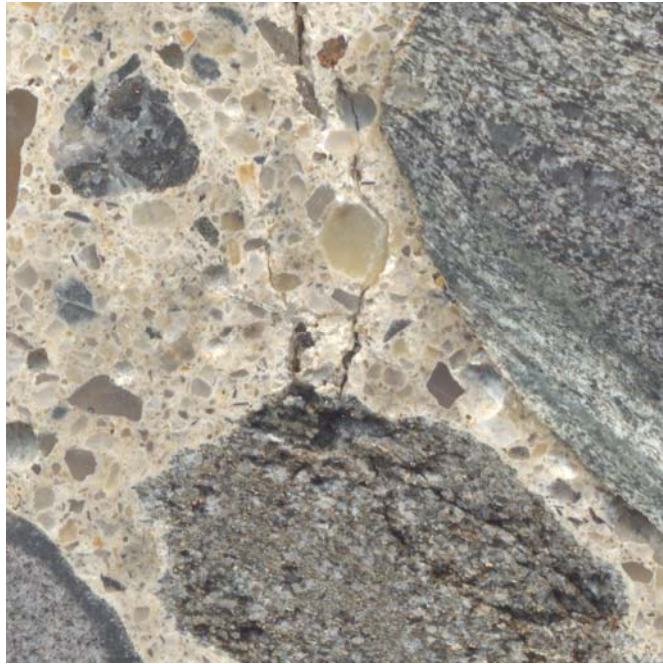
Figure 16 Section B close up of Figure 14 core #9

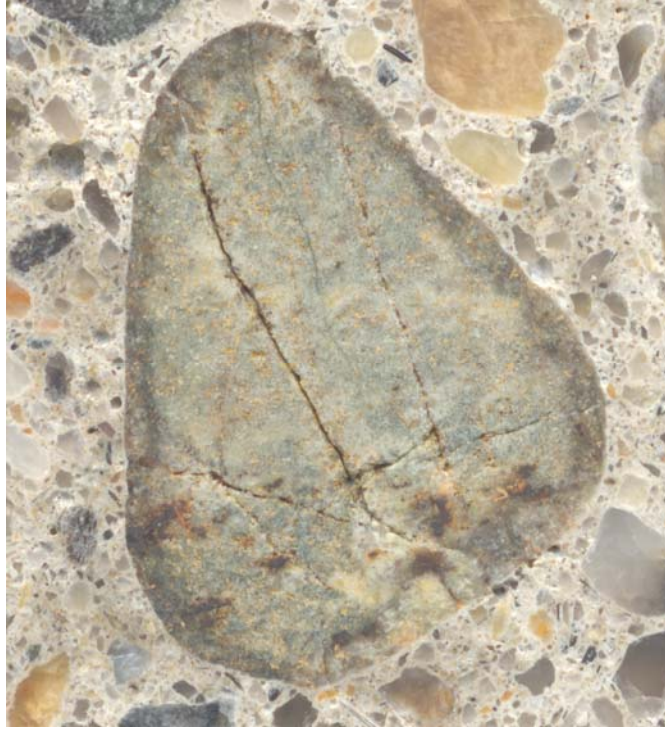
Figure 17 Section C close up of Figure 14 core #9

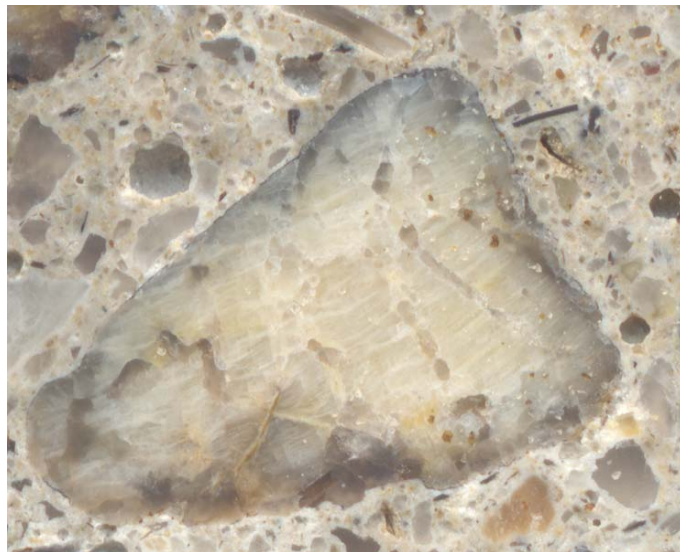
Figure 18 Section D close up of Figure 14 core #9

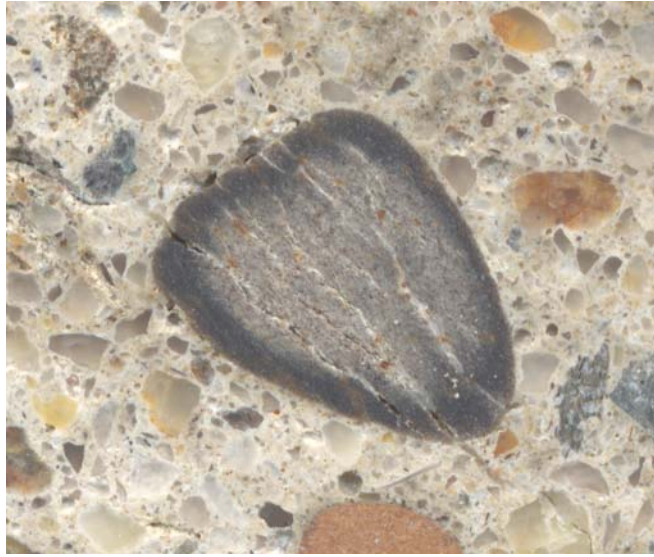
Figure 19 Section E close up of Figure 14 core #9

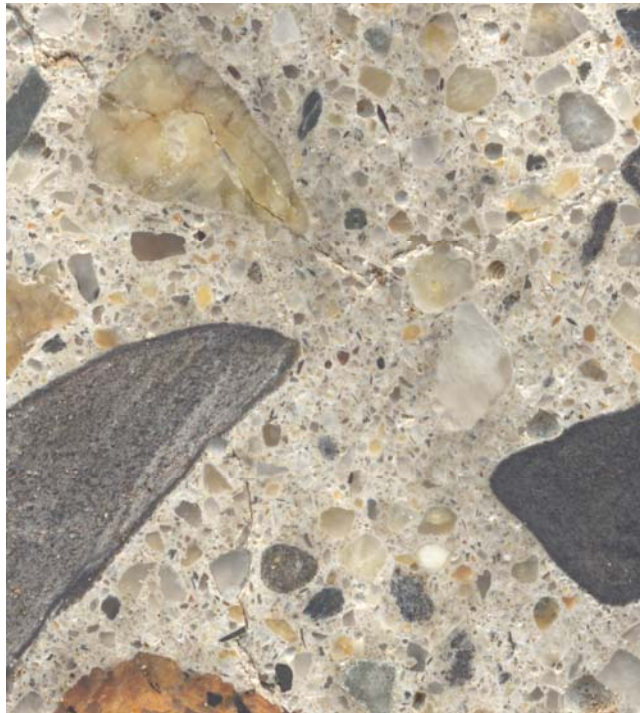
Figure 20 Section F close up of Figure 14 core #9

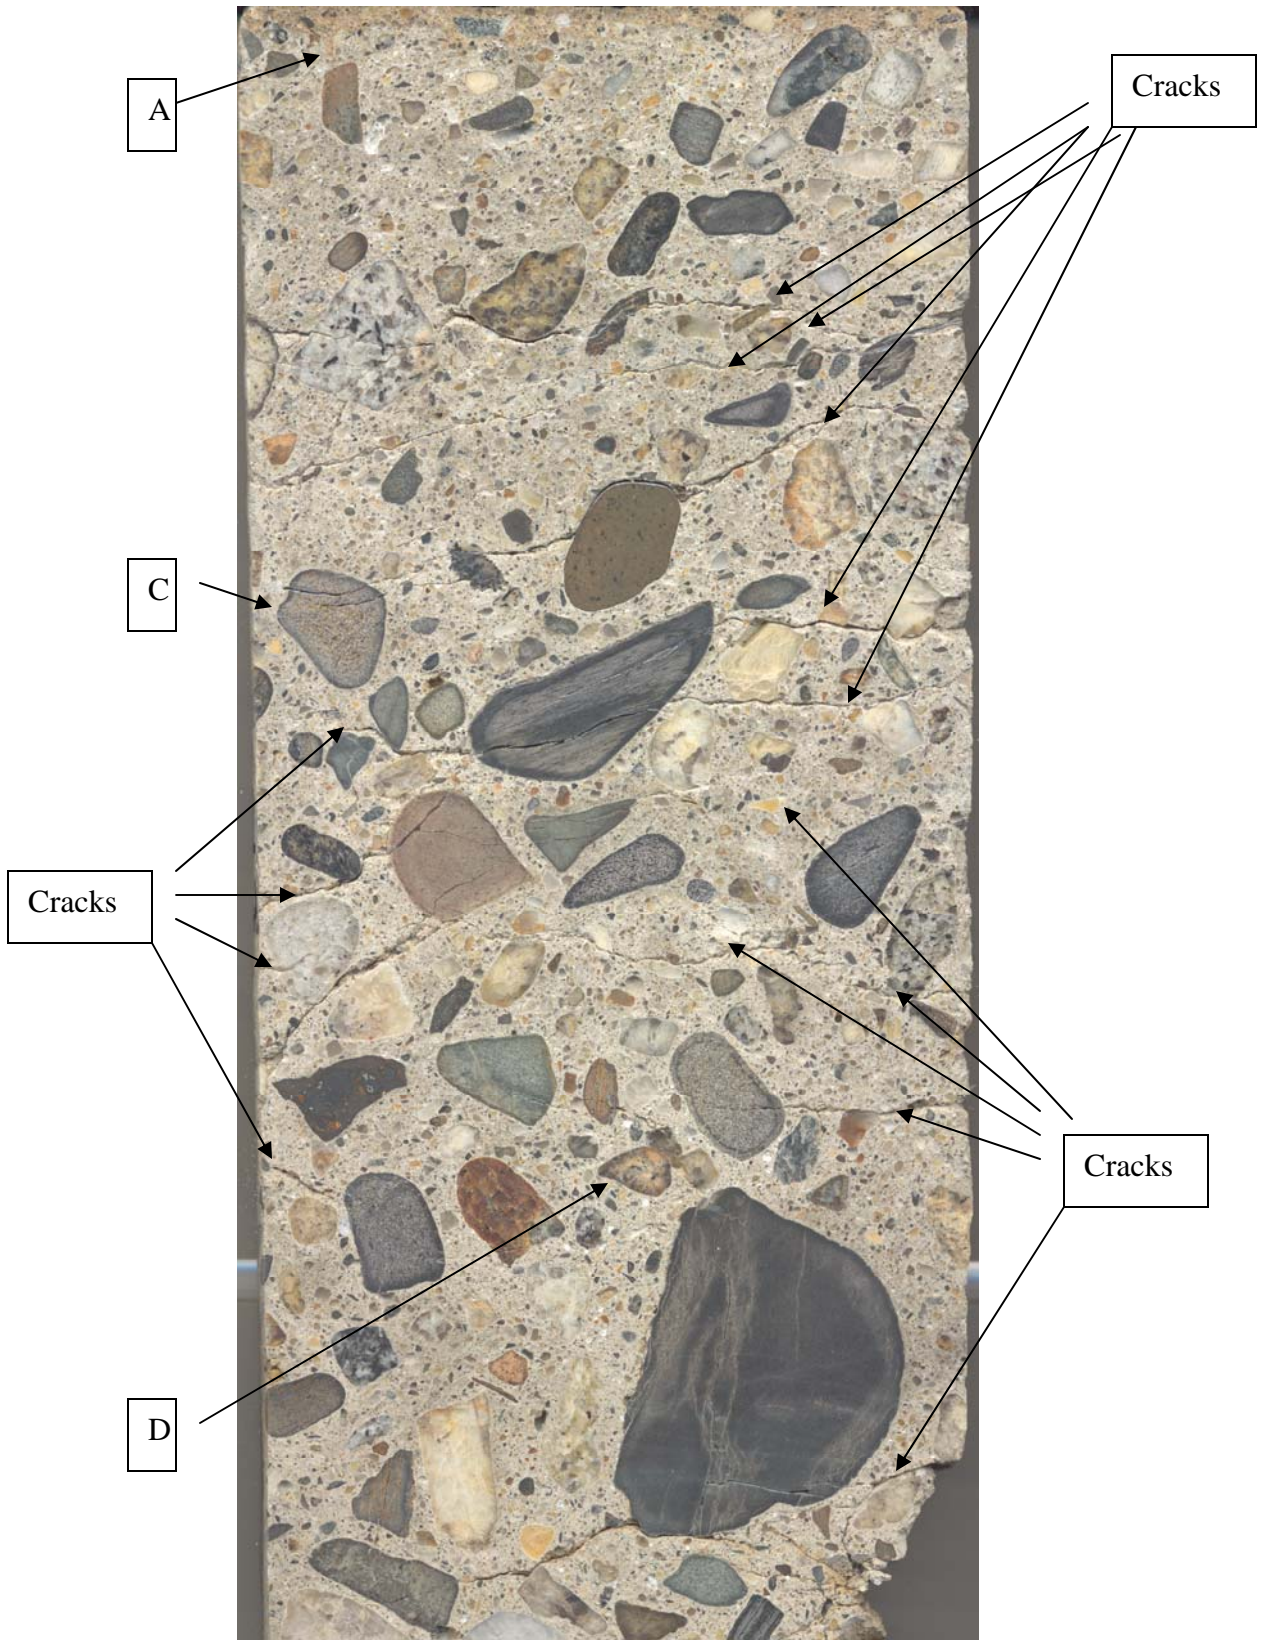
The polished sample of Core # 12 taken from the downstream face of the right abutment is shown on Figure 21. Many of the aggregate particles have reaction rims as noted in the previous polished sections. Section A shows a highly carbonated area with significant cracking. The polished sample shows massive cracking as noted by the arrows radiating from box B. Extreme swelling of the aggregate is noted by the large gap shown in the aggregate particle in the close up of section C in Figure 23. The area of paste to the left of the particle shows a very large crack, the same width as the aggregate crack, which has filled in with a reaction product. Cracking through and around aggregate particles is shown in the close up view of section D in

Figure 21 Polished surface of core #12

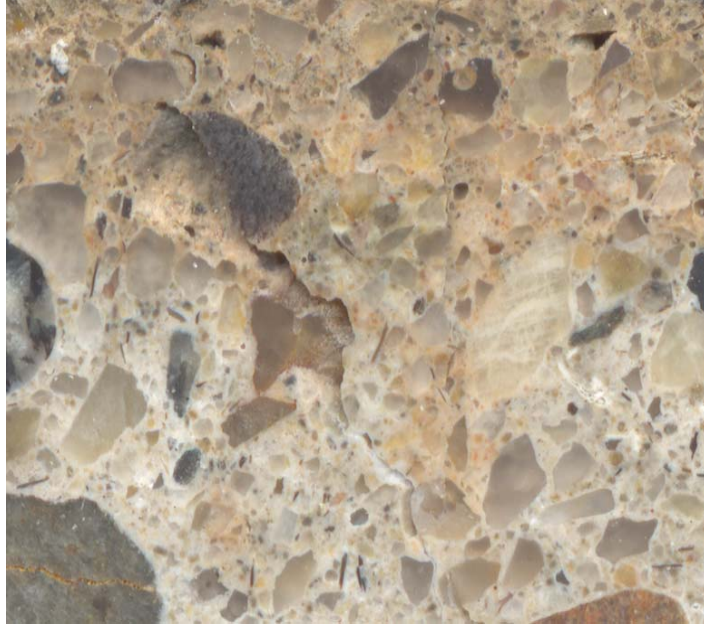
Figure 22 Section A of Figure 21 core #12

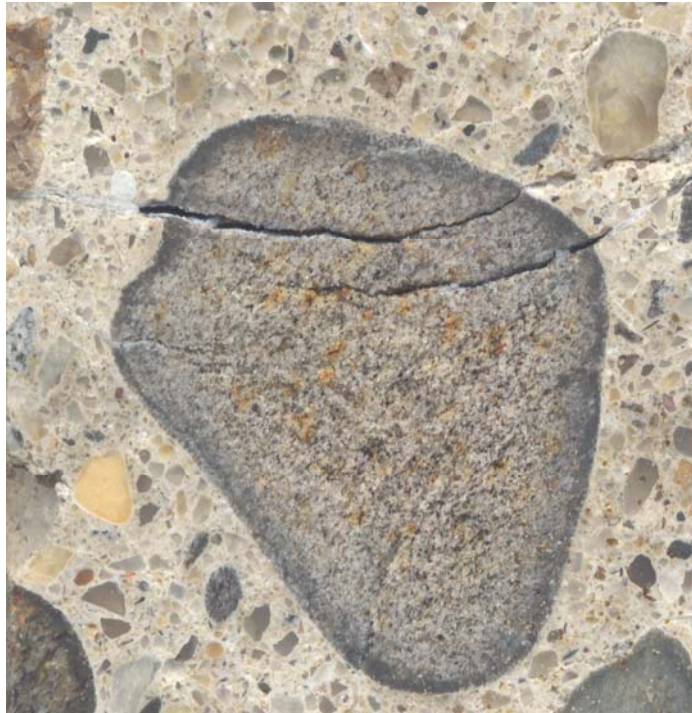
Figure 23 Section C of Figure 21 core #12

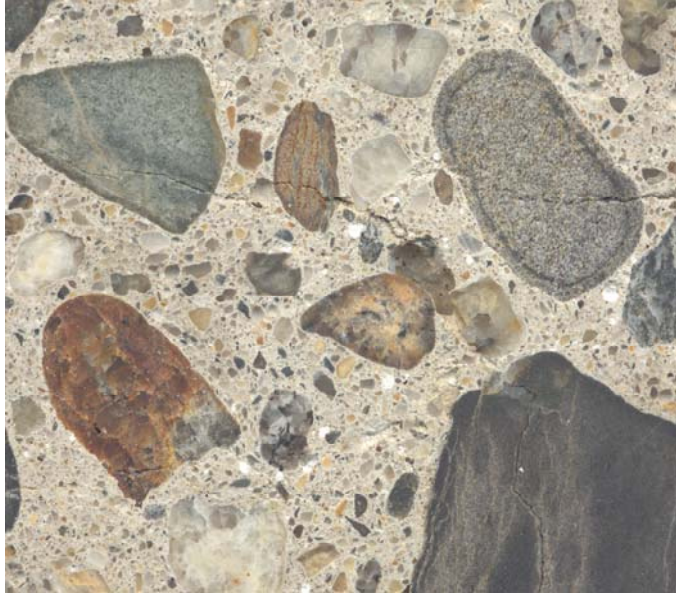
Figure 24. Several aggregate particles in this view also show reaction rims. This concrete has undergone significant expansion.

Figure 24 Section D of Figure 21 core #12

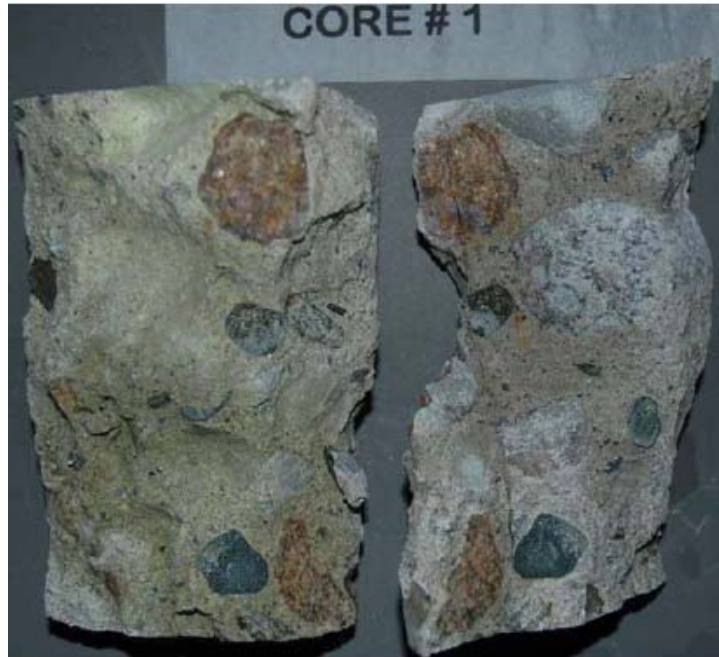
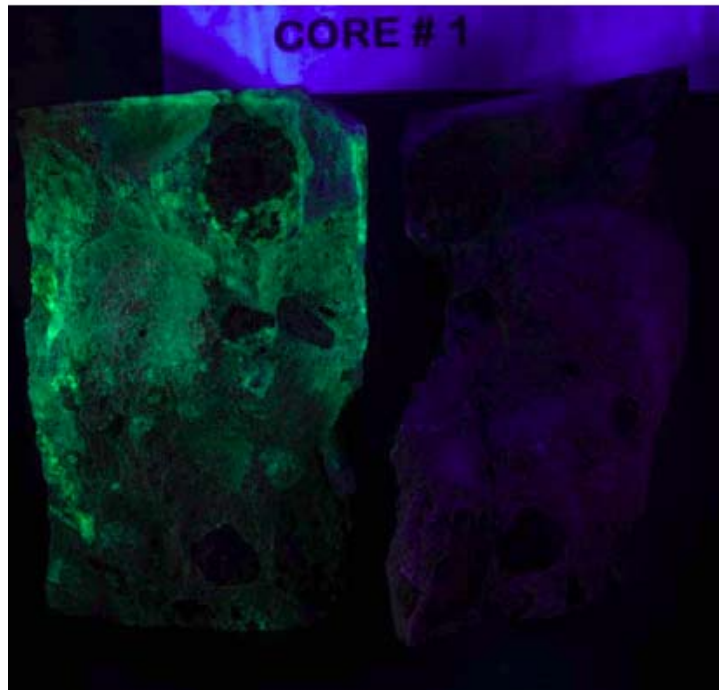
Core # 1 shown in Figure 25 definitely has signs of ASR as noted by the greenish glow under the UV light source. The concrete placed during the 1974 rehabilitation is shown in Figure 26 and 27. Although not significant, several of the aggregate particles definitely show signs of ASR in the repair concrete. The original concrete definitely shows significant signs of ASR as noted by Core # 8 of Figure 28.

Figure 25 Core #1 compression sample treated with Uranyl acetate dihydrate (left side) under normal light (top) and ultra violet light (bottom)

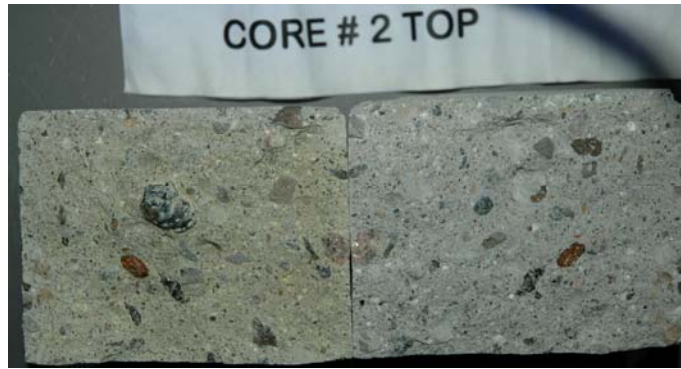
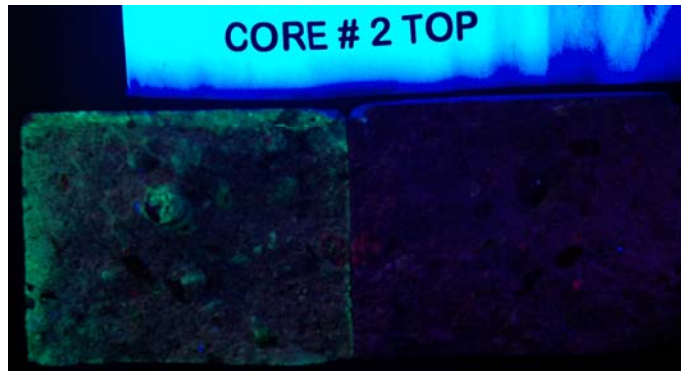
Figure 26 Core #2 tensile sample treated with Uranyl acetate dihydrate (left side) under normal light (top) and ultra violet light (bottom)

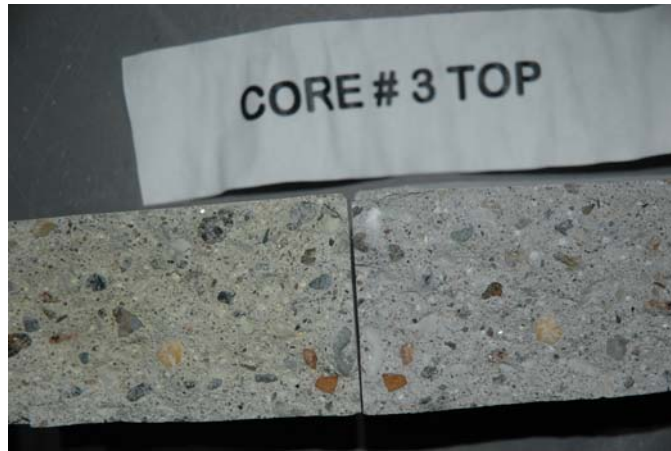
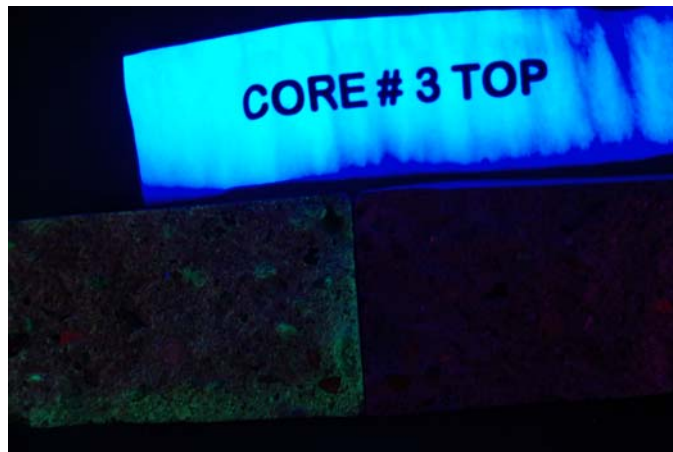
Figure 27 Core #3 Top tensile sample treated with Uranyl acetate dihydrate (left side) under normal light (top) and ultra violet light (bottom)

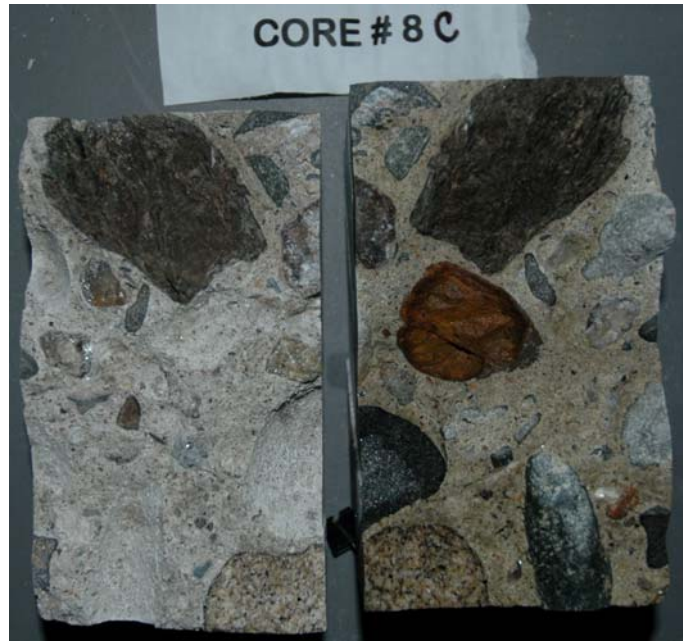
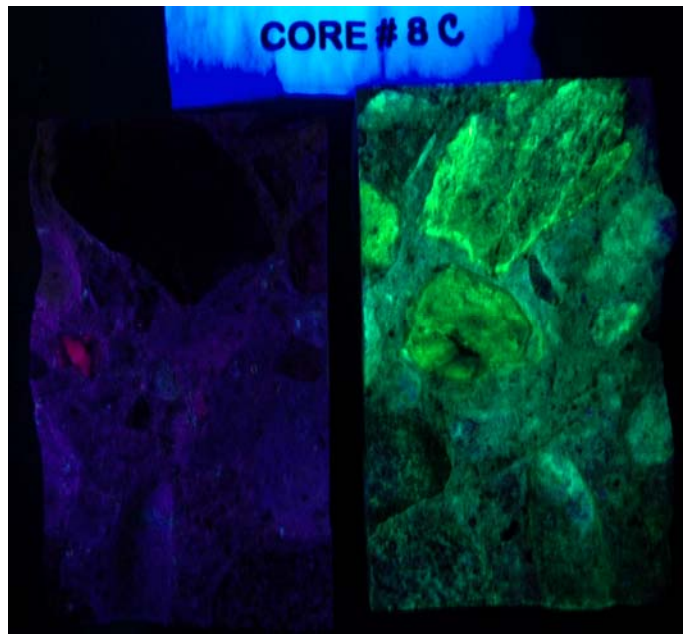
Figure 28 Core # 8C tensile sample treated with Uranyl acetate dihydrate (right side) under normal light (top) and ultra violet light (bottom)
