Evaluation of the Concrete of the Oyster River Durham Falls Dam Concrete

Final Report

Dr. David Gress Ph.D., P.E.

March 25, 2010

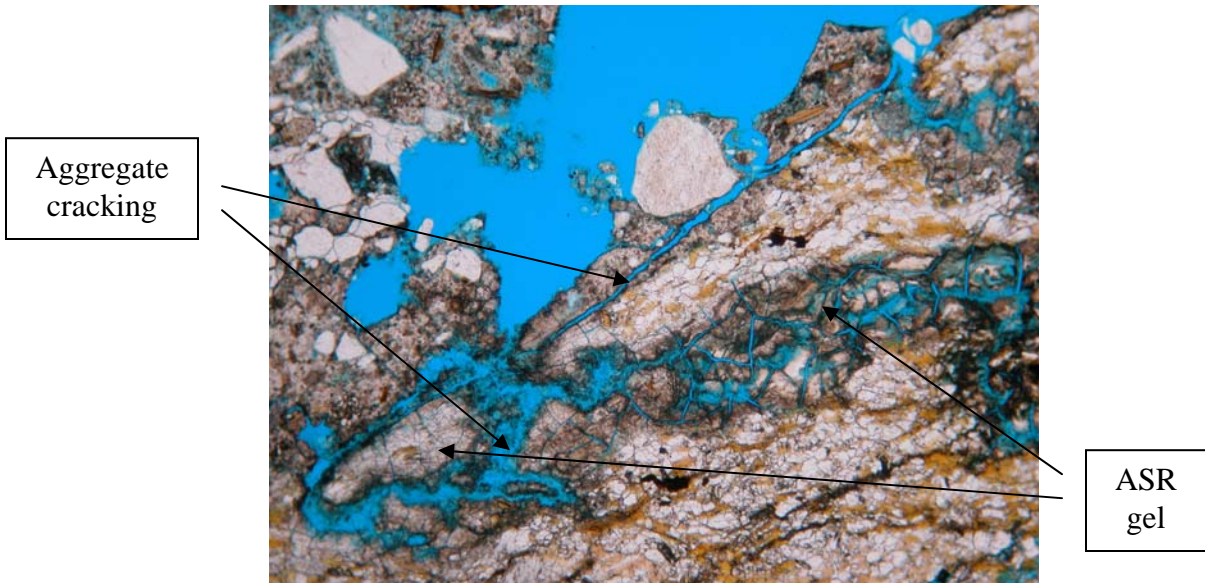
Figure 29 through Figure 36 are from the vertical section and Figure 37 through Figure 45 are from the horizontal section. Extensive aggregate cracking and deposits of ASR gel are shown on Figure 29. The blue color is from a dye used to emphasize voids and cracks that are empty. When the light source is changed from normal to polarized it is referred to as crossed nicols, this allow for the identification of various crystalline and amorphous materials. For example, Figure 30 shows a dark substance that is amorphous ASR gel by using polarized light. Layered ASR gel is shown in Figure 31. The same view under polarized light shows various layers of crystalline and amorphous ASR gel. The ASR reaction has been active for a long time period as shown by the multiple layers. Figure 33 shows the same area as figures 31 and 32 but under lower magnification. Extreme cracking is noted in the aggregate in Figure 34. The silica from the aggregate combines with alkali and calcium to make the ASR gel as shown deposited in the air void. Ettringite, a mineral with composition $(\text{CaO})_3(\text{Al}_2\text{O}_3)(\text{CaSO}_4)_3 \cdot 32 \text{H}_2\text{O}$ is produced naturally within portland cement during initial hydration. When a portland cement system becomes compromised by excessive cracking the Ettringite moves around and is redeposited.

Figure 29 Core 13 vertical section showing ASR gel inside cracked granite coarse aggregate

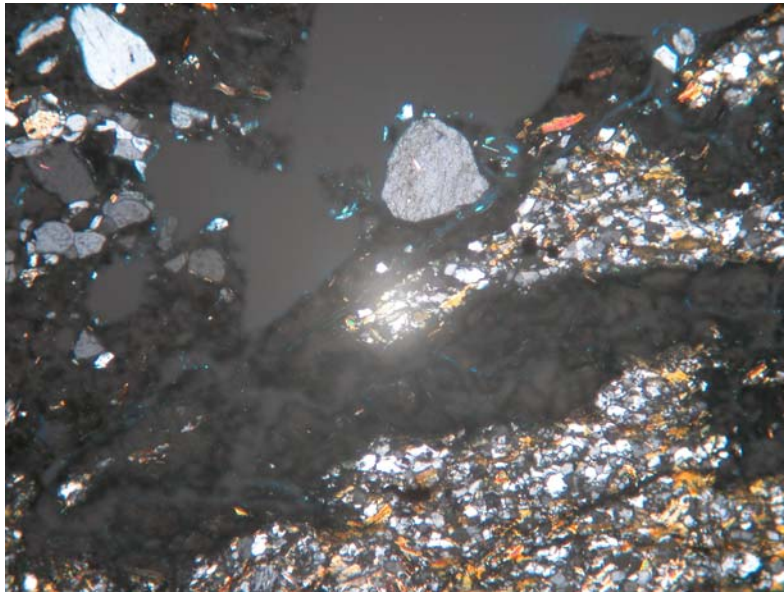
Figure 30 Core 13 vertical section showing amorphous gel (dark portion)

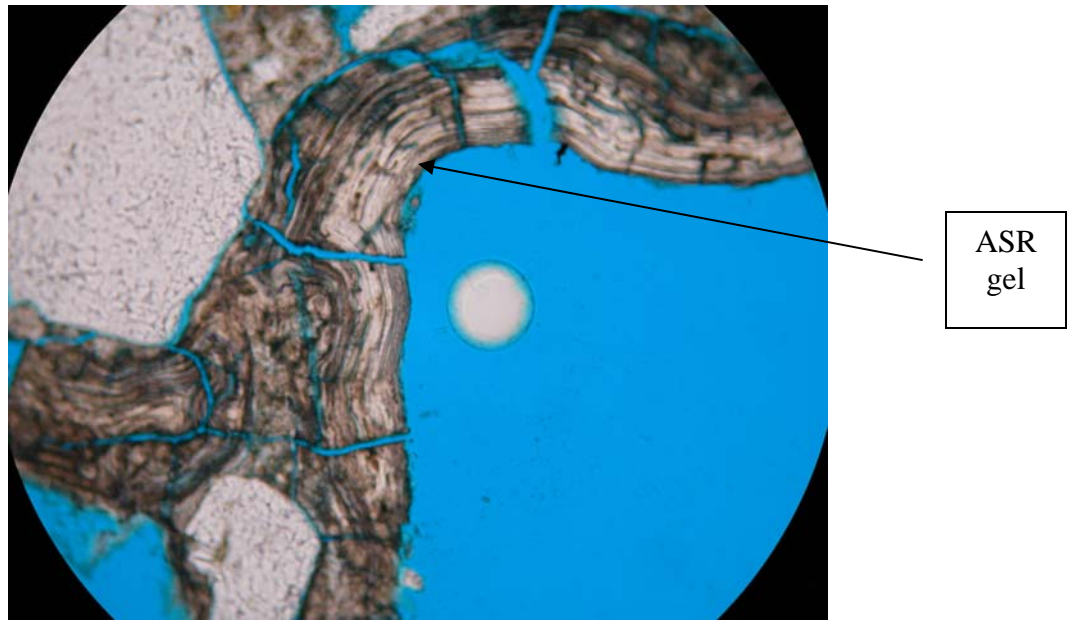
Figure 31 Core 13 vertical section showing layered ASR gel at the edges of a crack

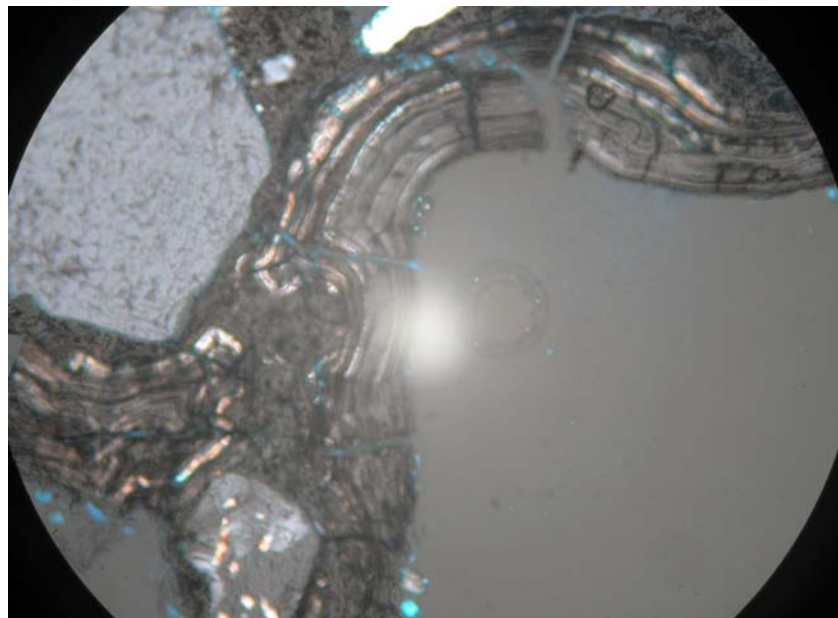
Figure 32 Core 13 vertical section showing the alternate layers of crystalline (colored portion) and non-crystalline gel (dark colored) under crossed polarized light (see Figure 31)

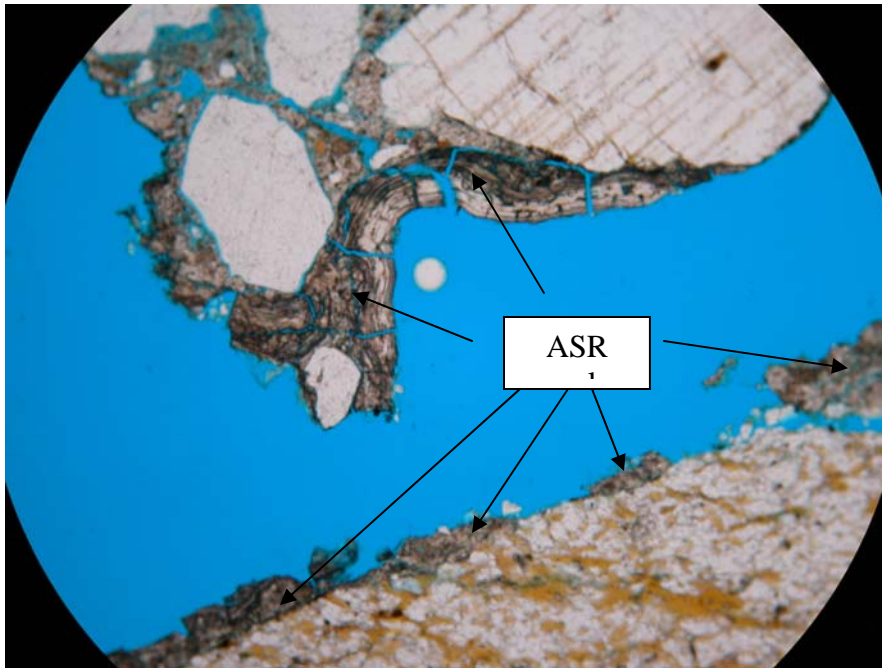
Figure 33 Core 13 vertical section showing a lower magnification view of Figure 31 and 32

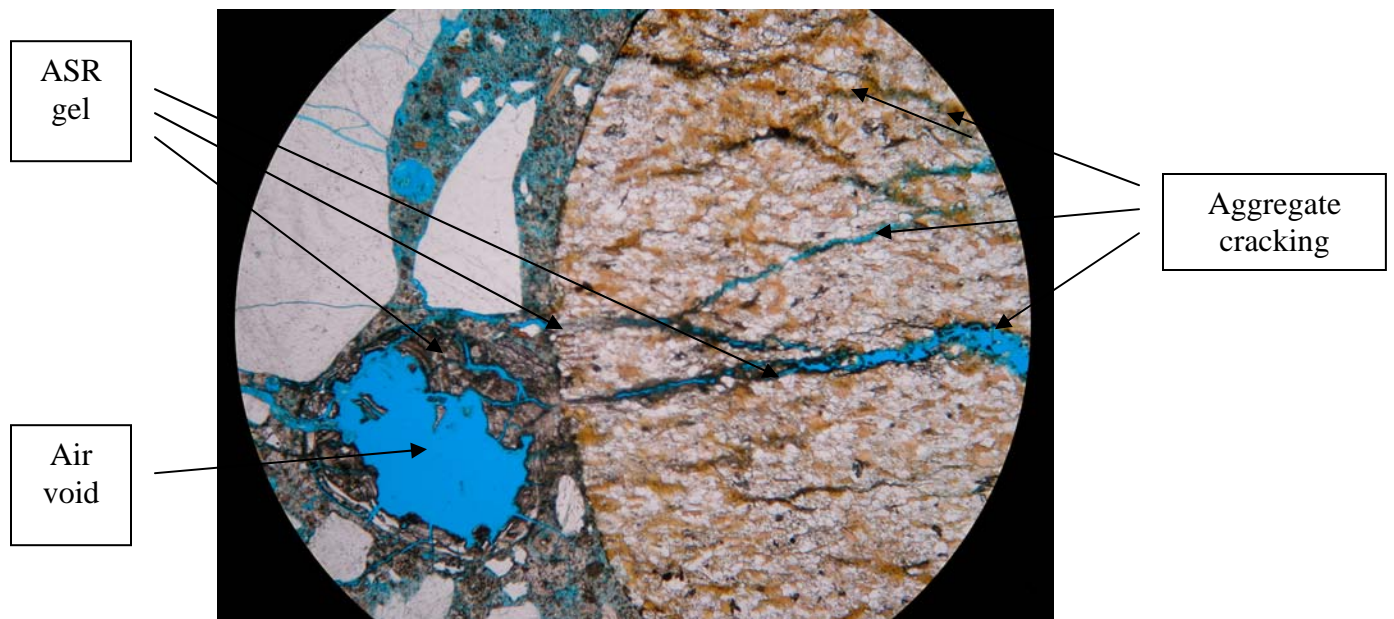
Figure 34 Core 13 vertical section showing aggregate cracking, ASR gel

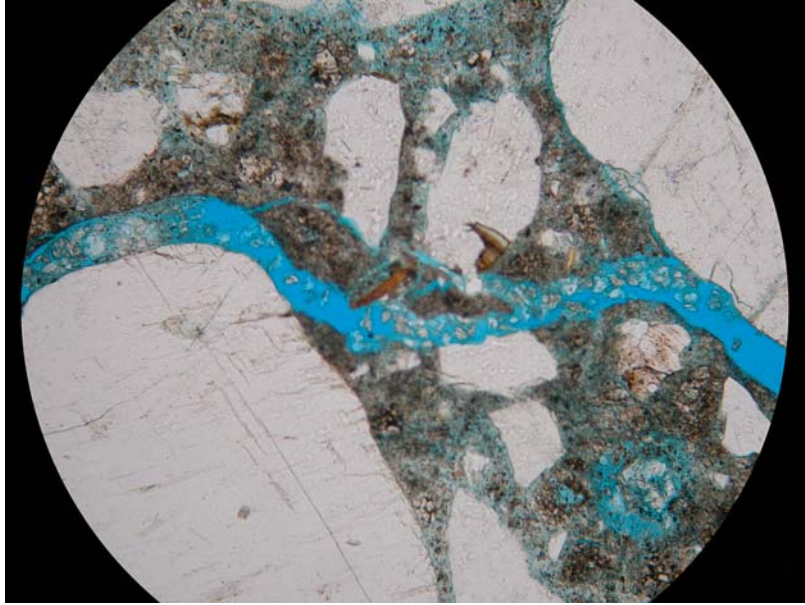
This is referred to as secondary Ettringite. Such is shown by Figures 35 through 38 where the secondary Ettringite has deposited within a crack at the aggregate paste interface. Figure 39 shows cracking through a granite particle due to ASR. Deposits of Ettringite are also indicated on Figure 39, 40 and 41. The crack shown in Figure 41 with the ASR gel gives a good indication of the destructive impact that the reaction has had on the dimensional stability of the concrete. This concrete has definitely expanded and in the process it has undergone excessive cracking as indicated by Figure 42 and 43. Some of these cracks could be associated with freezing and thawing damage. Once a concrete opens up from cracking it becomes vulnerable to other distress mechanisms.

Figure 35 Core 13 vertical section showing Ettringite along the crack at the aggregate-paste interfaces

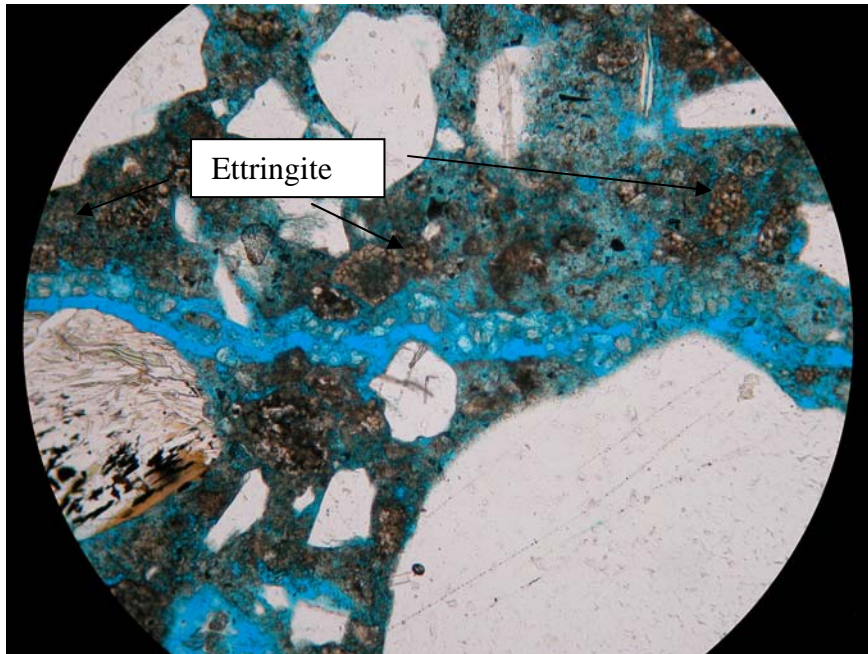
Figure 36 Core 13 horizontal section showing secondary ettringite

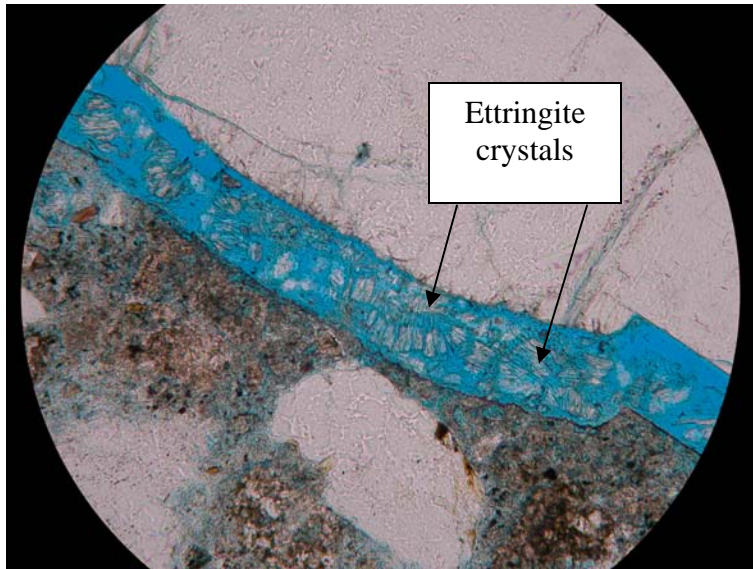
Figure 37 Core 13 horizontal section showing enlarged view of Figure 36

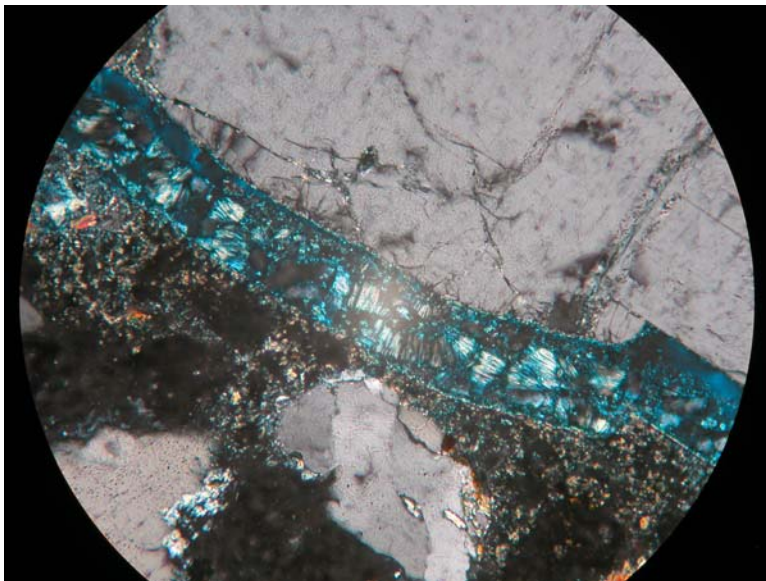
Figure 38 Core 13 horizontal section showing cross polarized light (see Figure 37)

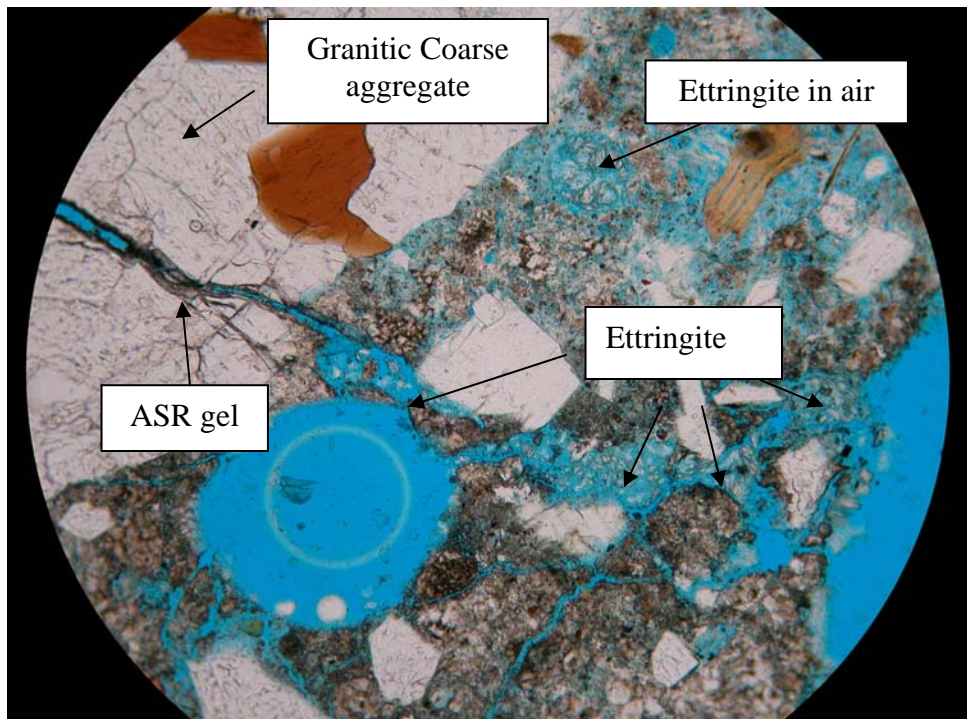
Figure 39 Core 13 horizontal section showing ASR and secondary Ettringite

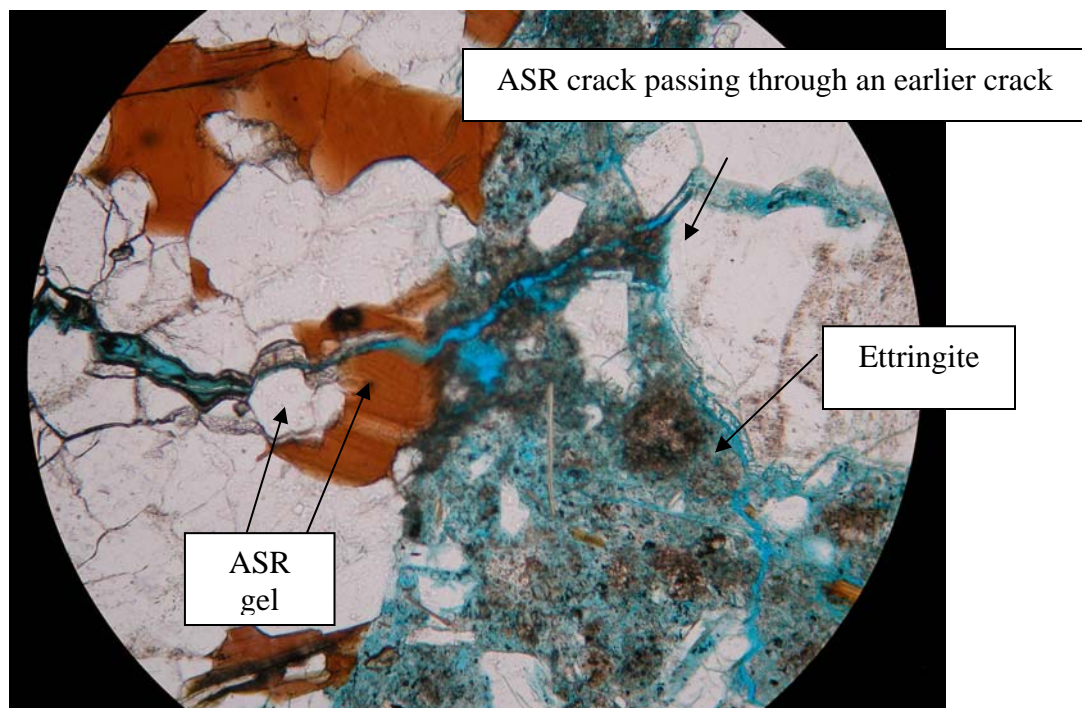
Figure 40 Core 13 horizontal section showing ASR and DEF in the same place

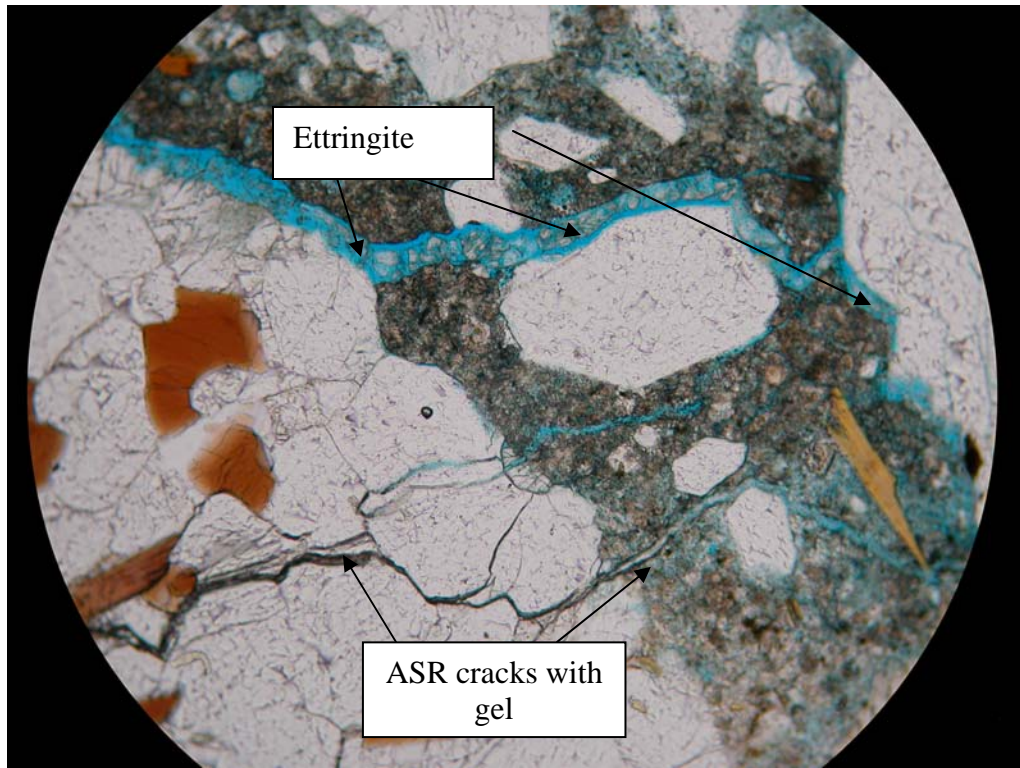
Figure 41 Core 13 horizontal section showing ASR and Ettringite

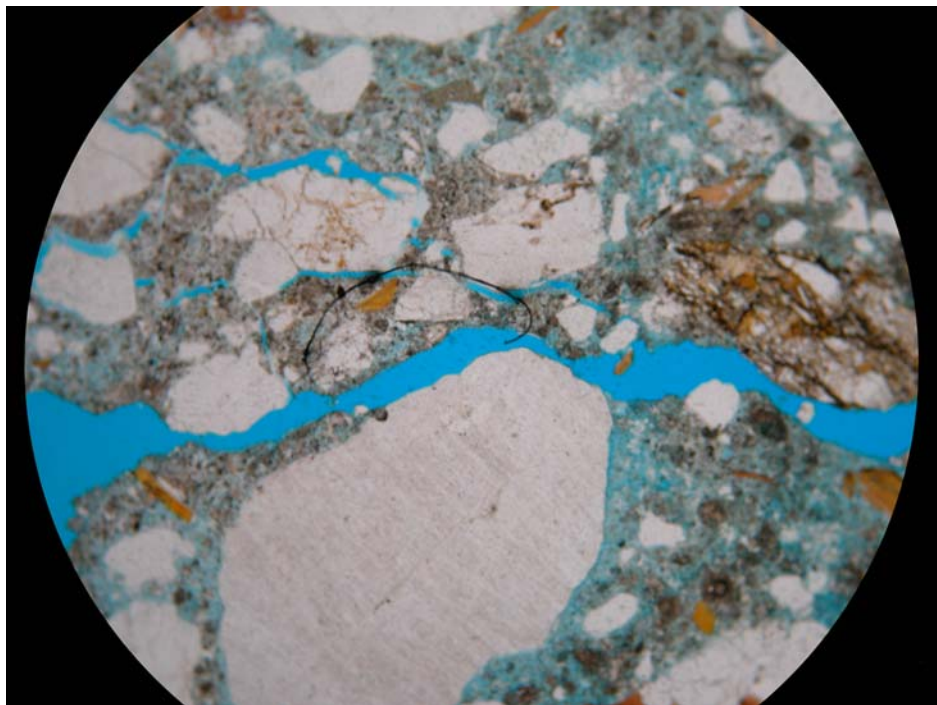
Figure 42 Core 13 horizontal section showing Typical crack pattern

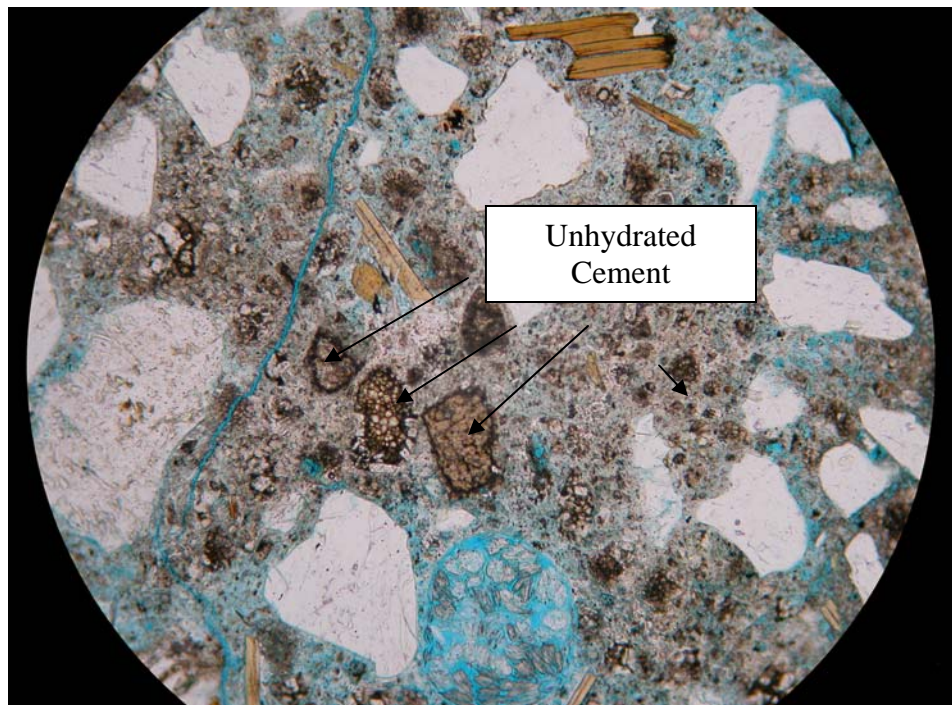
Figure 44 Core 13 horizontal section showing large number of unhydrated, coarser portland cement particles typical of Rosendale cement.

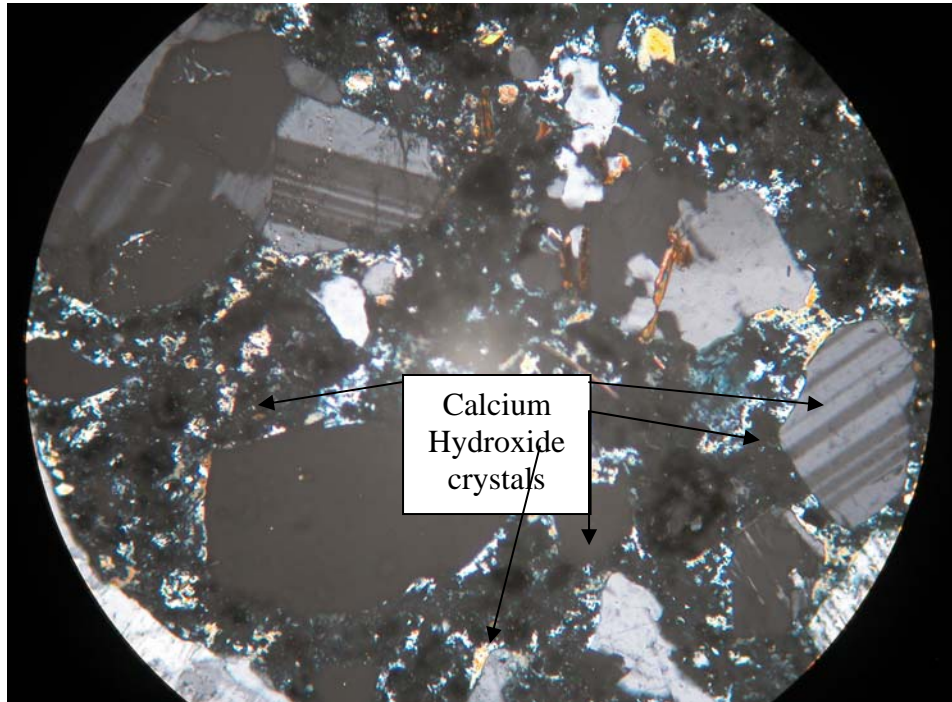
The portland cement used in the construction of the Oyster River Durham Falls Dam was a natural cement made of limestone with a high clay content (argillaceous limestone) from Rosendale, New York. The burn temperature of this cement was much lower than a normal portland cement resulting in a cement different from a normal portland cement. The Rosendale cement would have been expected to have a fast initial set, followed by a very slow and gradual rise in strength. There are always considerable amounts of unhydrated cement resulting in a common identifying feature when the concrete is viewed under a microscope as shown by Figure 44. Another characteristic of the Rosendale cement is the presence of a higher than normal, compared to normal portland cement, percentage of calcium hydroxide as shown in Figure 46.

Figure 45 Core 13 horizontal section showing well crystallized, coarser calcium hydroxide crystals at the aggregate-paste interfaces as well as in the matrix.
