The State of New Hampshire
DEPARTMENT OF ENVIRONMENTAL SERVICES

February 12, 2018
Letter of Deficiency
DSP #18-010

RE: Mill Pond Dam #D071003, Durham

DAM #D071003, MILL POND DAM, DURHAM, INSPECTED DECEMBER 8, 2017

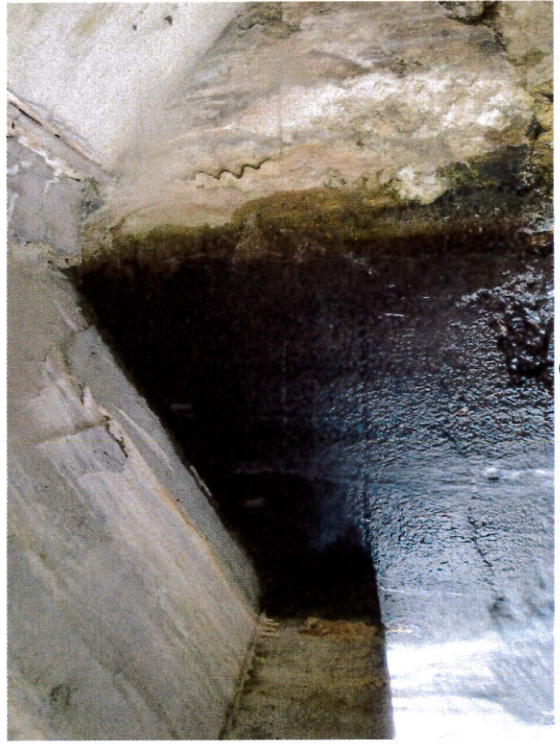
5. Reseal the vertical joints at the following locations to limit water infiltration into the joints.
 - a. Along the fish ladder. (See photo Q for a typical example); and
 - b. Along the joint between the right end of the spillway and the adjacent right concrete abutment/gate structure. (See photos C and R).

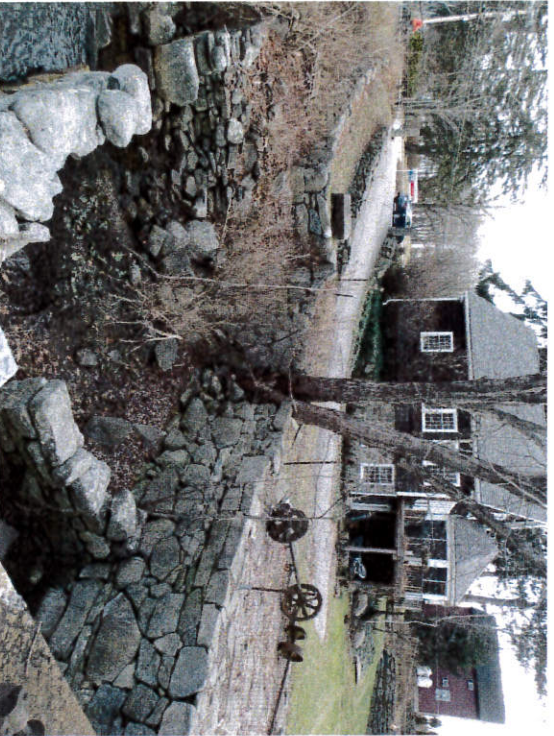
4. Remove the trees and brush in the following locations. All trees and brush should be removed from the footprint of the dam and for a distance of 15 feet beyond the footprint of the dam and establish a hardy grass cover on all portions of the embankment that are not protected by other erosion resistant materials (i.e. rip rap, gravel road on crest, etc.).
 - a. Within 15 feet of the fish ladder and the left abutment. (See photos L, M and N); and
 - b. Within 15 feet of the downstream side of the right abutment and along the downstream right training/retaining wall. (See photos O and P). The large mature tree should also be removed to limit further deterioration of the wall.
