# Community Church of Durham HDC Application

Building Background and Project Narrative: The Community Church of Durham occupies a group of attached buildings that consist of: the original historic, clapboard Church (1848- referred to as "Sanctuary" in drawings), a brick Education Center that was originally separate (1962), and a two story multipurpose addition (1998), which connects the original church to the Education Center. The original church underwent major interior modifications in 1923 and 1976, but its exterior remains extensively original. The goal of this project is to rehabilitate vital historic aspects of the Community Church of Durham, while preserving the building's original aesthetic. By renewing particular damaged or weathered aspects of the building, the objective is to mitigate maintenance, increase efficiency and overall building longevity.

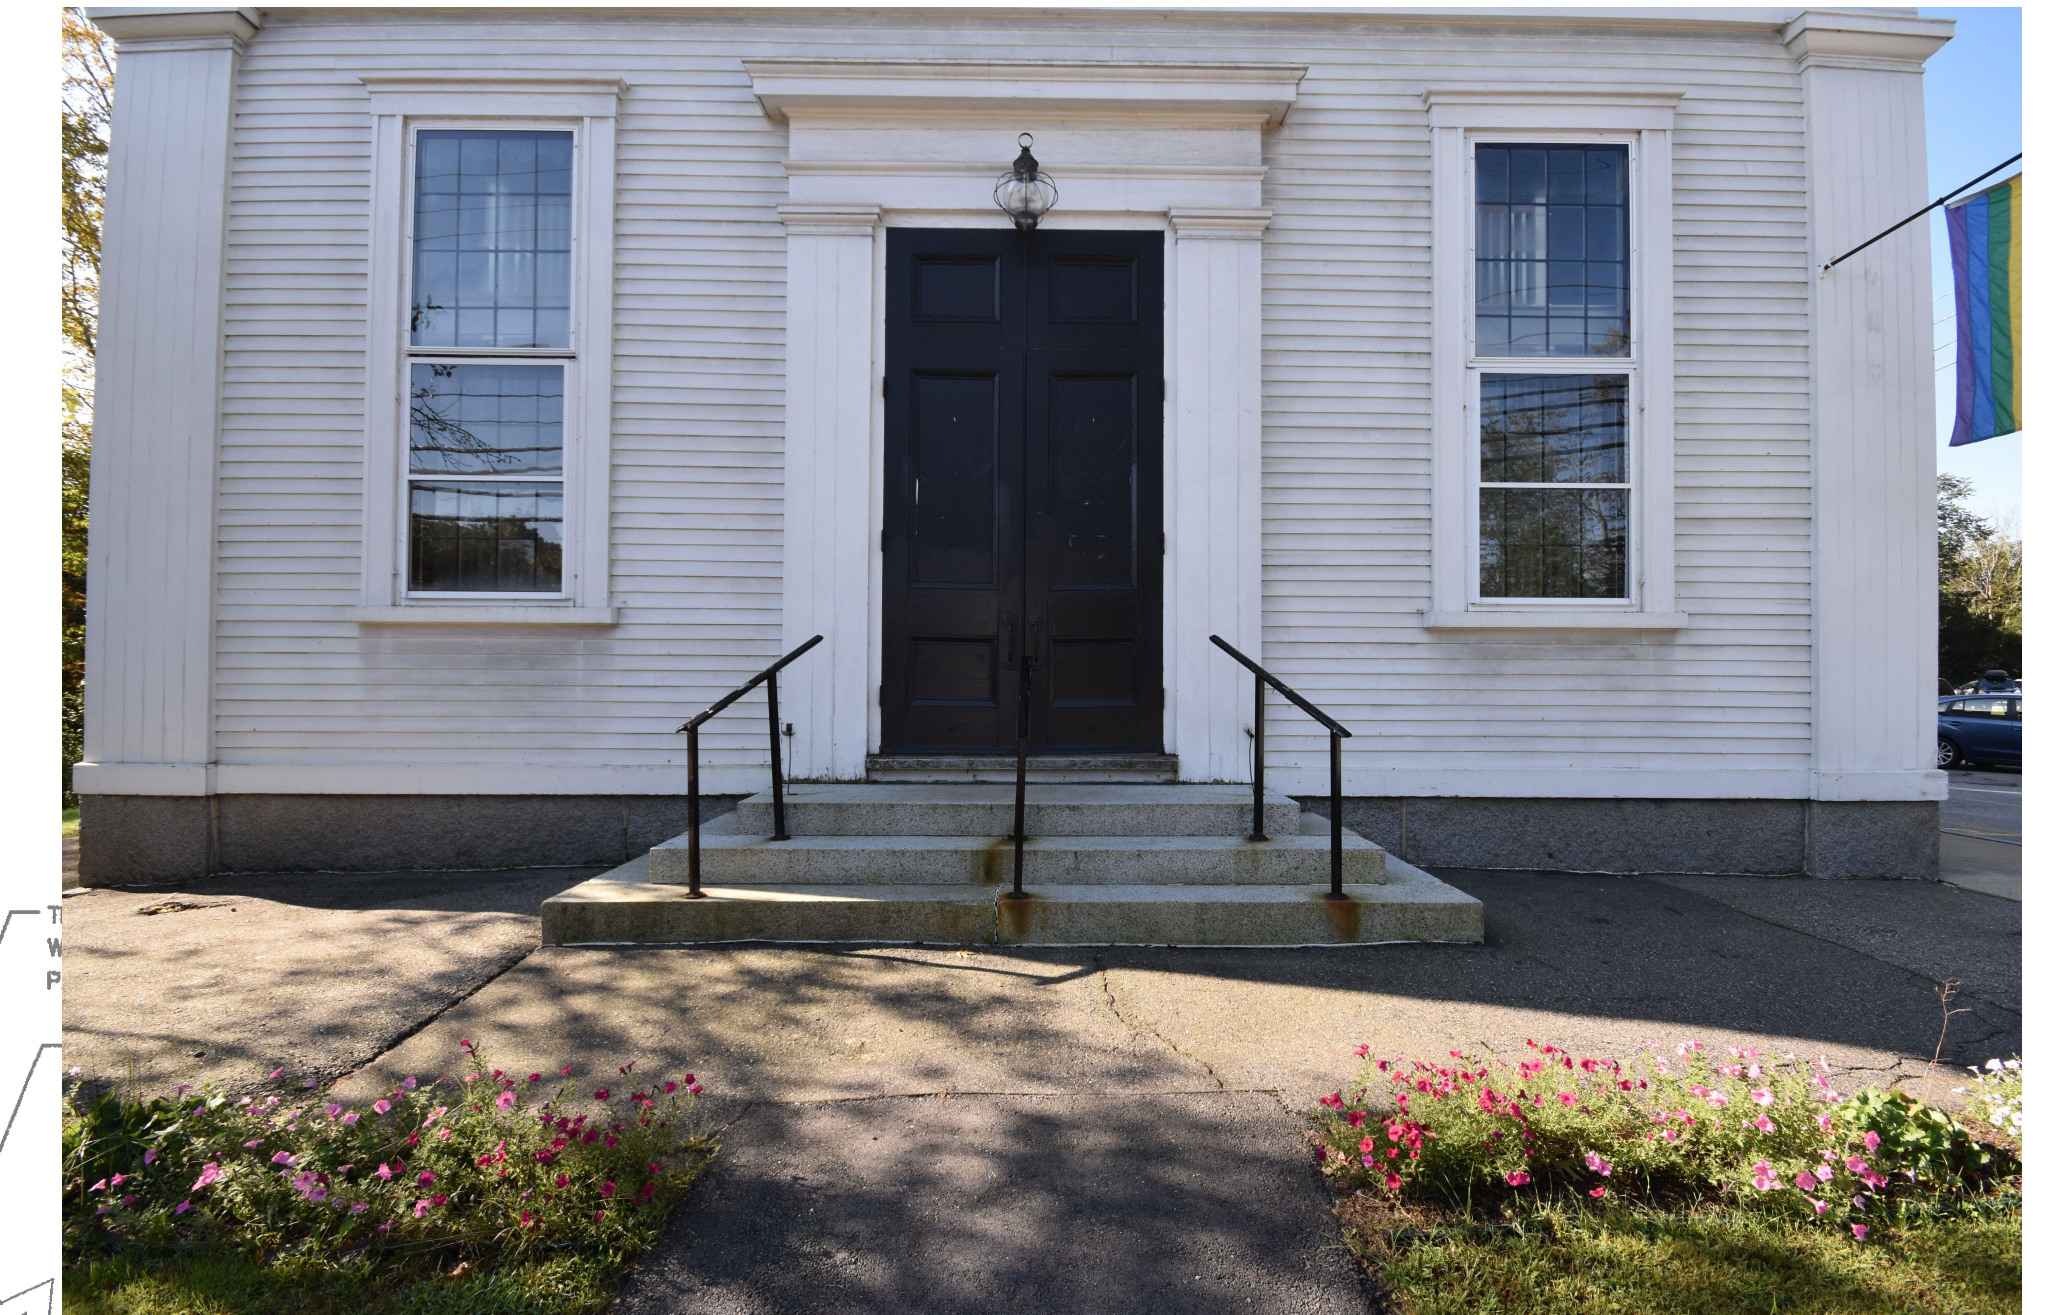
Image of Affected Pavement & Landscaping

Existing Granite Stairs to be replaced. New stairs will project 28" further than existing footprint (see enlarged plan below). Careno Construction will repave around new stairs to connect to walkway and sidewalk as necessary. Careno will provide a loam bed to accept new plantings along Main St. Landscaping will be provided by Church volunteers. All new paving will be sloped away from building to match existing draining conditions.

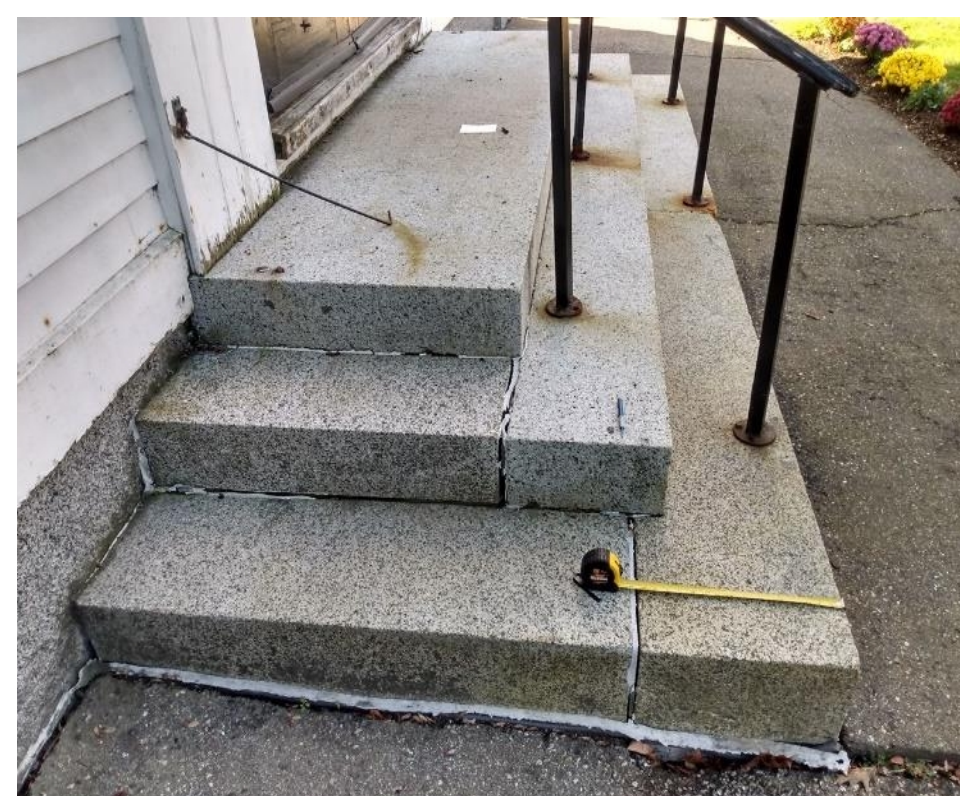
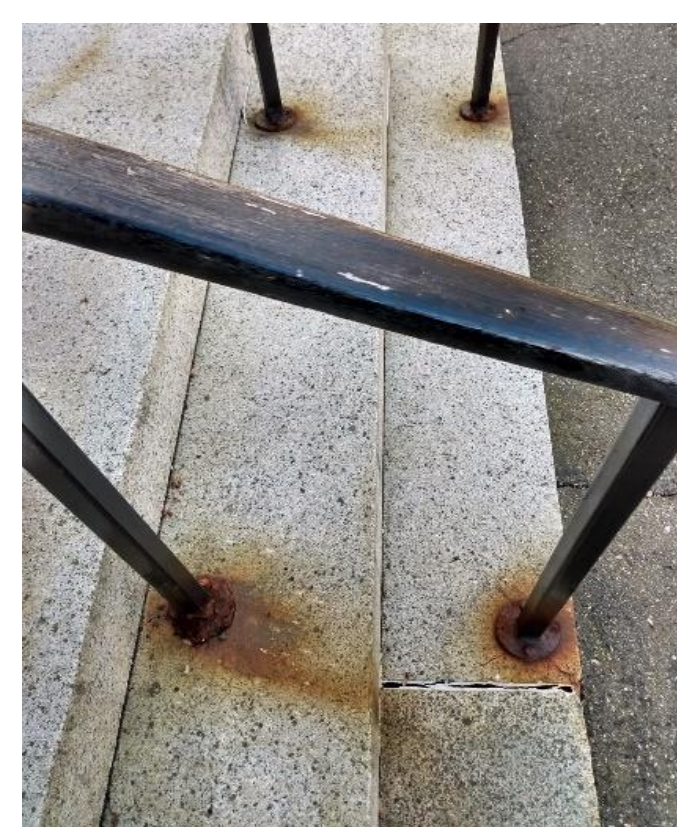
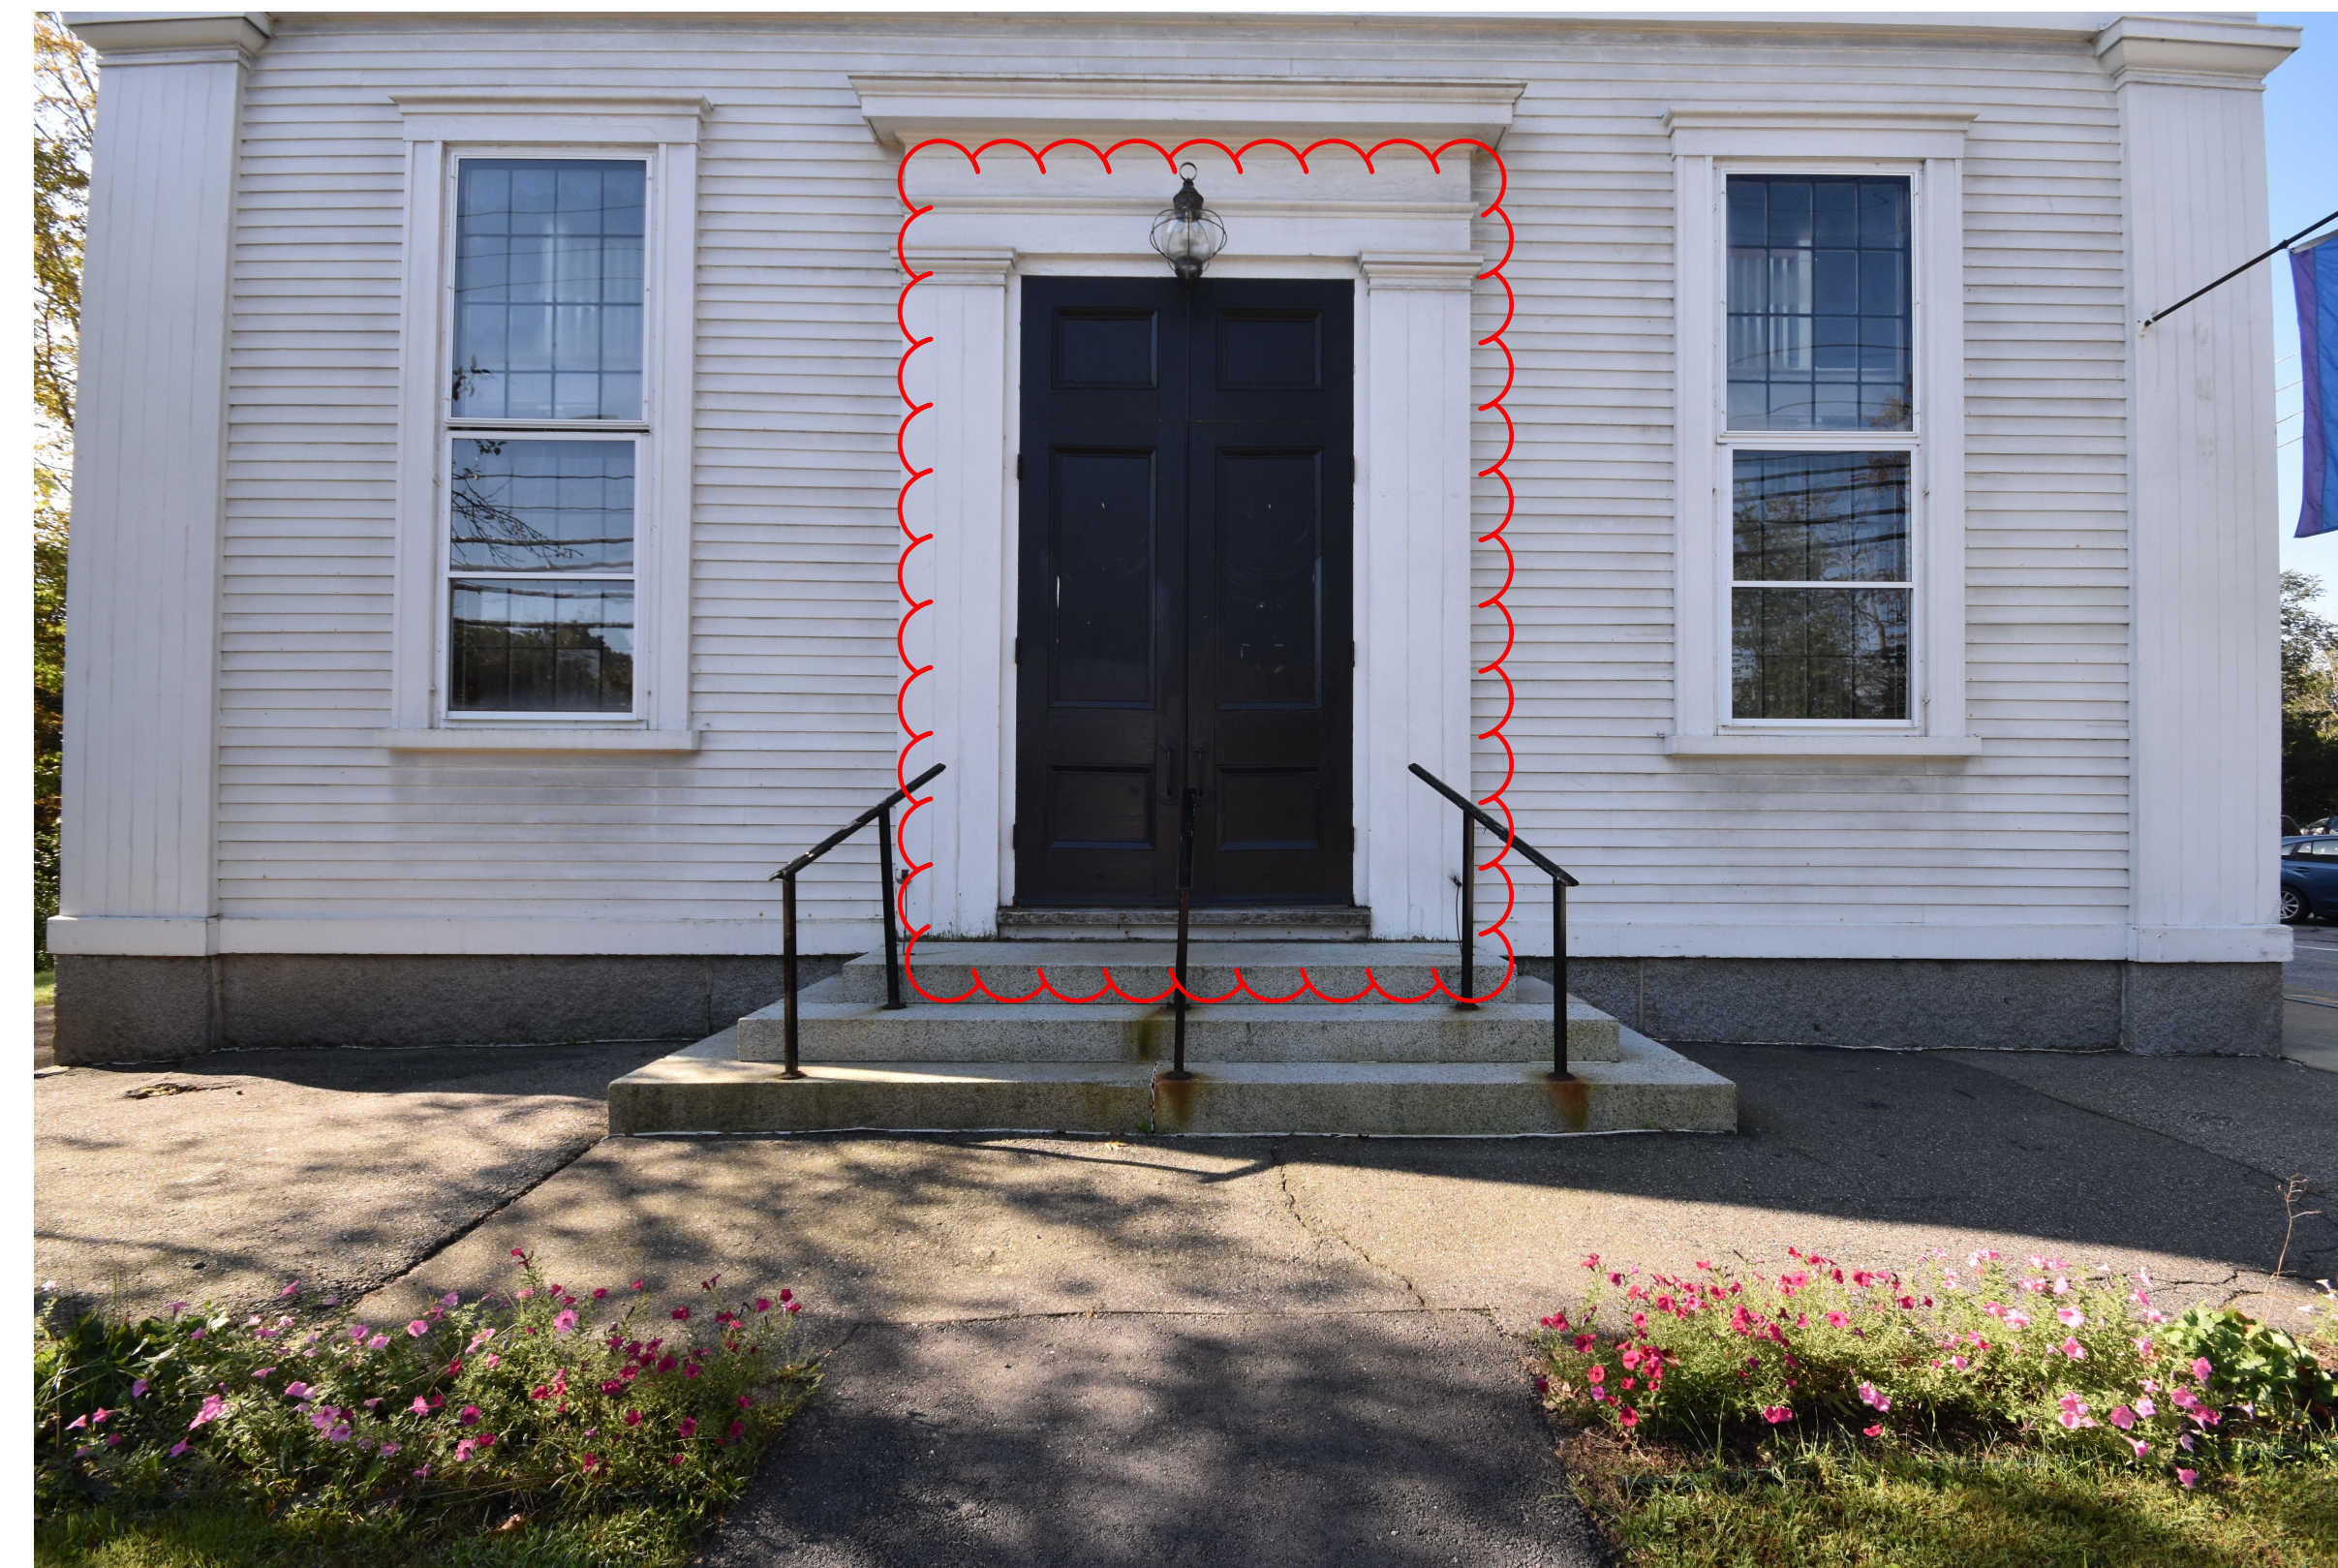
Existing Partial Front Elevation

The primary goal of replacing the existing granite stairs and railings is to increase safety. The existing stairs are not code compliant and the railings are damaged and have caused rusting to occur on the granite steps. We are proposing the following scope of work and stair layout to achieve code conformance:

- Increase the depth of the landing
- Add a riser so we are able to raise the landing so it is flush with the threshold of the out-swing front doors.
- Install new black, powder coated steel railings with curved terminations for increased safety
- Repave around new stairs as needed for positive drainage away from building and safe circulation

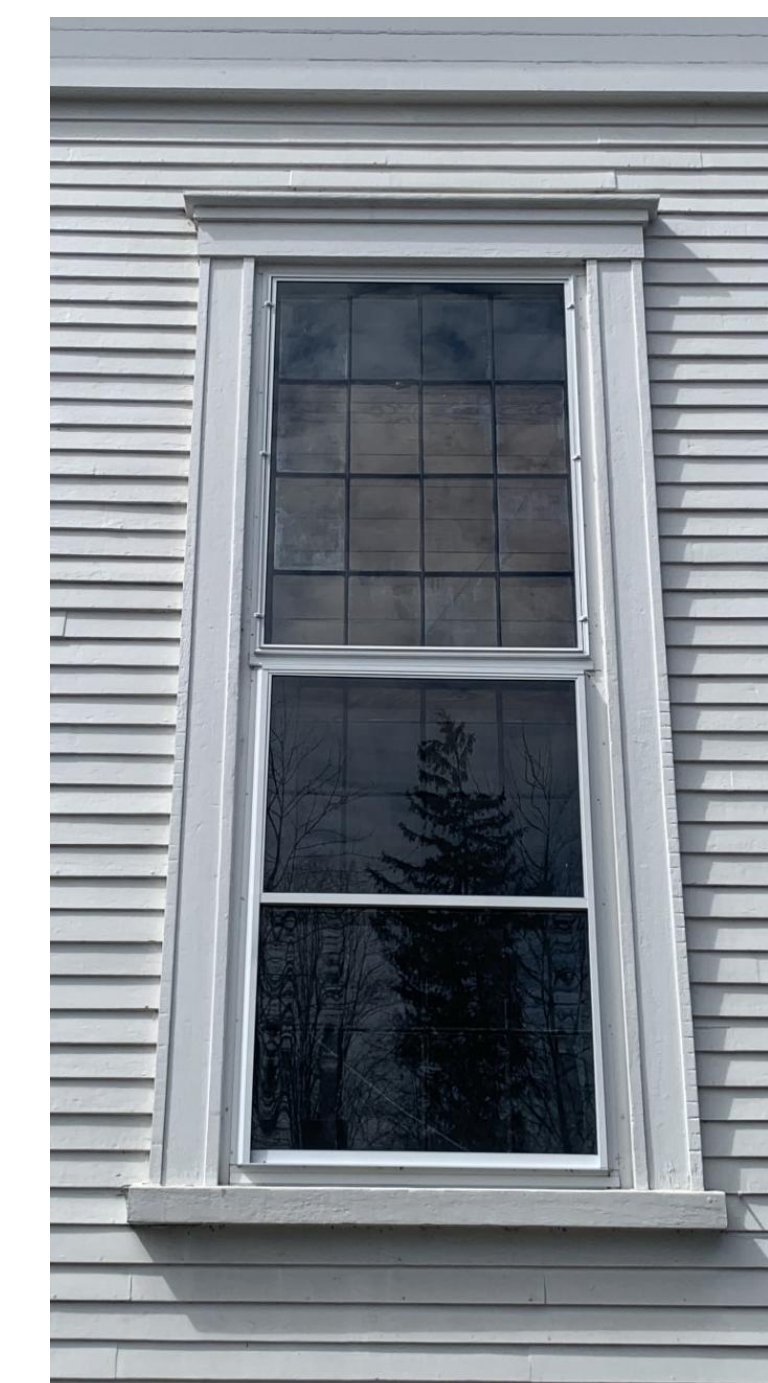
**Image of Existing Sanctuary Window**

1. Globe window: To be removed and transported off site to be renewed. Rotted elements of window will be removed and re-built with wood to match existing. Damaged components will be repaired using structural epoxy. Entire window unit to be scraped, primed and painting to match existing.
2. (12) Sanctuary windows: Scraped, re-glazed as need, repaired with structural epoxy, primed, painted and renewed to full operating capabilities. Renewed windows will match existing windows in material, color, and operability. The exterior aesthetic of the windows will not change, in fact, the goal of the rehabilitation is to preserve the window's original historic features as much as possible. Existing storm windows are to remain.

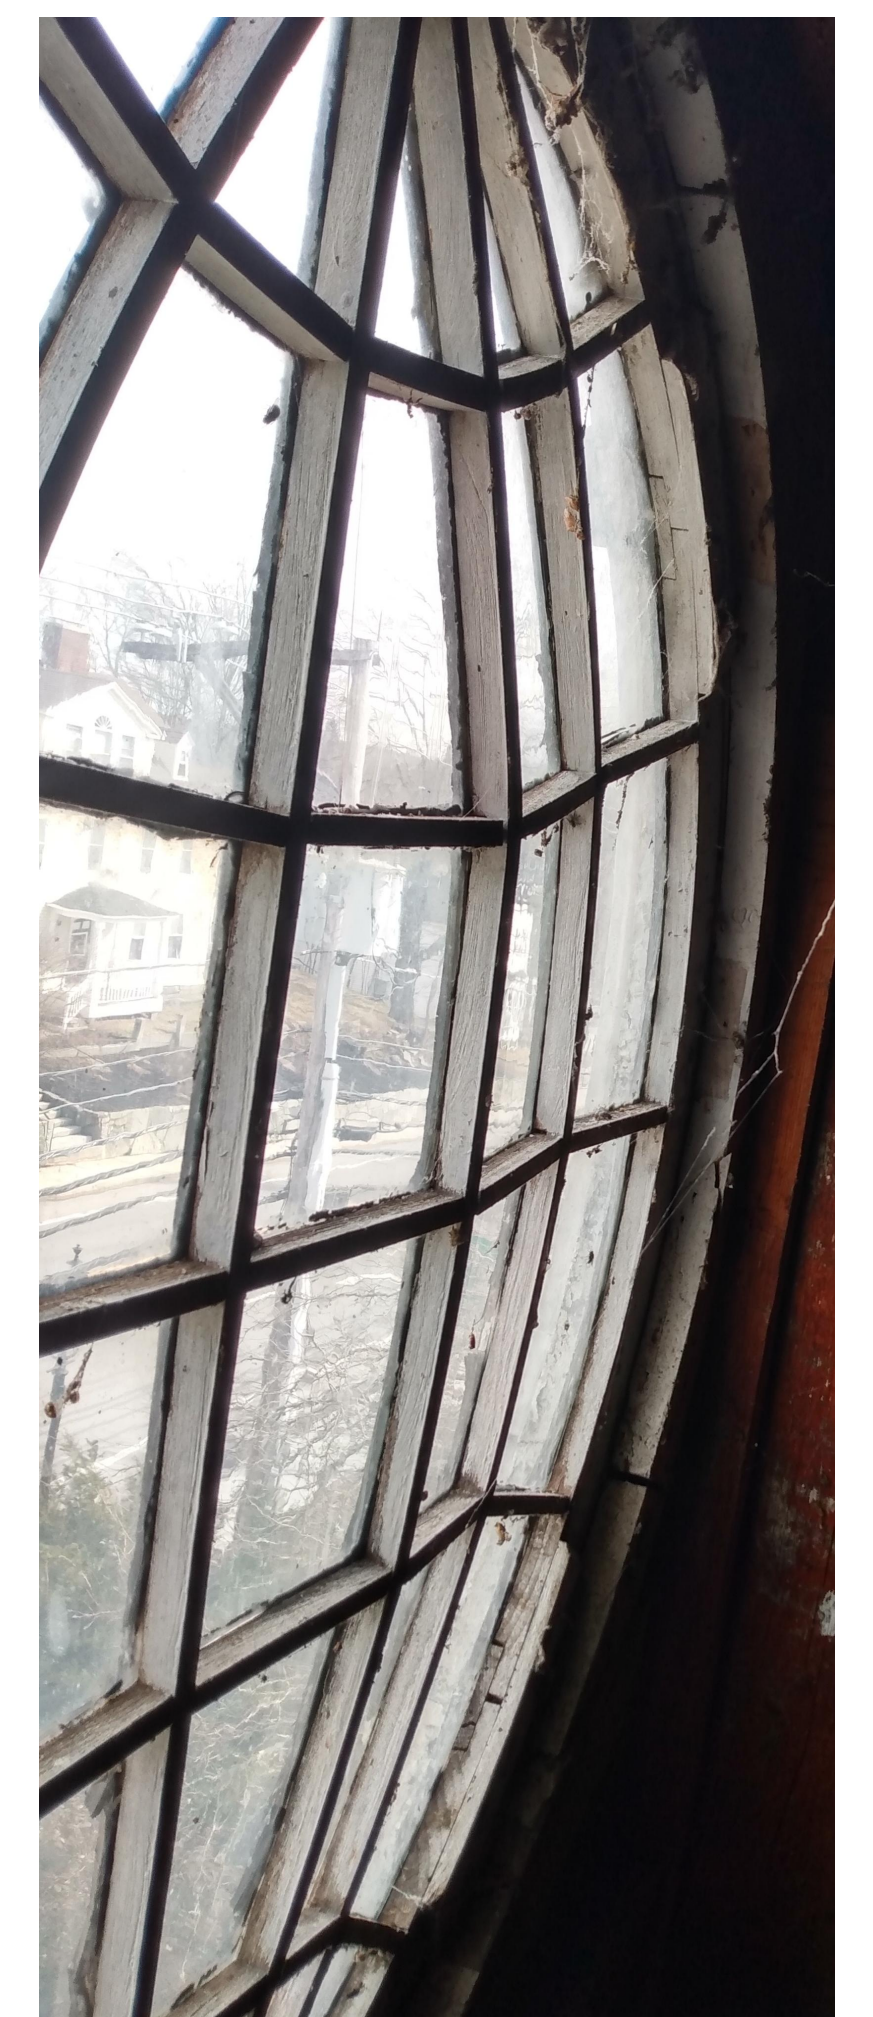
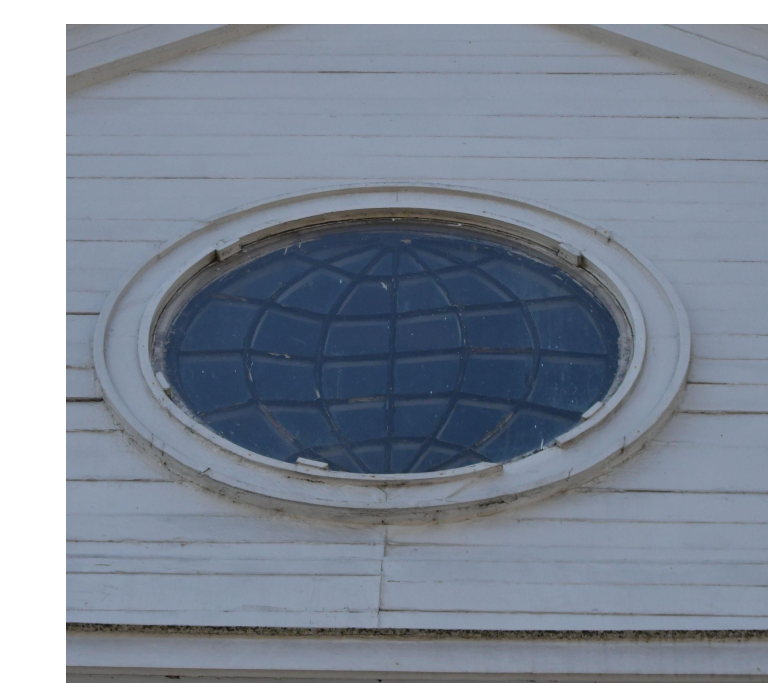
**Images of Existing Exterior & Interior Globe Window Conditions**

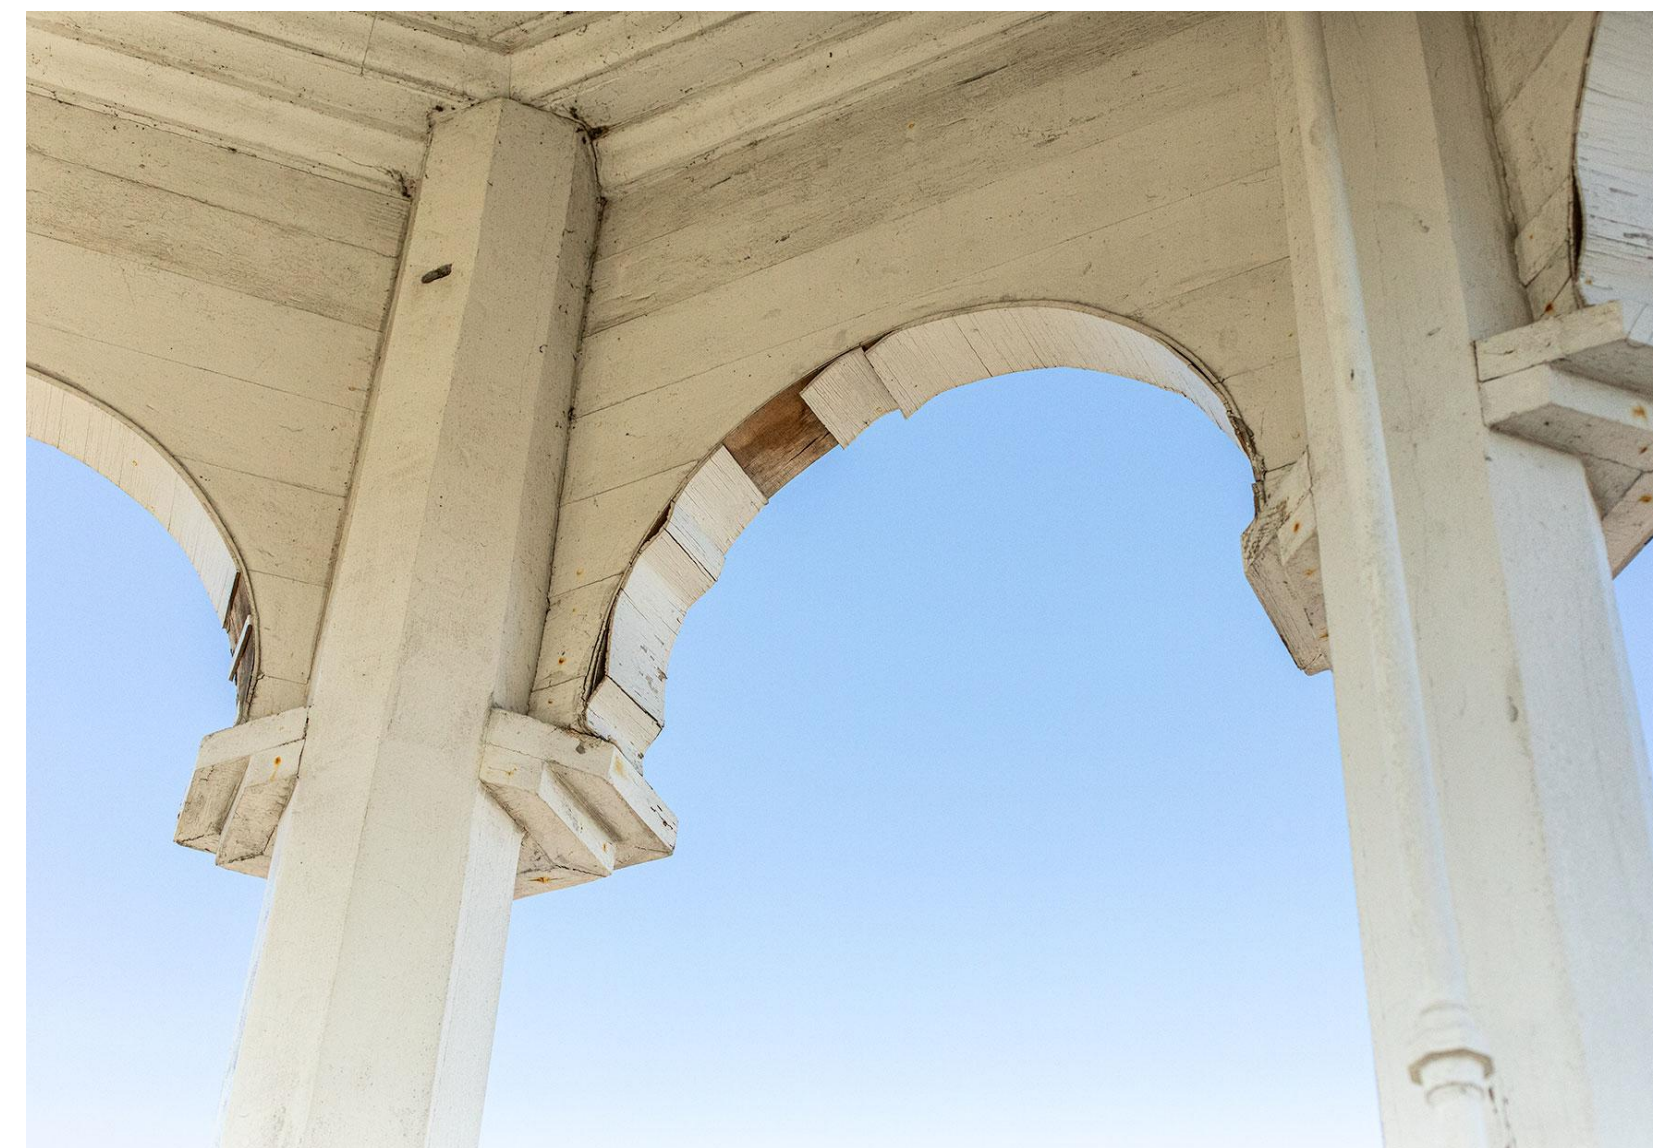
Image of Existing Arched Trim Condition

Arched trim elements & trim at top of columns to be replaced with PVC as needed. PVC to be primed and painted white to match existing.

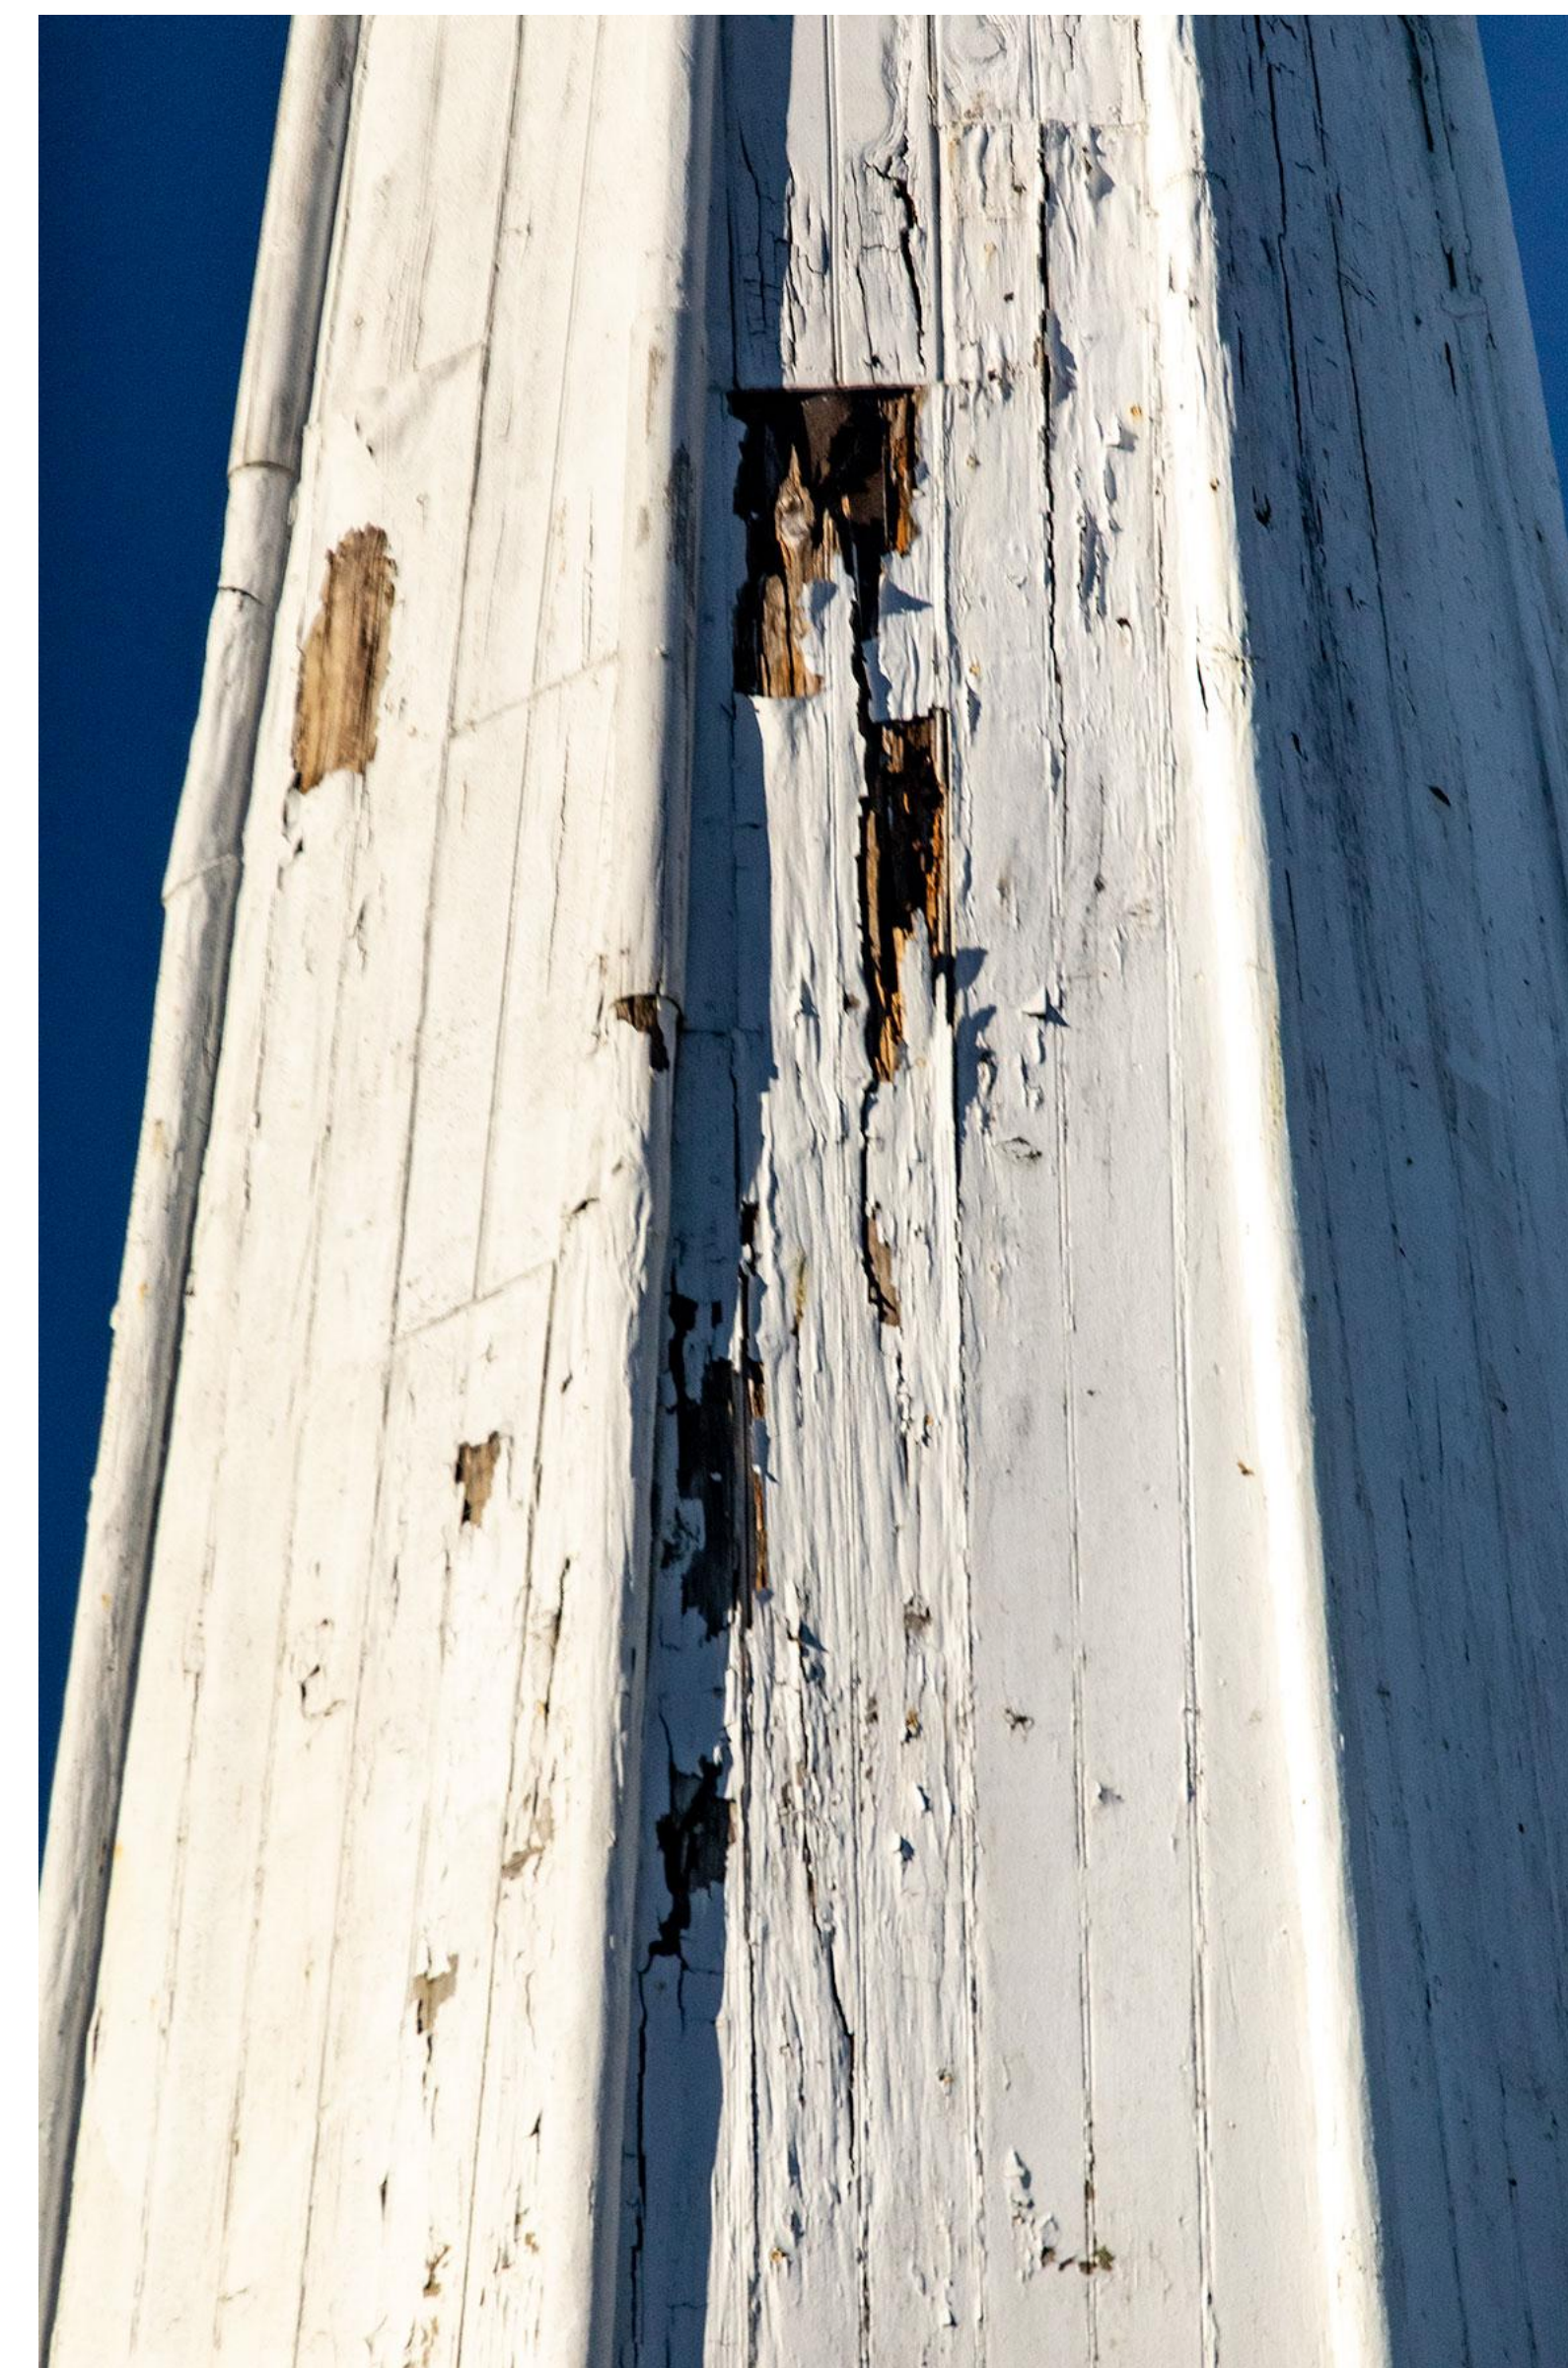
Image of Existing Spire Rotting

Existing wood spire boards to be replaced with mahogany (caulked and sealed at all ribs).

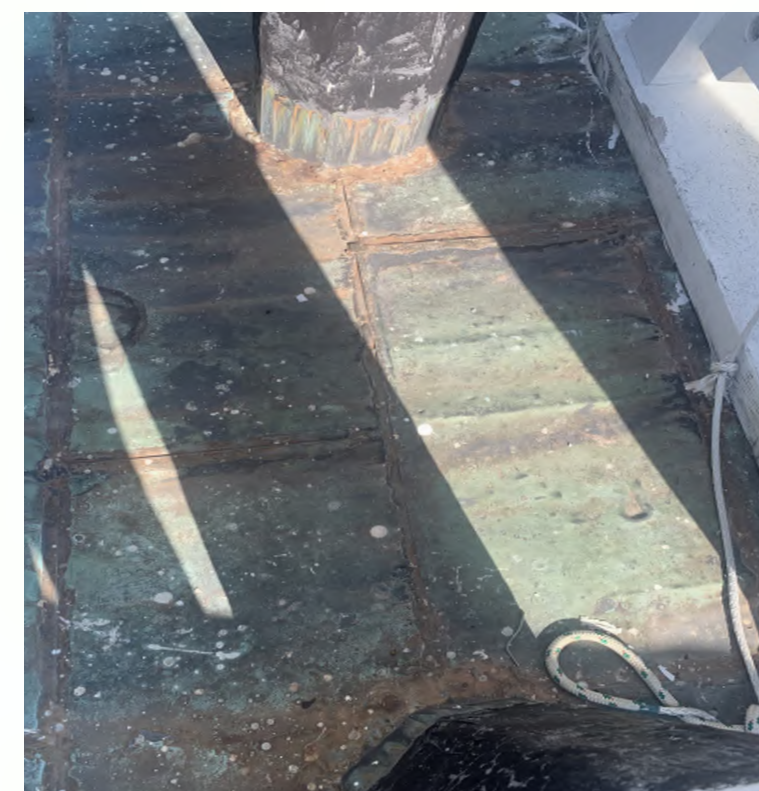
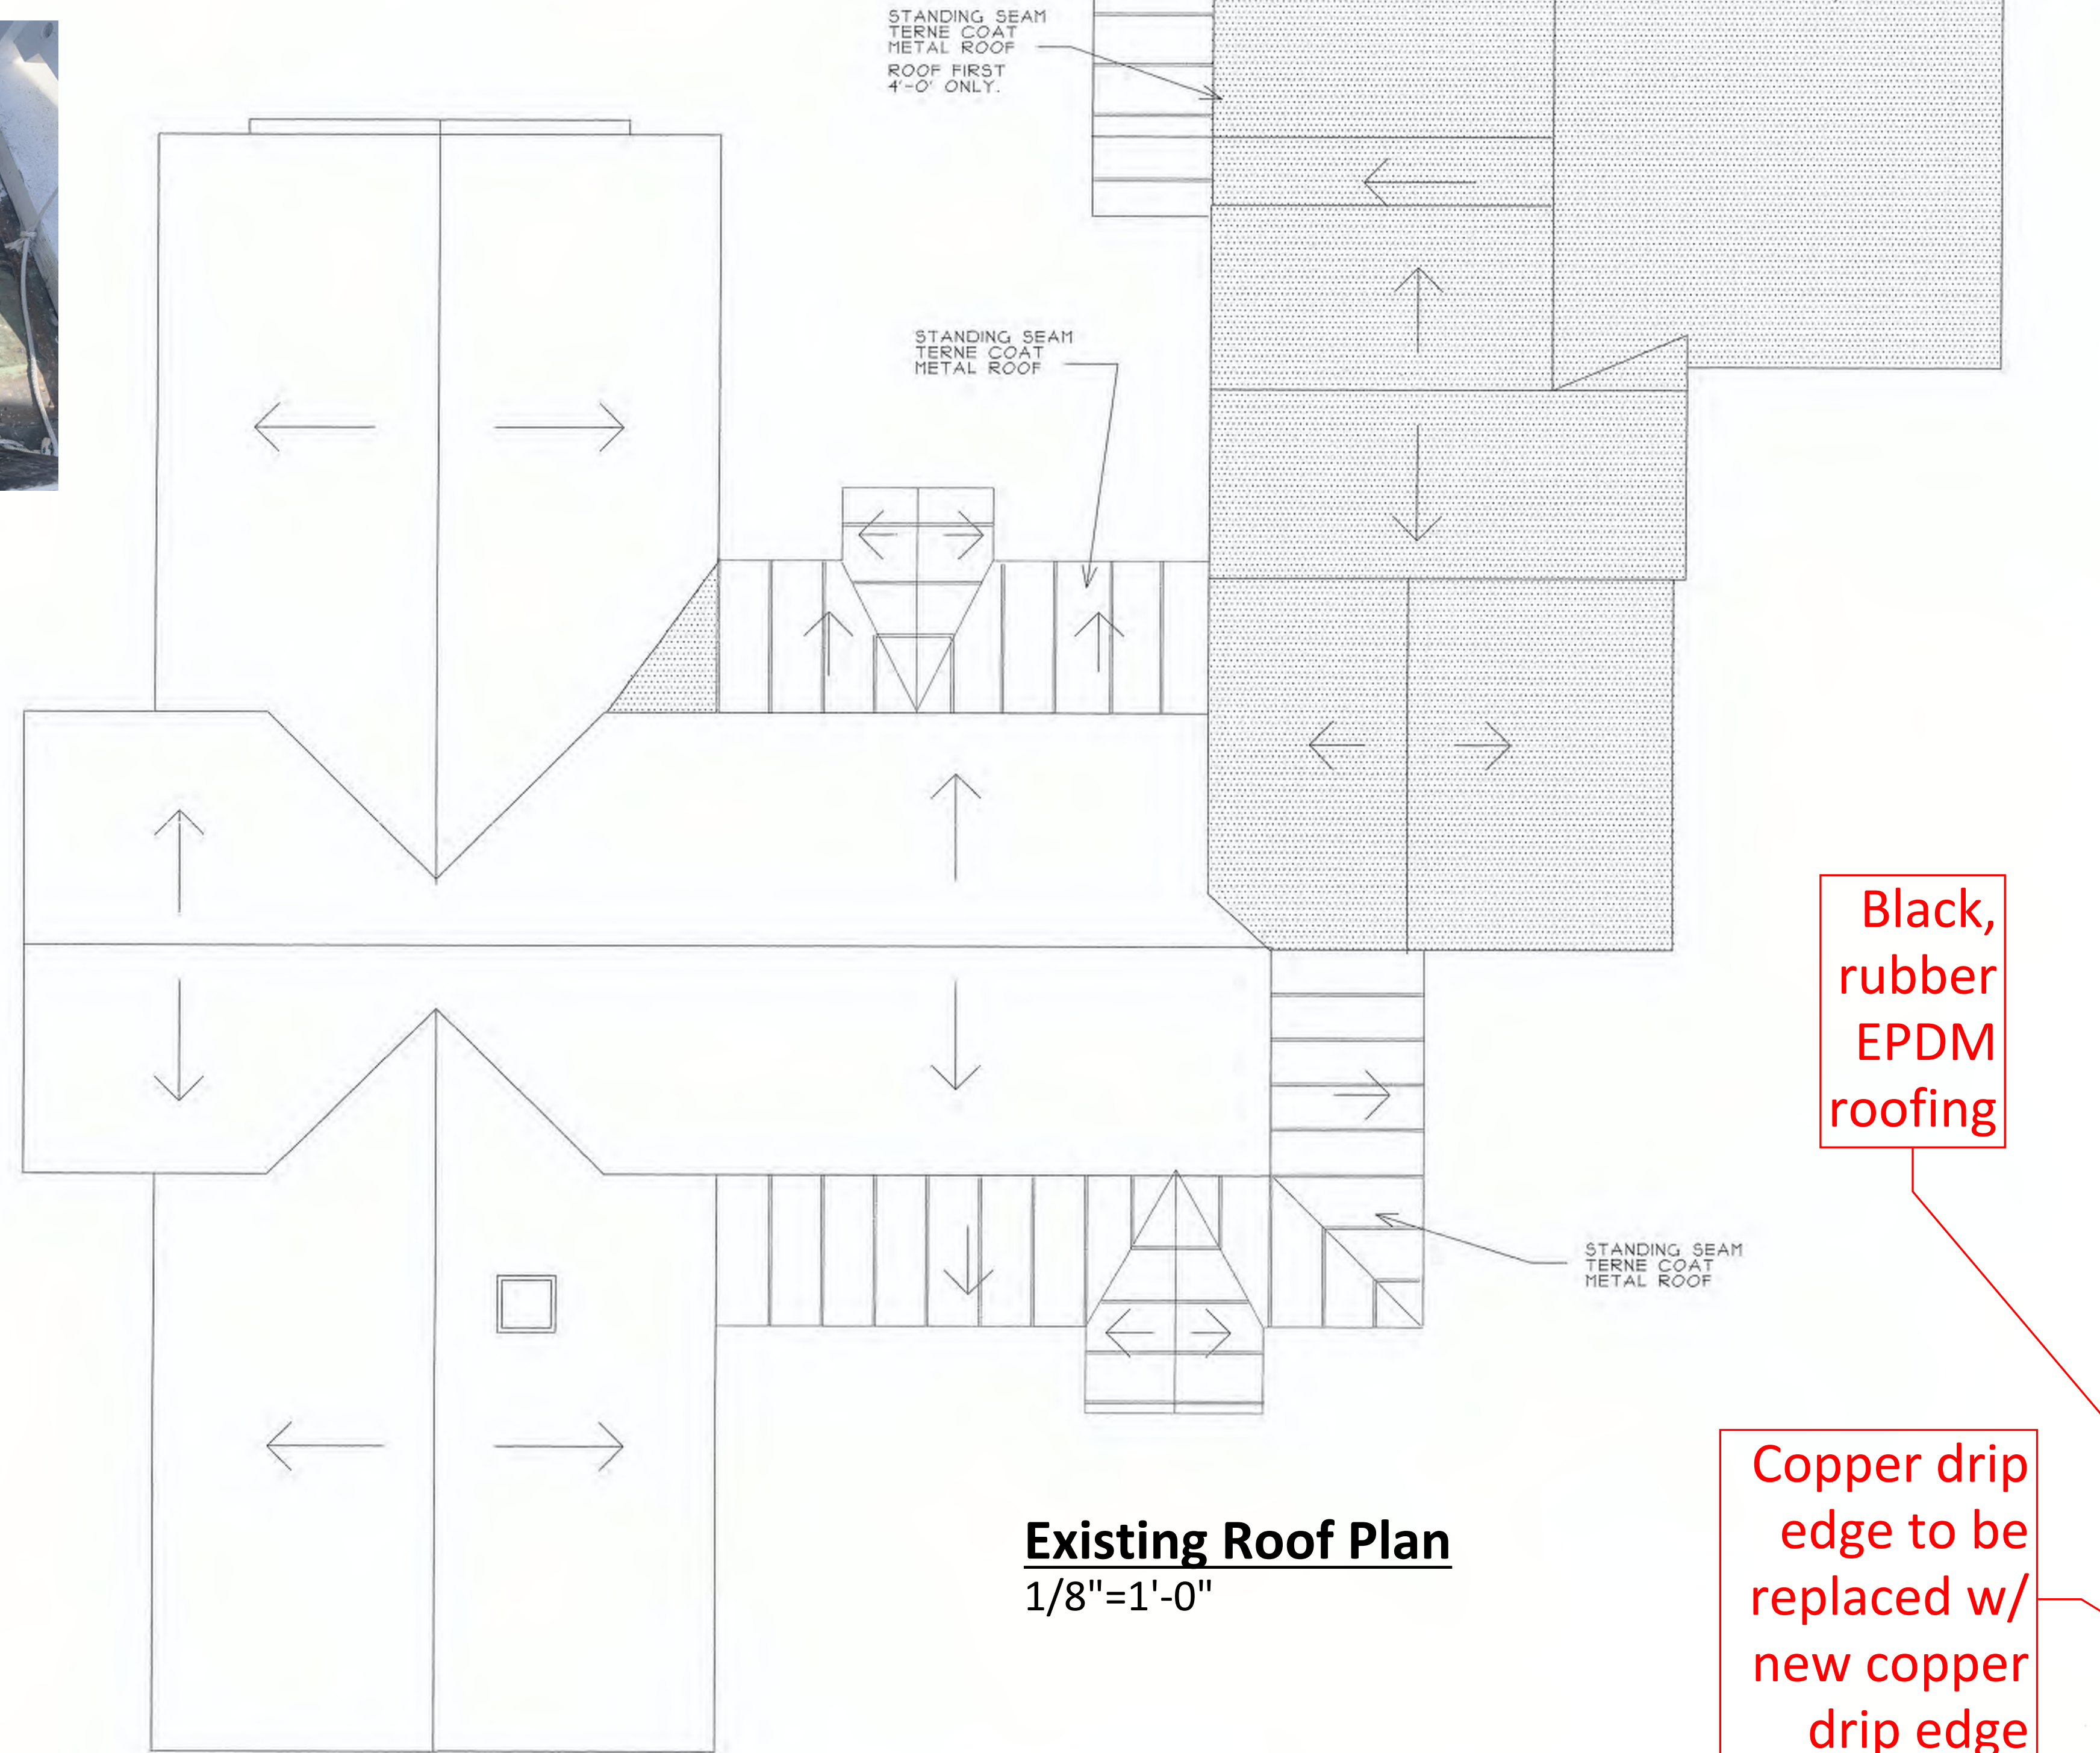
### Image of Exist. Weathering

Roof Area to be Renovated

- Remove existing balustrade (to be re-built to match existing)
- Install 1/2" Invinso Board over existing and damaged copper flat seamed roofing
- Install liquid applied EPDM Rubber Roofing System flashed to columns and penetrations.
- Install 1 1/2" Copper drip edge so copper edge is viewed from street (maintain existing aesthetic from below)
