# Community Church of Durham HDC Application

Building Background and Project Narrative: The Community Church of Durham occupies a group of attached buildings that consist of: the original historic, clapboard Church (1848- referred to as "Sanctuary" in drawings), a brick Education Center that was originally separate (1962), and a two story multipurpose addition (1998), which connects the original church to the Education Center. The original church underwent major interior modifications in 1923 and 1976, but its exterior remains extensively original. The goal of this project is to rehabilitate vital historic aspects of the Community Church of Durham, while preserving the building's original aesthetic. By renewing particular damaged or weathered aspects of the building, the objective is to mitigate maintenance, increase efficiency and overall building longevity.

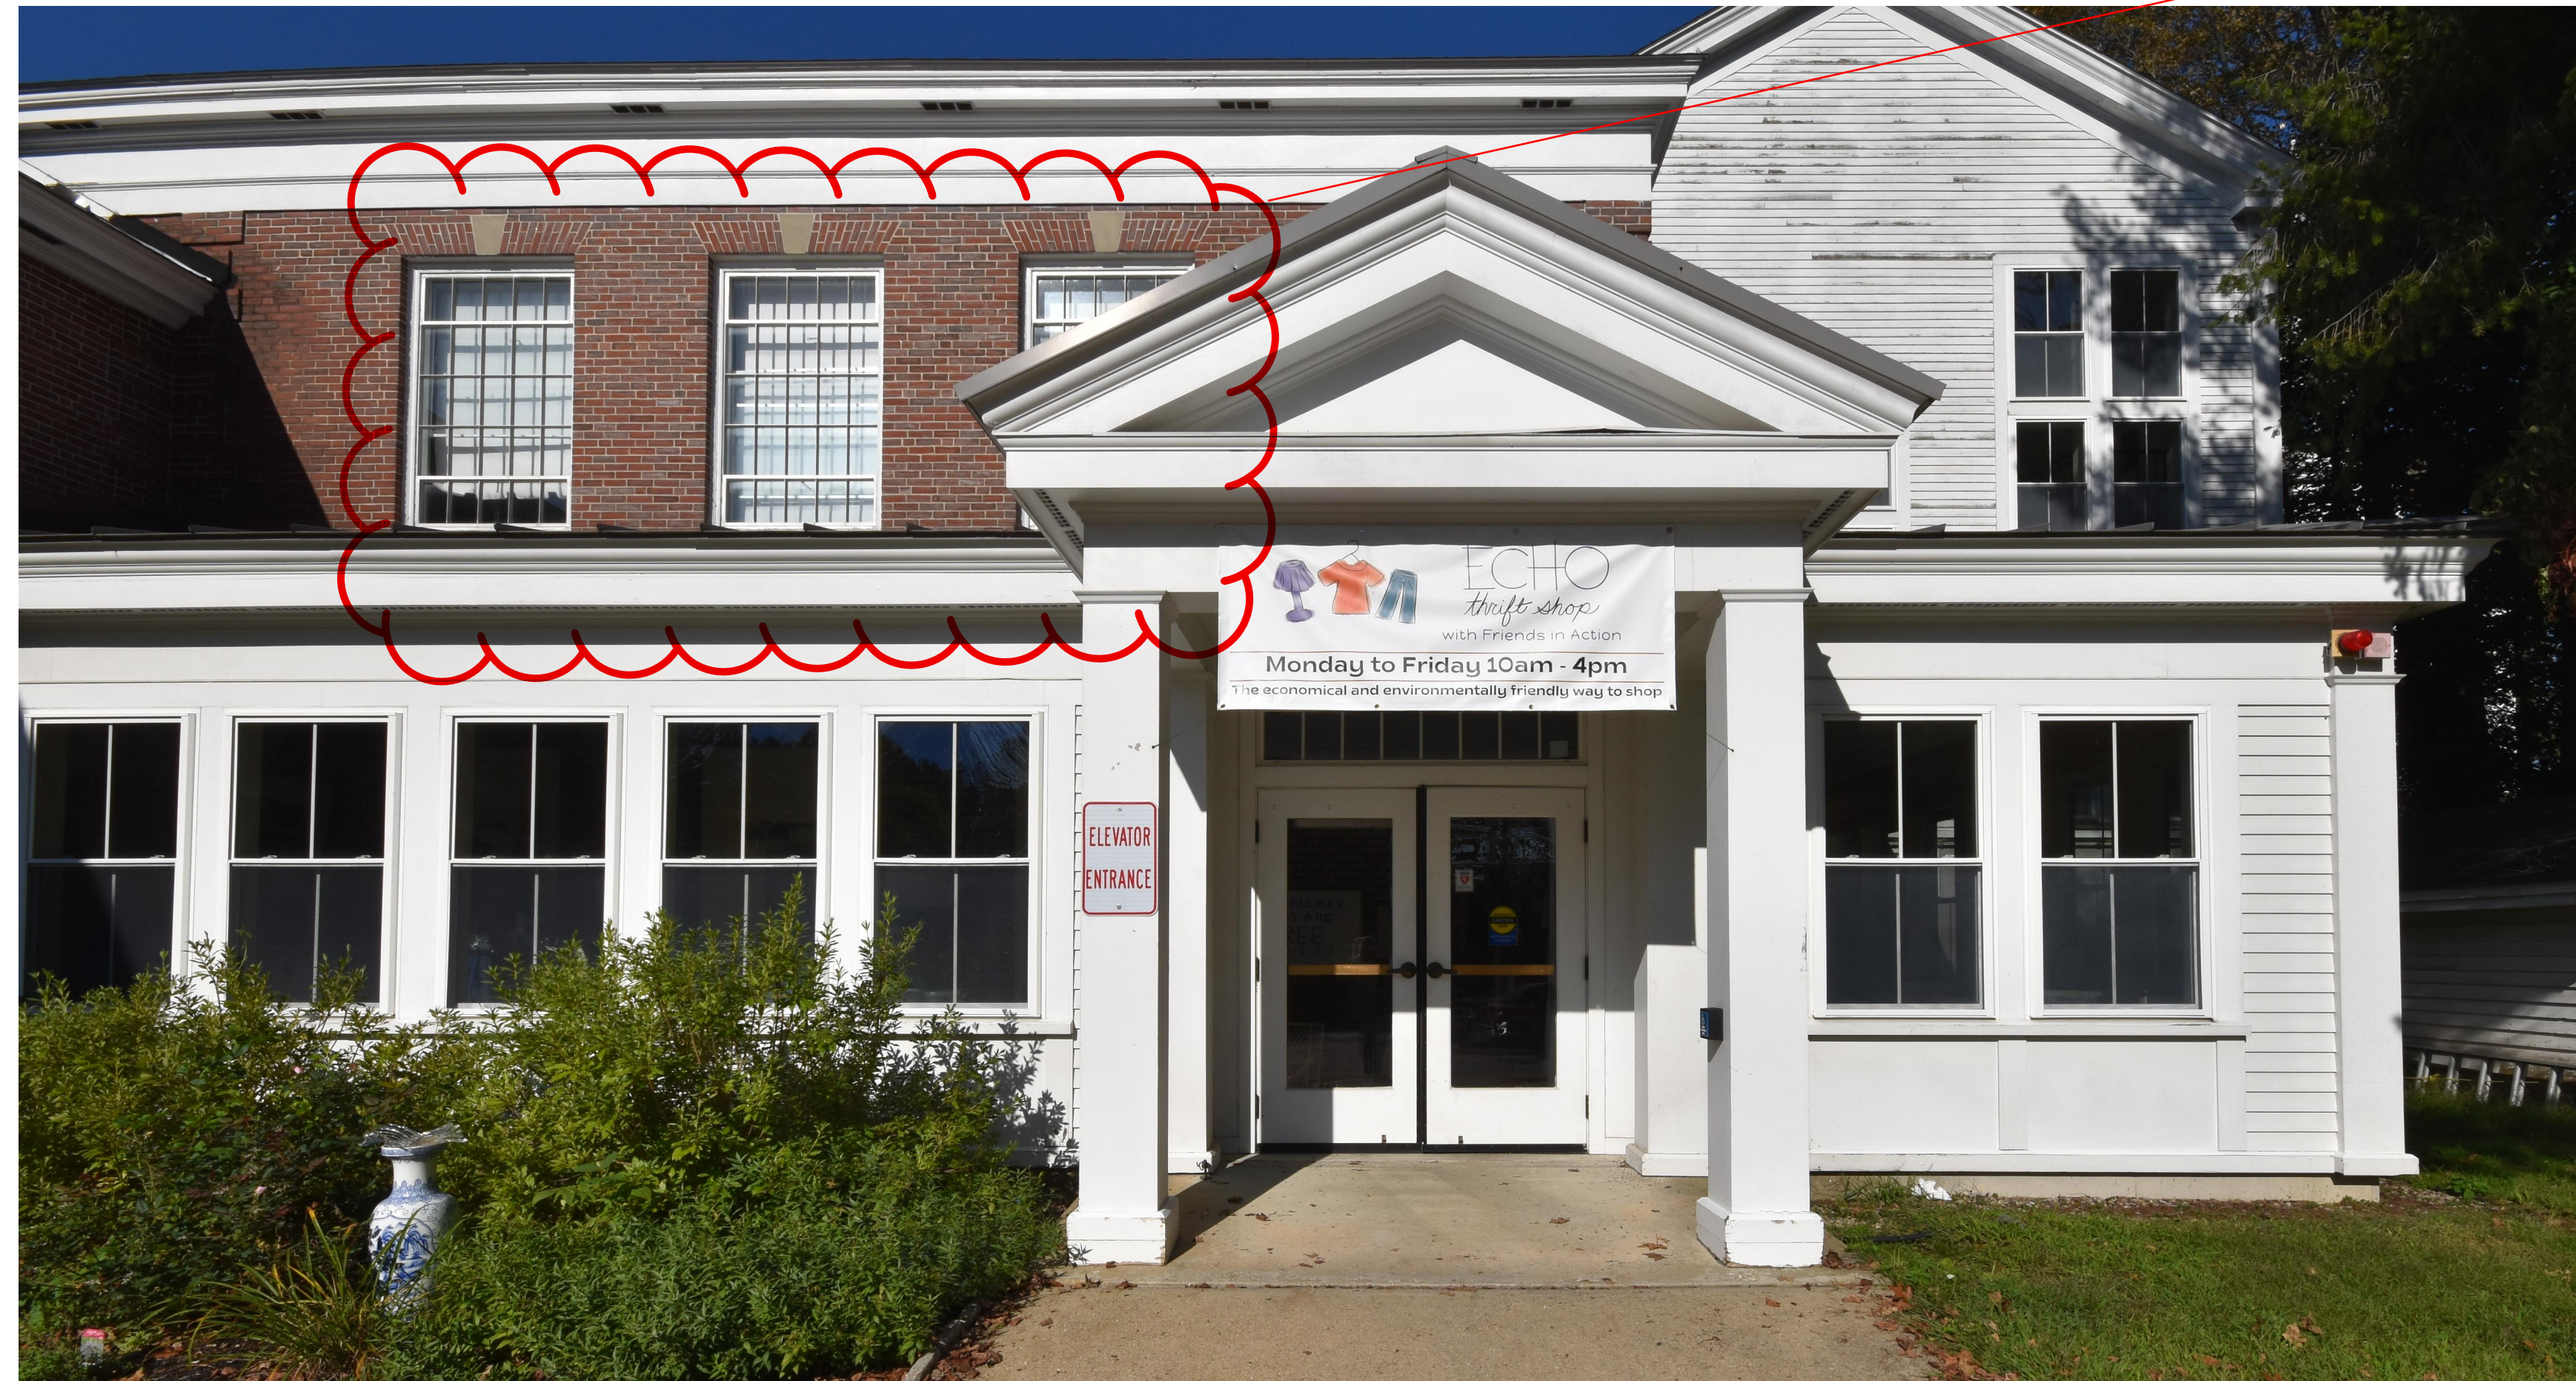
(3) Existing steel windows to be replaced

**Existing Window Unit:** Hopper Over Fixed Over Hopper  
**Existing Material:** Steel  
**Interior Finish:** "Silver" Steel  
**Exterior Finish:** White

**Notes:** 1. Existing masonry header detail at window exterior to remain.  
 2. We are proposing to change the operation of the window in order to mitigate the thickness of the new window frame. If we were to select a new hopper over fixed over hopper unit, the mullions would be very thick and differ greatly from the existing, narrow steel frame. Our goal is to keep the overall aesthetic of the new window frame similar to existing conditions.  
 3. The goal of this aspect of the project is to increase the energy efficiency and operability of the windows. The existing windows are currently a source of sufficient heat loss.

**Proposed Window Unit:** Marvin Elevate- Double Hung  
**Material:** Fiberglass Exterior & Wood Interior  
**Interior Finish:** Painted White  
**Exterior finish:** Stone White
