FIGURE 2 - PHOTO LOCATION PLAN

FOR PERMIT APPLICATION ONLY

Project: 075-05-001
Name: **Miswall Dam Upgrades and Repairs**
Durham, New Hampshire
Subject: **NHDES Wetland Impacts**

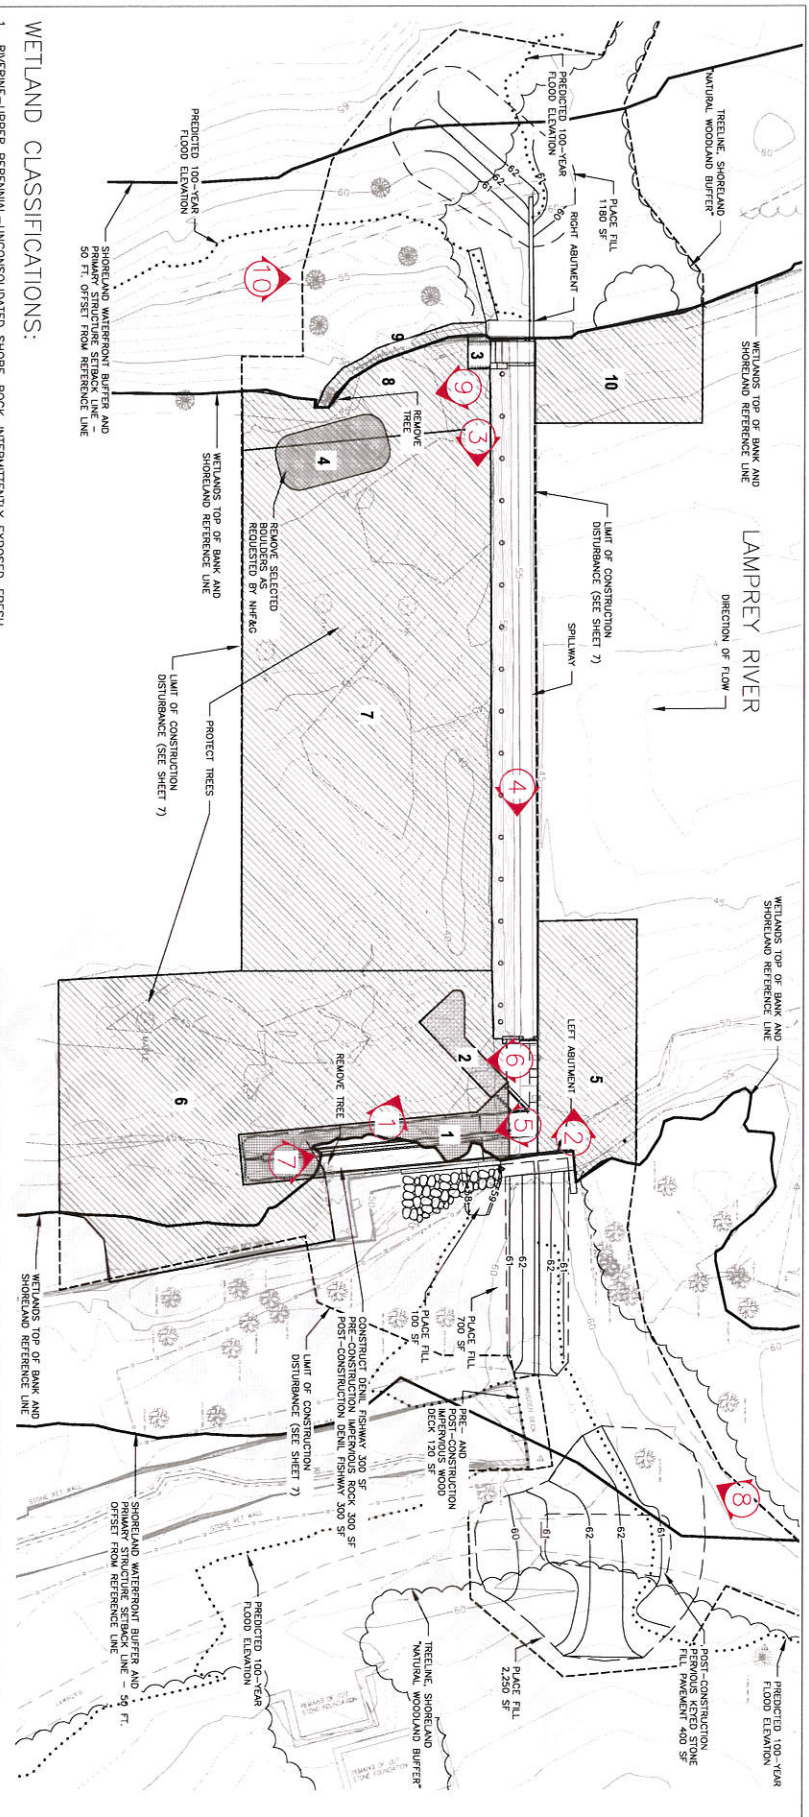
WETLAND CLASSIFICATIONS:

1. RIVERINE-UPPER PERENNIAL-UNCONSOLIDATED SHORE-ROCK-INTERMITTENTLY EXPOSED-FRESH
2. RIVERINE-UPPER PERENNIAL-ROCK BOTTOM-ROCK-TEMPERATELY FLOODED-FRESH
3. RIVERINE-UPPER PERENNIAL-ROCK BOTTOM-ROCK-TEMPERATELY FLOODED-FRESH
4. RIVERINE-UPPER PERENNIAL-AQUATIC BED-ROOTED VASCULAR-PERMANENTLY FLOODED-FRESH
5. RIVERINE-UPPER PERENNIAL-UNCONSOLIDATED SHORE-VEGETATED-SEASONALLY FLOODED-FRESH
6. RIVERINE-UPPER PERENNIAL-ROCK BOTTOM-RUBBLE/BEDROCK-INTERMITTENTLY EXPOSED-FRESH
7. RIVERINE-UPPER PERENNIAL-ROCK BOTTOM-RUBBLE/BEDROCK-INTERMITTENTLY EXPOSED-FRESH
8. RIVERINE-UPPER PERENNIAL-UNCONSOLIDATED SHORE-VEGETATED-SEASONALLY FLOODED-FRESH
9. RIVERINE-UPPER PERENNIAL-UNCONSOLIDATED SHORE-VEGETATED-SEASONALLY FLOODED-FRESH
10. RIVERINE-LOWER PERENNIAL-AQUATIC BED-ROOTED VASCULAR-PERMANENTLY FLOODED-FRESH

SUMMARY OF WETLAND IMPACTS/CONSTRUCTION ACTIVITIES

DESCRIPTION OF IMPACT/ACTIVITY	AREA OF IMPACT, FT ²	LENGTH OF IMPACT, FT.
PERMANENT WETLAND IMPACTS	TOTAL = 1,116	TOTAL = 194
1. ROCK EXCAVATION DENIL FISHWAY	943	66 (BANK) + 66 (RIVER)

2. CONSTRUCTION FOR DENIL FISHWAY FISH ENTRANCE	181	25
3. REMOVAL OF EXISTING DENIL FISHWAY	42	7
4. REMOVAL OF FISH AND GAME DEPARTMENT OF NEW HAMPSHIRE	30	30
TEMPORARY WETLAND IMPACTS	TOTAL = 13,908

5. CONSTRUCT CONCRETE CONSTRUCTION EQUIPMENT ACCESS FOR DEMOLITION/CONSTRUCTION OF LEFT ABUTMENT	1,354	
6. ACCESS FOR CONSTRUCTION EQUIPMENT TO CONSTRUCT DENIL FISHWAY	5,329

7. ACCESS FOR CONSTRUCTION EQUIPMENT TO INSTALL RIGHT ABUTMENT ON STEEL DOWNSTREAM FACE AND TO CONSTRUCT DENIL FISHWAY	7,966	
8. ACCESS FOR EQUIPMENT AND PERSONNEL TO CONSTRUCT CONCRETE FLUME POOL AND RECONSTRUCT STONE MASONRY WALL. POSSIBLE STOCKPILING OF STONE MASONRY WHILE DISMANTLING/RECONSTRUCTING STONE MASONRY WALL.	779

9. MAINTENANCE/REPAIR OF RIGHT DOWNSTREAM STONE MASONRY WALL. ACCESS TO DAM UPSTREAM LIKELY BY BARGE/BOAT. POSSIBLE MIGRATION NOTCH.	135	
10. ACCESS TO DAM UPSTREAM LIKELY BY BARGE/BOAT. POSSIBLE MIGRATION NOTCH.	945
