PRESERVATION TIMBER FRAMING
P.O. Box 28
Berwick, ME 03901
www.preservationtimberframing.com

Durham Old Town Hall
Nancy Sandburg
NH-108
Durham, NH 03824

12.16.2019
Issue 001
Jessica MilNeil

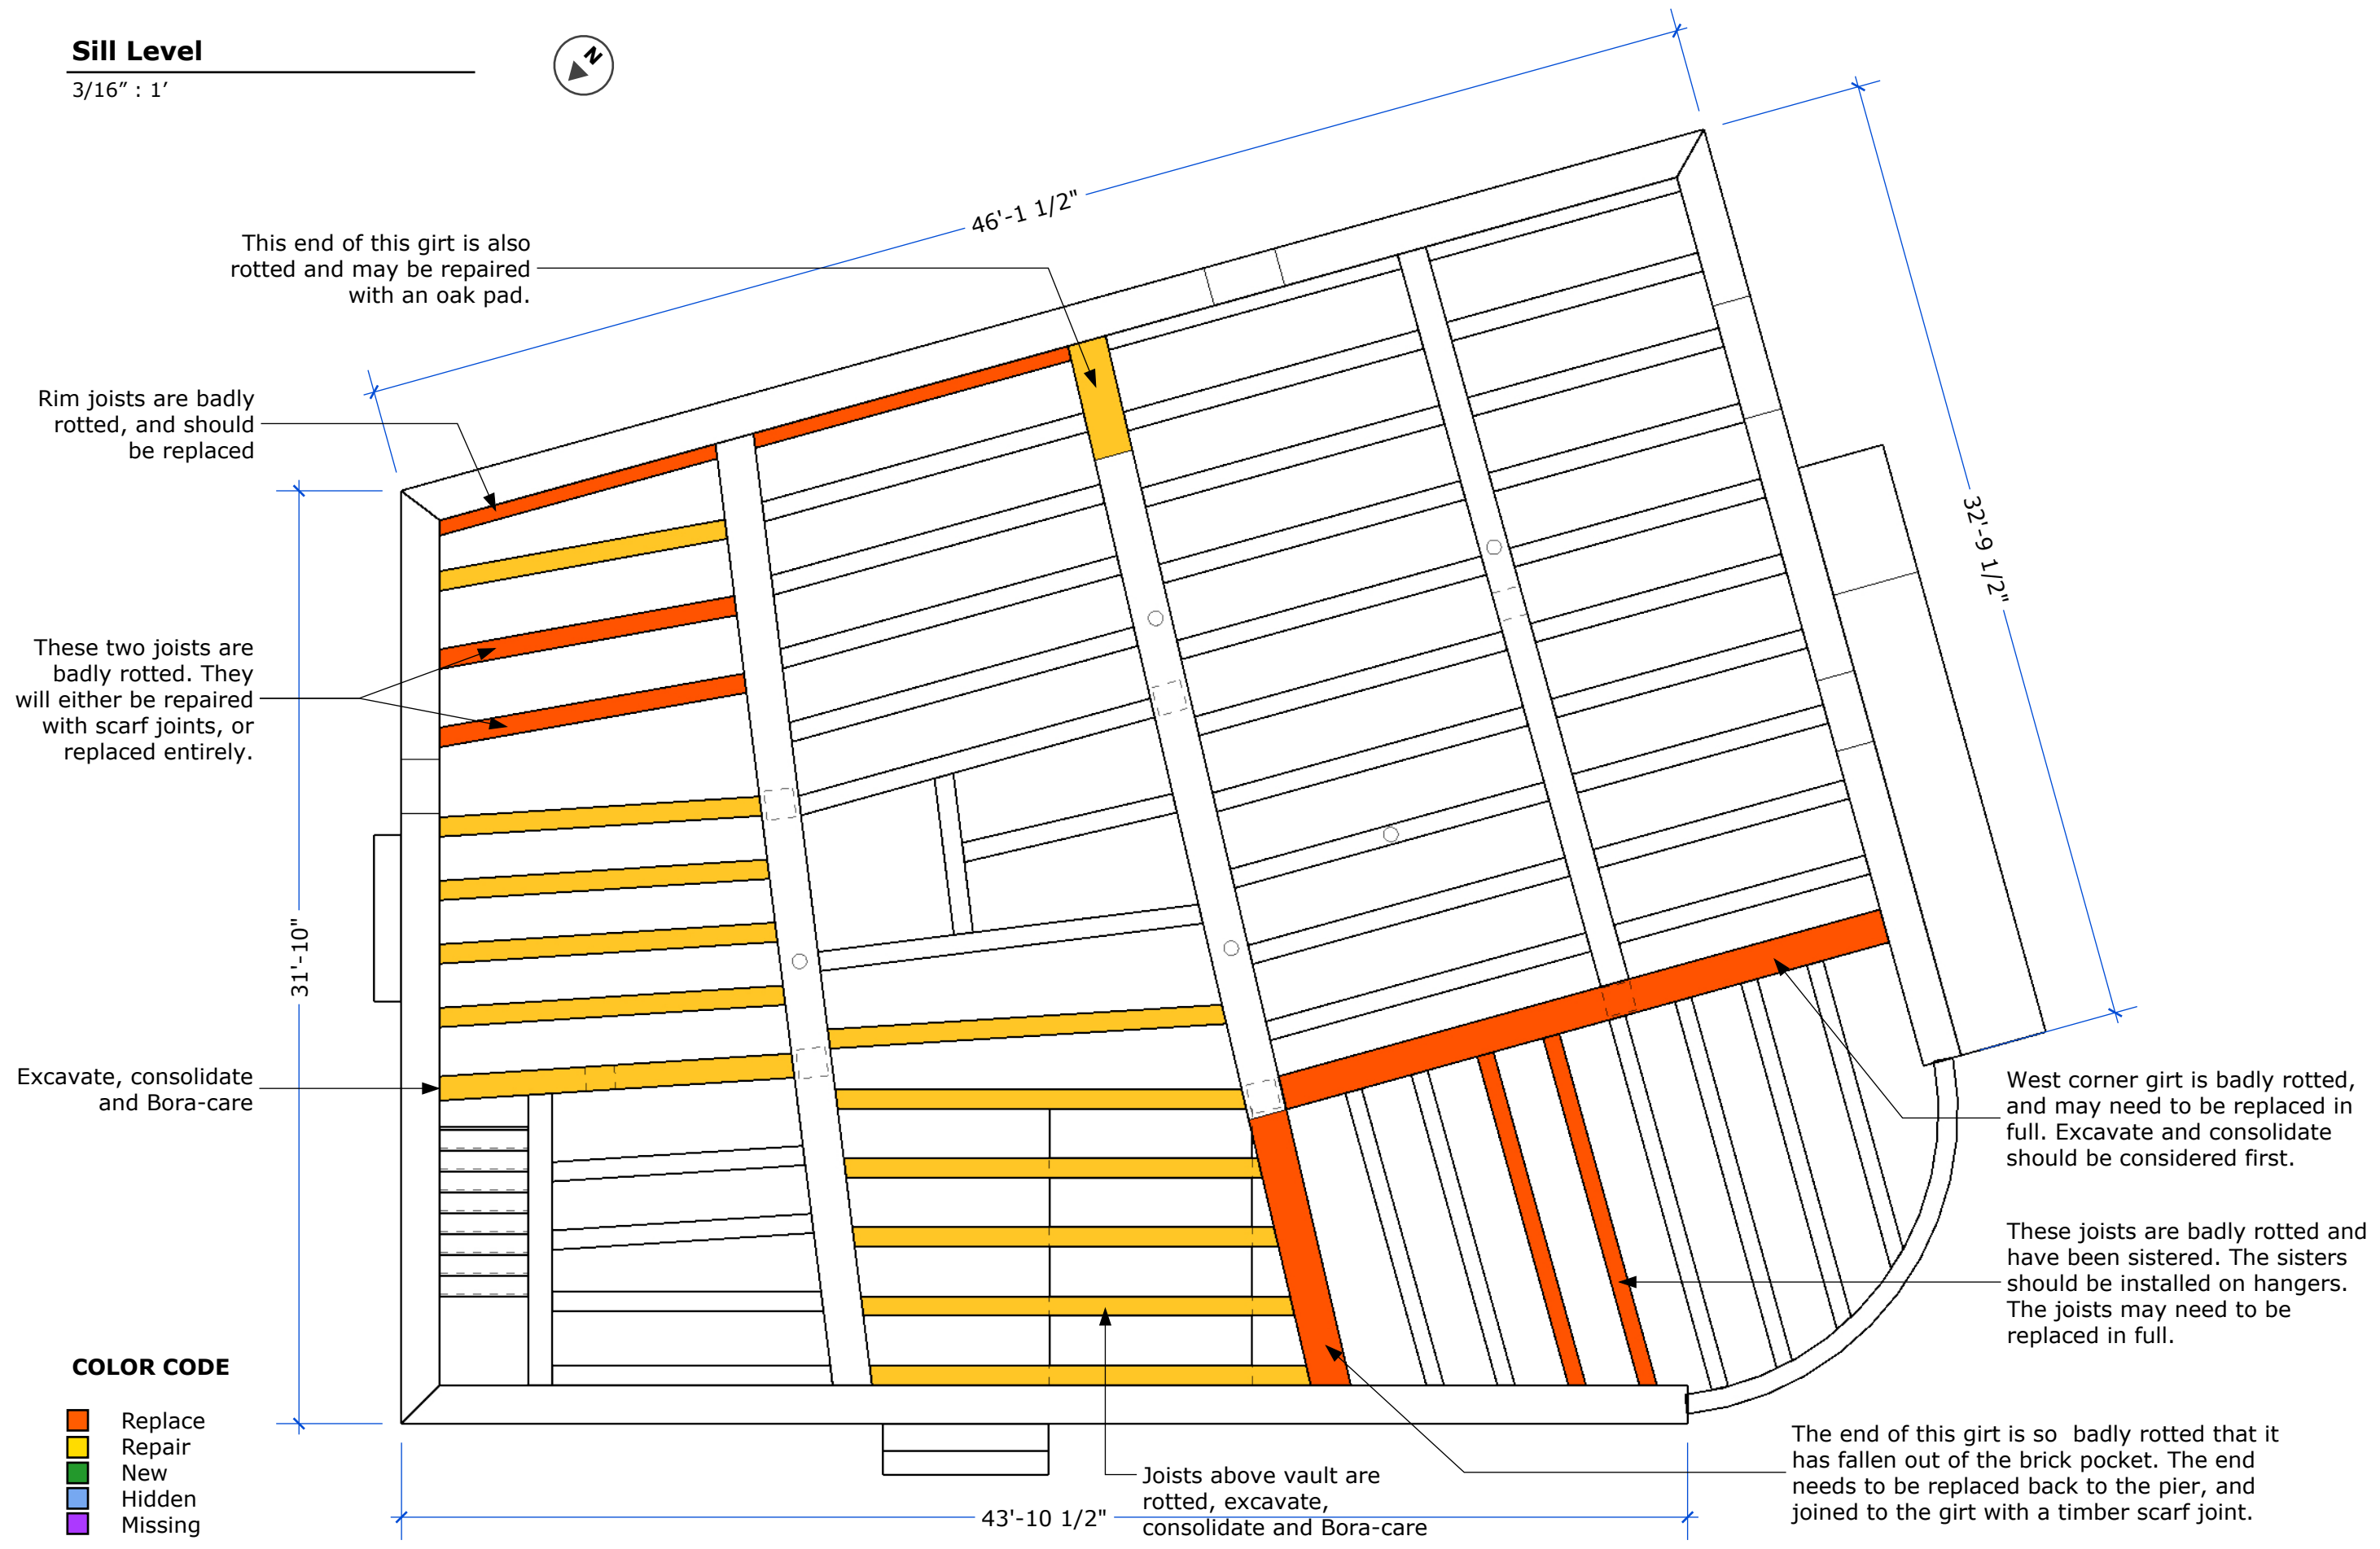
Sill Level

This end of this girt is also rotted and may be repaired with an oak pad.

Rim joists are badly rotted, and should be replaced

These two joists are badly rotted. They will either be repaired with scarf joints, or replaced entirely.

Joists above vault are rotted, excavate, consolidate and Bora-care

West corner girt is badly rotted, and may need to be replaced in full. Excavate and consolidate should be considered first.

These joists are badly rotted and have been sistered. The sisters should be installed on hangers. The joists may need to be replaced in full.

The end of this girt is so badly rotted that it has fallen out of the brick pocket. The end needs to be replaced back to the pier, and joined to the girt with a timber scarf joint.

Excavate, consolidate and Bora-care
