Mill Pond Dam Feasibility Study

Oyster River Dam at Mill Pond

Public Information Meeting
January 16, 2020

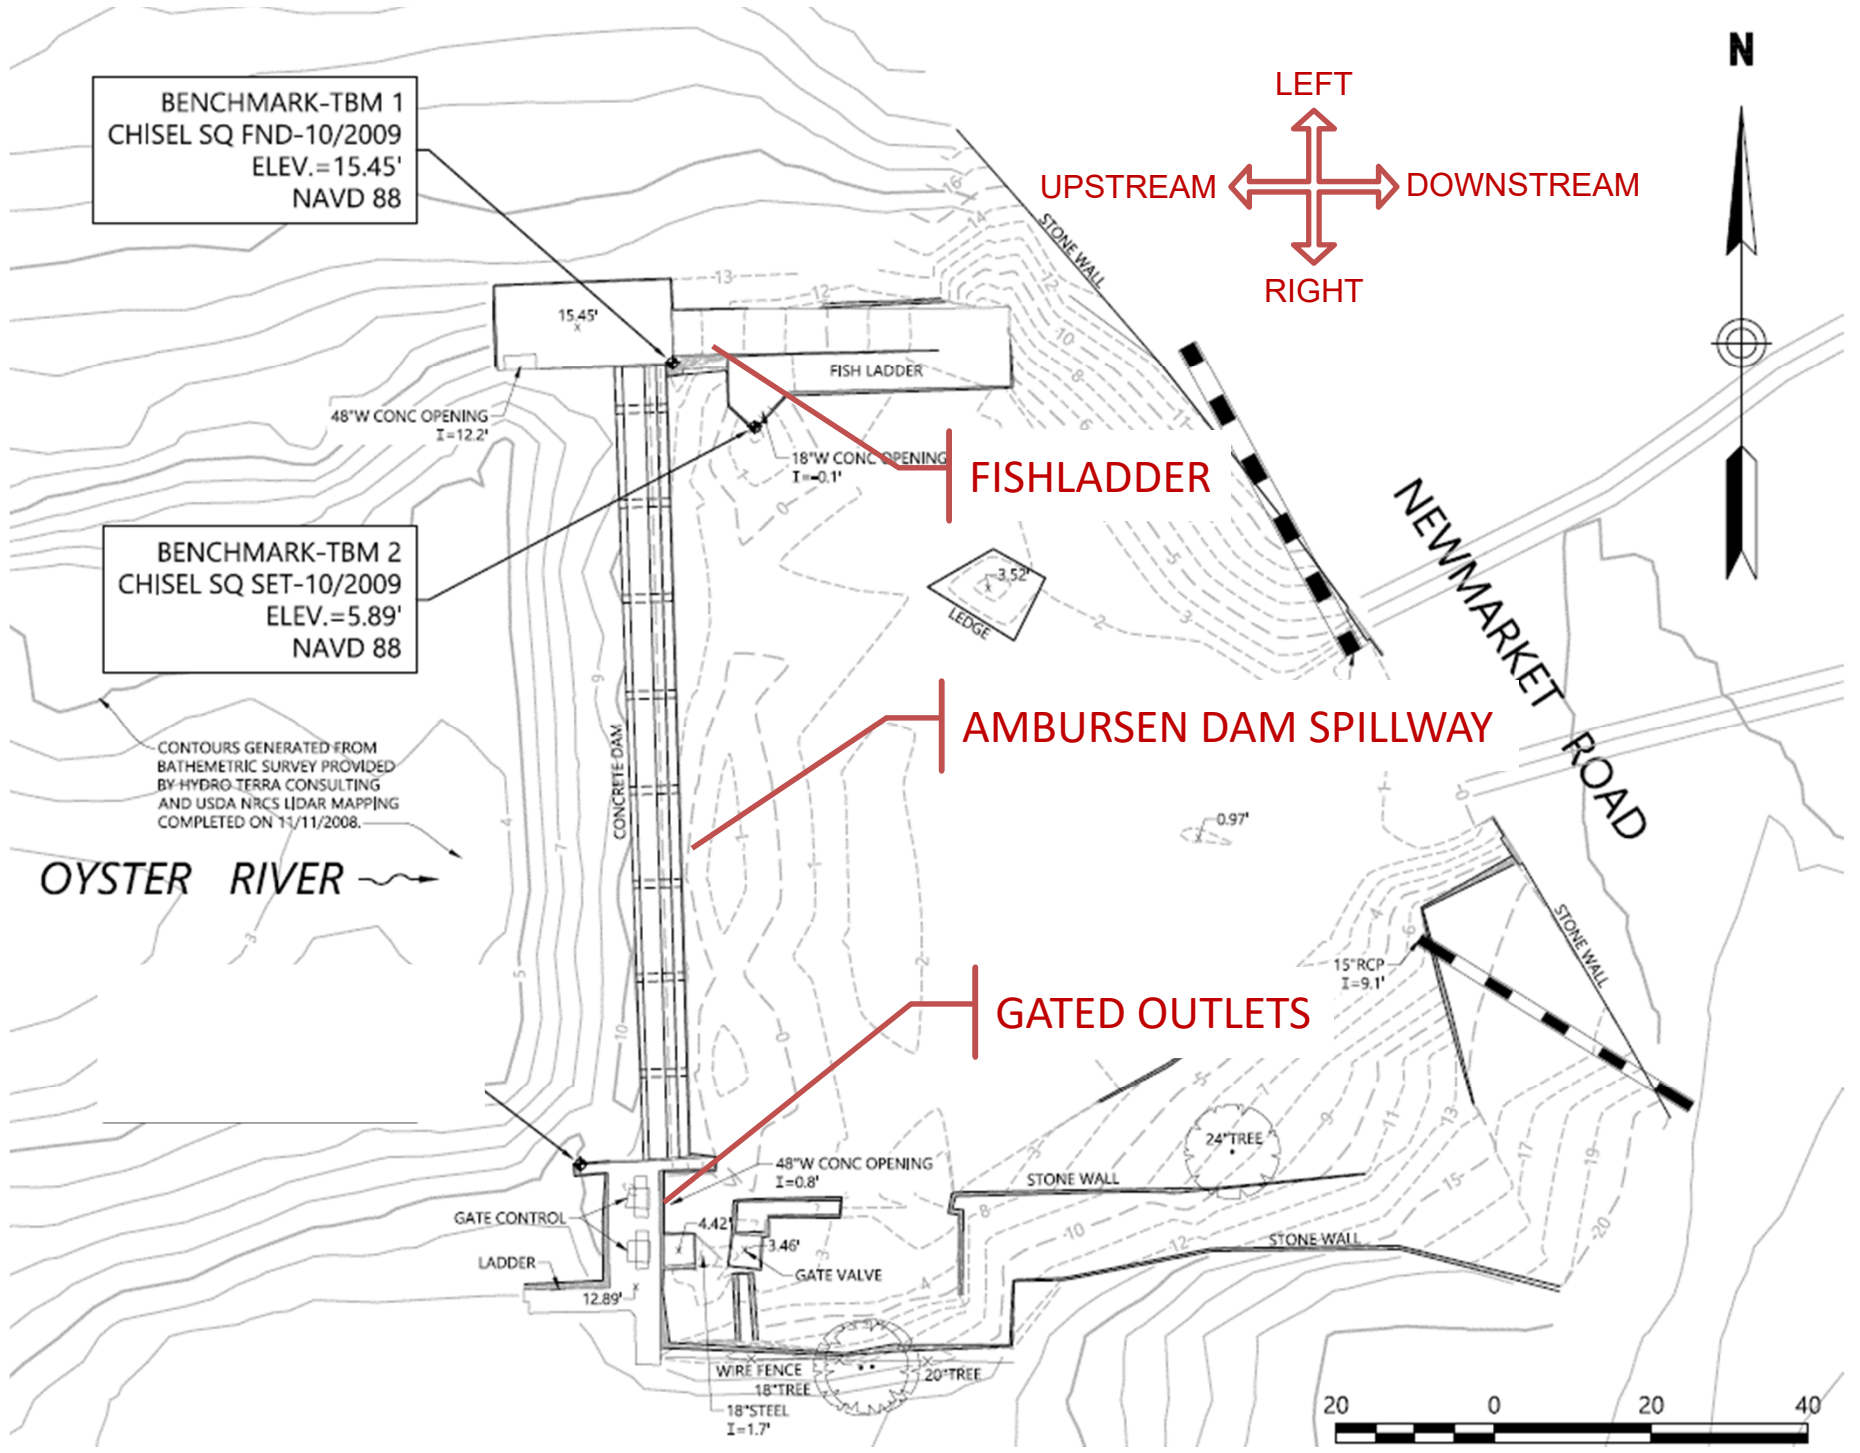
OYSTER RIVER

LEFT
UPSTREAM
RIGHT
DOWNSTREAM

FISHLADDER

AMBURSEN DAM SPILLWAY

GATED OUTLETS

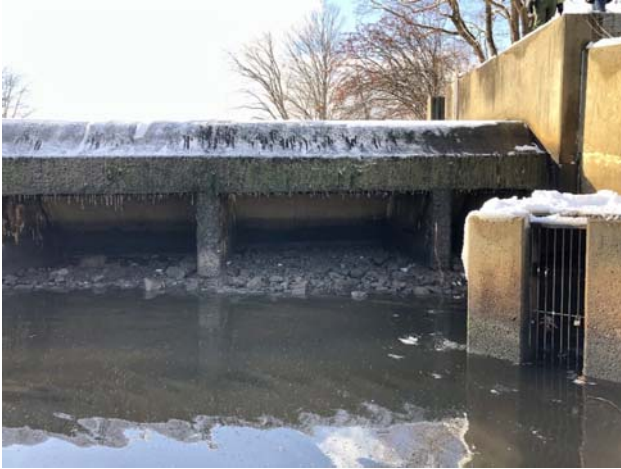
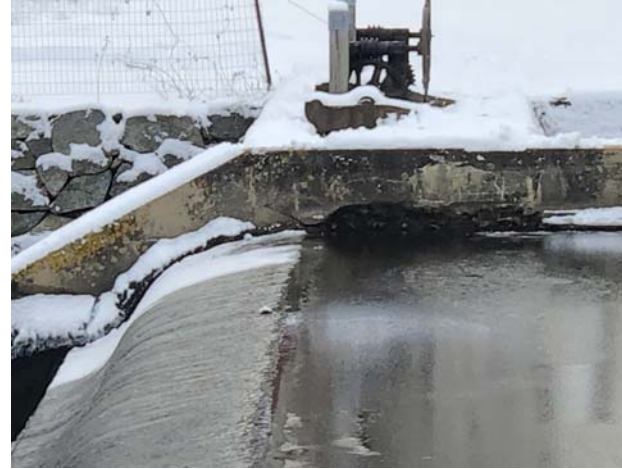
- December 18, 2019
- 4-inch Drawdown to facilitate inspection
- Visual & Tactile Inspection of Above Water Components of the Spillway, Gate Headwalls, and Dam Sections
- Included:
 - Spillway “Exterior”
 - Spillway “Interior”
 - Gates
 - Fish Ladder

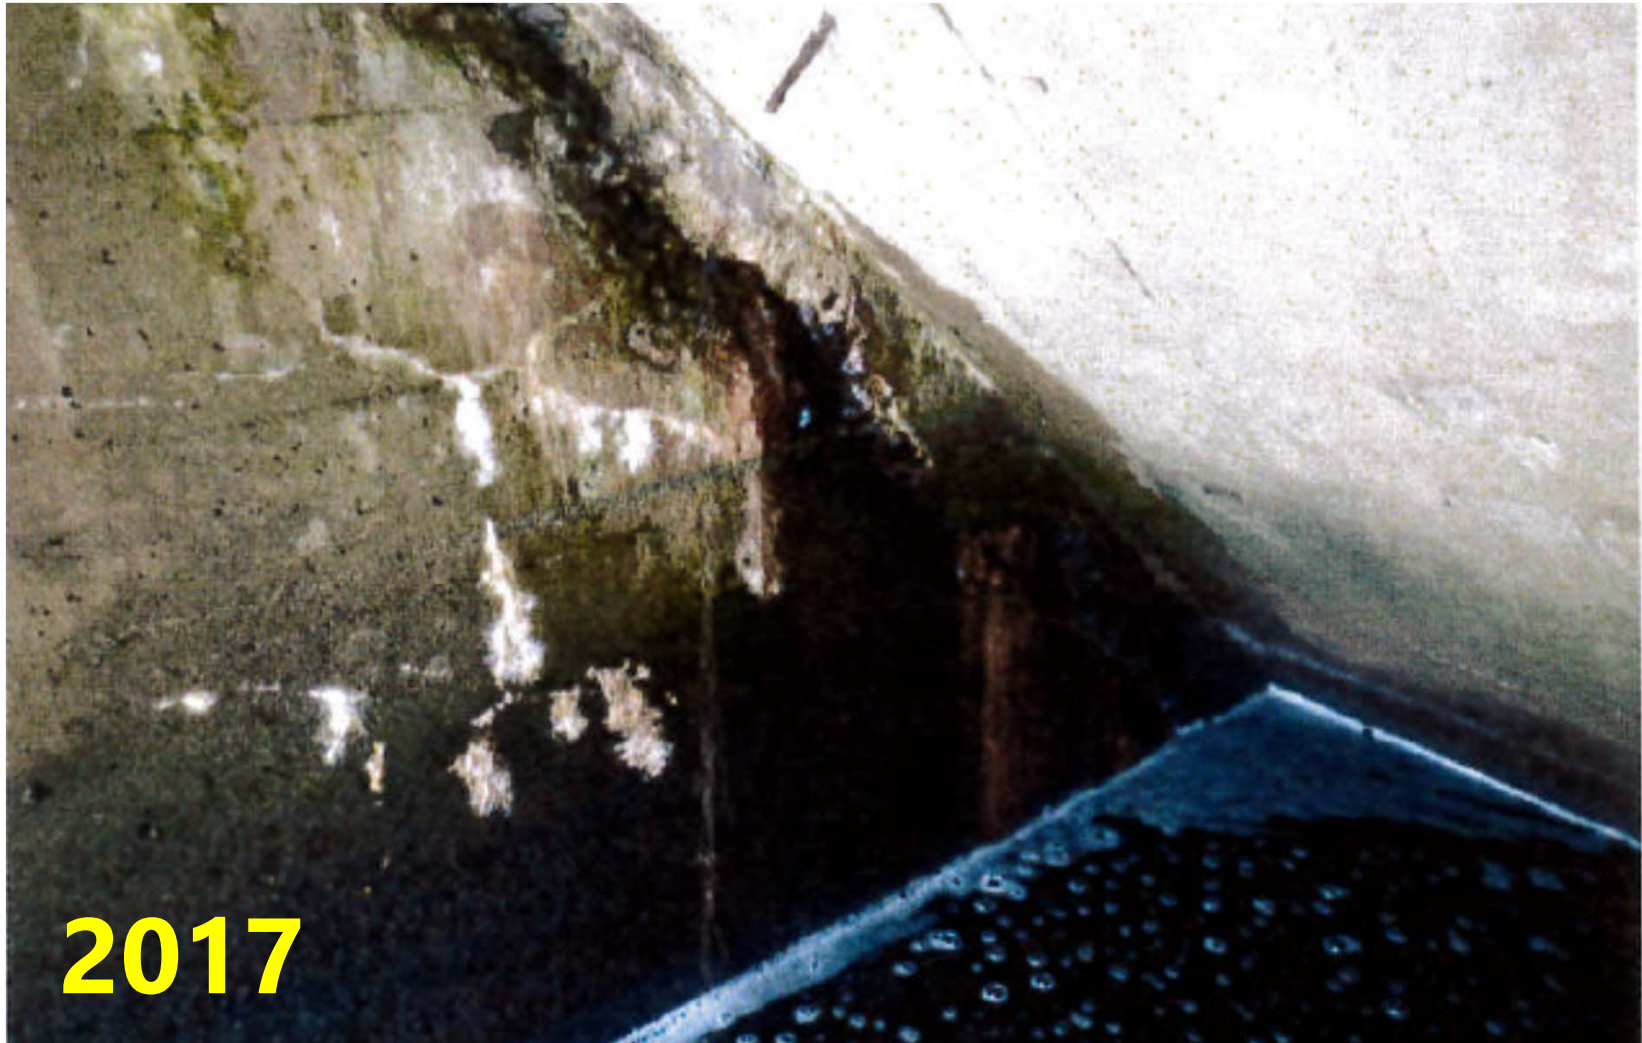
- Examples of Deterioration Progression

- Gress Study Concurrence
 - Concrete Deterioration
 - Advanced Deterioration
- Degradation of Concrete Has Continued
- Short Term Stability Concerns
- Next Steps
 - Evaluate Impacts to Alternatives
 - Assess Replacement Requirements
 - Consider life expectancy for Alternatives

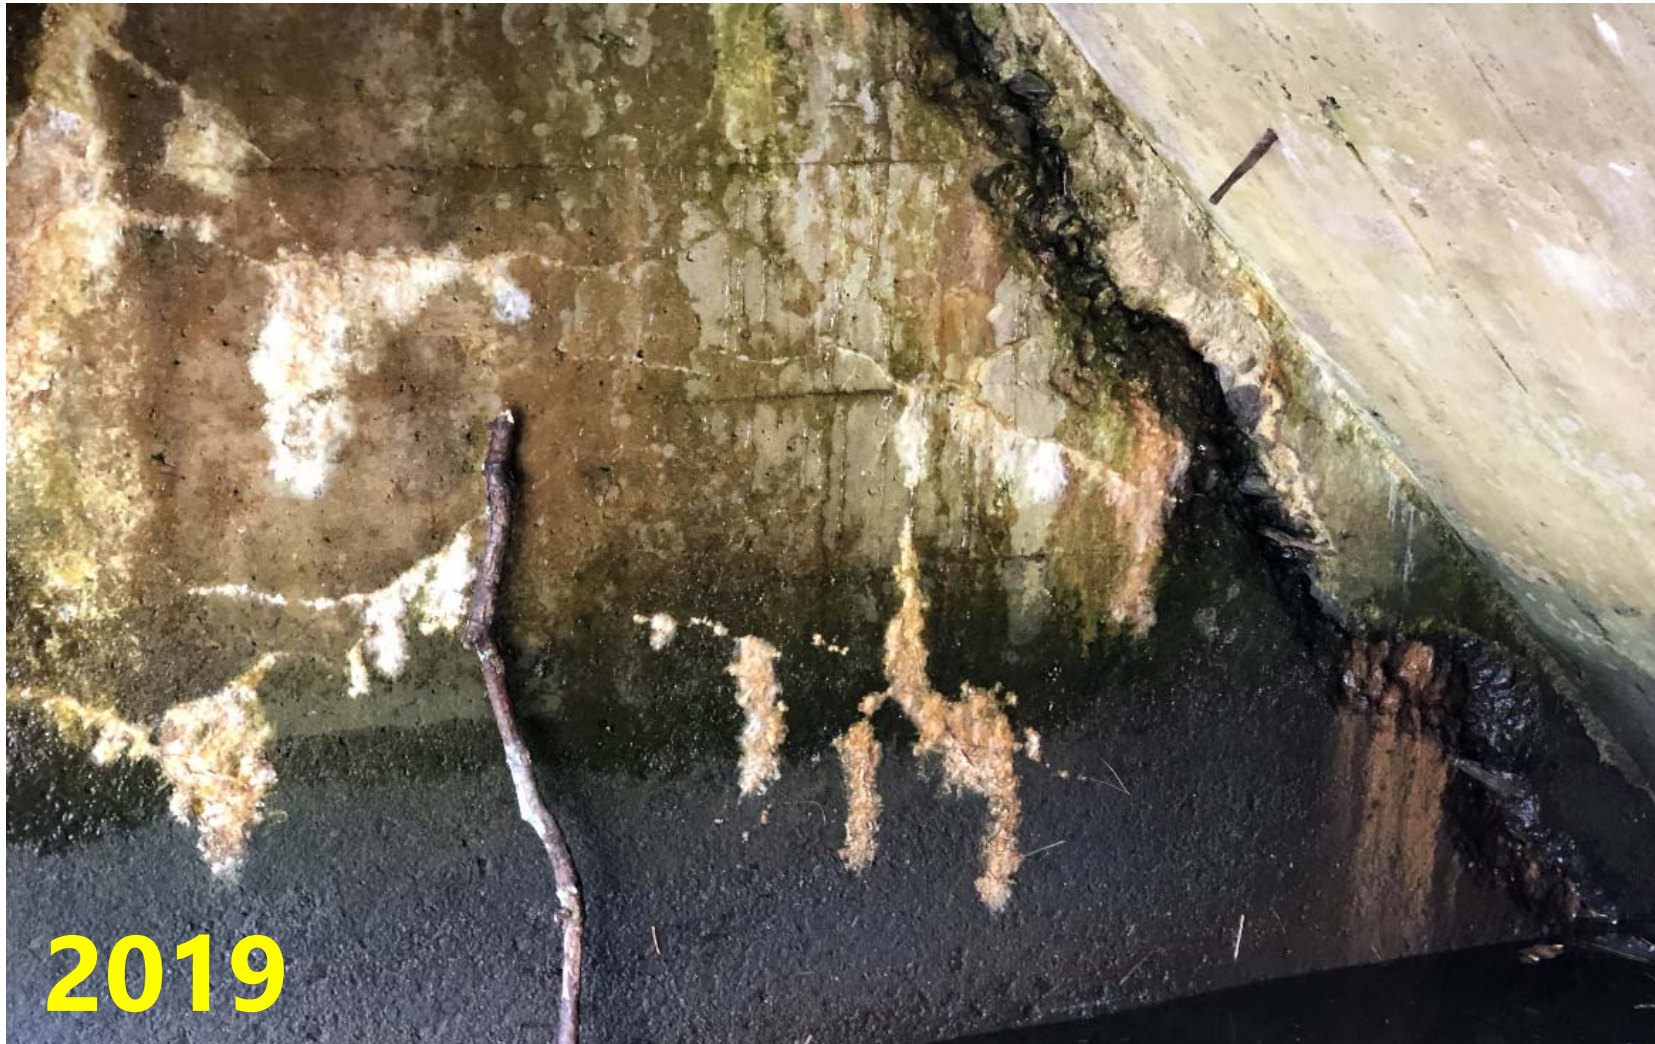
- Examples of Deterioration Progression

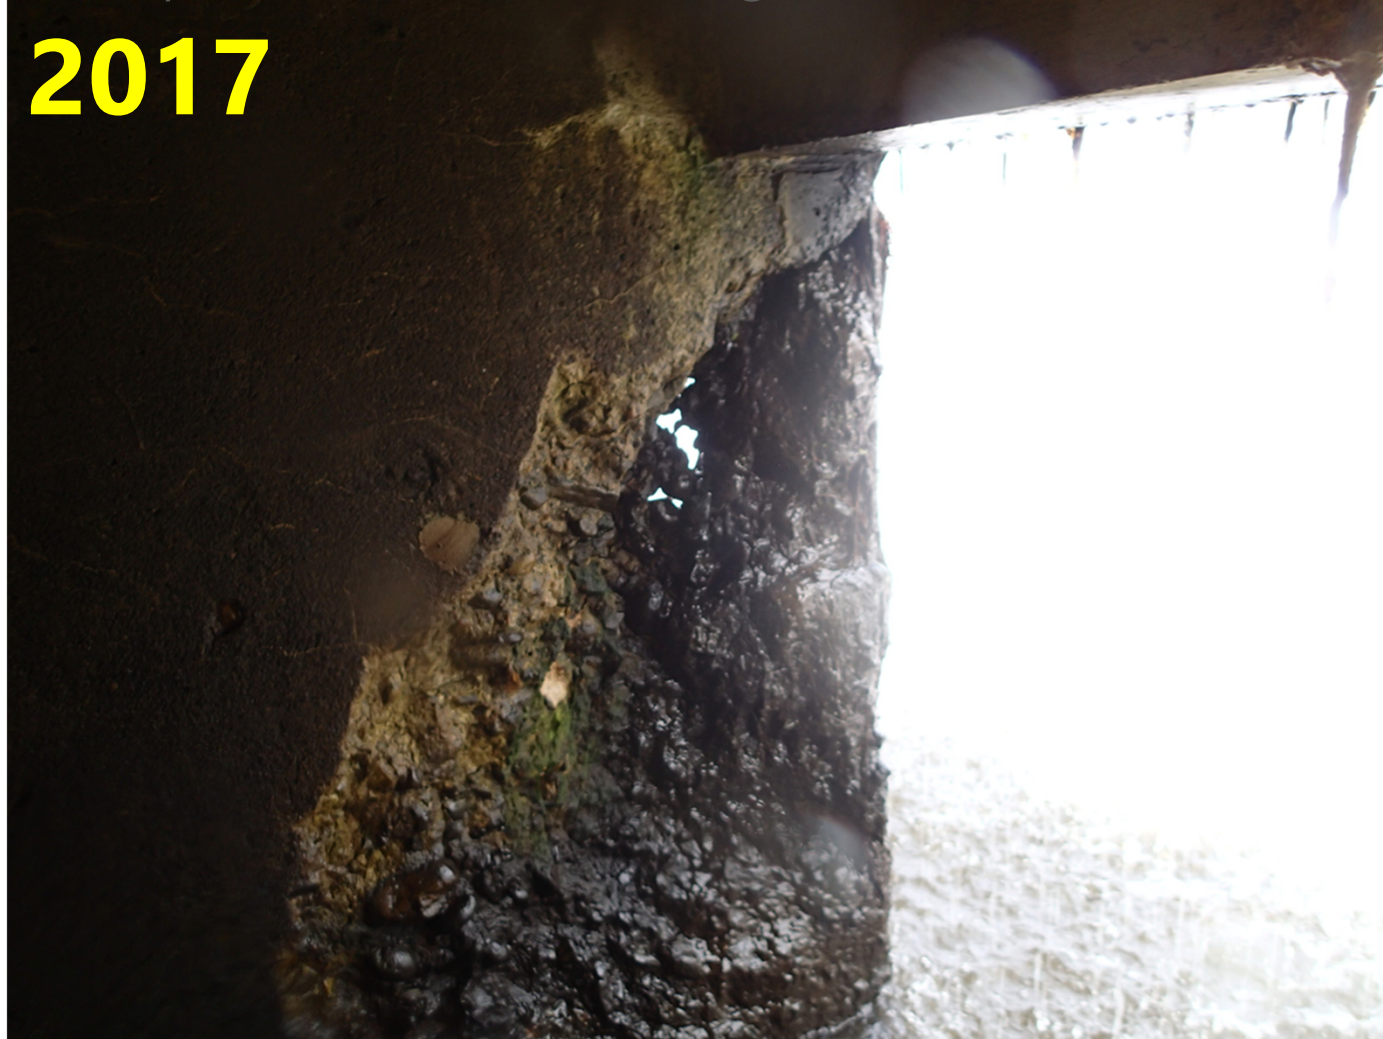
- Examples of Deterioration Progression

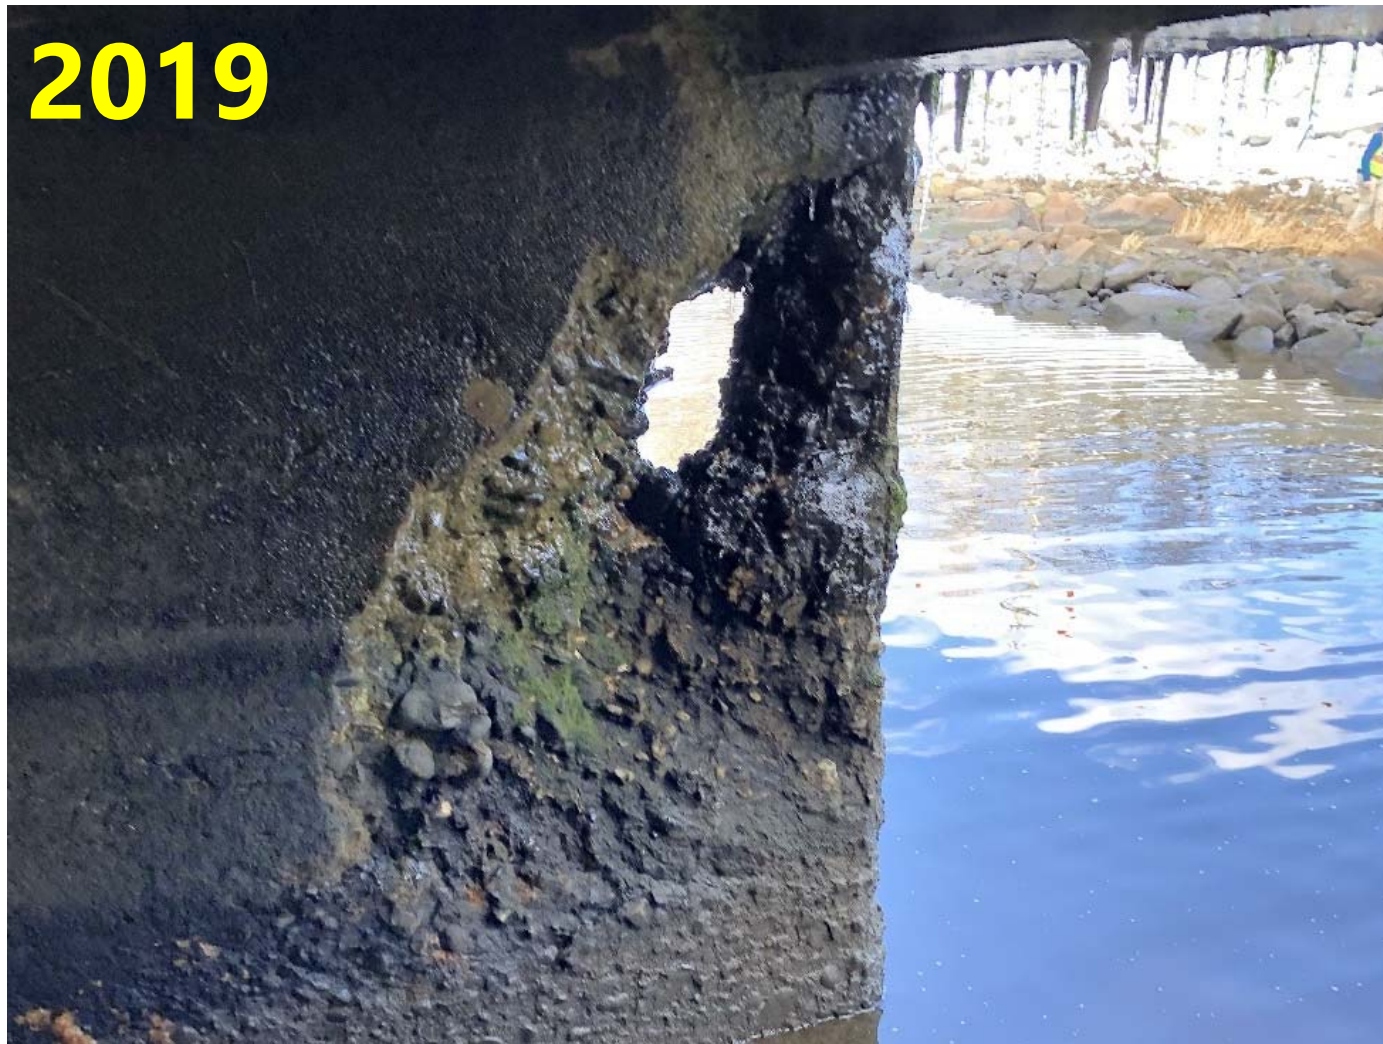
- Examples of Deterioration Progression

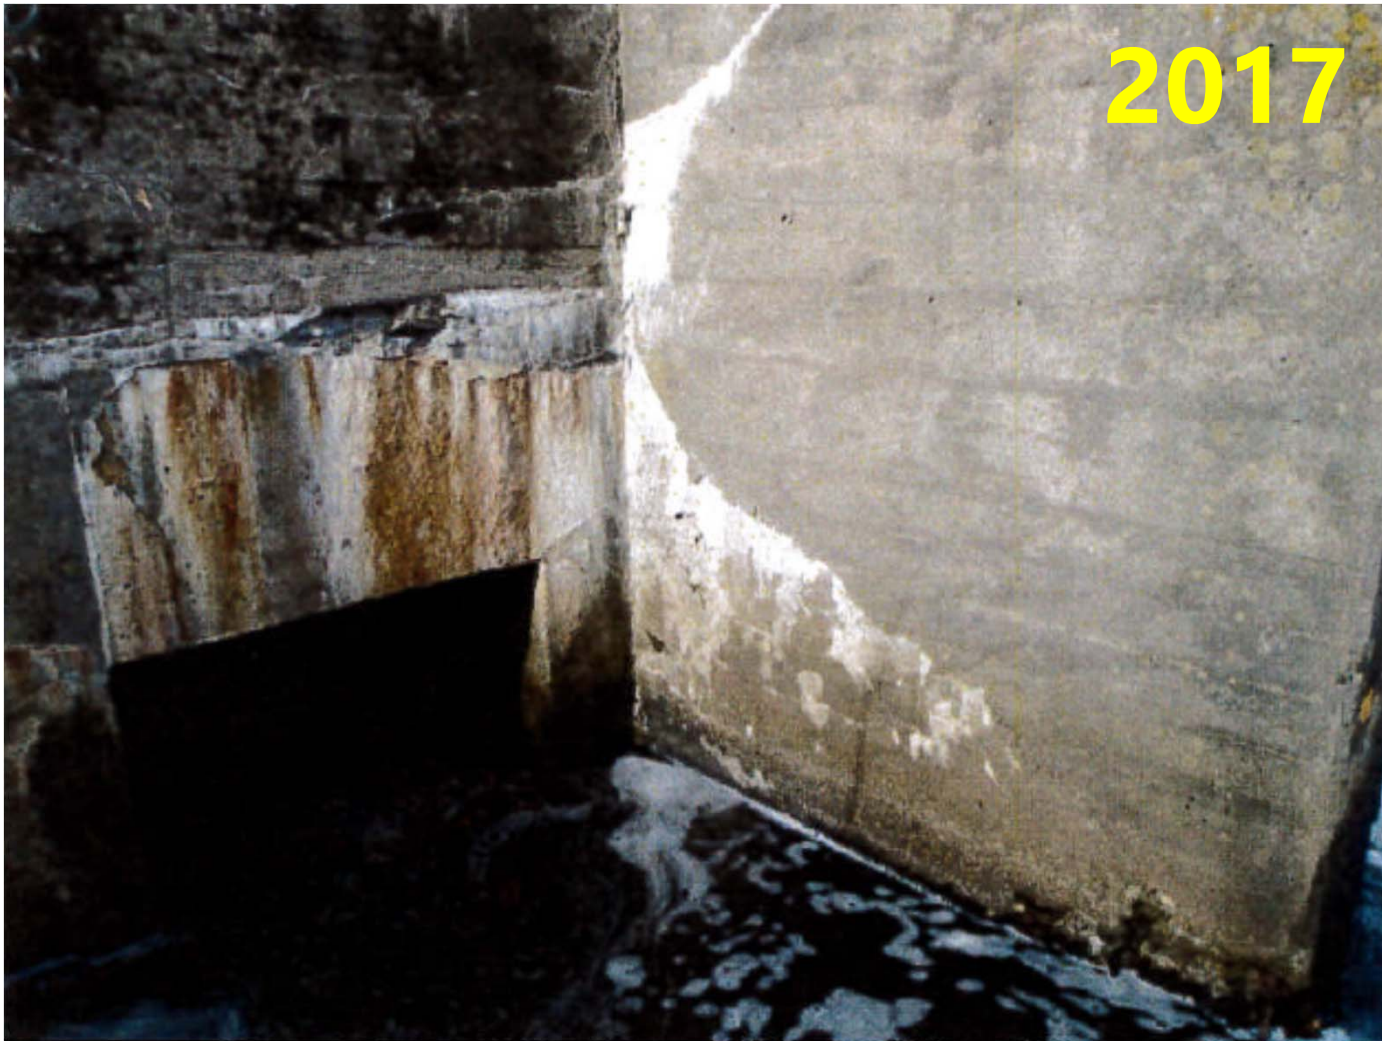
- Examples of Deterioration Progression

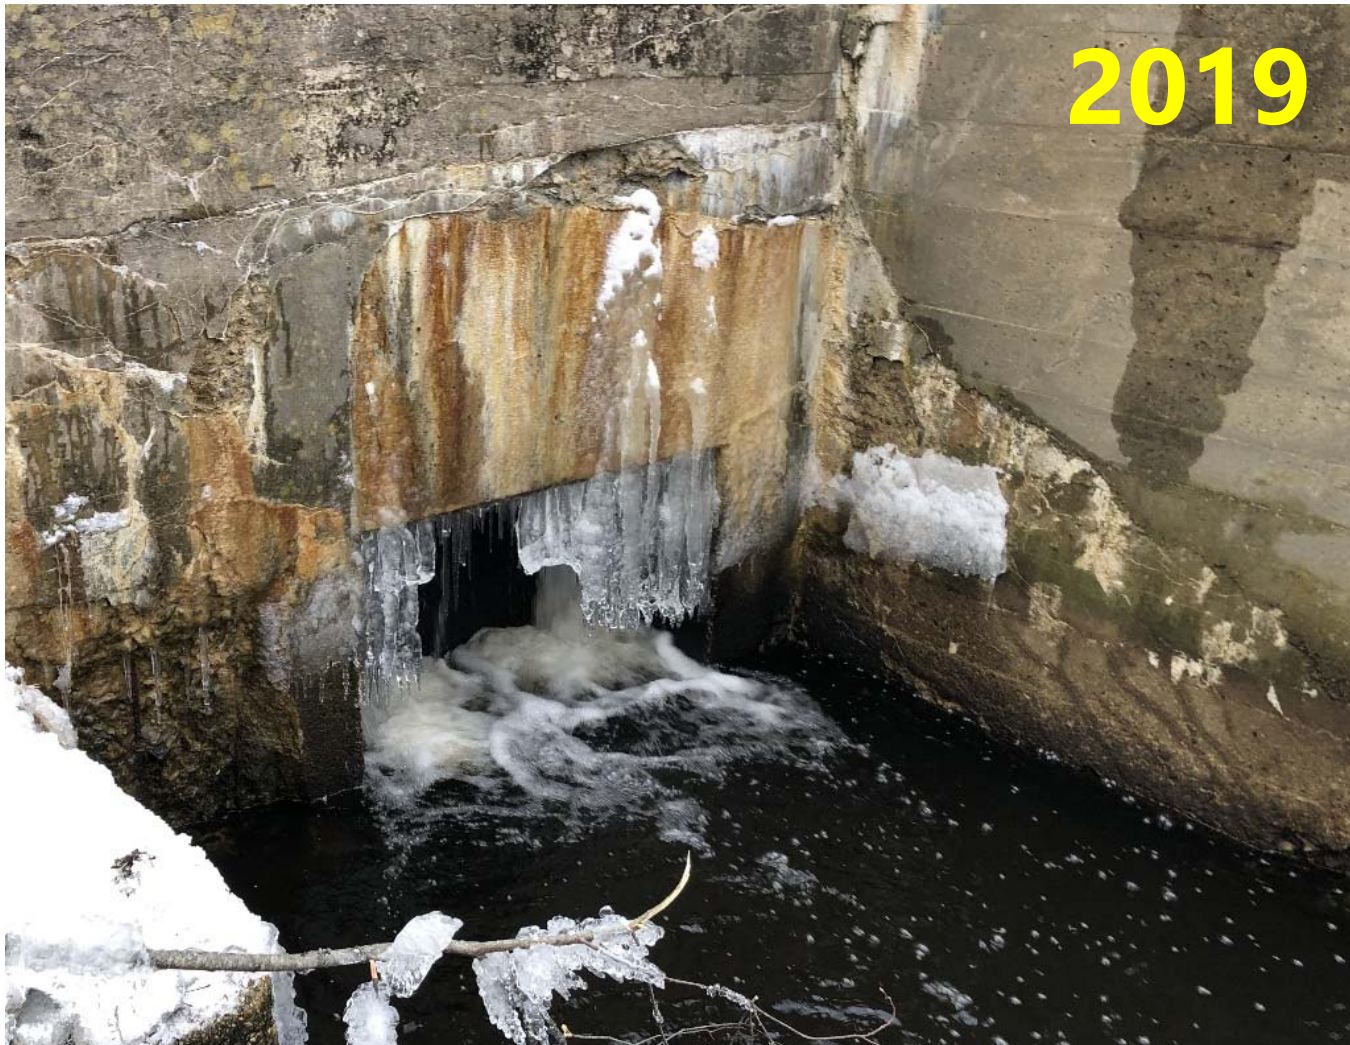
- Examples of Deterioration Progression
