### College Brook Report

## **REPORT TO THE MILL PLAZA STUDY COMMITTEE**

The College Brook Restoration Work Group volunteered to prepare a brief report for the Mill Plaza Study Committee to identify the opportunities to restore the ecological health of College Brook (the Brook) associated with the proposed redevelopment of the Mill Plaza. The audiences for this report are Mill Plaza Study Committee members and AIA150 Design teams.

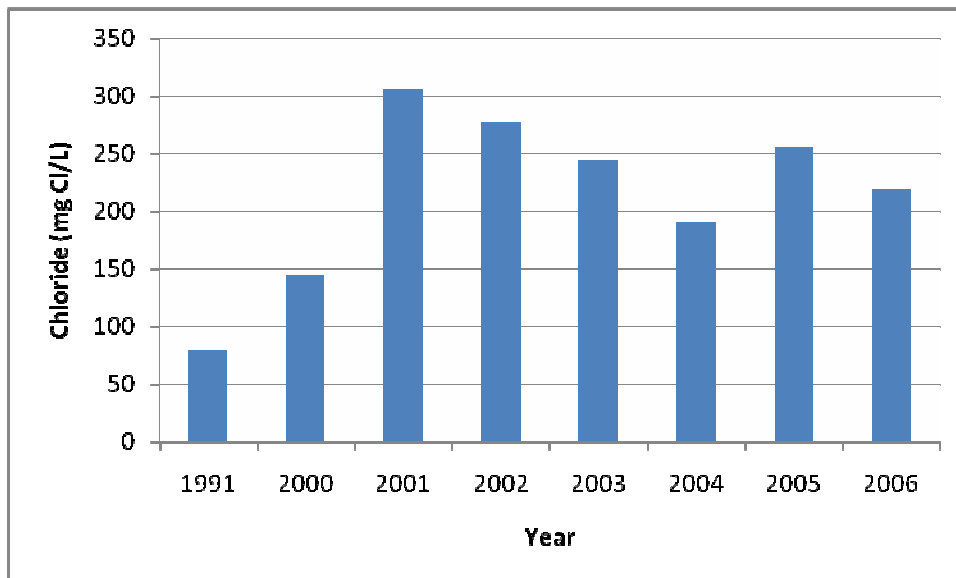
**Figure 1.** Average annual chloride concentrations in College Brook based on monthly samples.

*Water quality* along the length of the Brook is poor, and has been measured at least since 1991 (Figure 1 below and Table 2, page 4). Nitrogen levels are high. Chloride levels are very high, and the Brook was recently listed as impaired due to chloride levels by the NH Department of Environmental Services. Although some water quality parameters have improved since 1991 (BOD, DO, and phosphate in particular), chloride and nitrate levels appear to have increased.
