Pike Family Revocable Trust of 2021 Conservation Easement

Durham, New Hampshire

Baseline Documentation Report

June 2023

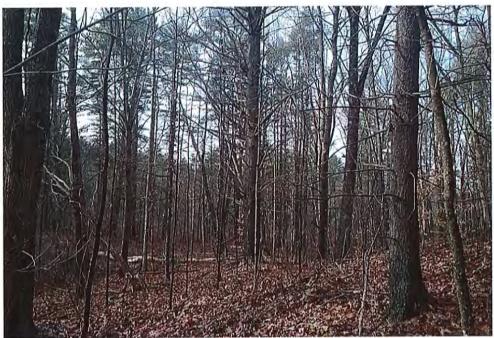
Map Ref.: 37 Date: 12/6/2022

Standing within southern portion of Property, looking west at approx. 70x20 -ft. area along edge of wetland with scattered debris of glass, rusted metal pieces and car parts, 3-4 tires and 2-3 tire tubes. This is an old area of debris and is integrated into the forest floor. Note wetland in left side of frame with good forest buffer.

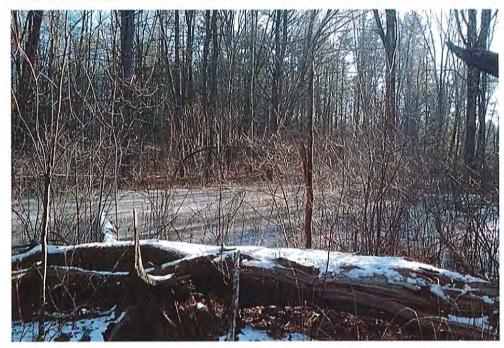
Map Ref.: 38 Date: 1/11/2023 File Name: Photo: 40 photo_Pike_2023-01-11_(40) Photographer: Shaun Dillon

Standing within southern portion of Property, looking southeast at vernal pool with good forest buffer.

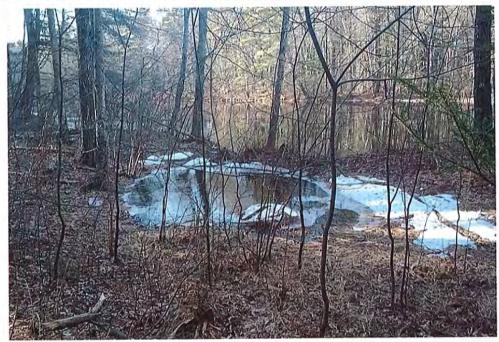
Map Ref.: 40 Date: 1/11/2023 File Name: Photo: 39 photo_Pike_2023-01-11_(39)

Standing in western portion of Property, looking southwest at vernal pool with good forest buffer which is connected with the Lamprey River, in the background, at high water levels.
