Durham Old Town Hall

Existing Conditions Photo Report

By Jessica MilNeil | December 11, 2019

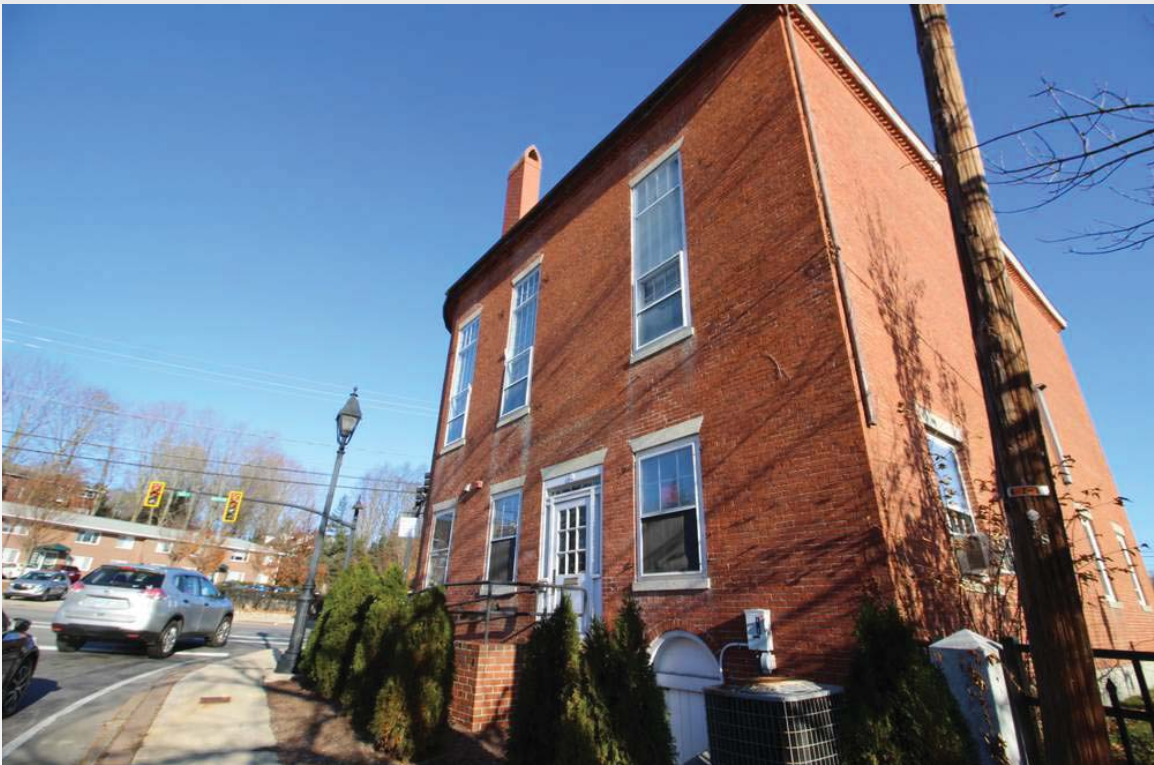
2 NH-108 | Durham, New Hampshire Nov 13, 2019 | 9:01 AM Jessica MilNeil

South Corner. This is one of two corners that creates a right angle.

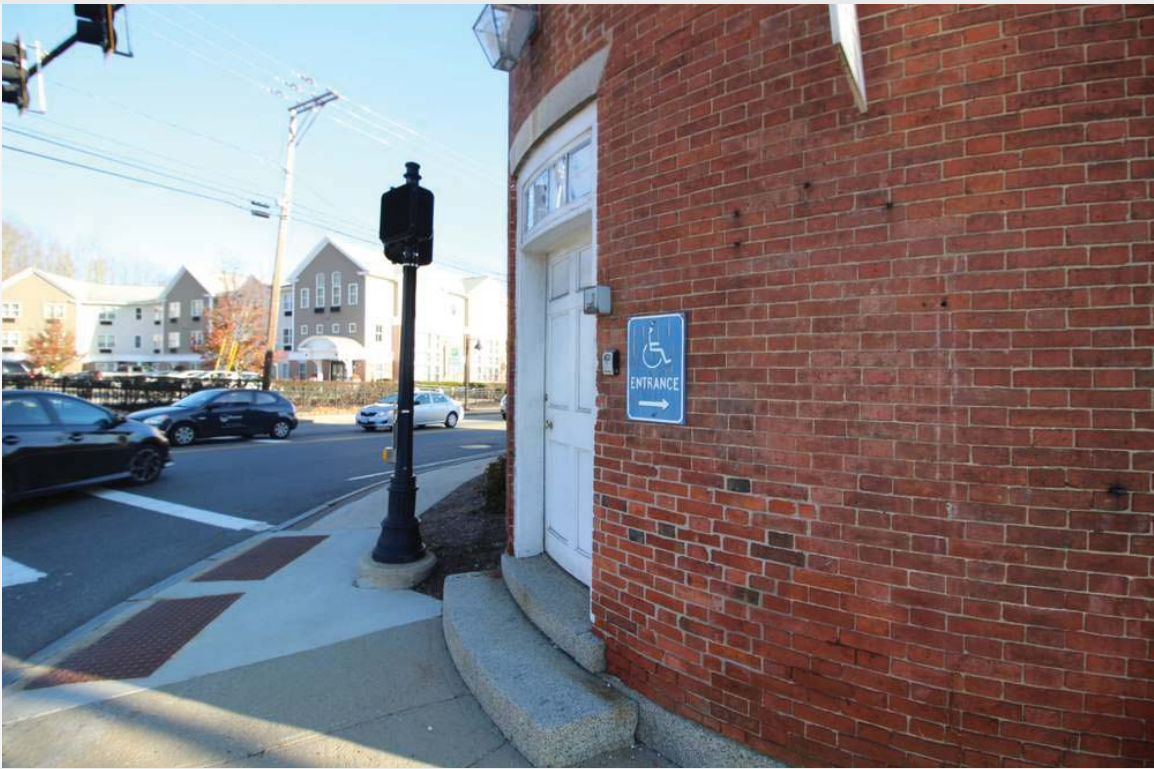
4 NH-108 | Durham, New Hampshire Nov 13, 2019 | 9:01 AM Jessica MilNeil

The street is very close to the building. Many cities are choosing to remove slip lanes like this one to improve pedestrian access.

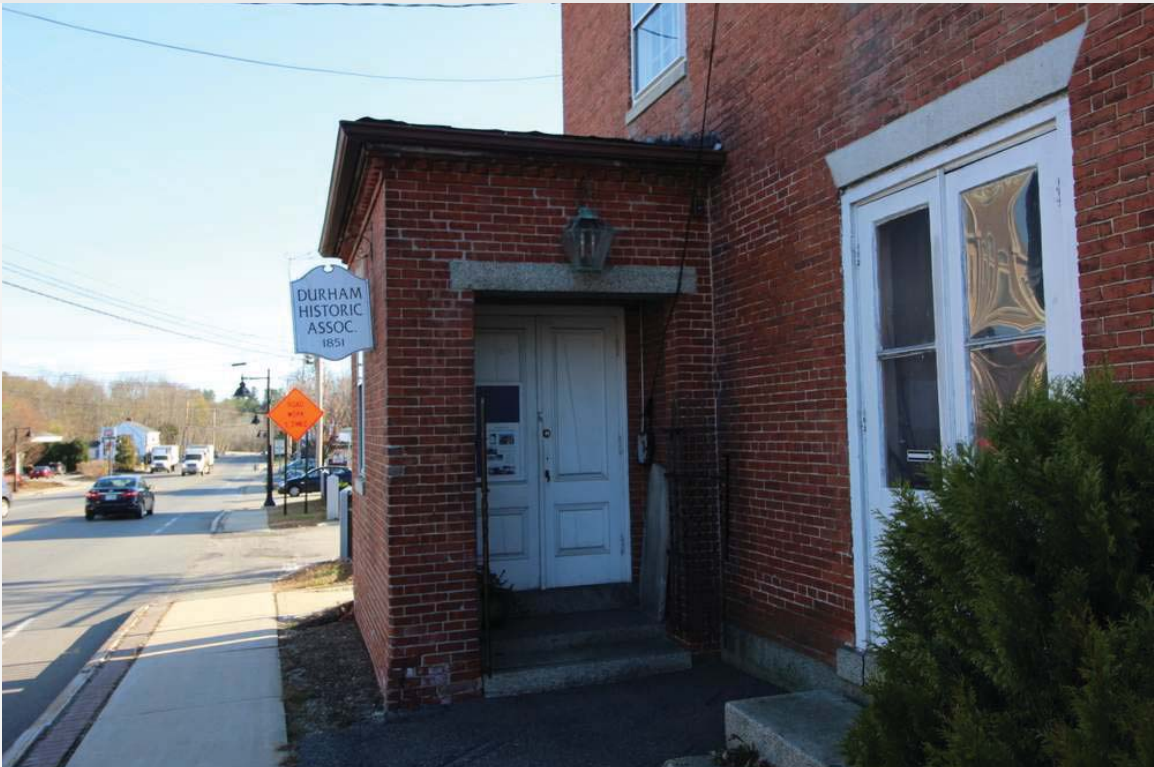
7 NH-108 | Durham, New Hampshire Nov 13, 2019 | 9:02 AM Jessica MilNeil

This one-story entrance allows access to the stairs. Notice the granite lintel above the entrance.

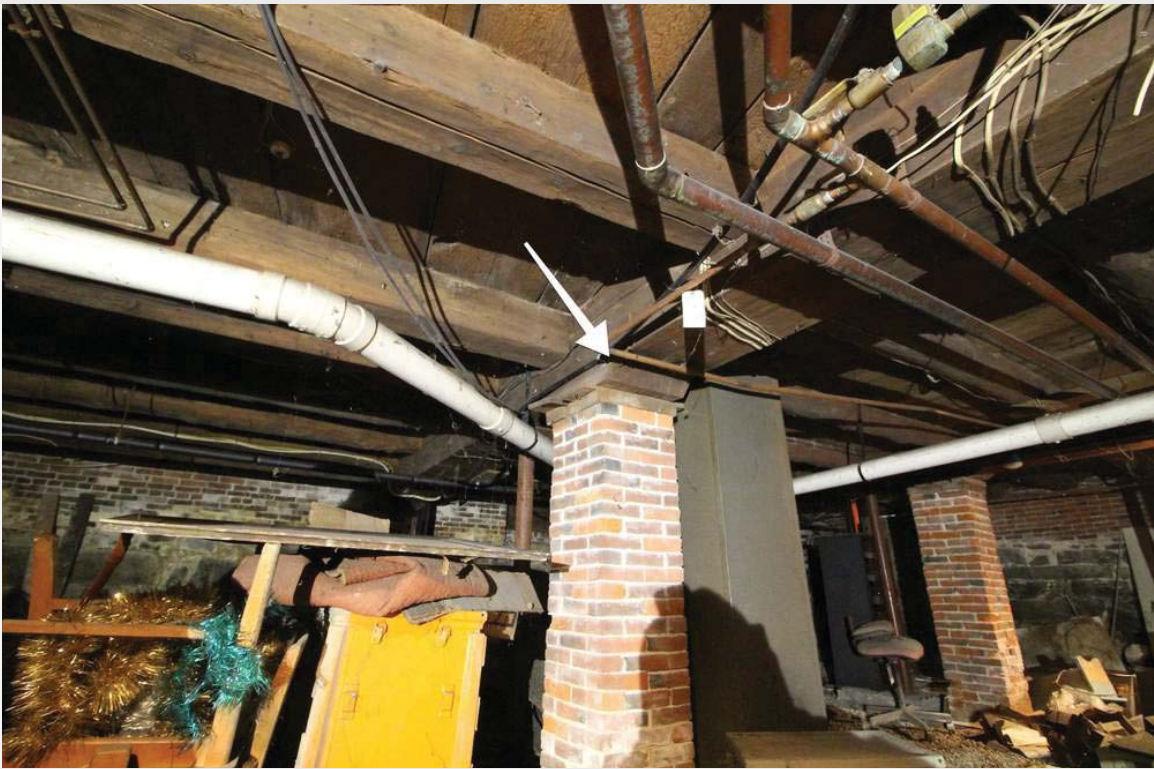
8 NH-108 | Durham, New Hampshire Nov 13, 2019 | 2:53 PM Jessica MilNeil

Undercarriage is supported by five major floor girts, only two of which are full length from brick to brick. The girts are enormous; at the piers they measure up to 14" x 17". The girt is relieved where it crosses the open span, which would have taken an enormous investment of labor.

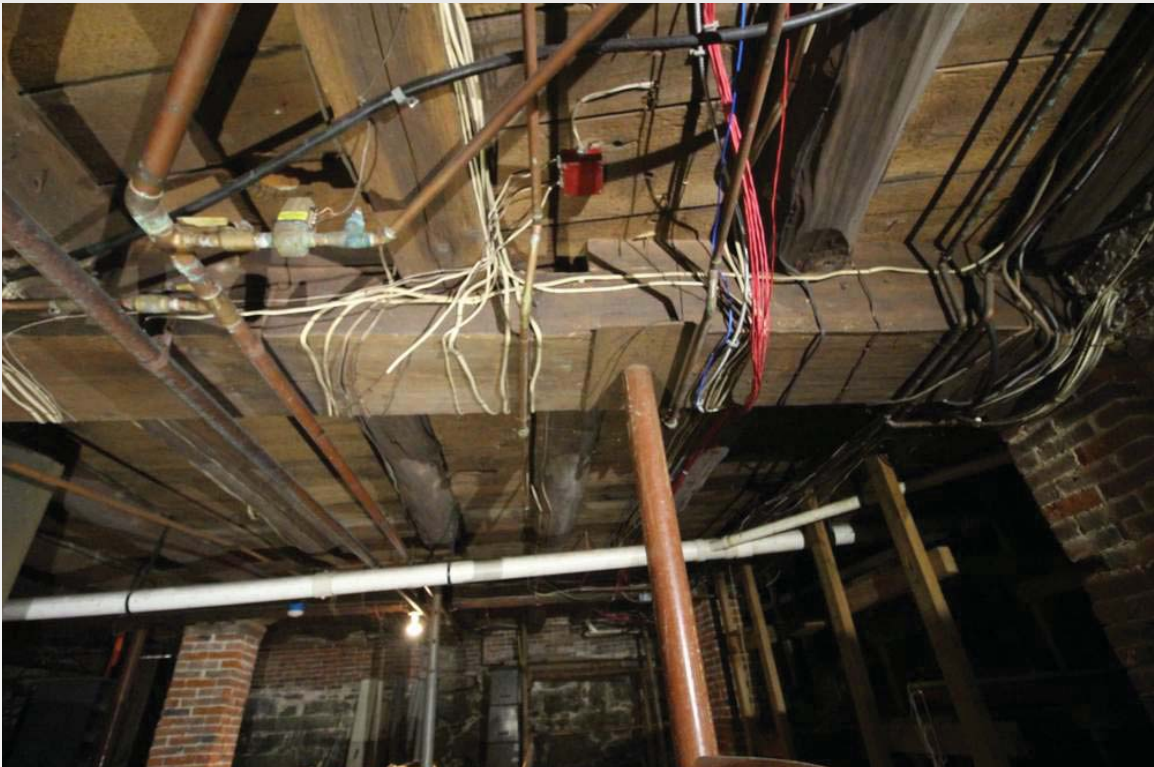
13

A combination of hewn square and round log joists can be seen on either side of this major floor girt. A lally column provides additional support near an original pier. (probably to carry the excess cable weight).

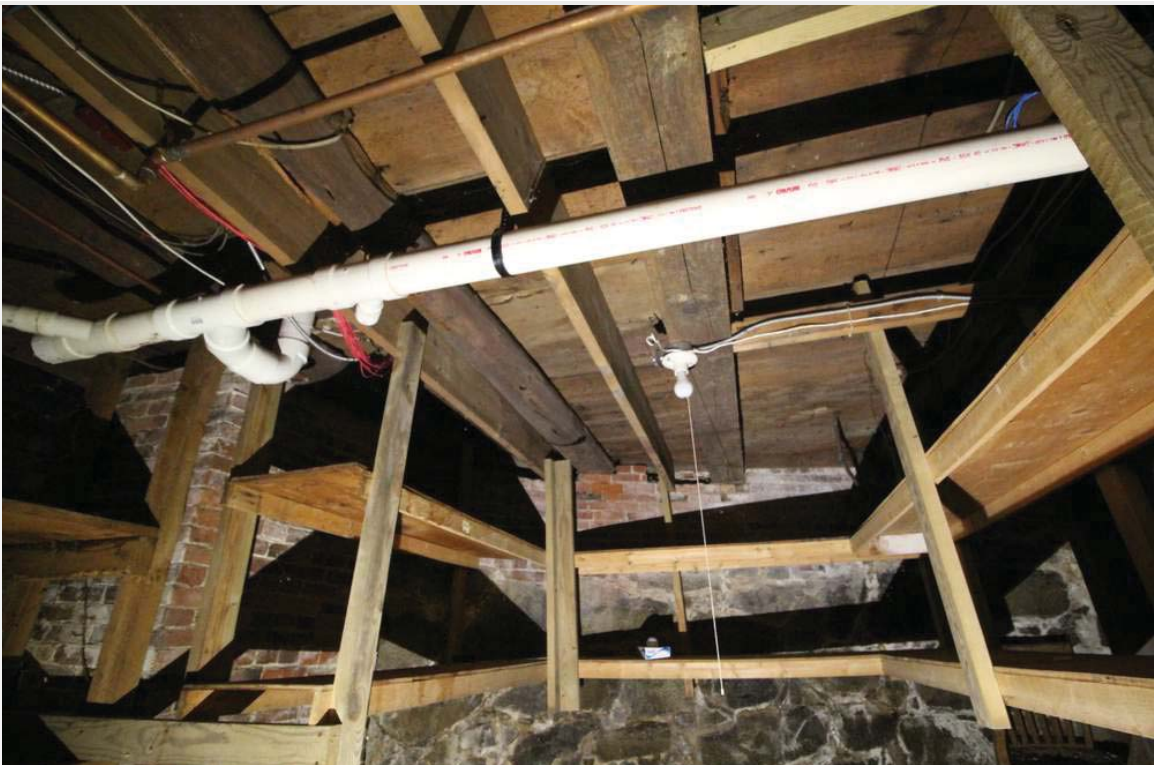
15

West corner, with log joists, hewn, squared joists, and sisters.

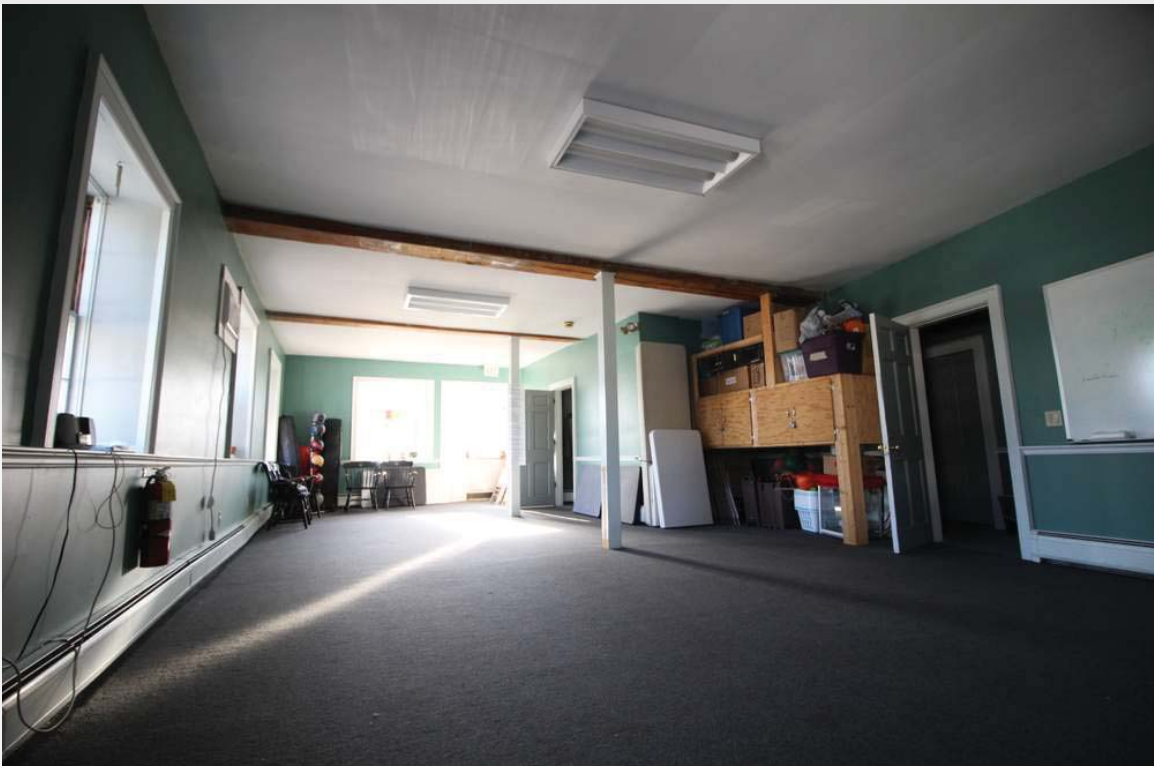
29

This large open space is created by the heavy timbers above. This room is supported by the timbers in Photos 11,12,16,17, 22-24.

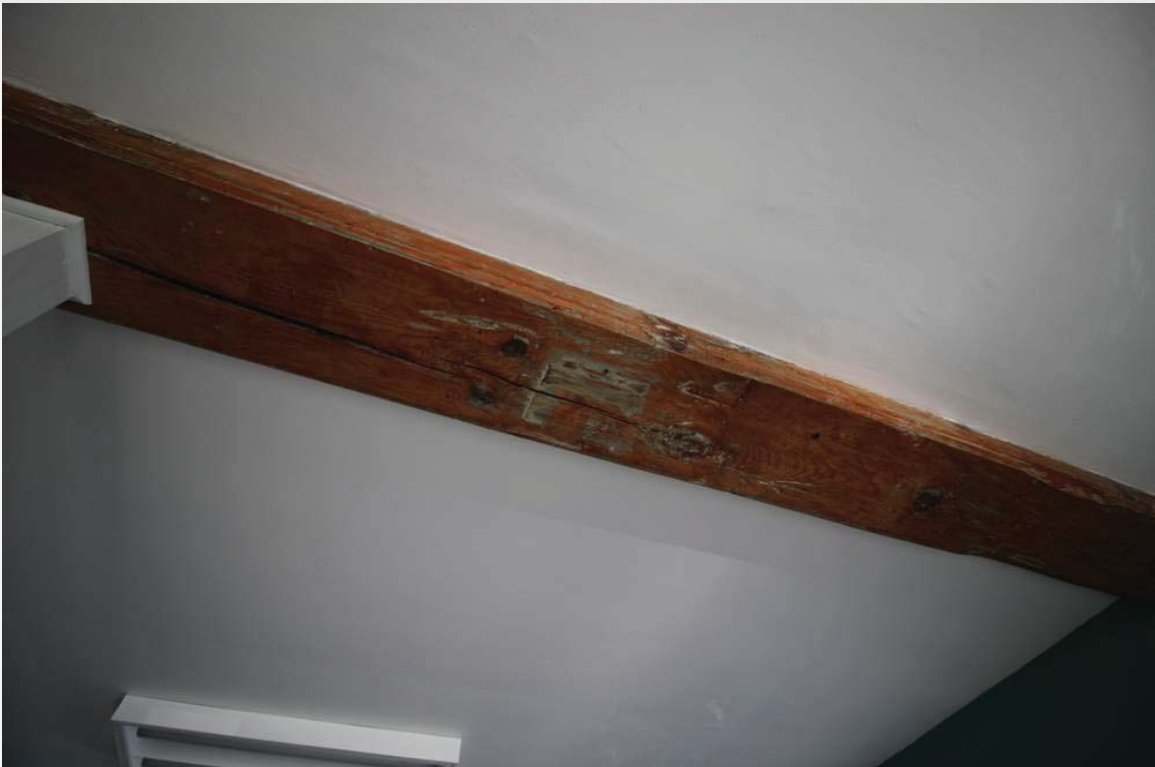
30

The major second floor girts were intended to be seen. Their exposed corners were molded with a molding plane. Evidence of former column locations can be seen in the paint shadow lines.

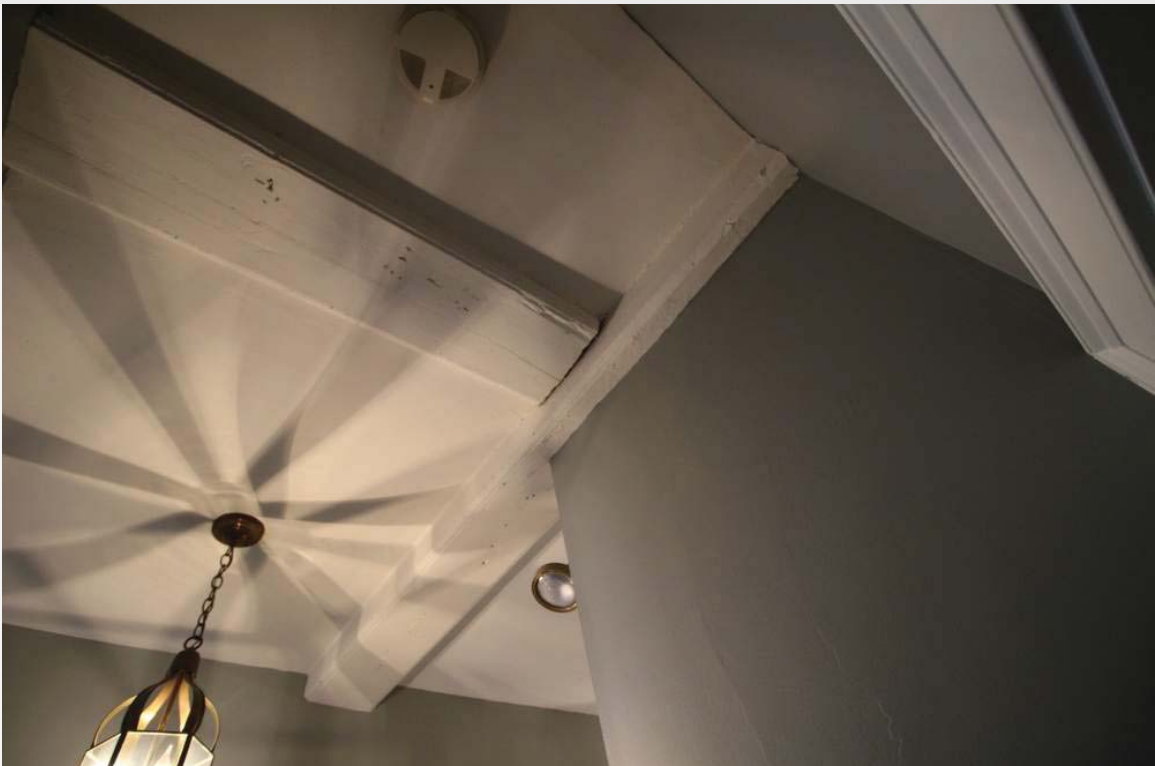
31

Girts were also left exposed in the corridors. It is lovely that the frame can be seen, rather than hidden behind a drop ceiling.

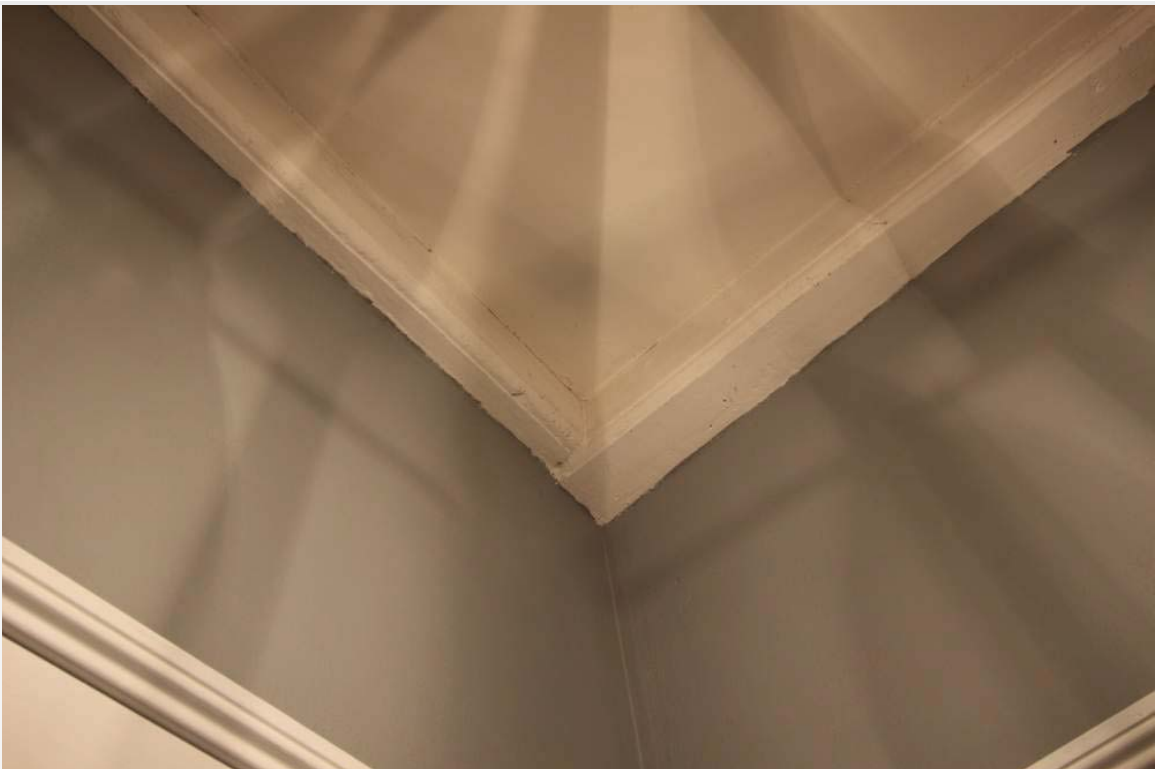
32

Another girt intersection is visible in the corner of the corridor, showing that the partition walls align with timbers, where possible. The exposed corners of these timbers are molded, as well.

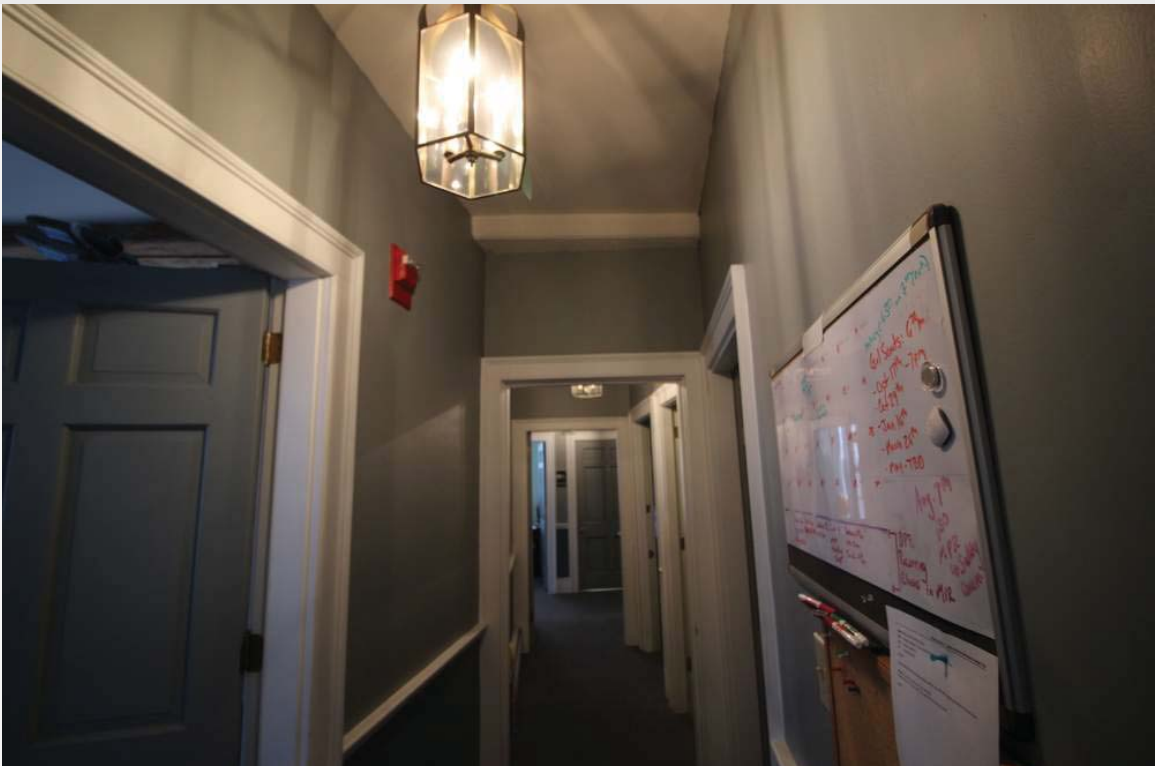
33

Like the rest of the building, the corridors not parallel with exterior walls. There is a bend in the corridor where it passes the leading edge of the former vault.

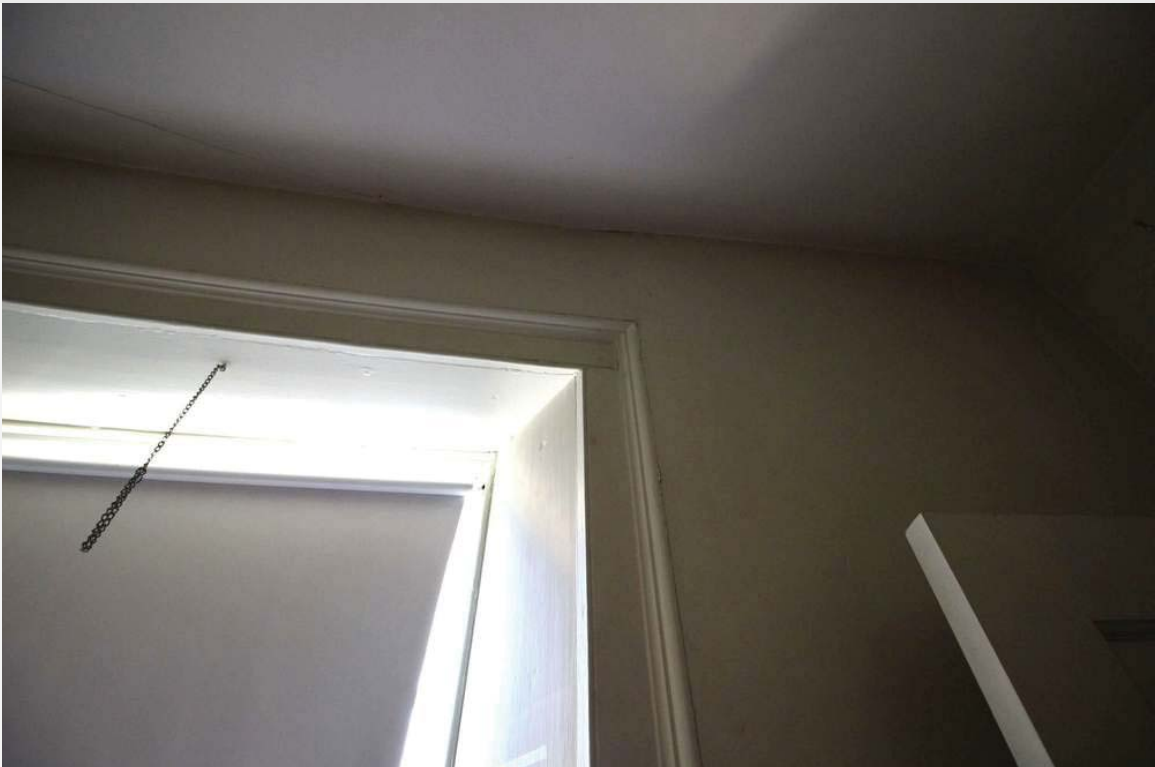
34

The casing surrounding this exterior window in the front office is likely old or original. The casing is flat with a simple interior bead. Significantly, the back-band has been used as a ground for the plaster.

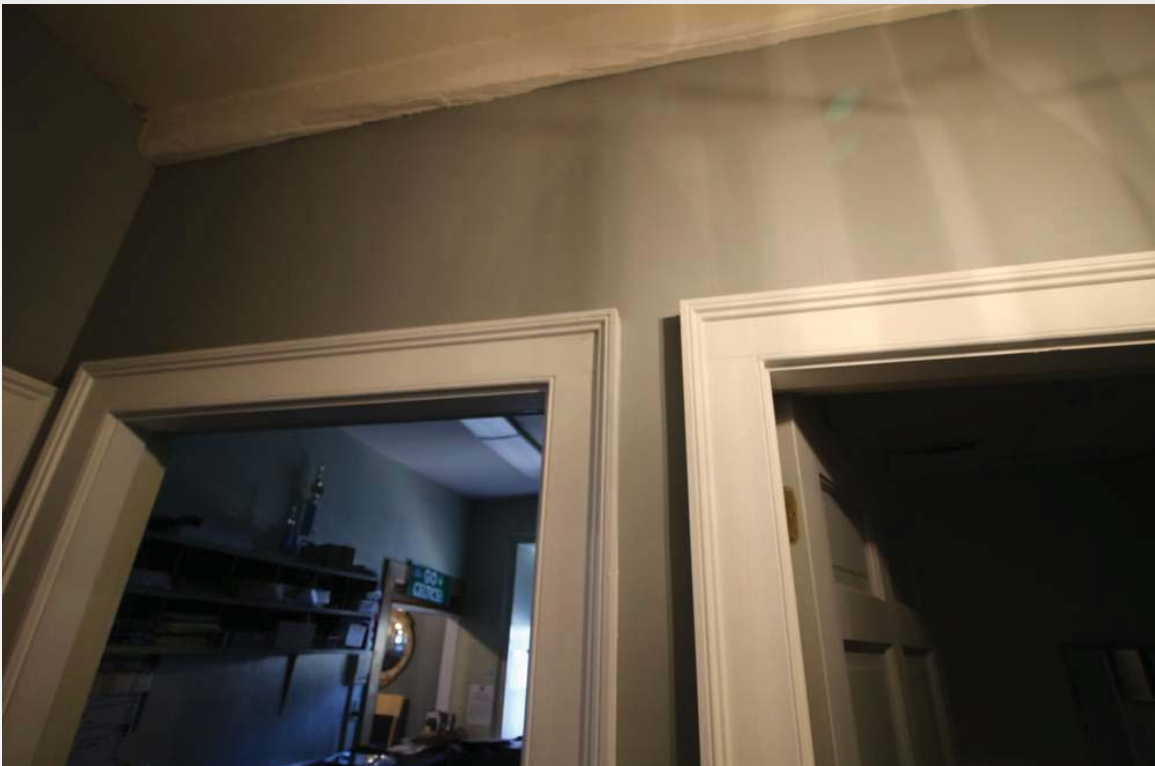
35

These door casings within the partition walls are a later addition, but they blend well with the original elements of the building.

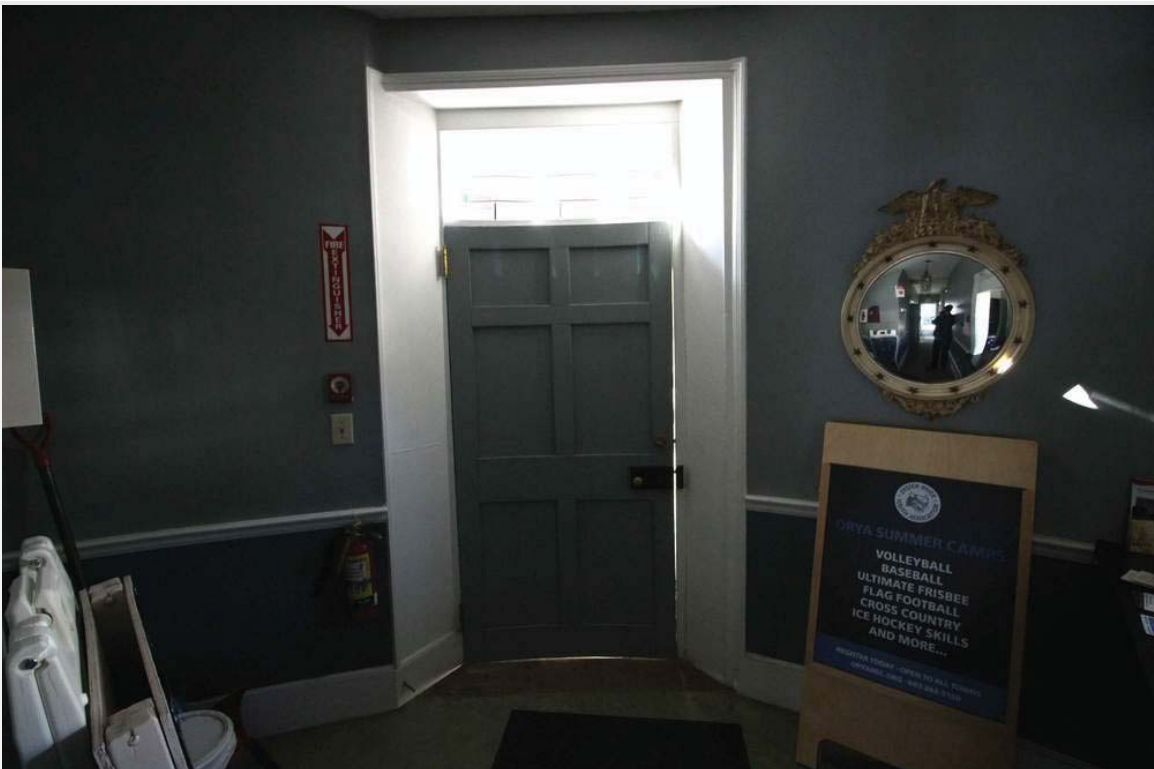
36 NH-108 | Durham, New Hampshire Nov 13, 2019 | 1:45 PM Jessica MilNeil

This door appears to retain its original casing and back-band, especially where it is co-planar with the surface of the plaster. The door and transom show an extremely high level of craft and would be extremely difficult to duplicate.

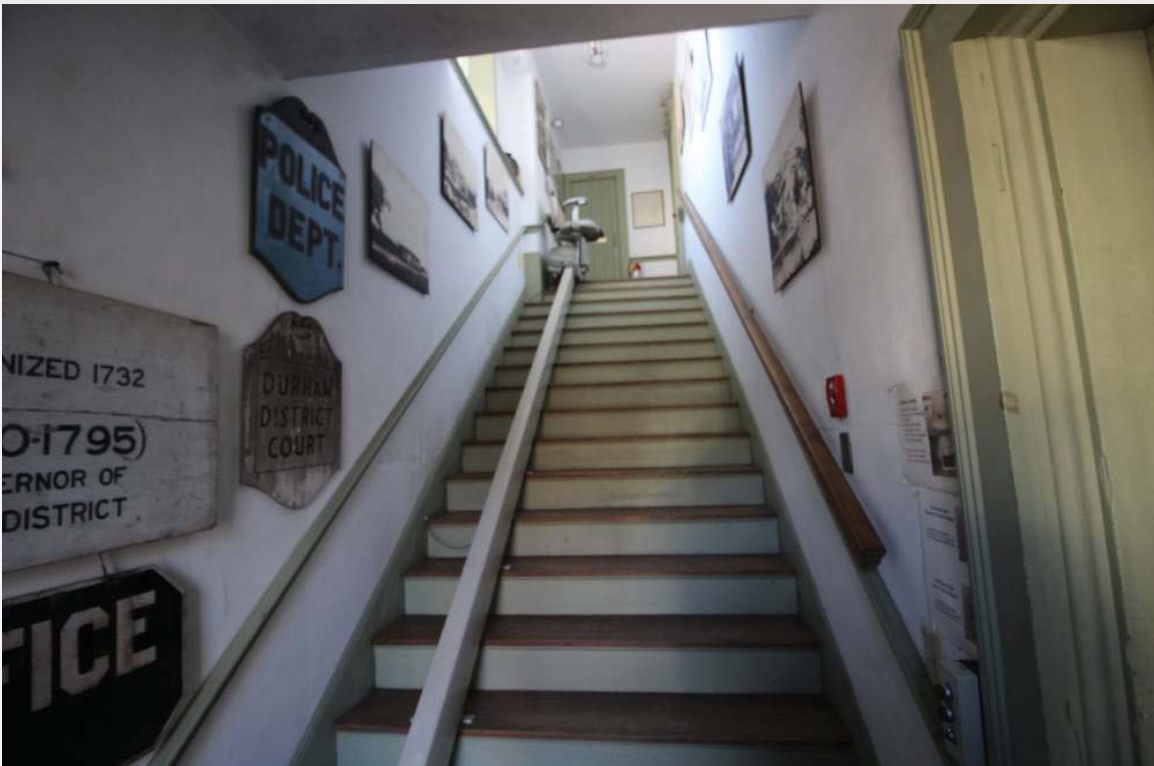
37 NH-108 | Durham, New Hampshire Nov 13, 2019 | 9:04 AM Jessica MilNeil

The stairs to the second floor are quite wide for a 19th century building. The bottom stair is co-planar with the outside wall. Presumably, the stairs were altered when the third story was removed, in 1852.

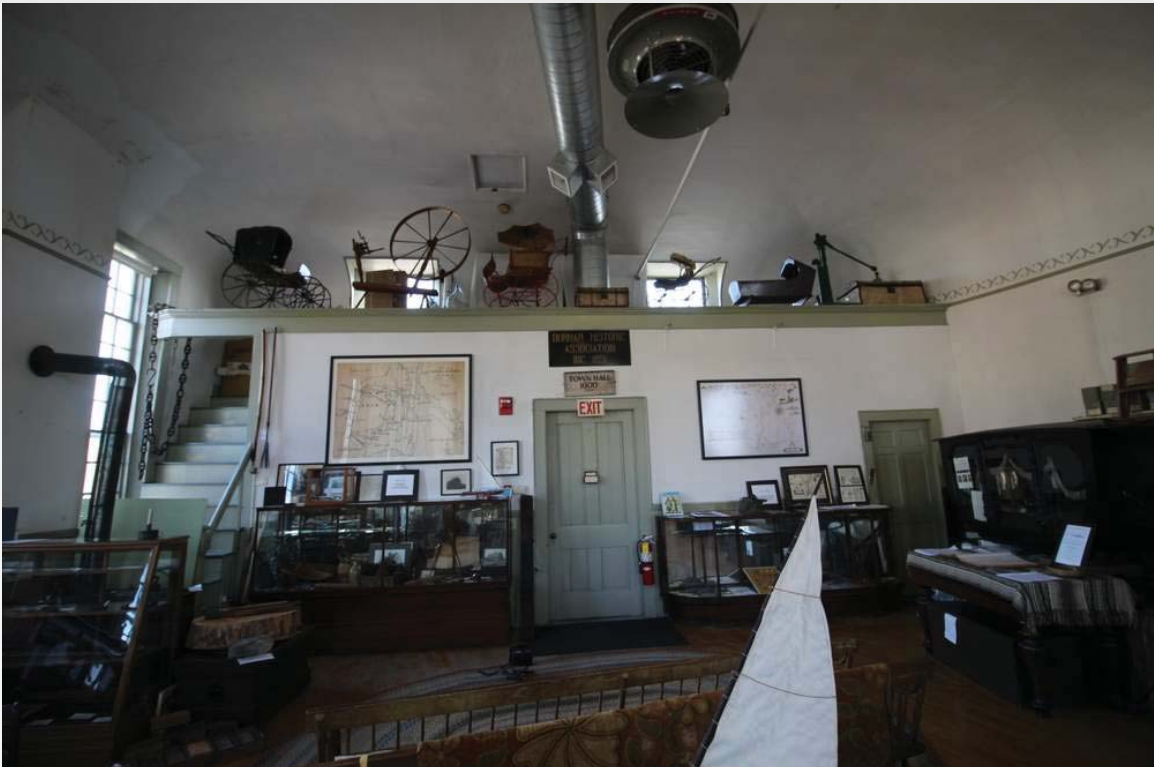
38

The second story partition walls have been in place since the town removed the third story. Note the heating and ductwork.

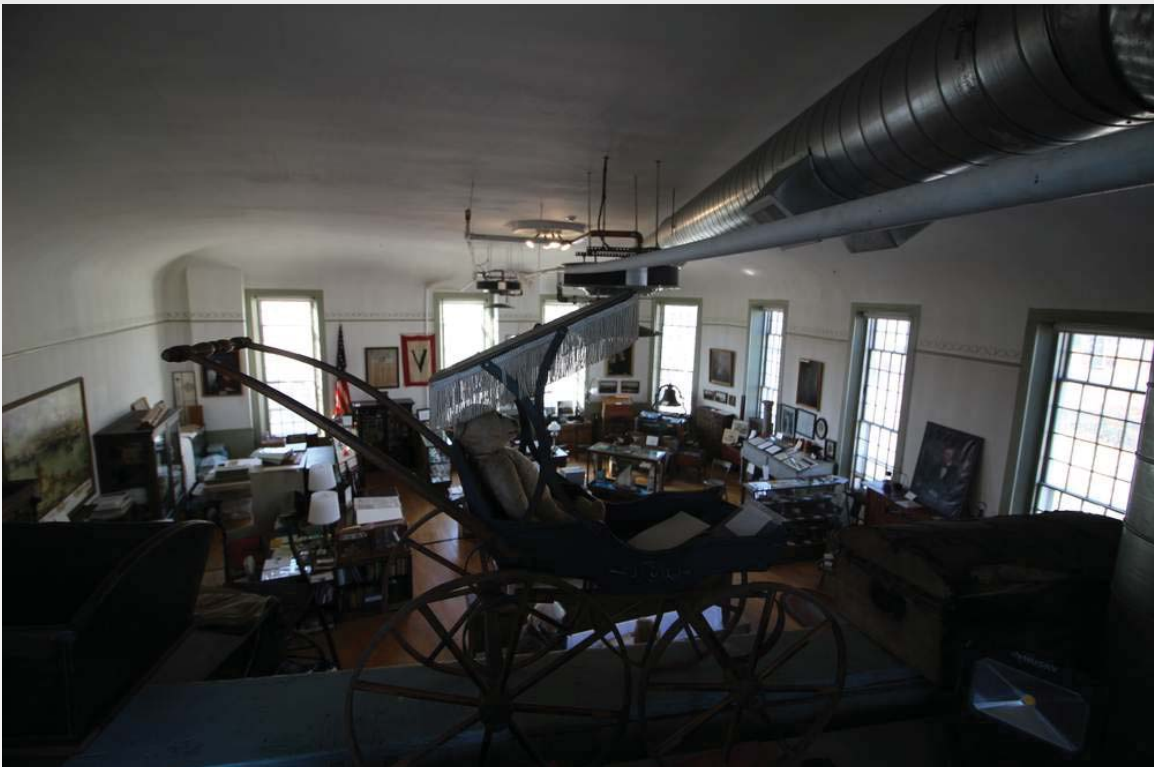
39

Looking out into the hall from the balcony. The ductwork looms large, and makes it even more difficult to access the attic.

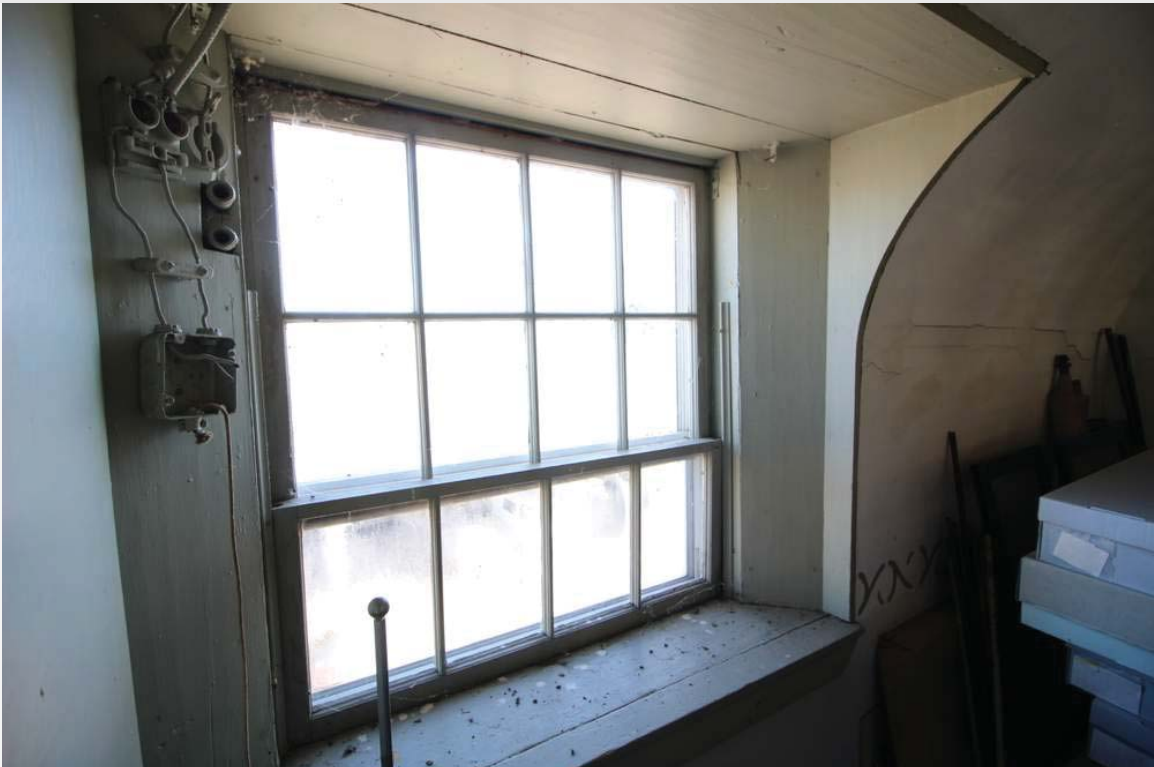
40

Balcony windows may be original to the third story. They are cased by both the angled casing found throughout the building, and an extension jamb that follows the curve of the coved ceiling. The jambs and the casing are beautifully hand planed.

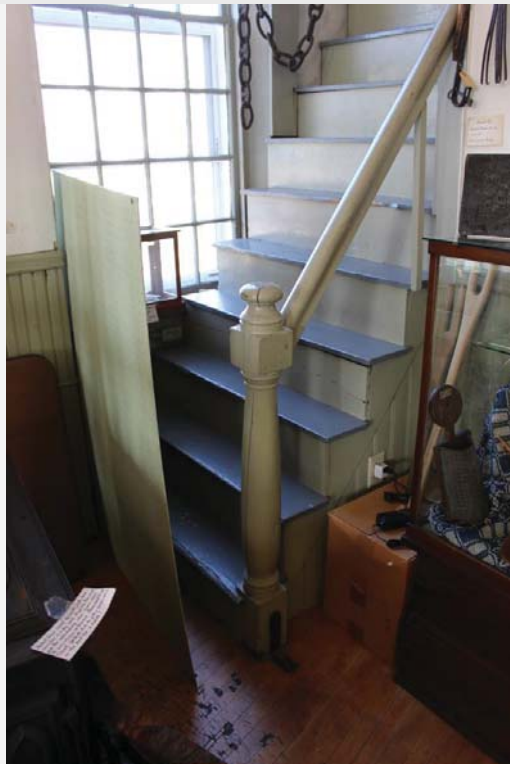
41

These balcony stairs are steep and lovely. One wonders whether they date to the 1852 renovation, or were the original means of ascent to the third floor.

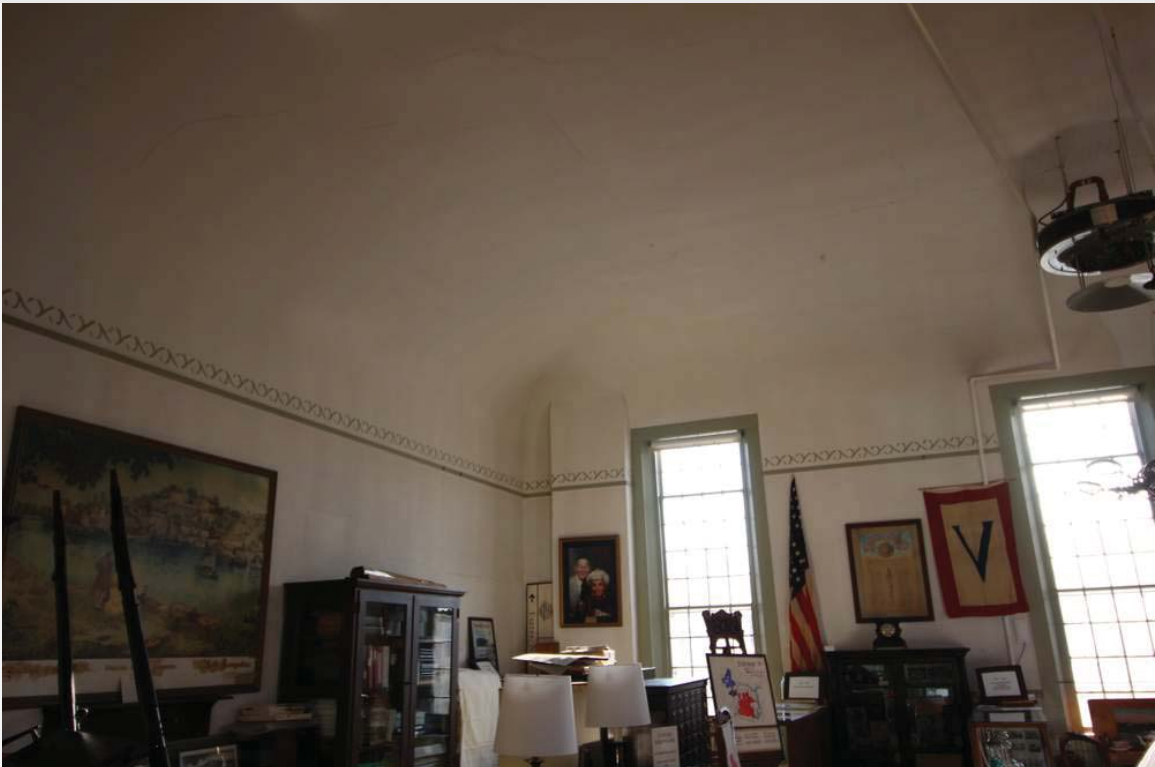
42

The ceiling is coved in four directions, creating excellent acoustics in the hall.

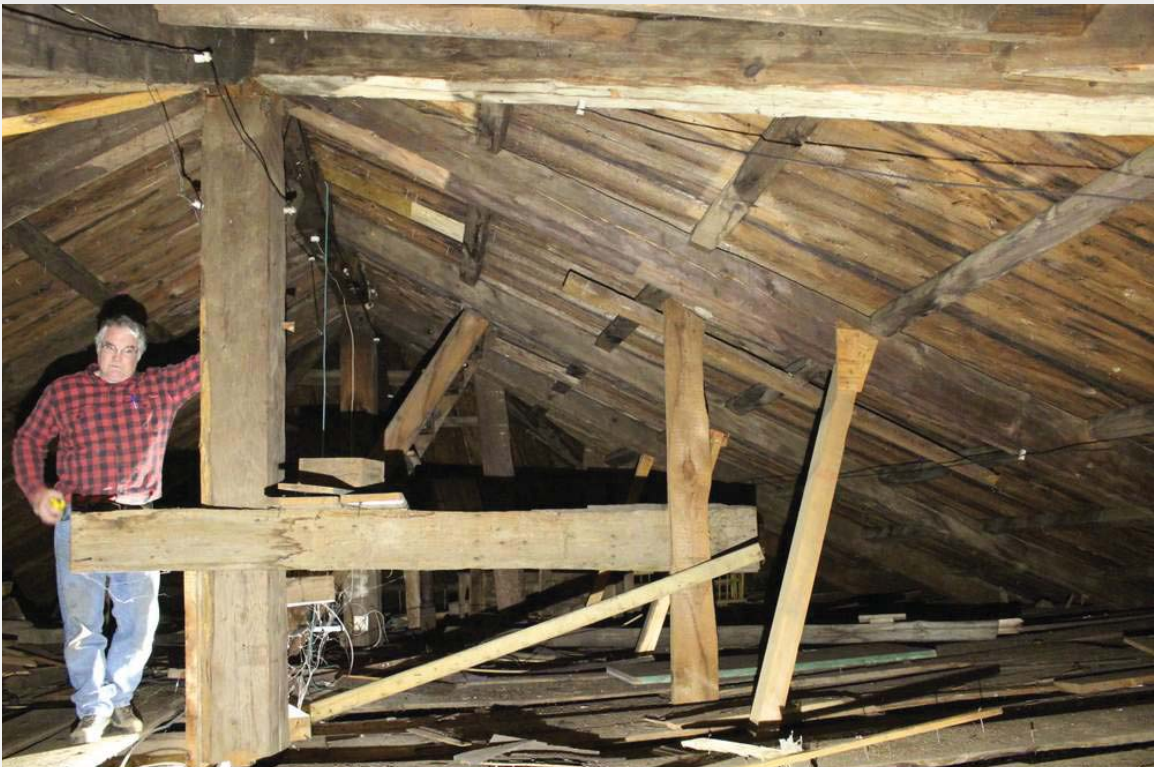
47

Attic and roof system looking southwest. The roof is framed out of principal rafters, hip rafters, gable rafters, jack rafters and the horizontal purlins that connect them. Arron leans against a modified king post, which picks up the principal rafters, hip rafters and gable rafter of the northeast end.

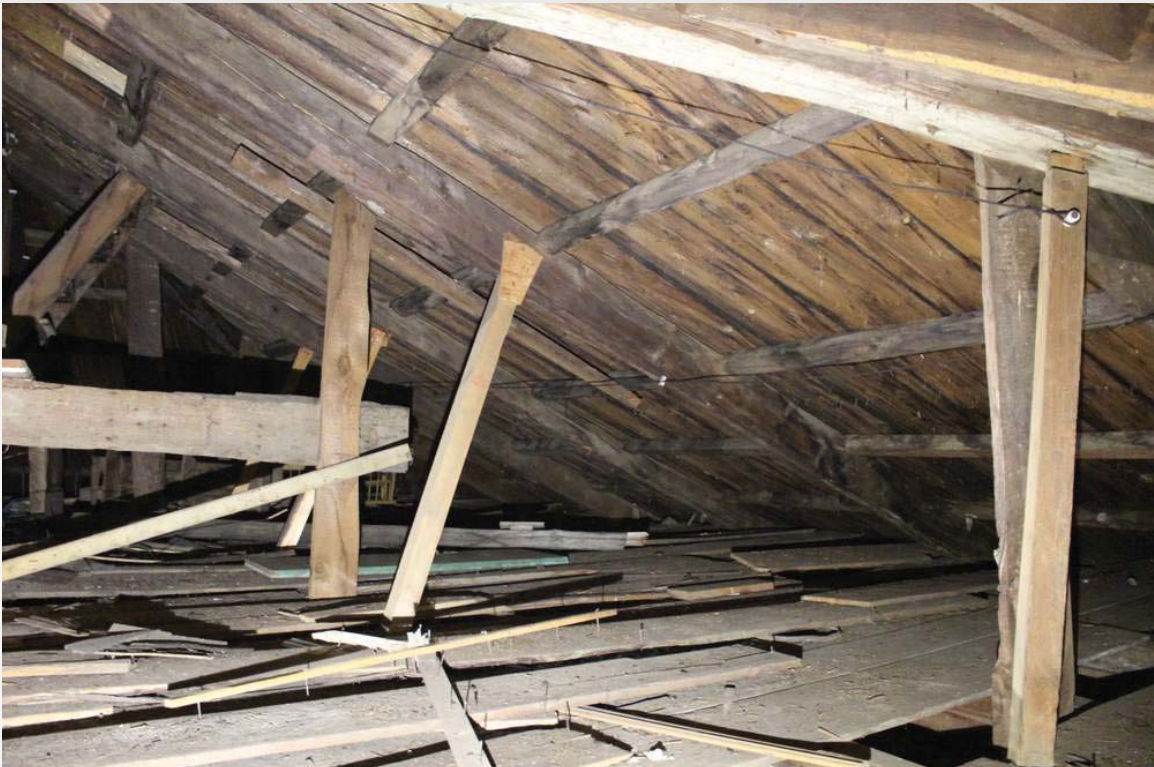
48

The rafters are connected by horizontal purlins which fan out over the pitch, rather than align with the ridge or the exterior wall. The framing is covered in vertical sheathing.

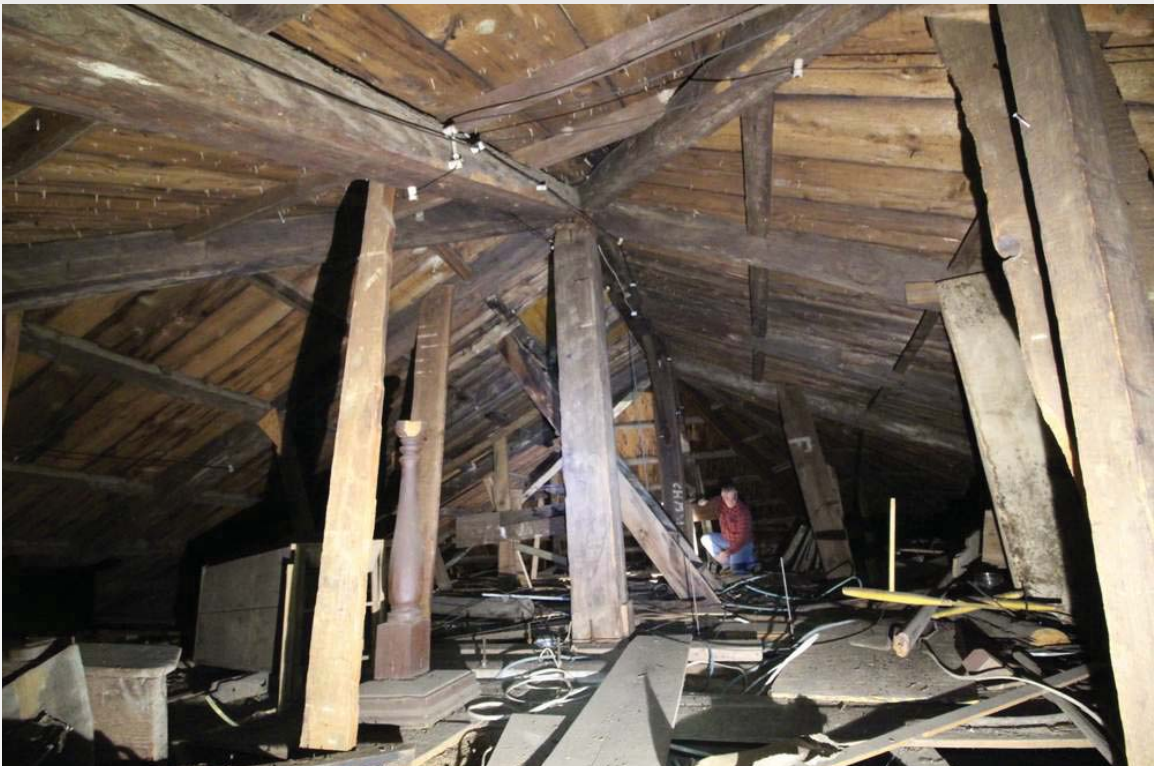
49

The hip rafters and ridge purlin are supported by a modified king post. In a typical king post truss, the king post hangs from the rafters, and supports the tie beam at the middle of its span.

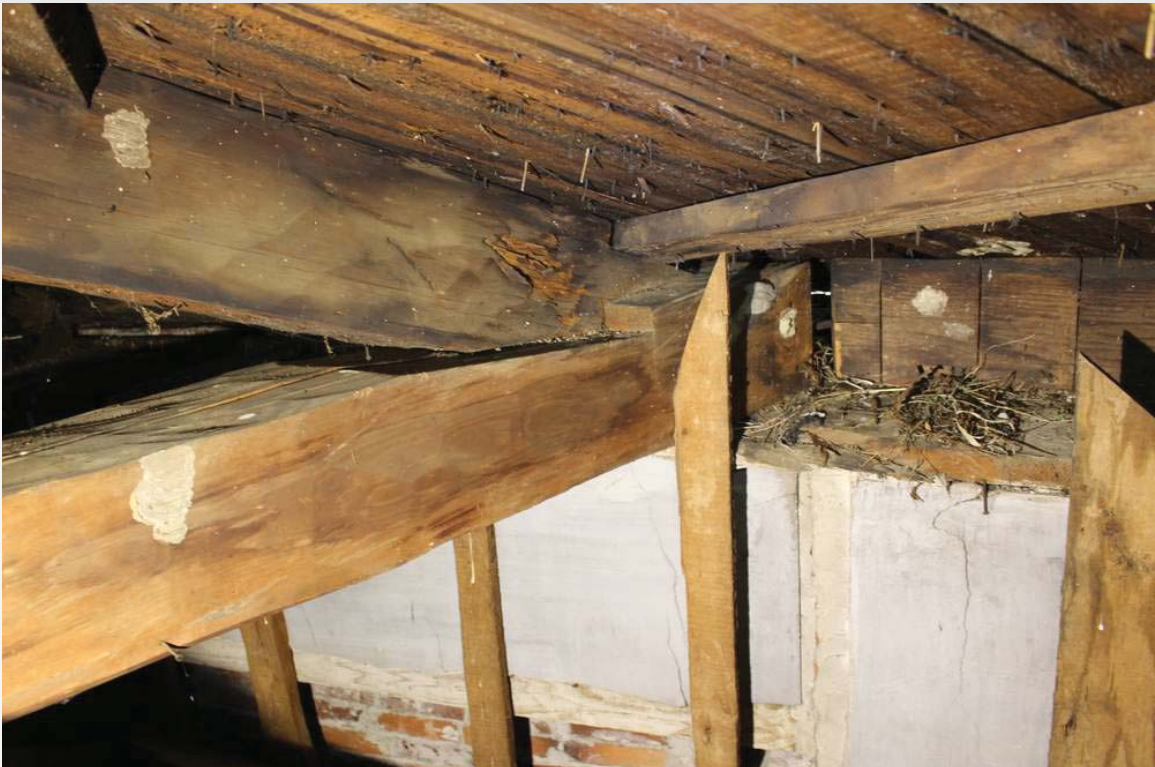
50

The tie beams cross the exterior walls over a wide plank and support the fascia and cornice. Here the curved fascia can be seen, the interior face was scored to create the curve. The rafter lands on the end of the tie beam in a nice, tight birds-mouth joint.

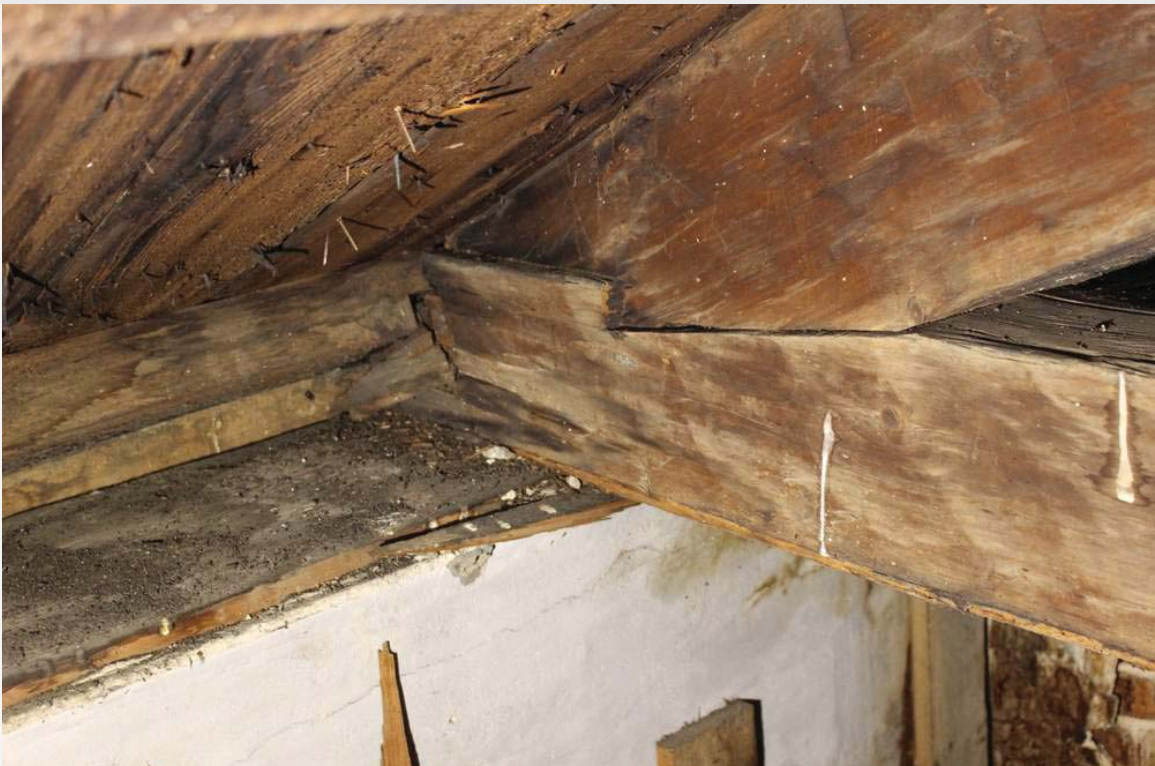
51

The roof framing is beautifully hewn. Another beautiful birds mouth here.
