Durham Old Town Hall

Existing Conditions Photo Report

By Jessica MilNeil | December 11, 2019

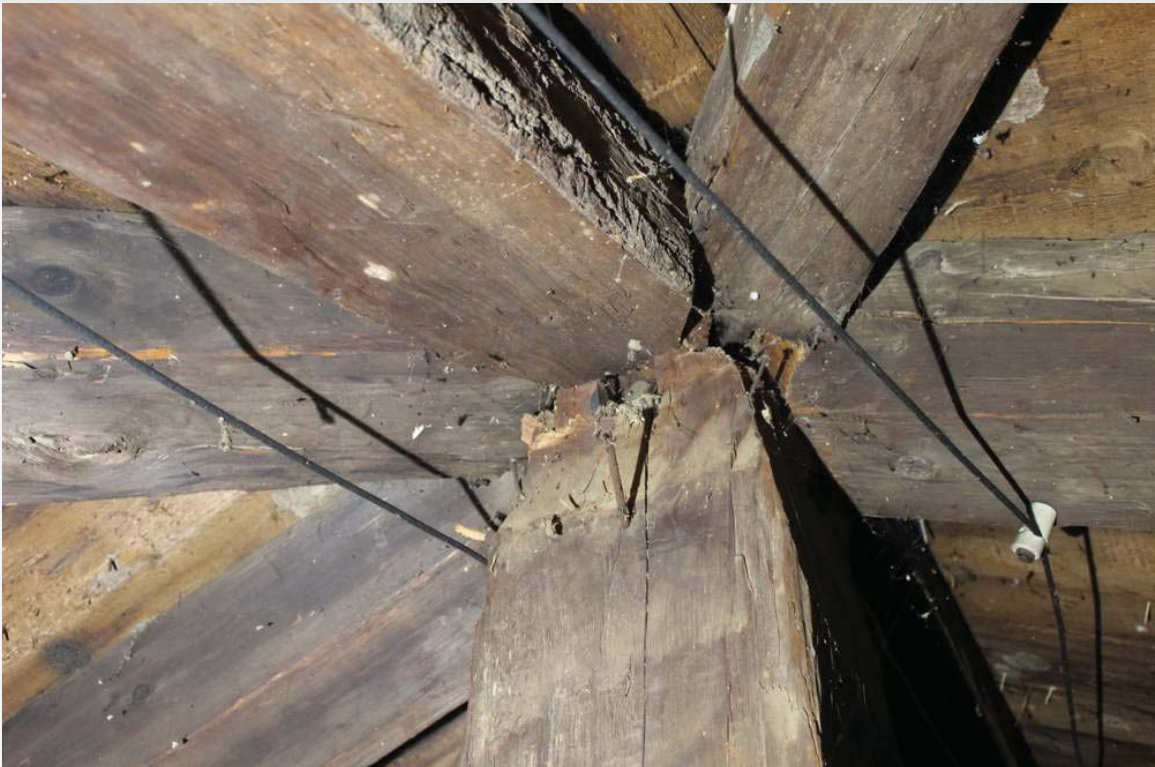
54

This is the back side of the same king post. The rear half accepts two additional hip rafters and a rafter coming up from the northeast wall.

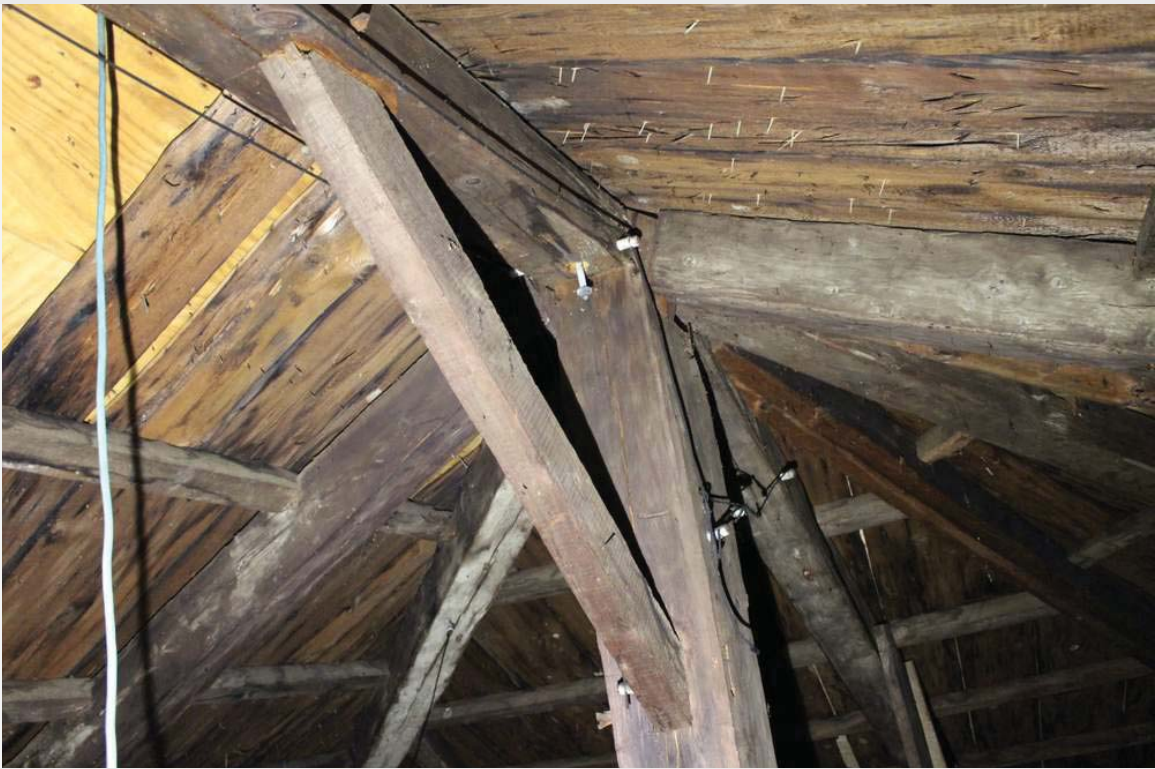
55

This is the opposite "king post", showing the ridge purlin and its associated brace. There are two additional jack rafters intersecting the principals and hips at this location.

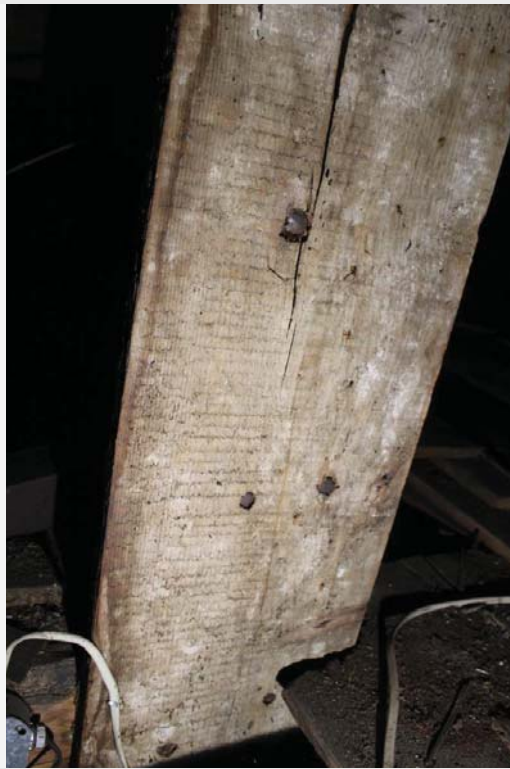
59

The improvised bolster is secured with wrought nails. A wrought stirrup would have been better, but this appears to have worked, so I guess we should be learning rather than judging.

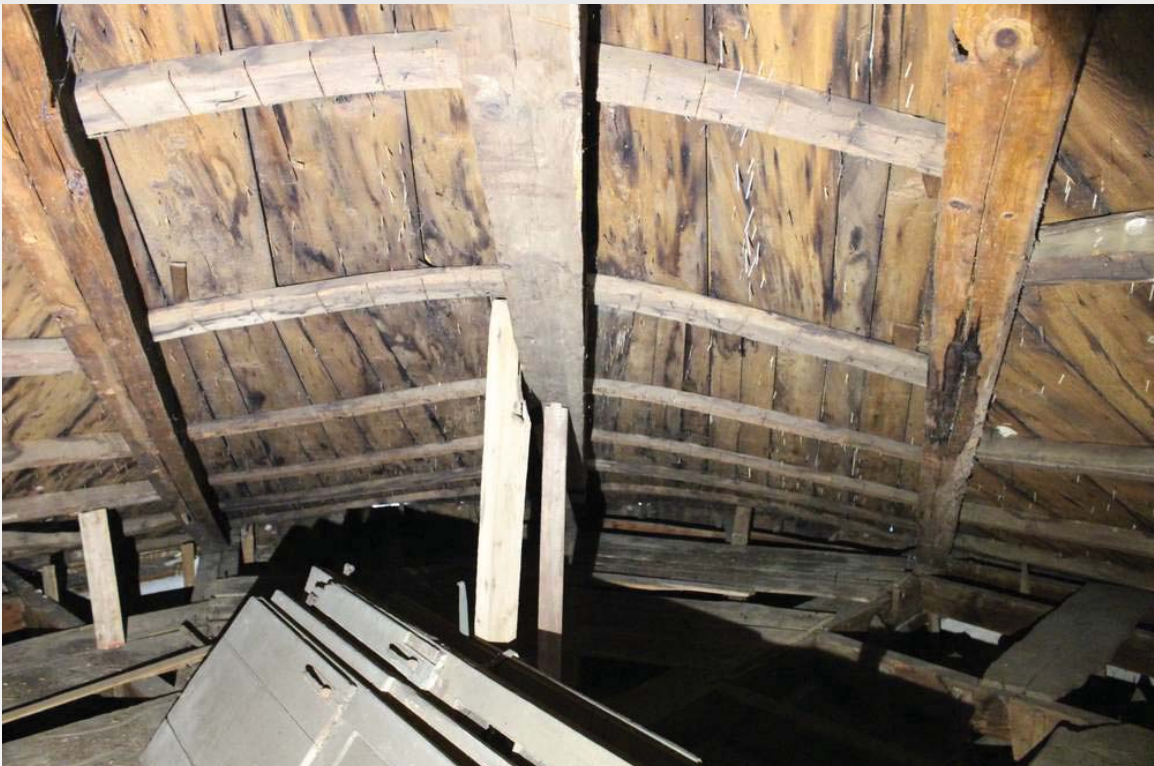
61

West hip rafter, strut and jack rafters. This photo shows the curve of the roof over the west corner, and the kerfed and curved purlins that support it.

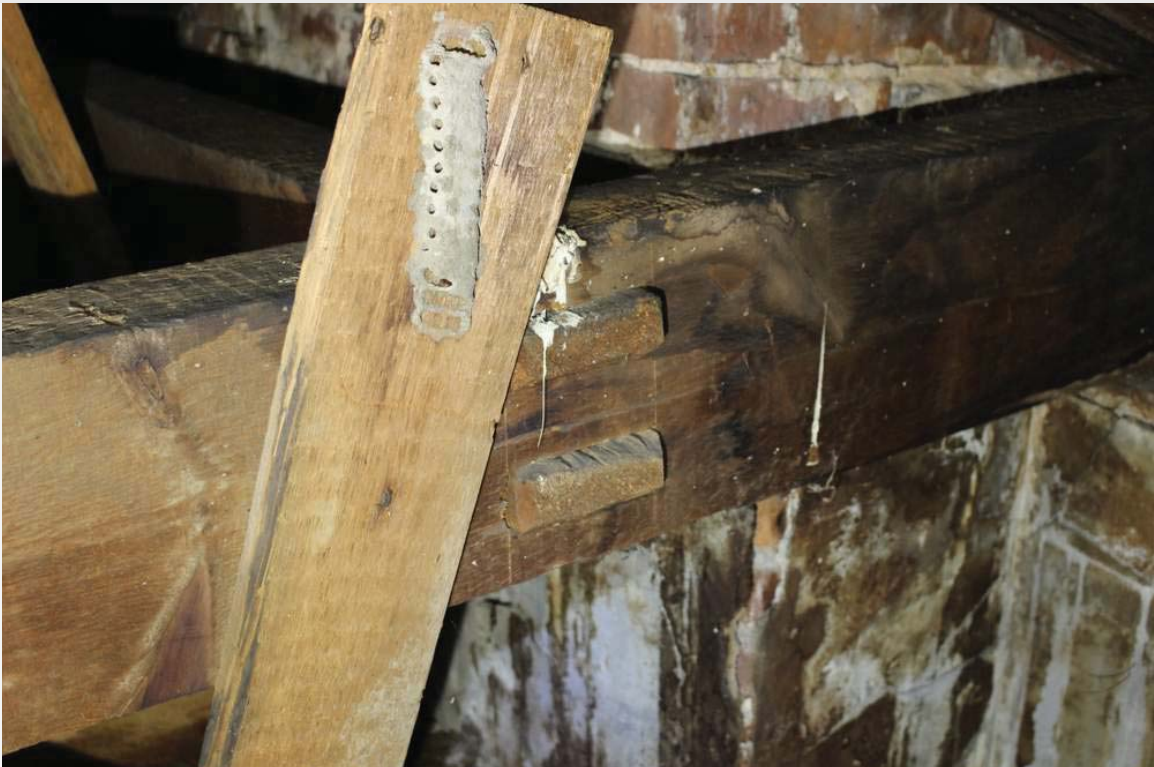
62

The chimney headers are joined to the adjacent ceiling joists with a double tenon more typical of furniture construction. Little details like these confirm the skill of the joiner.

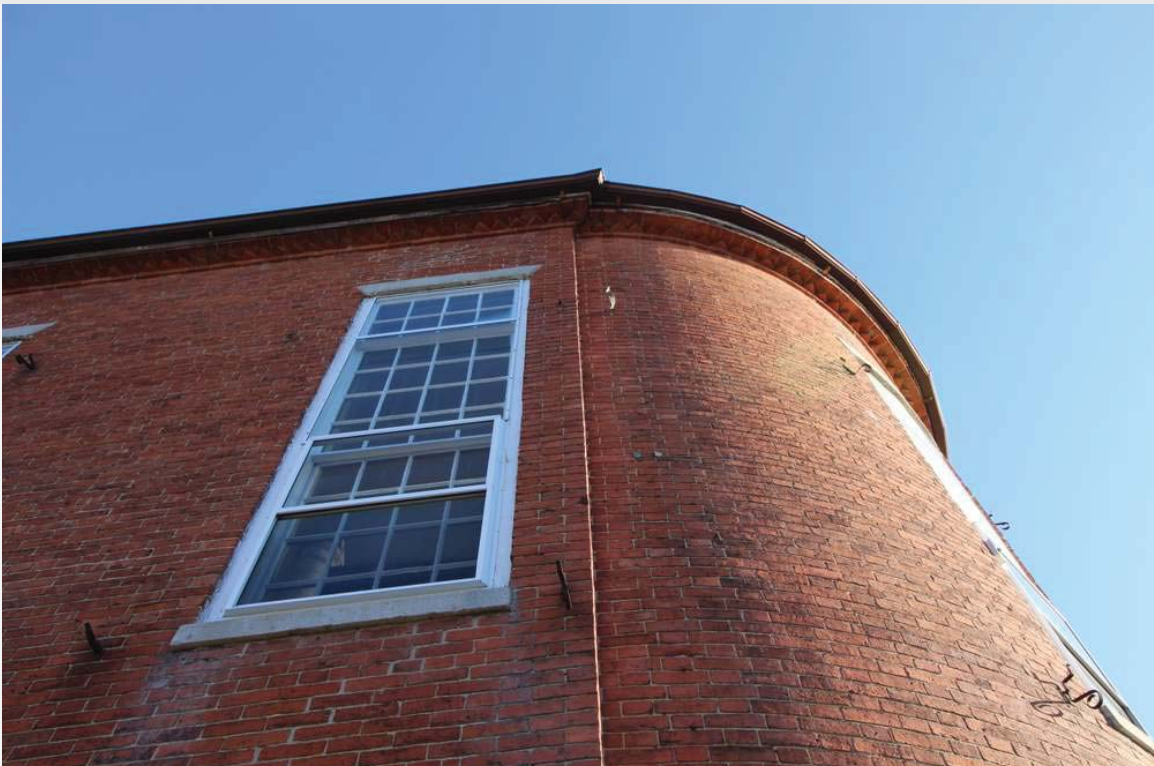
63

West corner, from northwest wall. The masonry is very skillfully laid. The bricks are old, the joints are narrow and the mortar is relatively soft. The gutter on this face has been replaced, but the profile does not appear to match the original.

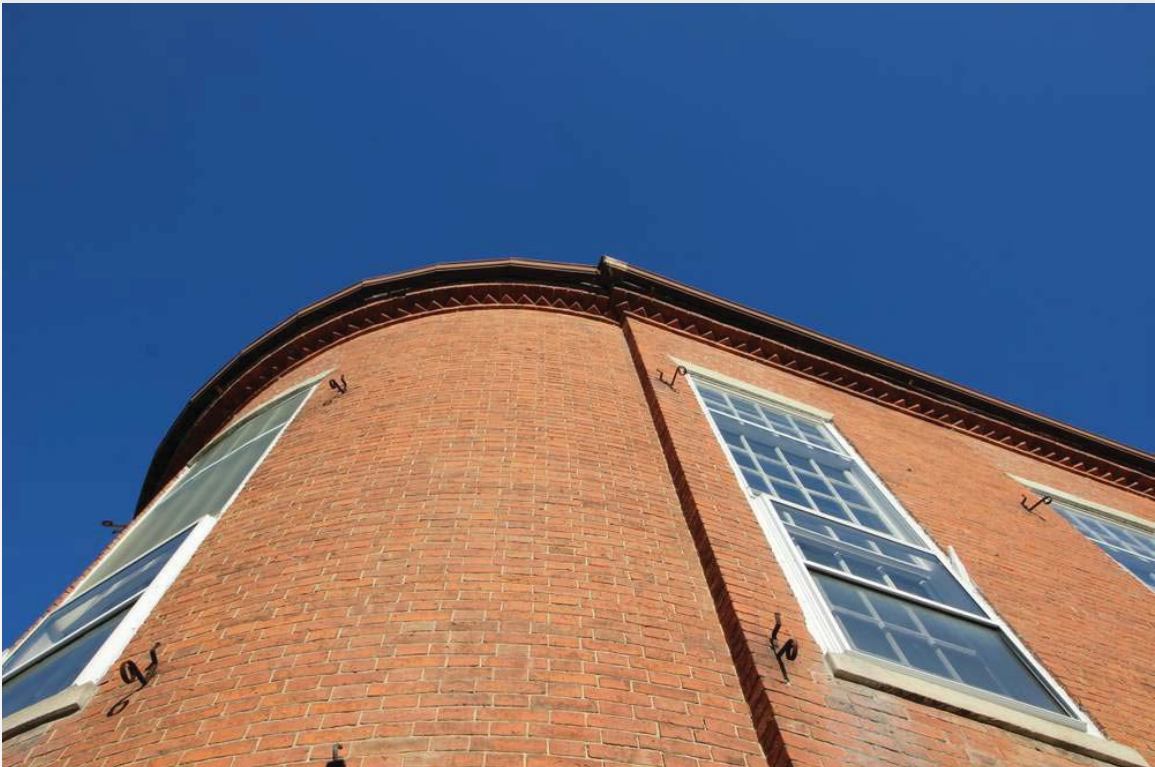
64

West corner, from southwest wall. The building has lasted so long because it was built so well.

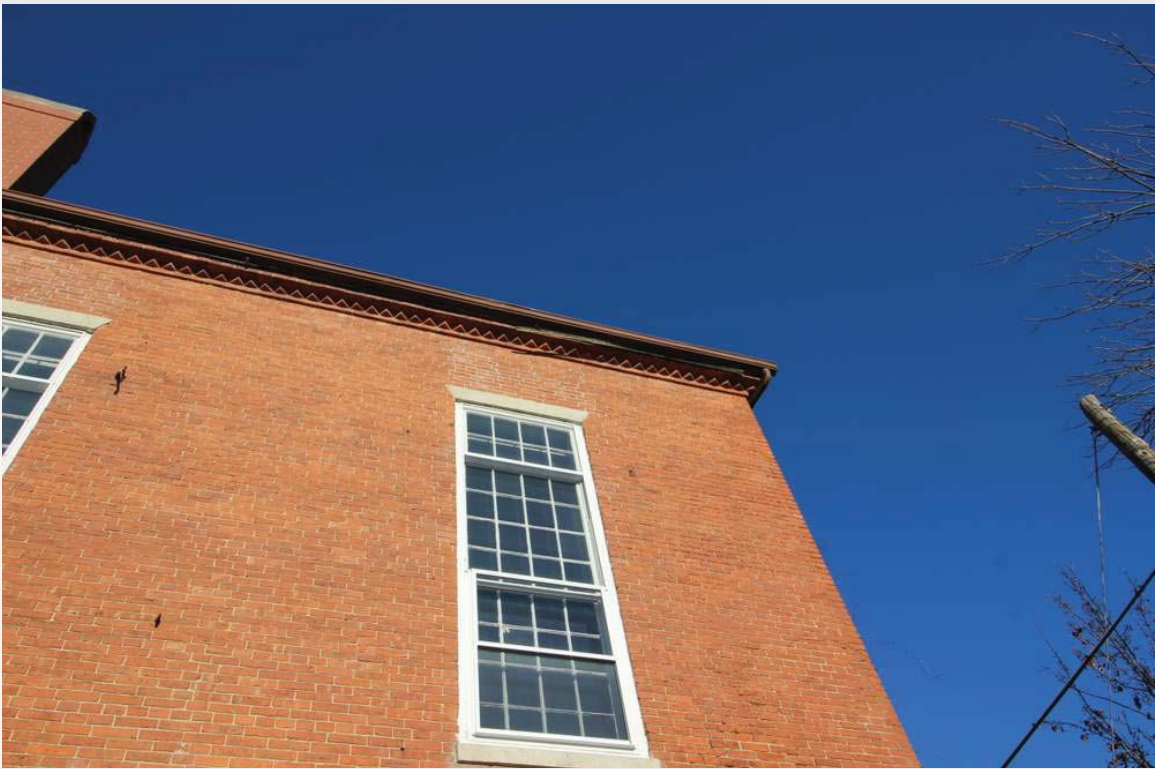
65

The gutter extends along the southwest face and the downspout drains off to the southeast.

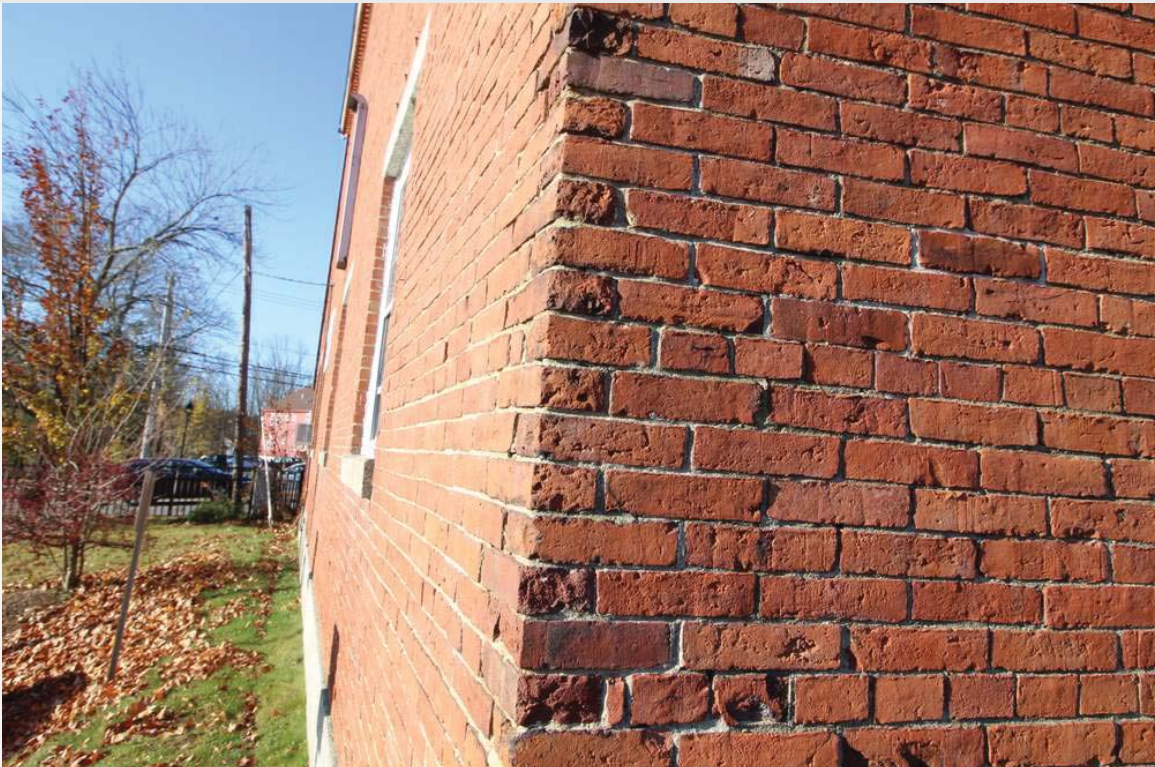
66

The bricks and mortar are relatively soft by contemporary standards. The Hill report recommends hand-raking when re-pointing.

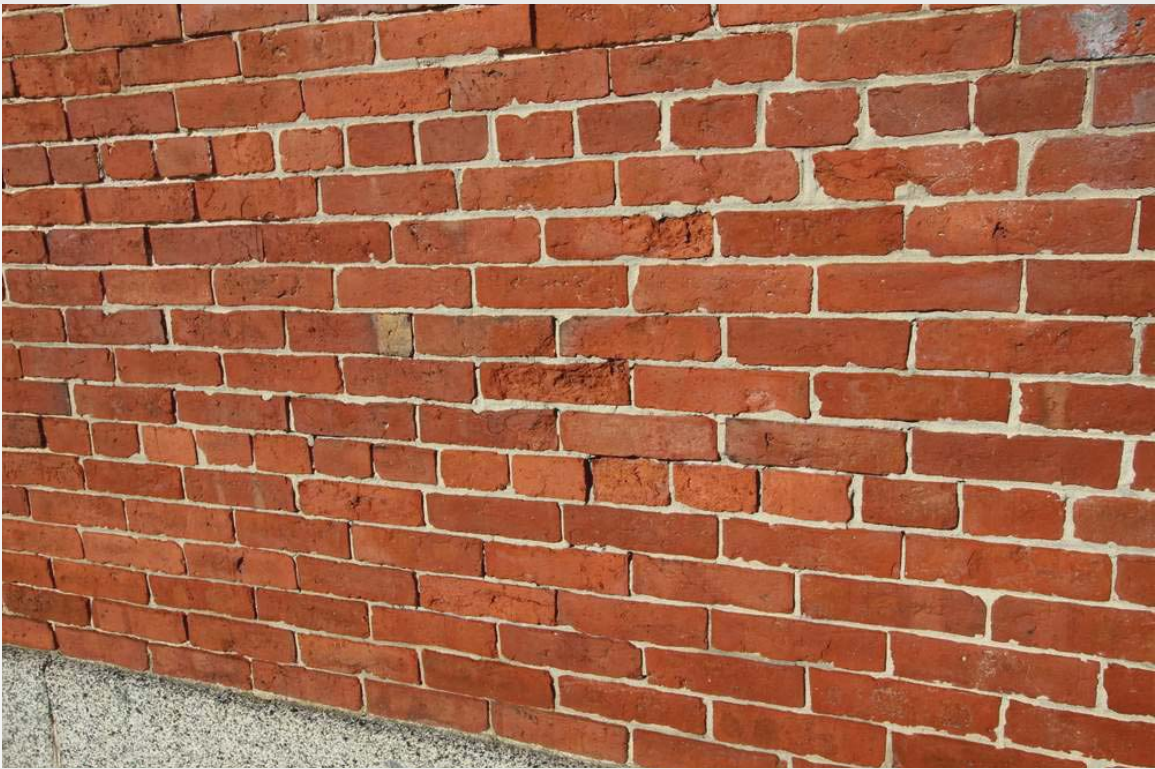
67

This part of the wall was repointed.

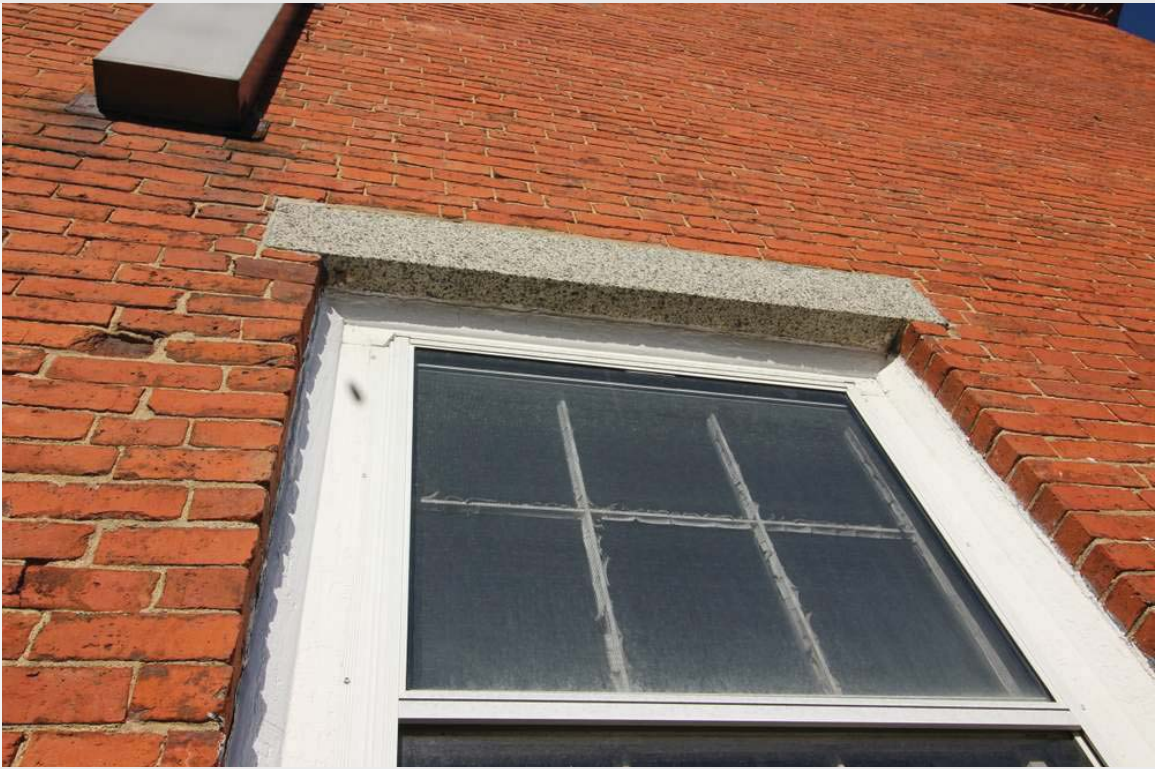
68

Granite lintel over an original window.

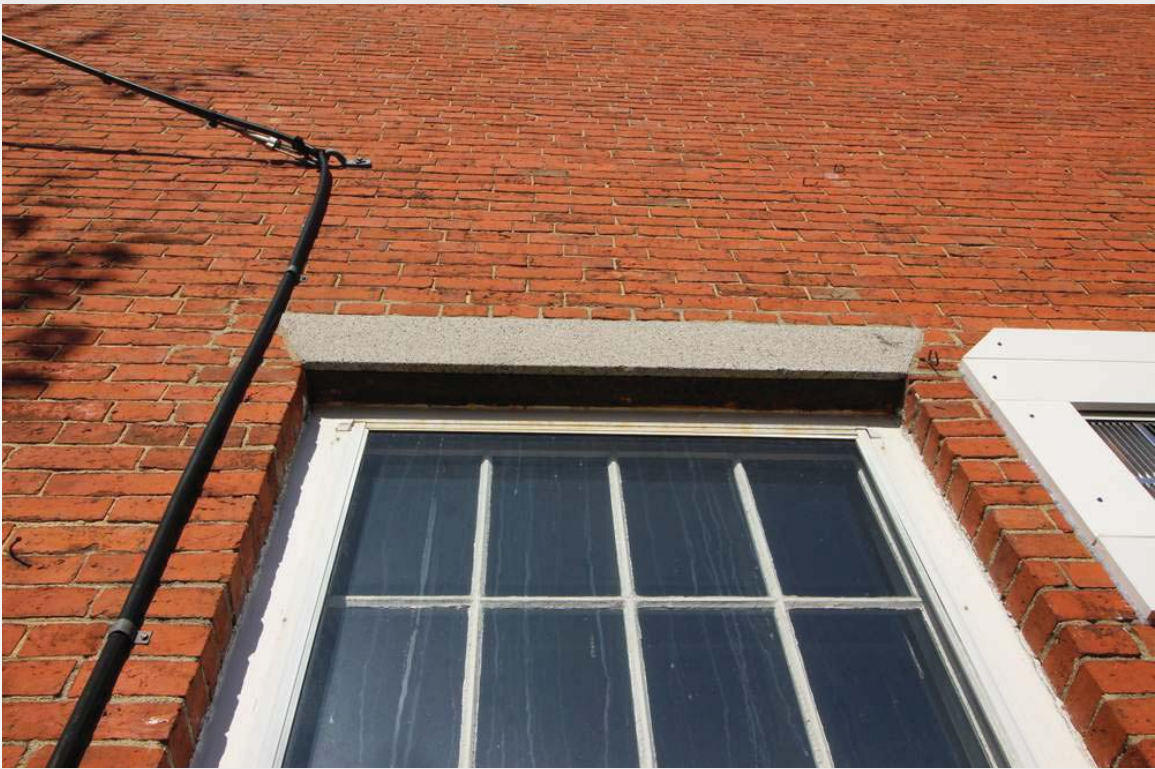
69

Concrete-style header with metal lintel. This window was added after 1935.
