PRESERVATION TIMBER FRAMING
P.O. Box 28
Berwick, ME 03901
www.preservationtimberframing.com

Wagon Hill Existing Conditions Drawings
156 Piscataqua Rd
Durham, NH 03824

02.5.2020
Issue 001
Jessica MilNeil

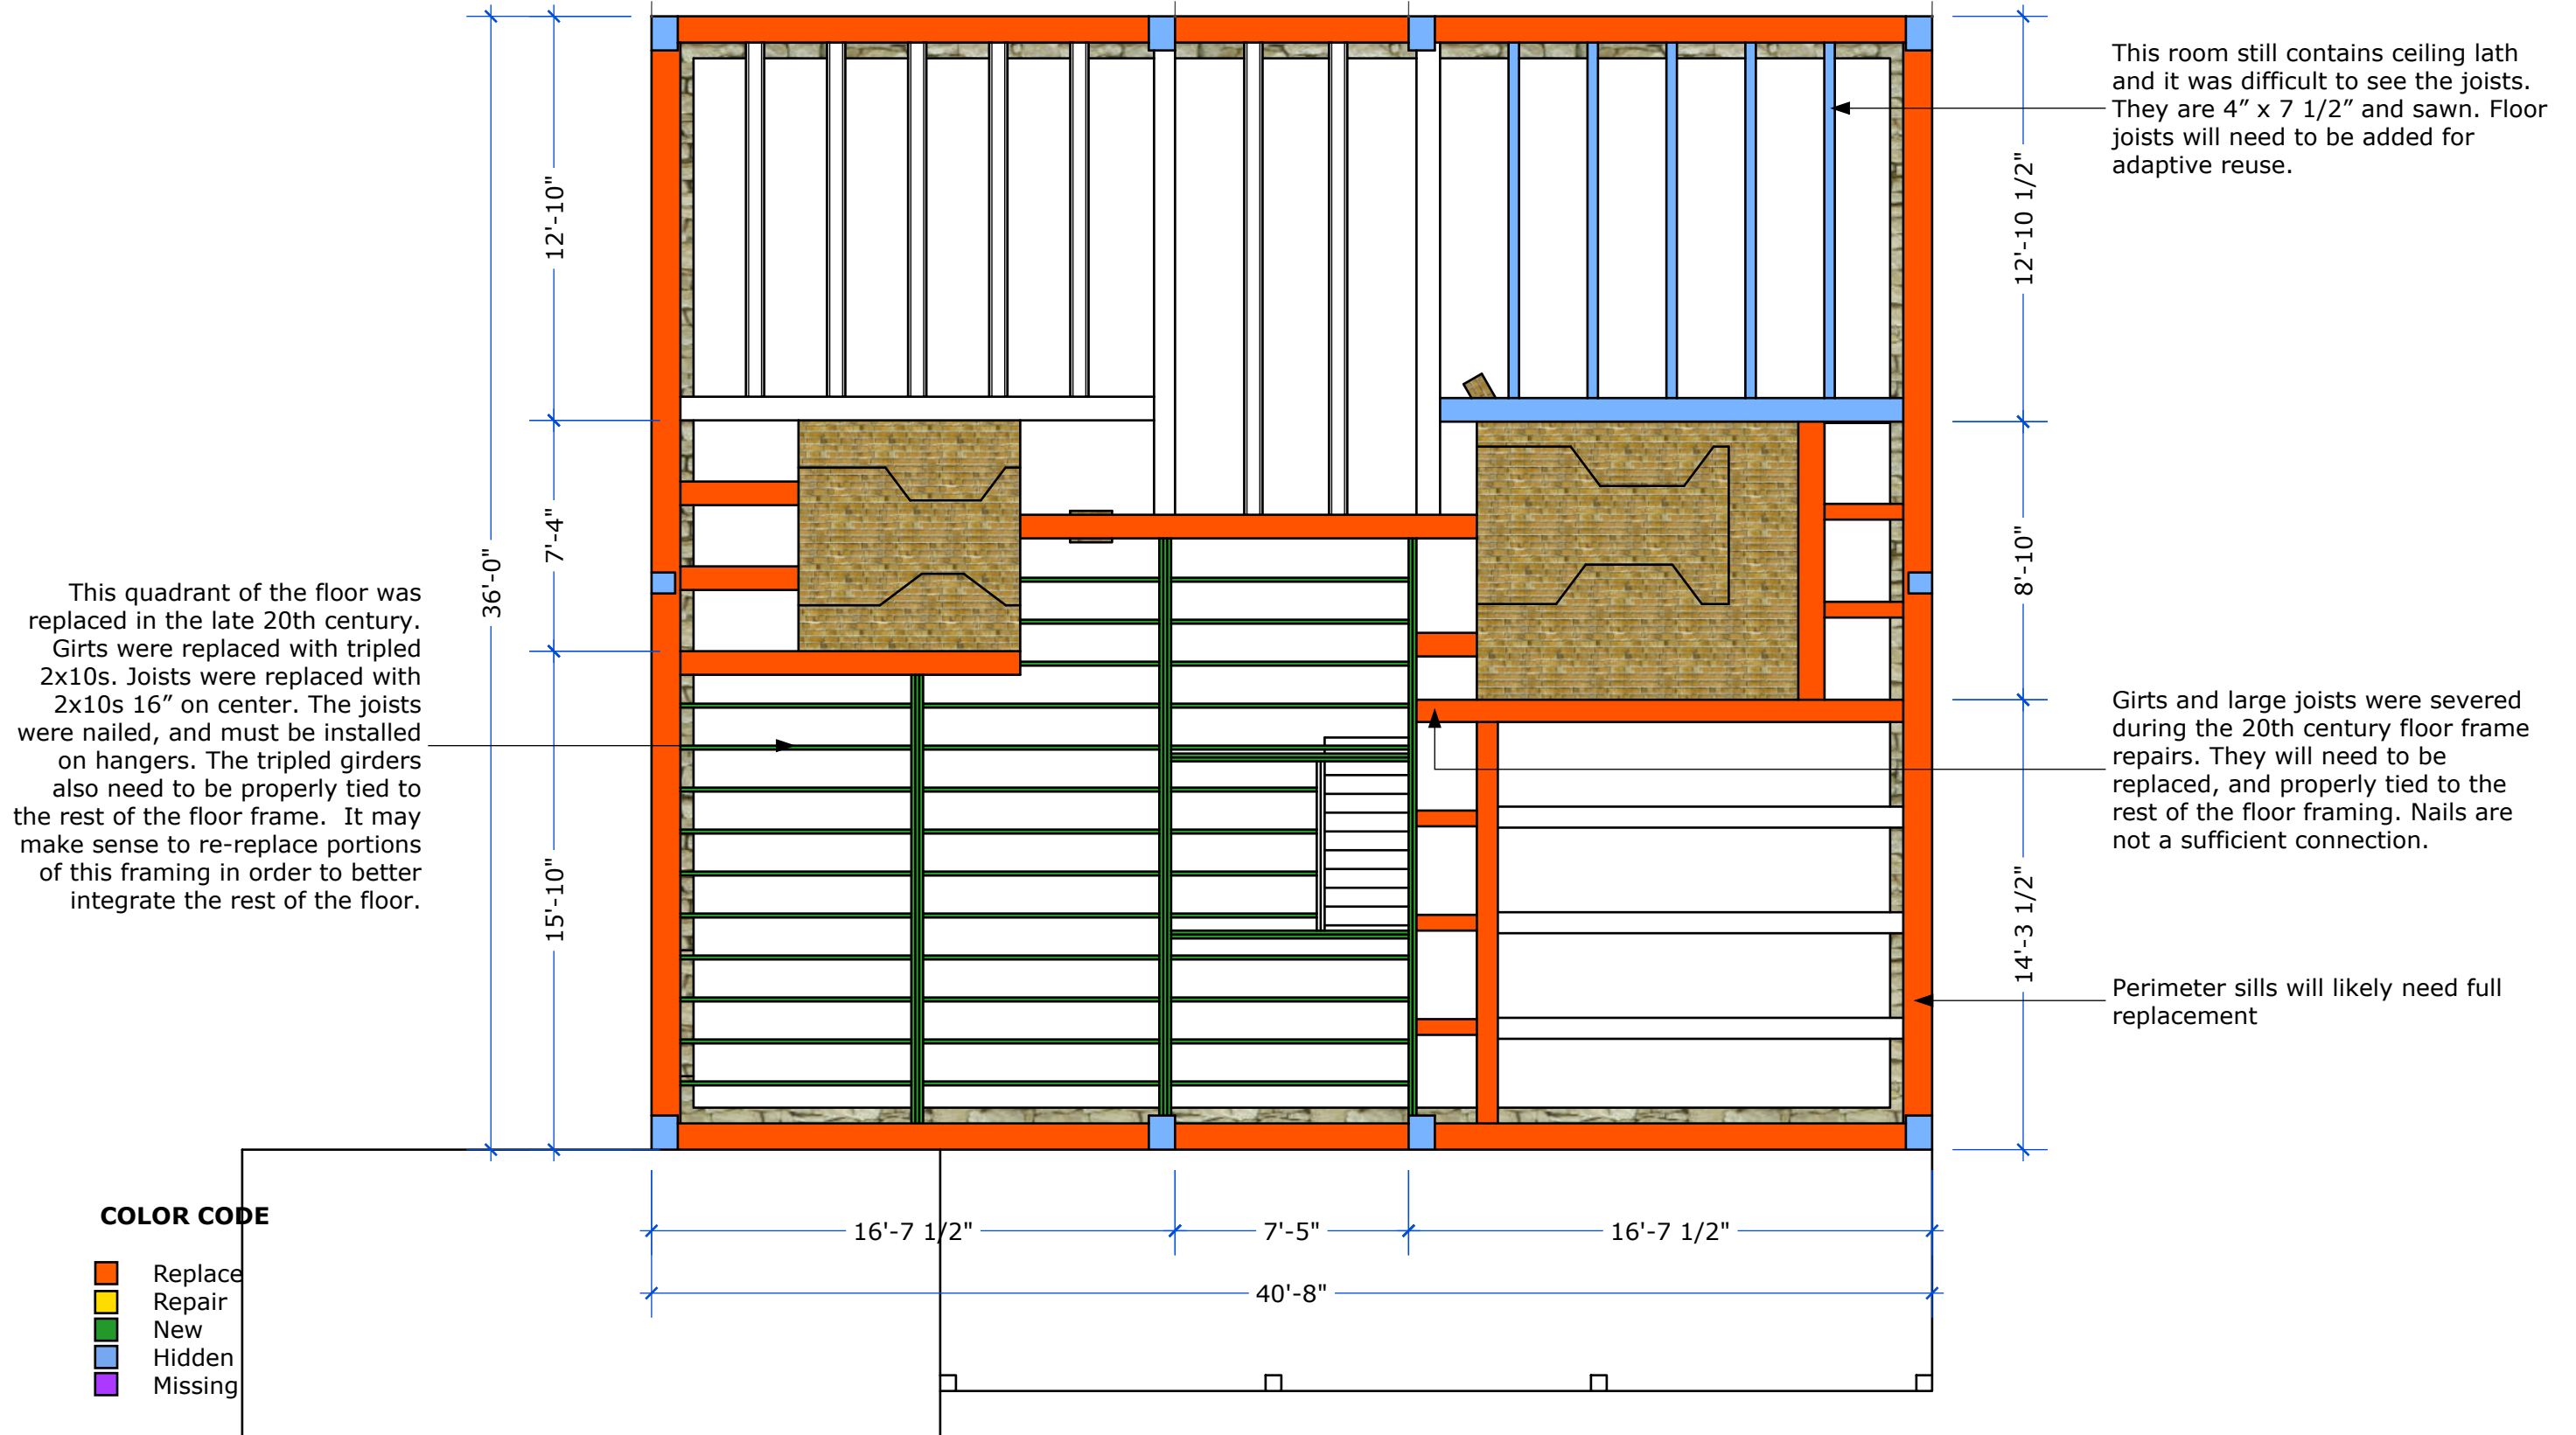
Sill Level

Original floor girts are supported over brick partition walls. The undercarriage framing is remarkably well-supported.
