# Wagon Hill Farm

## Photo Report

By Jessica MilNeil | December 12, 2019

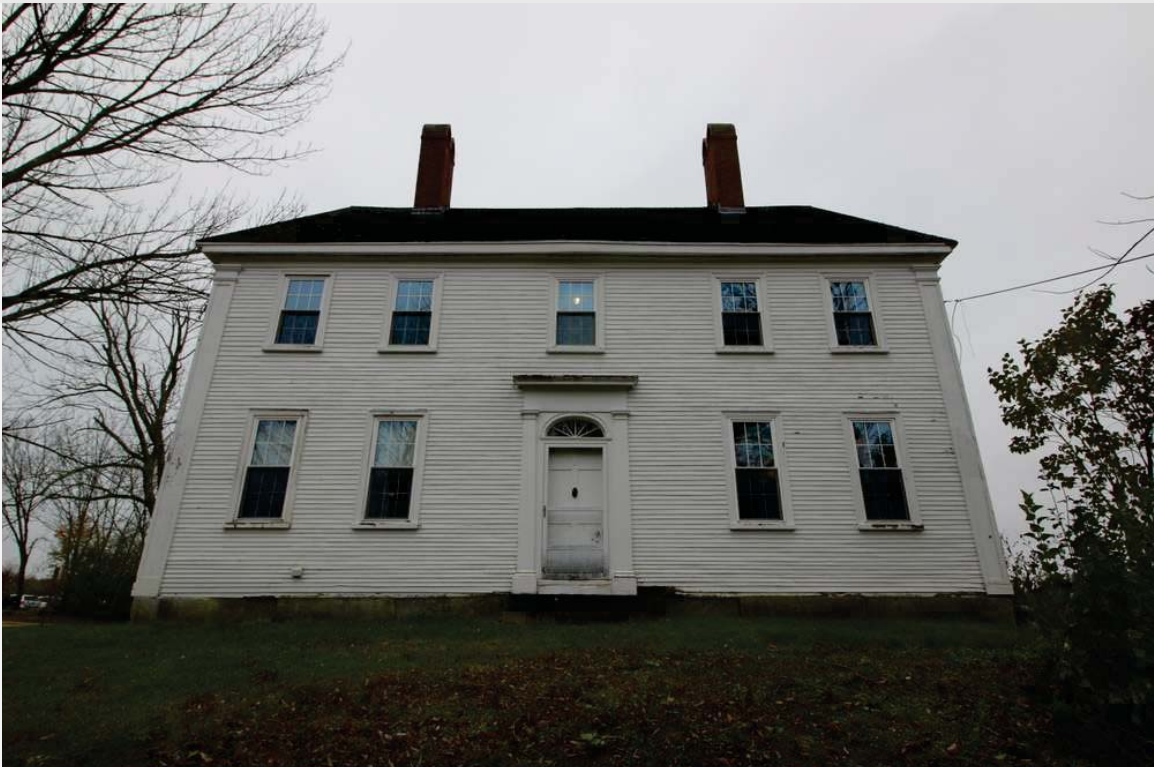
1

North Eave. The front facade exhibits the fenestration and trim details of a typical Federal-era farmhouse.

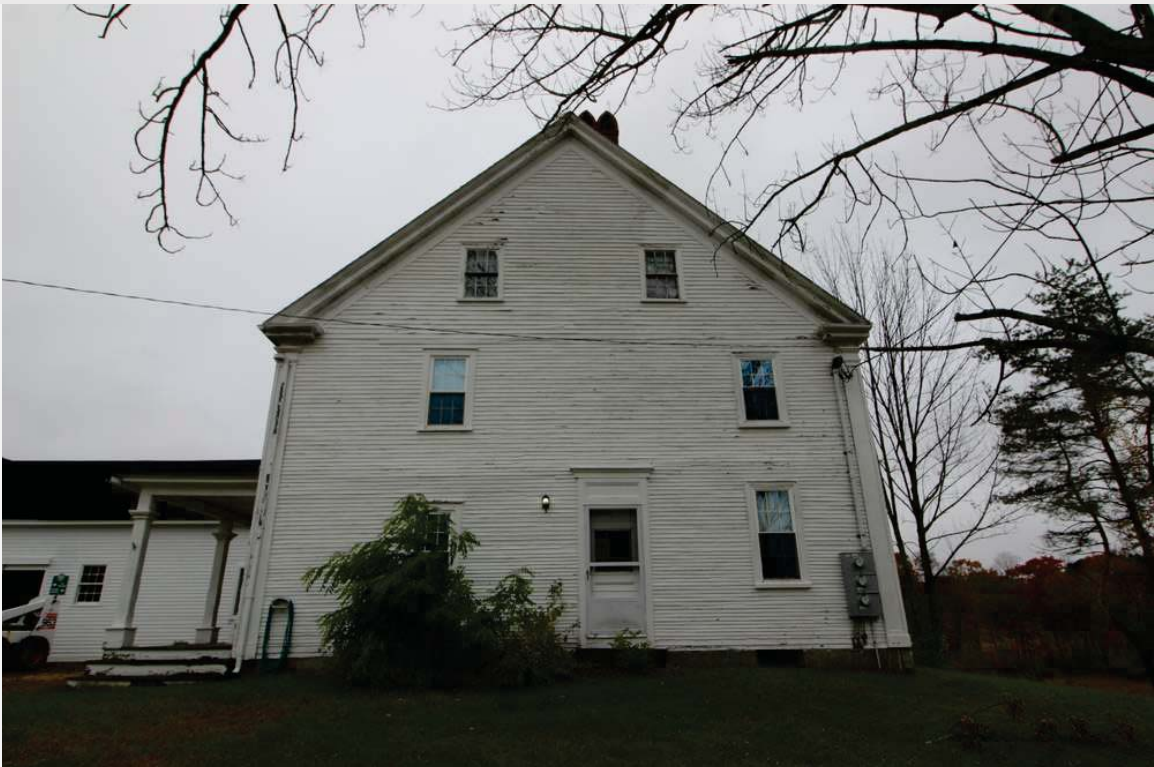
2

East Gable. The east facade faces the driveway. The original roof was a shallow hip, which is more typical of the Georgian era. This gable roof was added later, perhaps concurrent with other Greek Revival updates.

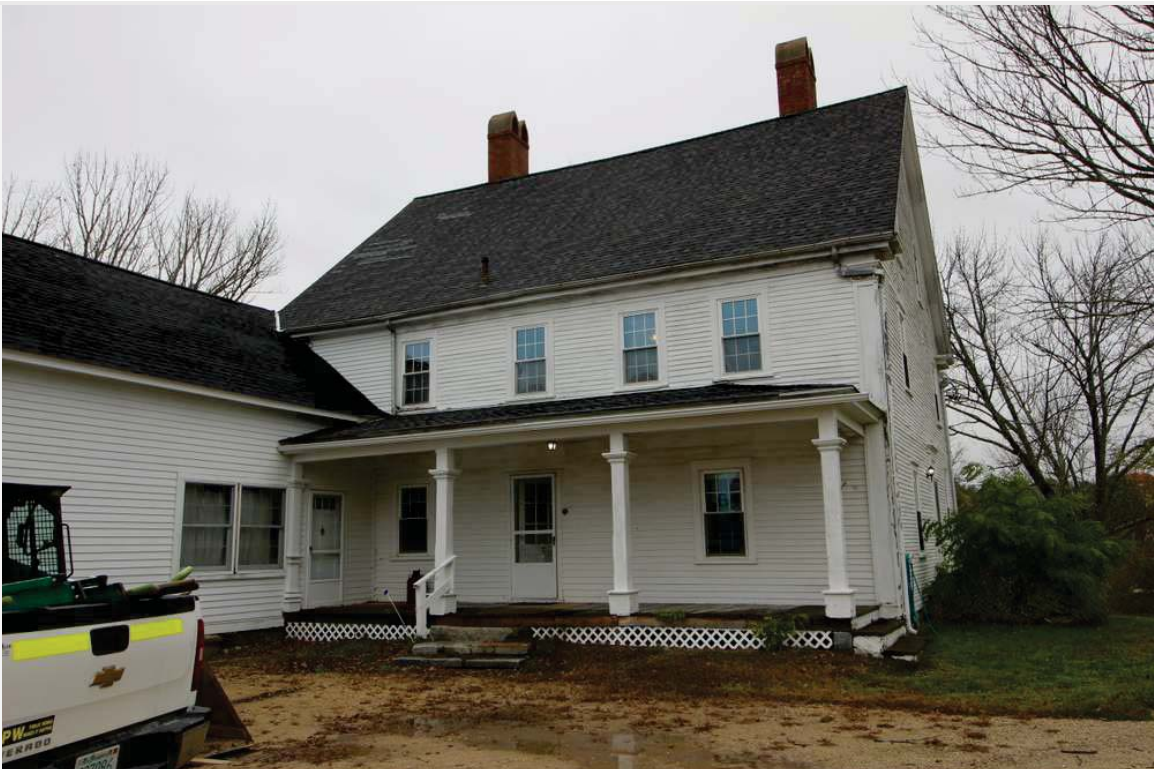
3

South Eave. The porch was a later addition with Greek Revival and vernacular elements.

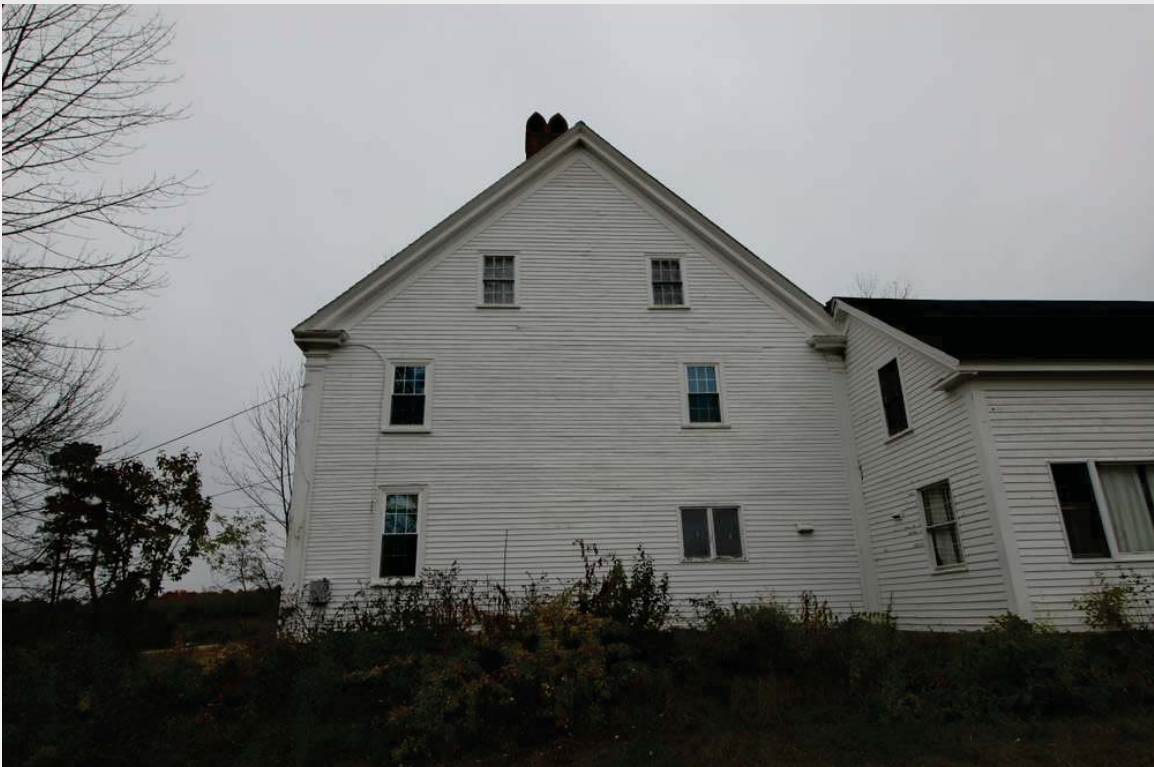
4

West Gable. The Ell was added after the roof changed from hip to gable.

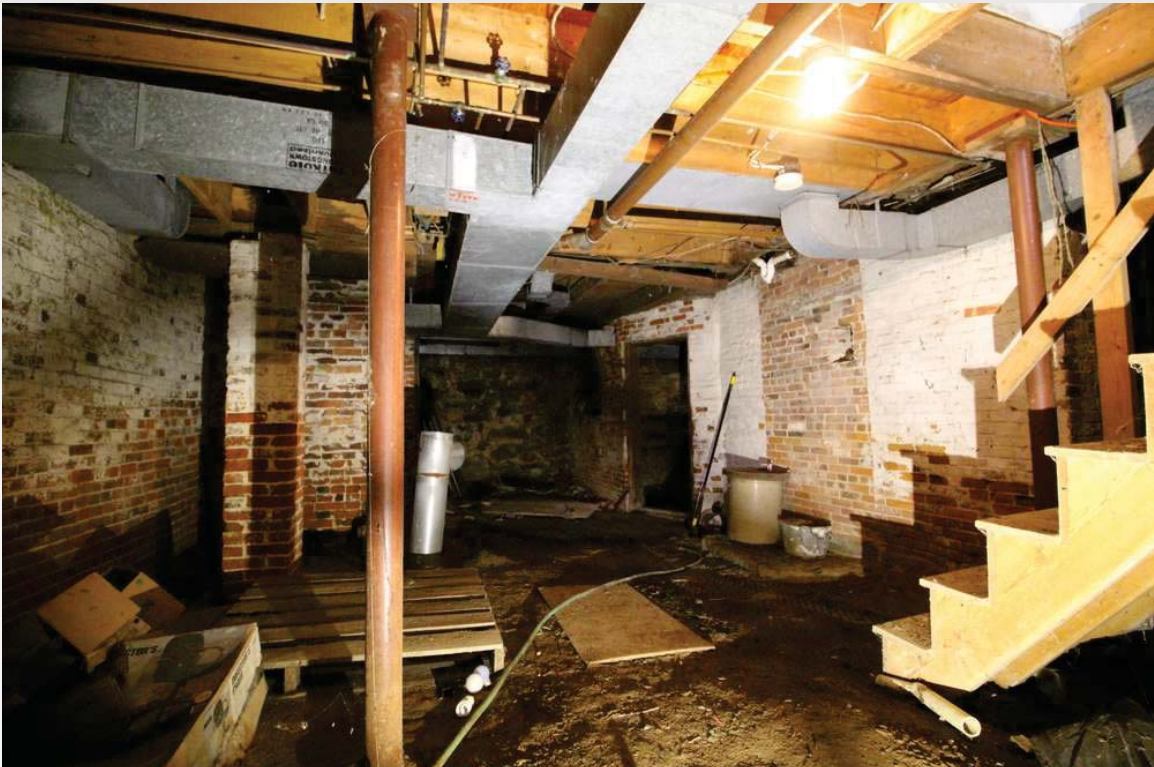
Basement, standing at south wall, looking north. The basement space contains two large chimney masses and brick partition walls which help support the framing.

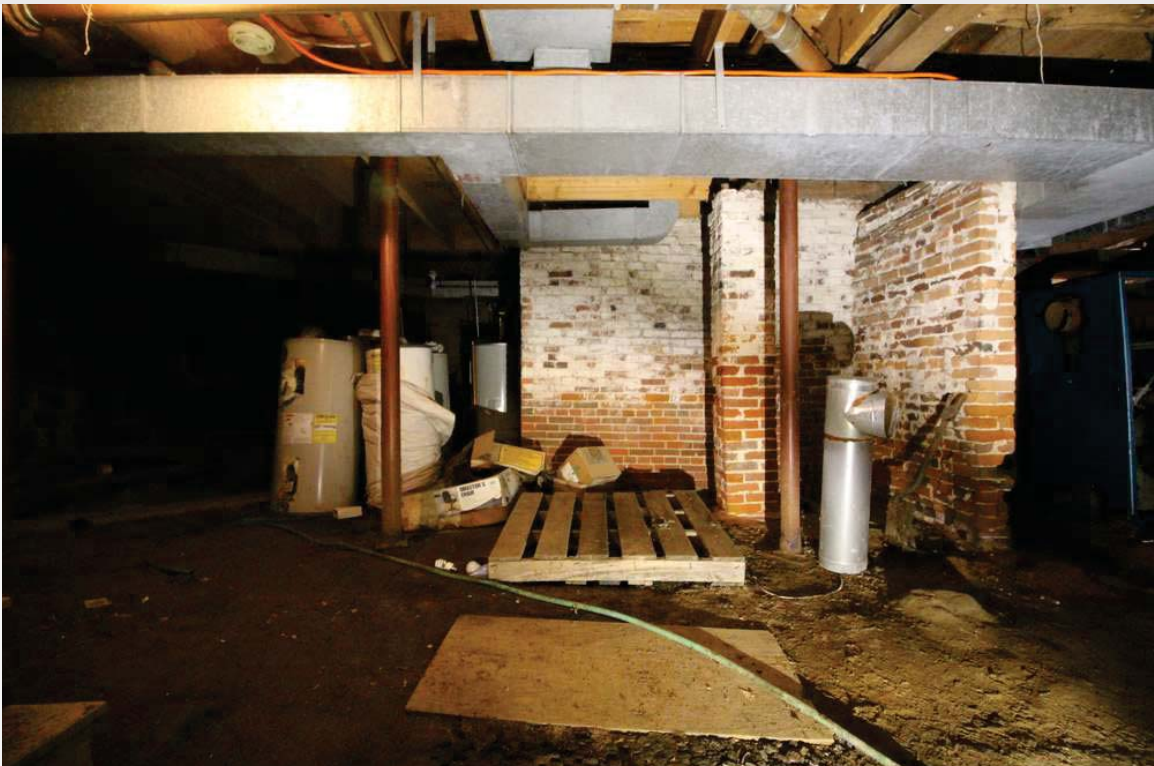
Basement, looking towards the west chimney mass. The partition wall and lally column layout is irregular and idiosyncratic.

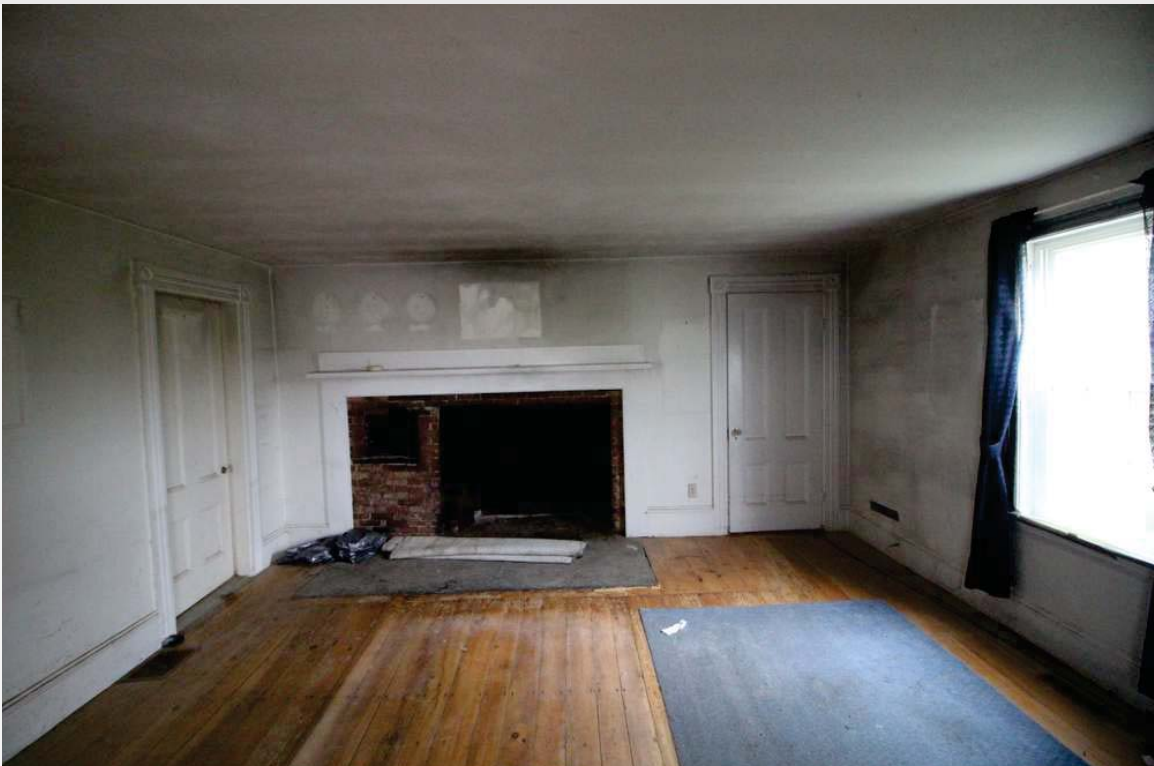
Southeast kitchen. The building is unusual in that it contains two large kitchen hearths. This hearth surround does not appear to be original, and the trim in the rest of the room looks like it was updated as part of the later Greek Revival renovation.

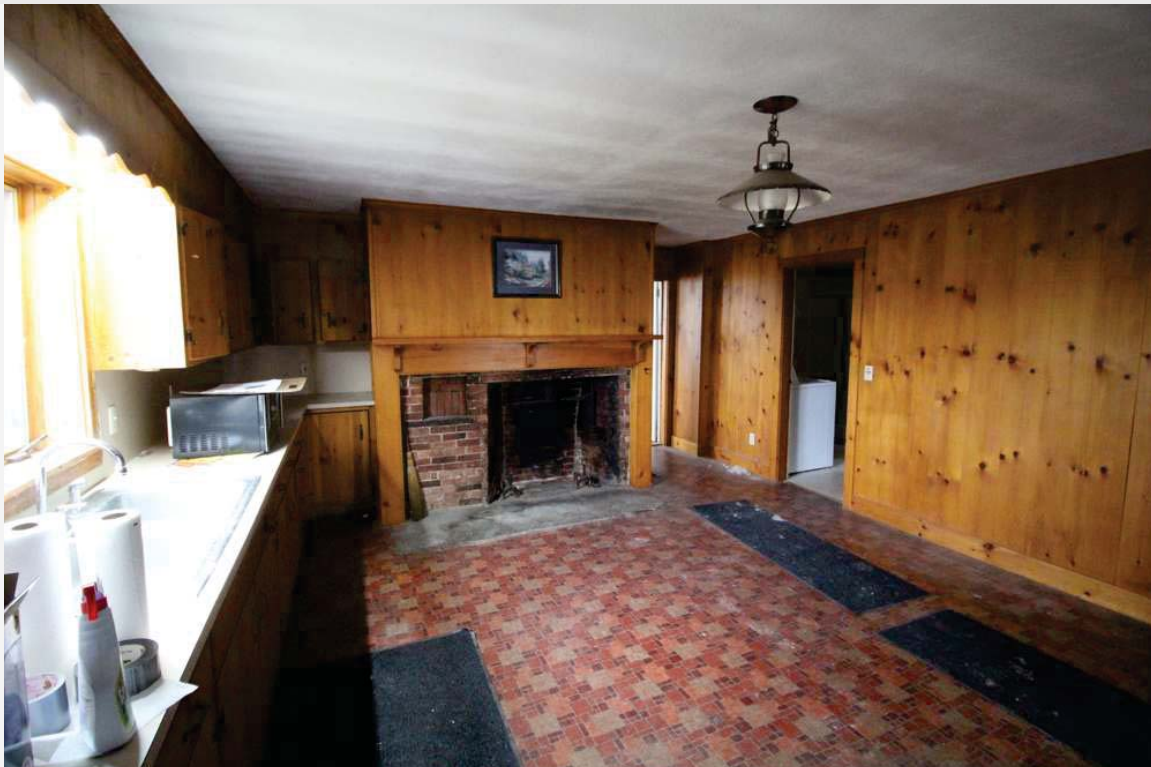
Southwest kitchen. This kitchen was updated in the 1960s with extensive pine paneling and laminates. The second kitchen hearth is highly unusual and should be preserved.

Layout of second floor girts and joists can be seen in the shadows lines in the ceiling, above.

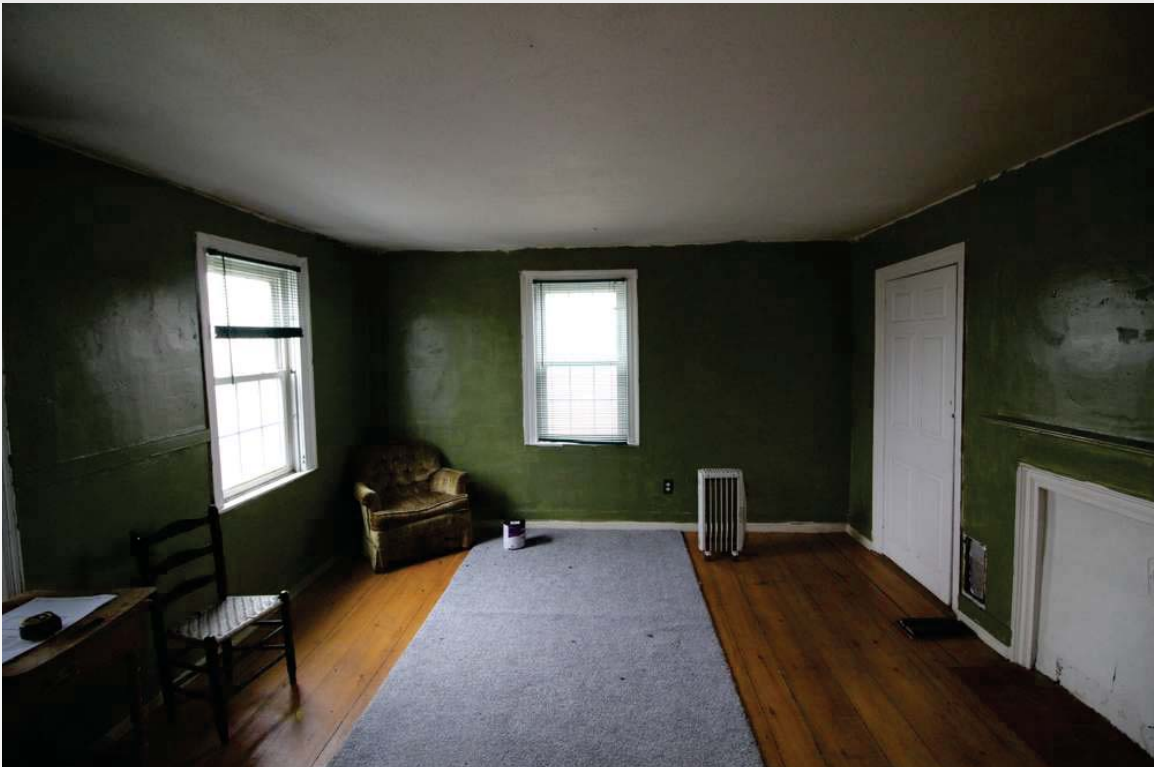
47

Northeast chamber, second floor. It is irritating that someone painted this room with so little care or concern for its history, and the beauty of its woodwork. Fortunately, the paint job is reversible.

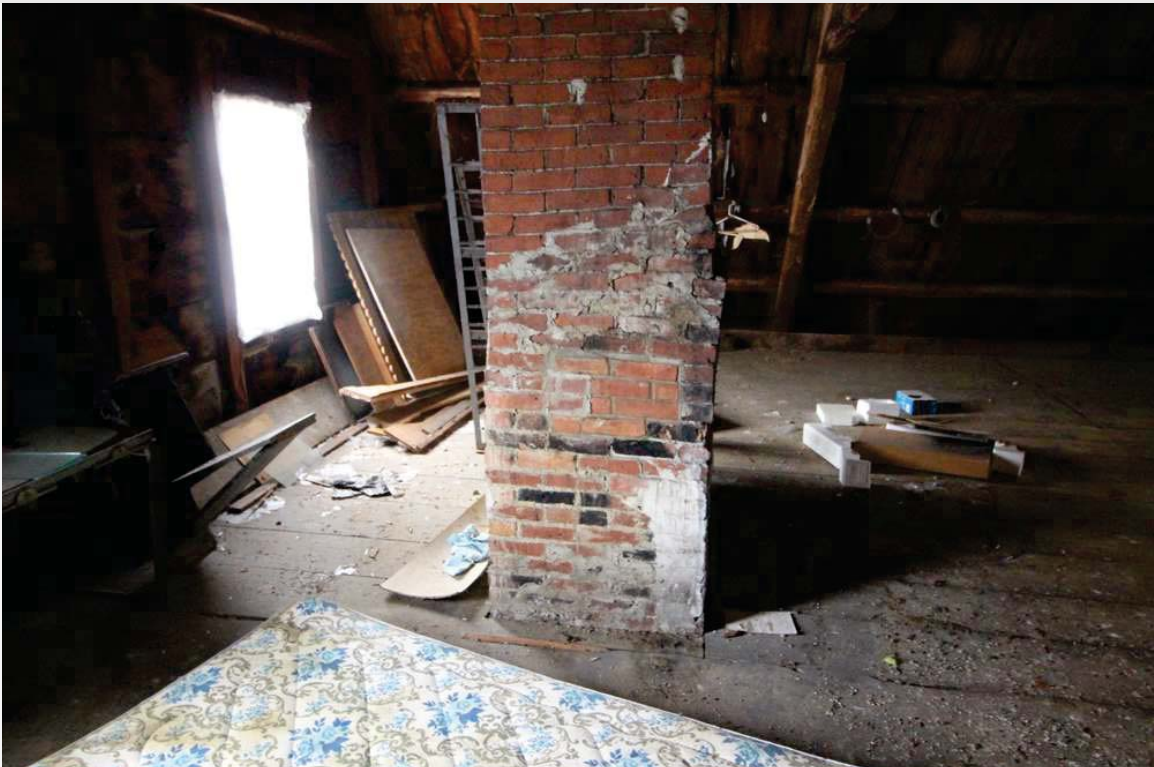
West chimney, attic. Shadow-lines on both chimneys are consistent with a hip roof.

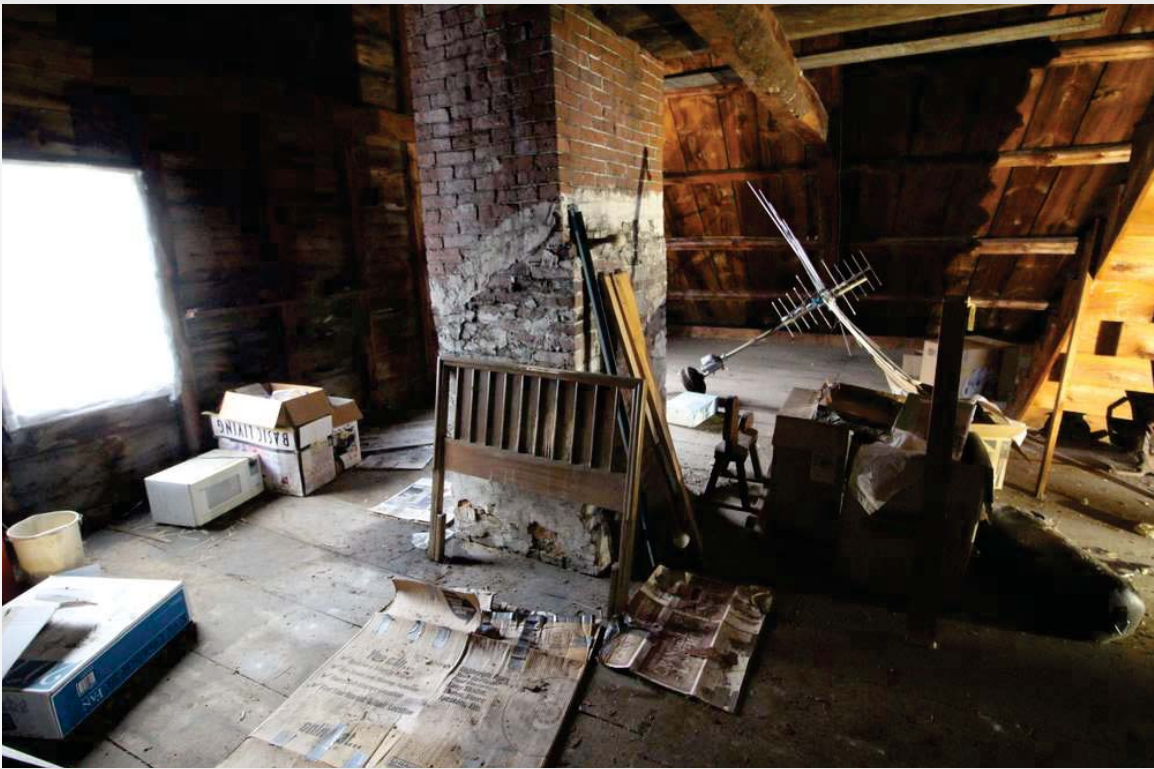
East chimney, attic. This chimney shows the same mortar and former flashing lines, giving an excellent indication of the original roof line. When the roof frame was changed, the chimneys were also built taller, starting somewhere above the collar ties.

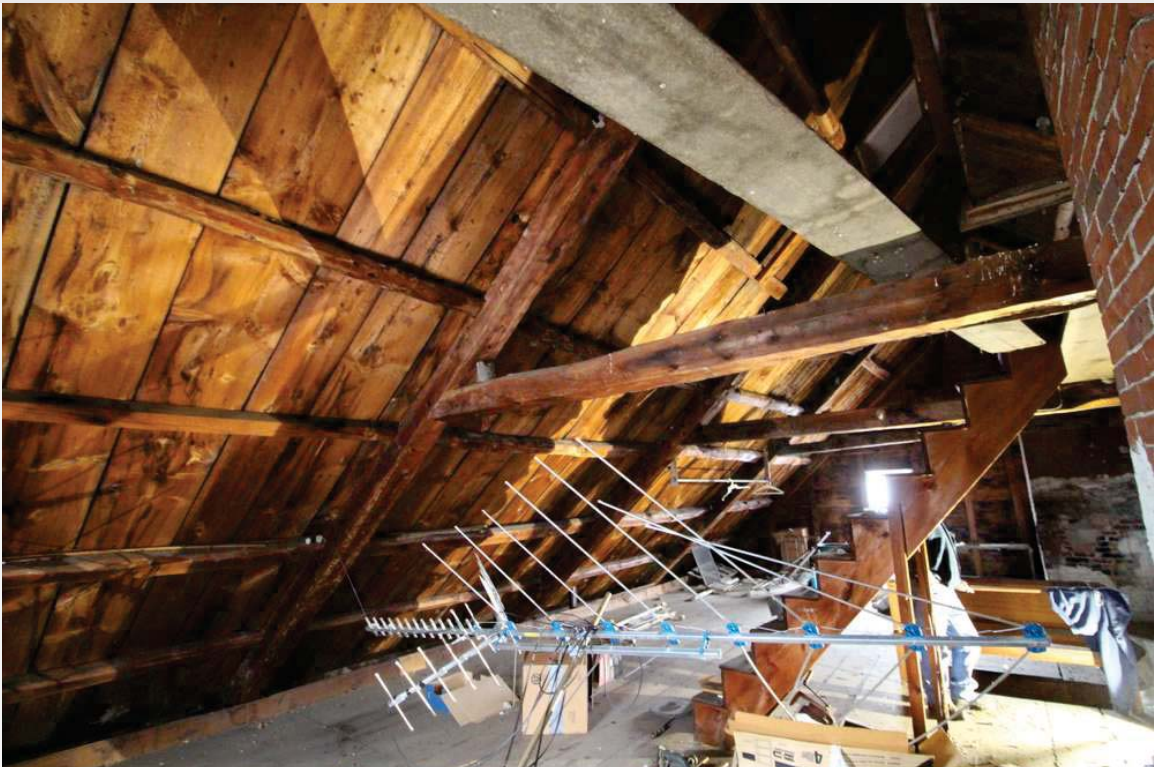
The current roof is called a principal rafter-common purlin roof. The rafters are large timbers, tapering from heel to apex of roof. Each pair is connected by a collar tie at the mid-span and bridle joint at the ridge.

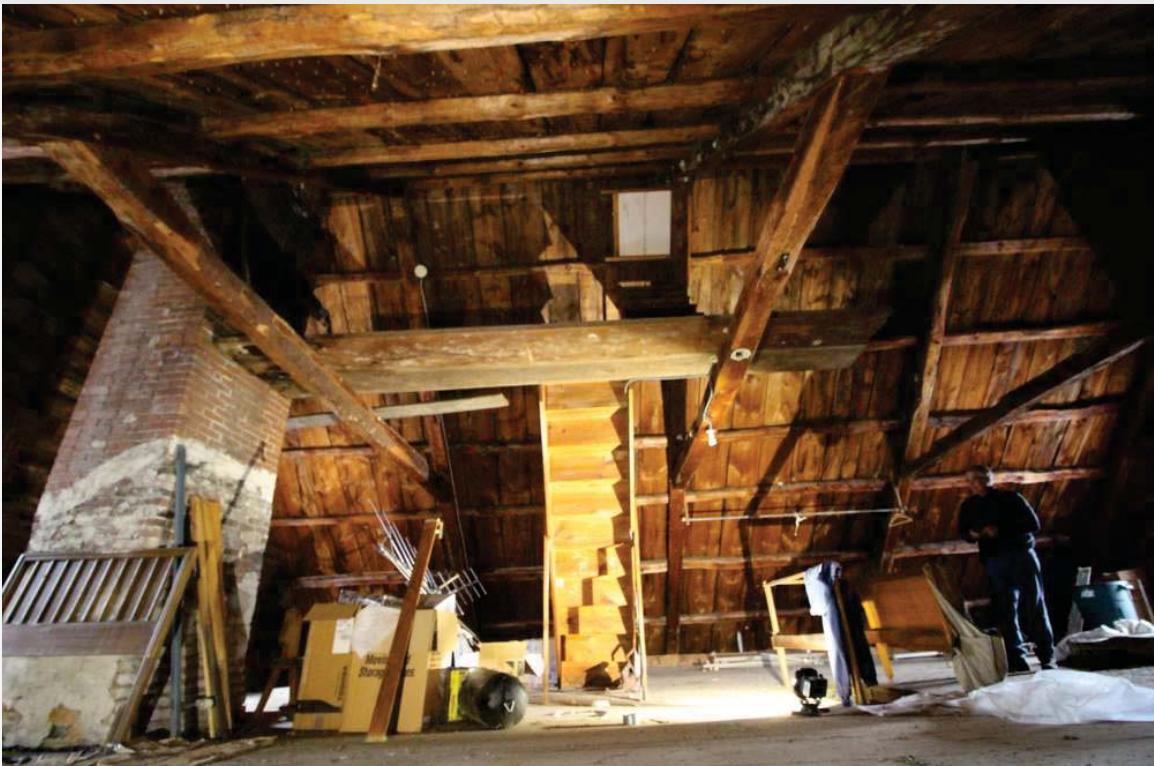
A set of stairs ascends to a landing over the collar ties, and then to a hatch in the roof, which is excellent for access, and assessing roof conditions.

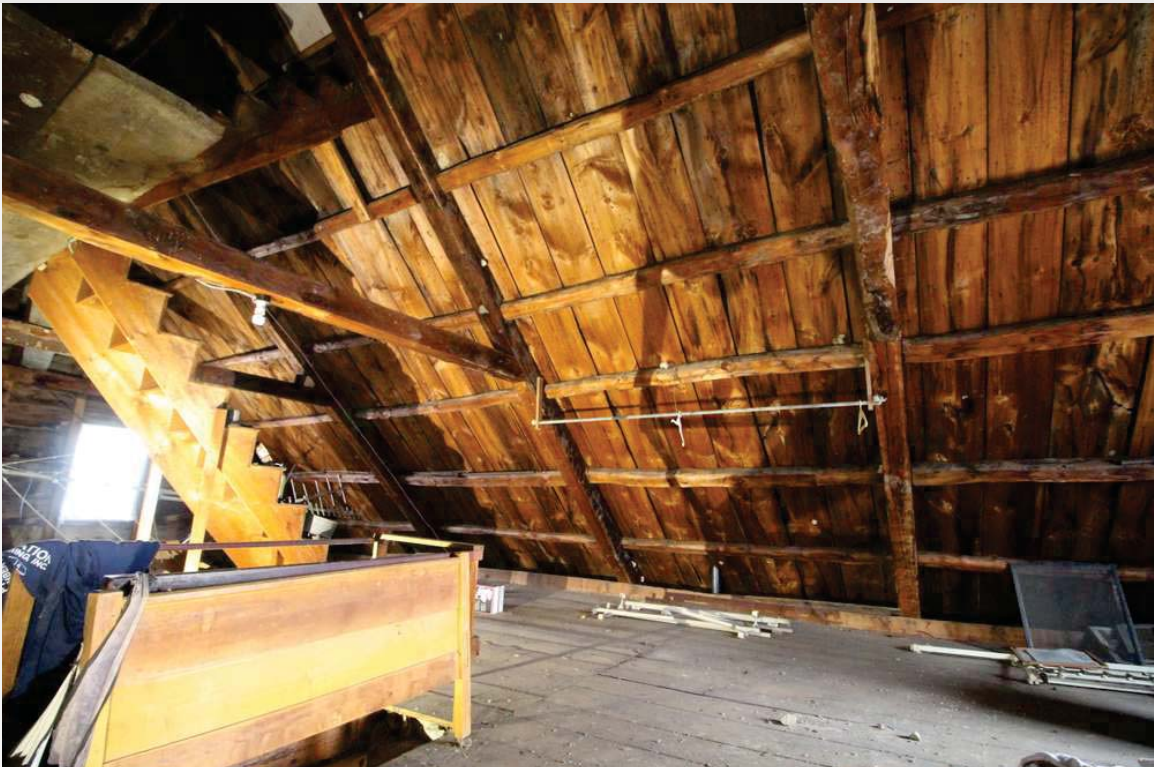
55

This roof system is really beautiful, and strong, too. It is in very good condition. This type of roof was popular in the area until around 1850.

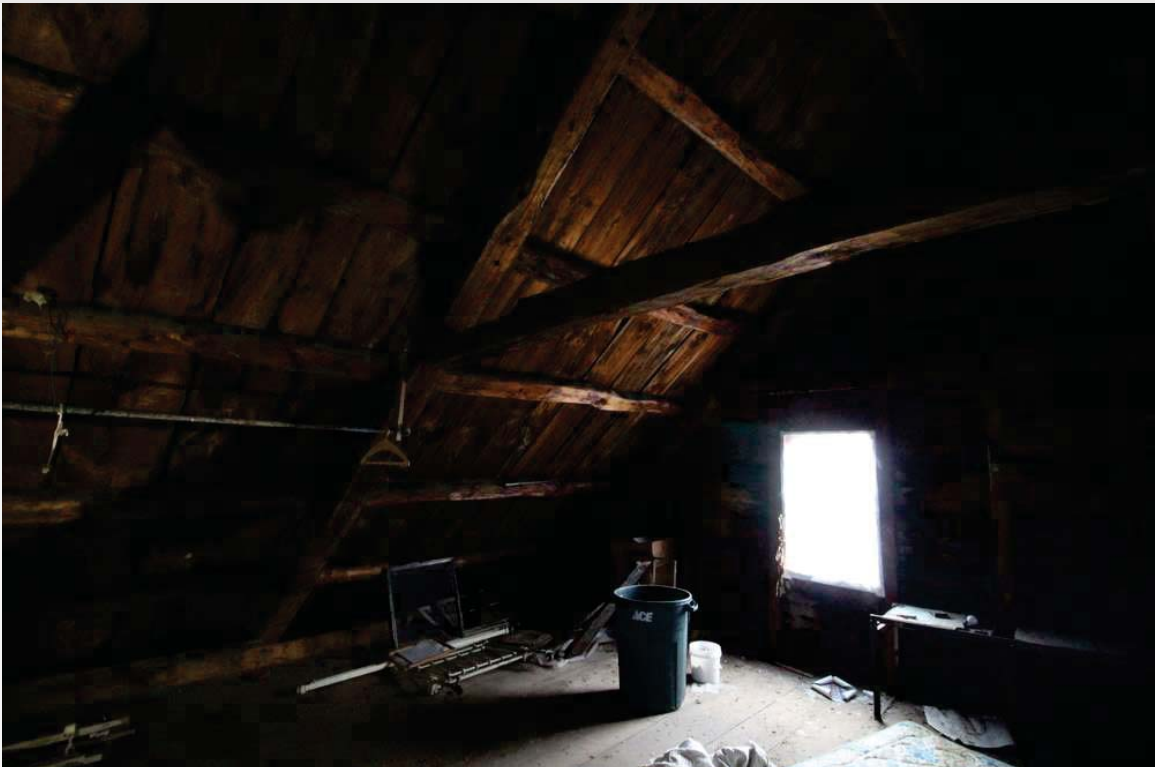
57

Gable end framing, moody lighting.

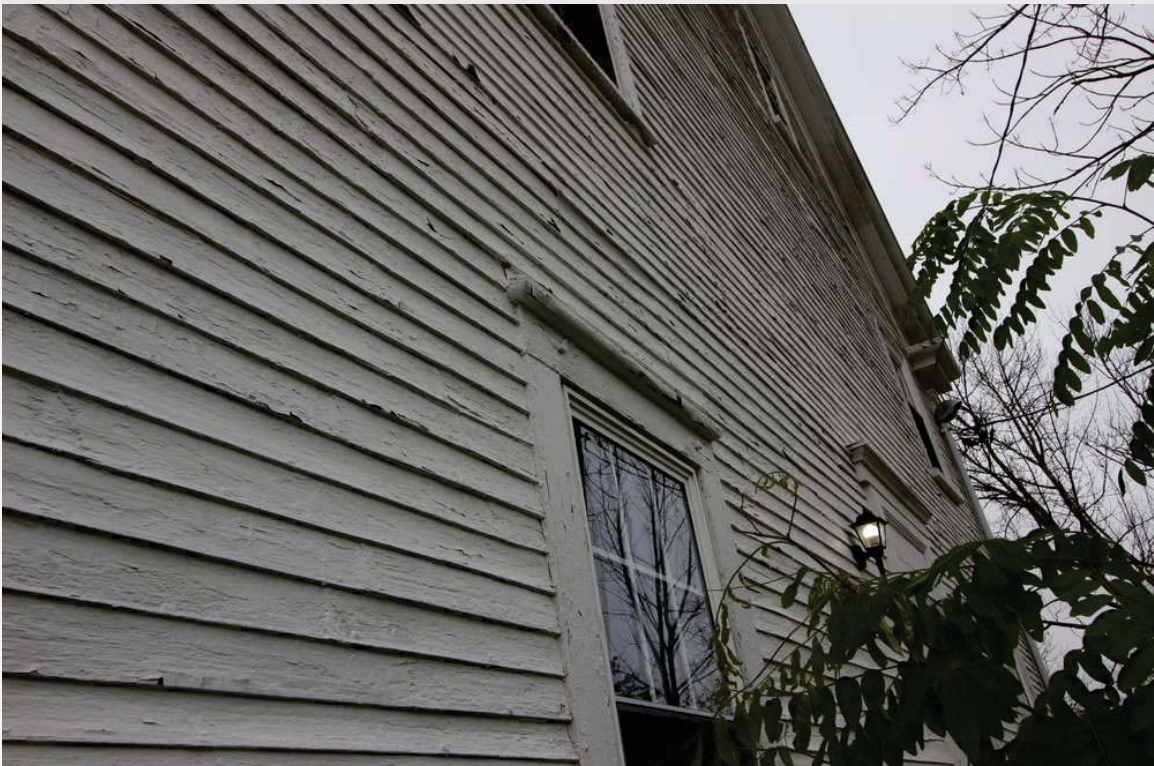
63

The raking gable trim is crisp and impressive. It should not be removed for repair until there is a sound plan for faithful reproduction. Trim profiles like these cannot be bought off-the-shelf. The subtle differences in radius and dimension add up to a big difference in overall aesthetic.
