# Mill Pond Dam

## Visual Inspection Report

Durham, New Hampshire

Dam #071.03

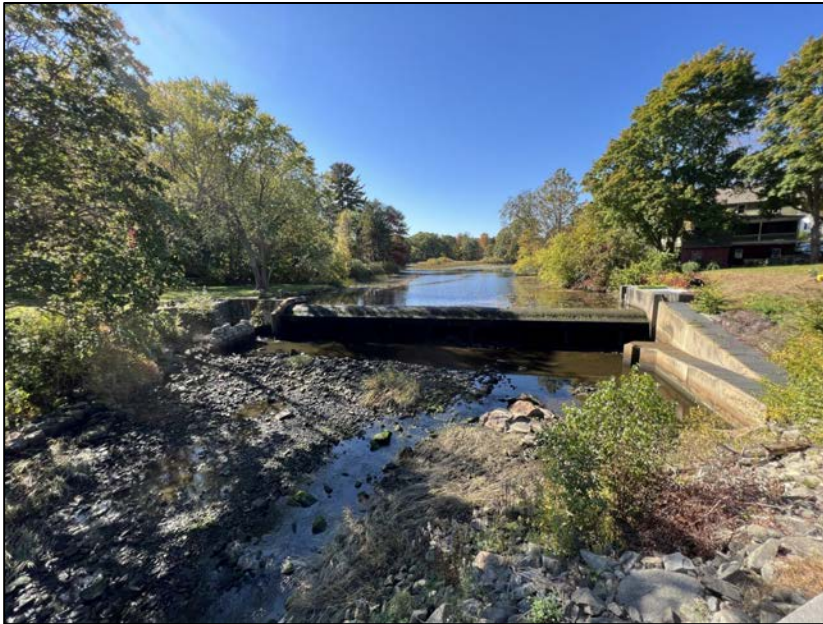
Photo No. 1.: Overview of the downstream side of the dam.

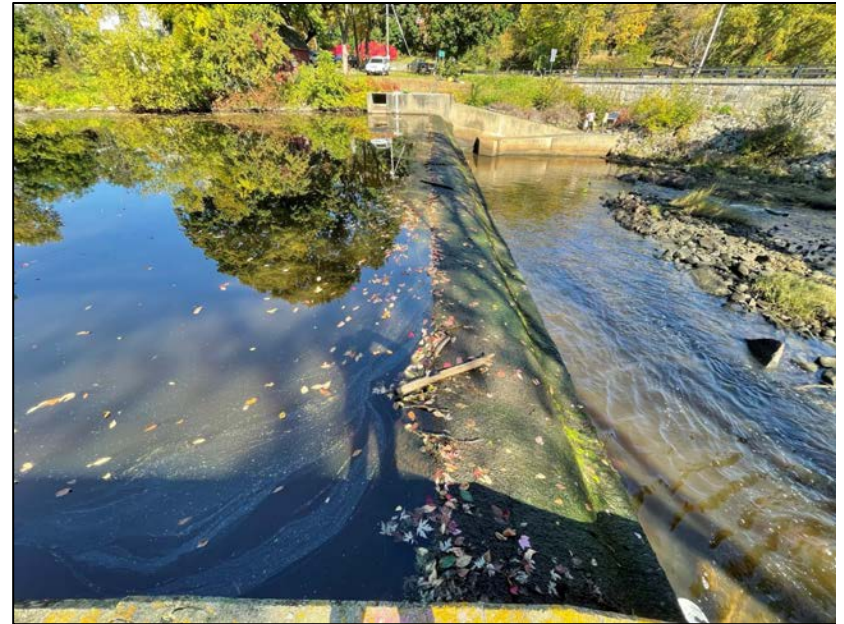
Photo No. 3.: View of the spillway crest

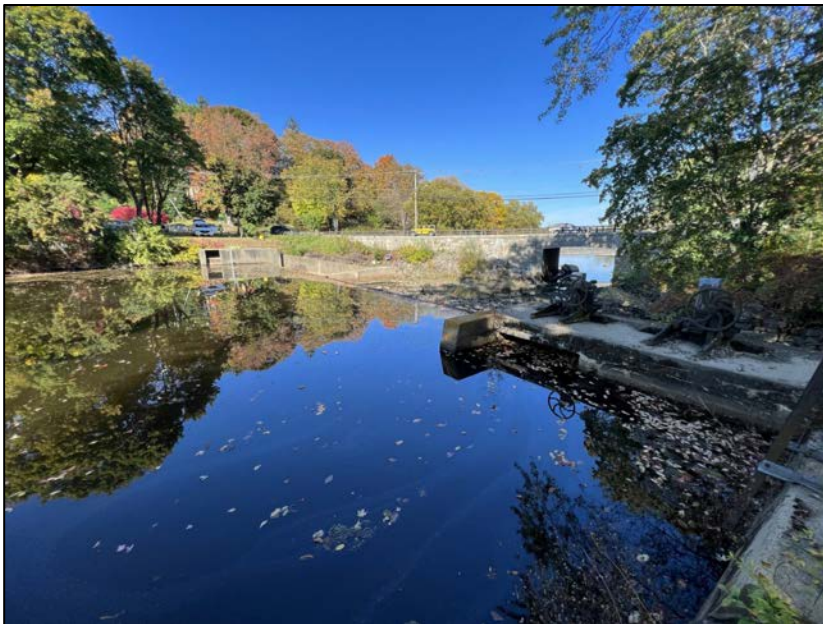
Photo No. 2.: Overview of the upstream side of the dam.

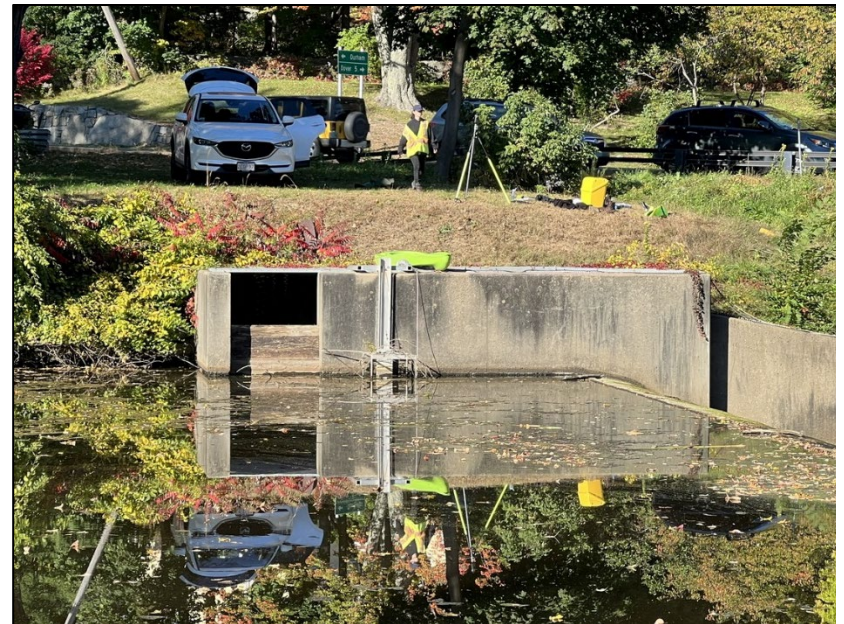
Photo No. 4.: View of the left abutment

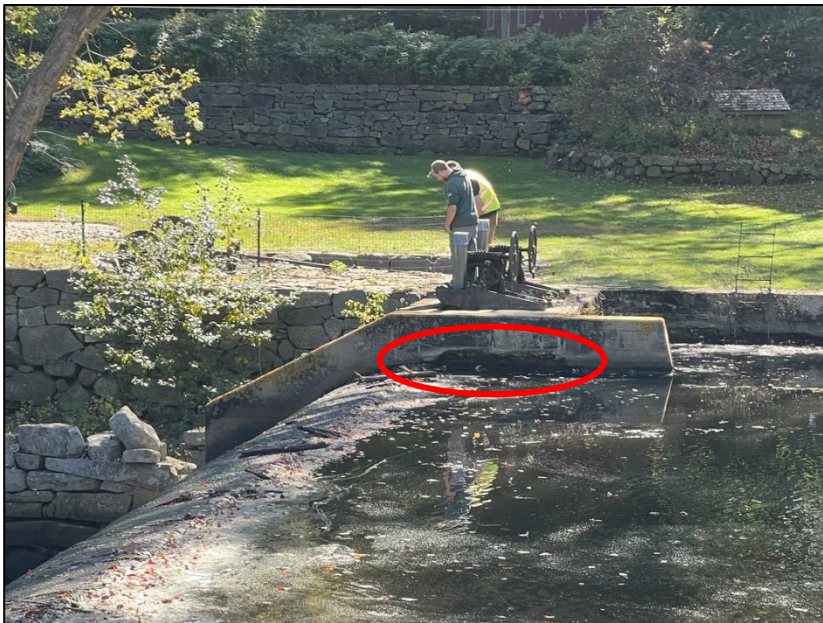
Photo No. 6.: View of the right spillway channel wall. Note scoured concrete behind the spillway crest.

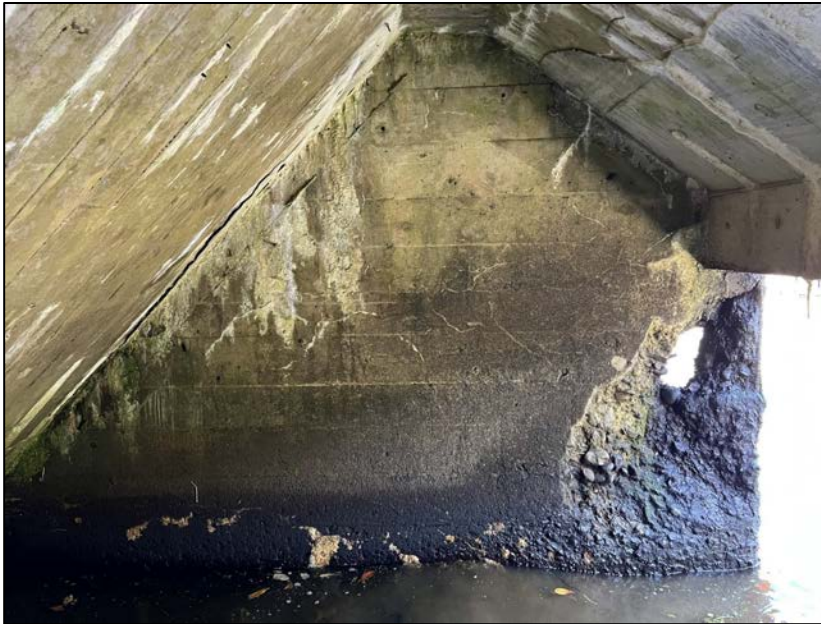
Photo No. 9.: Left interior wall

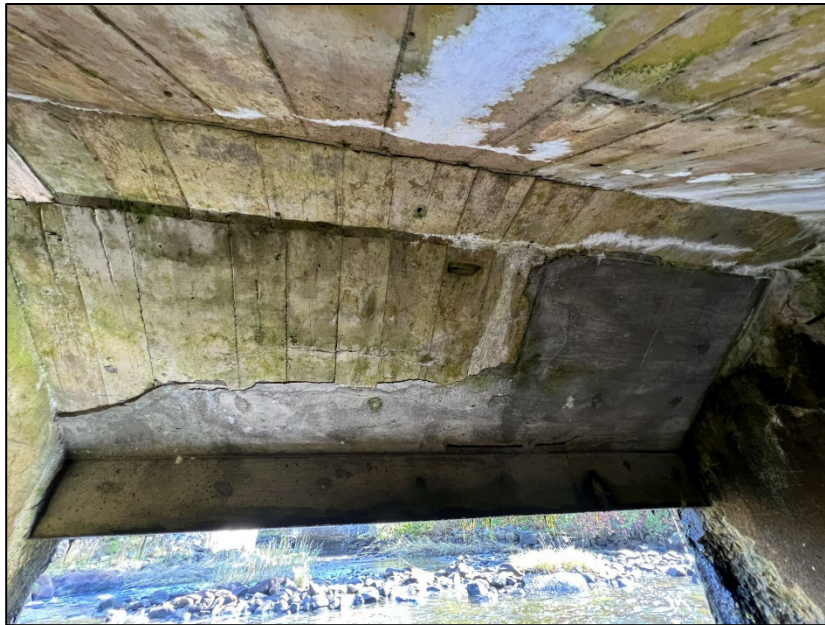
Photo No. 22.: Overview of the downstream slope of the ceiling (ceiling face no. 3).

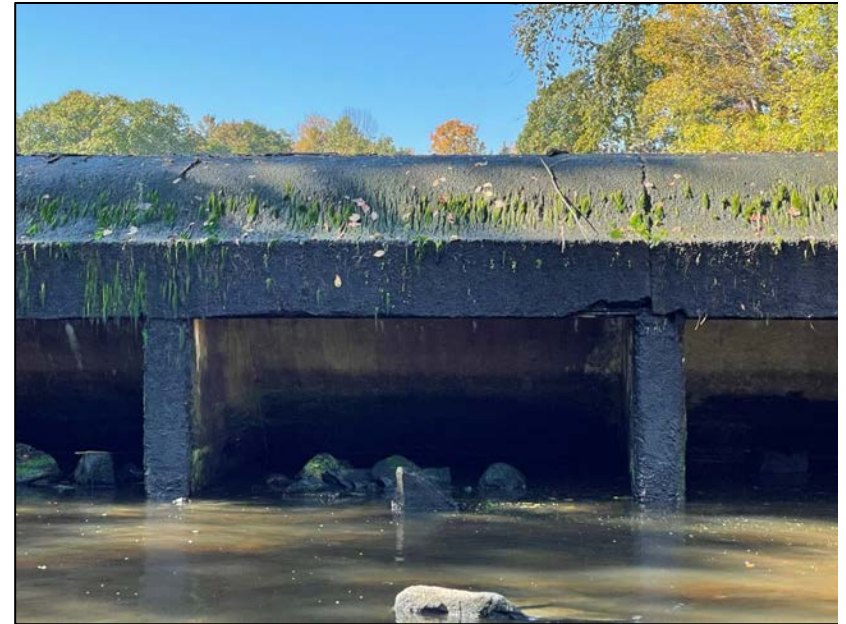
Photo No. 31.: Overview of the downstream face of the Cell.

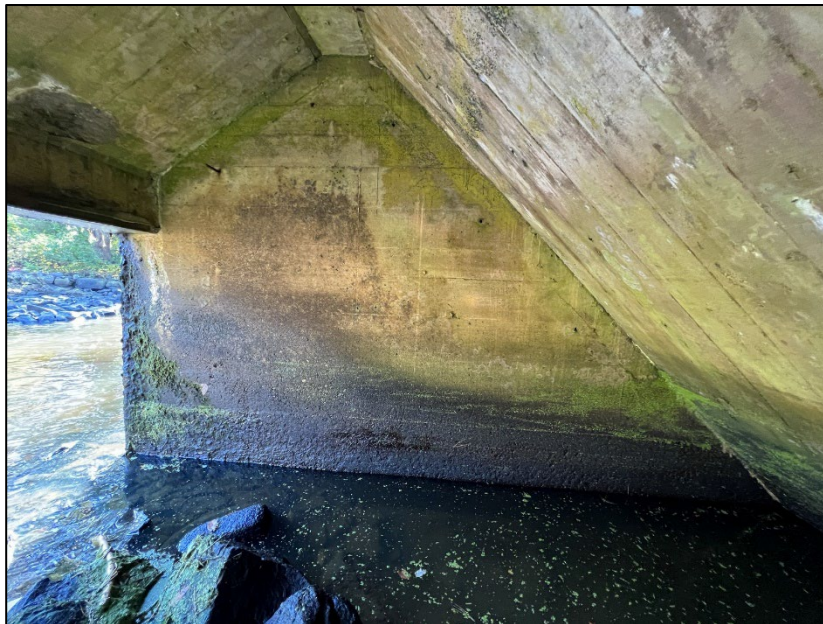
Photo No. 30.: Right Wall. Concrete in fair condition.

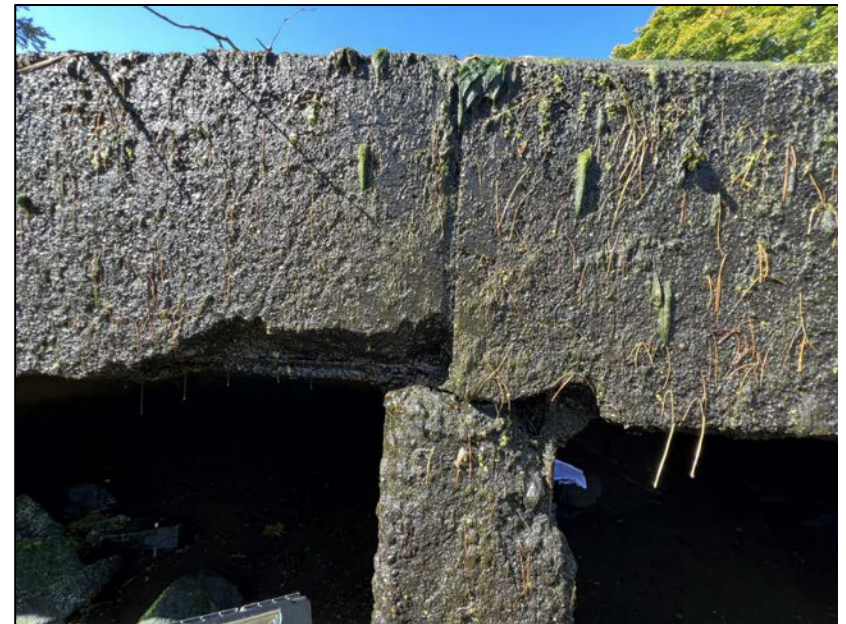
Photo No. 32.: Section loss and debonded rebar along the top of the rib between Cell 6 and Cell 7.

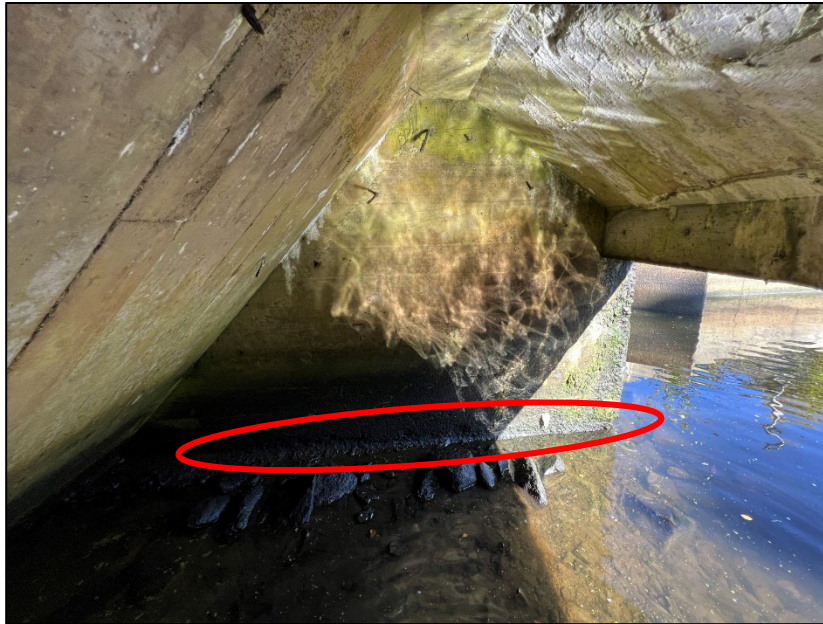
Photo No. 33.: Left Wall. Note scour up to 1.25 inches deep along the bottom 5 inches of the wall.

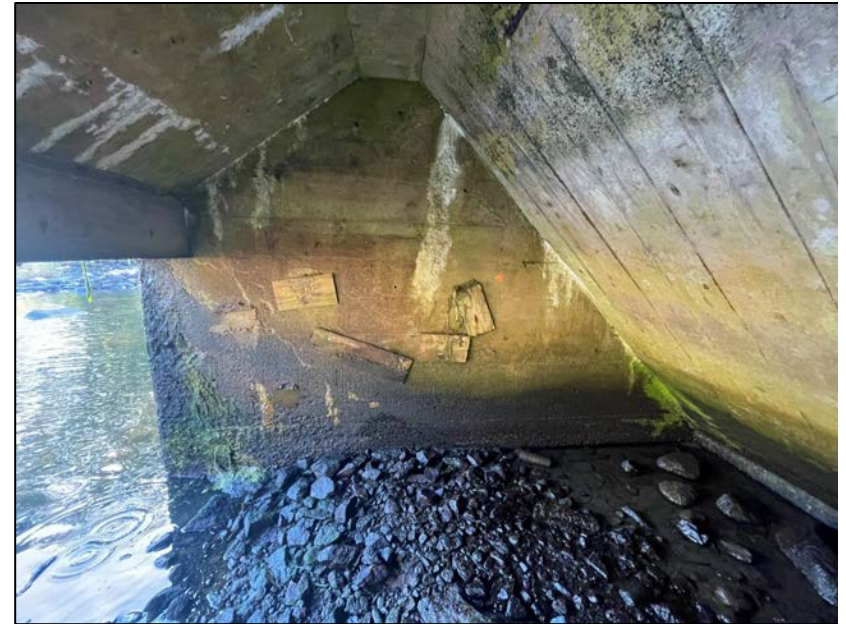
Photo No. 39.: Right wall

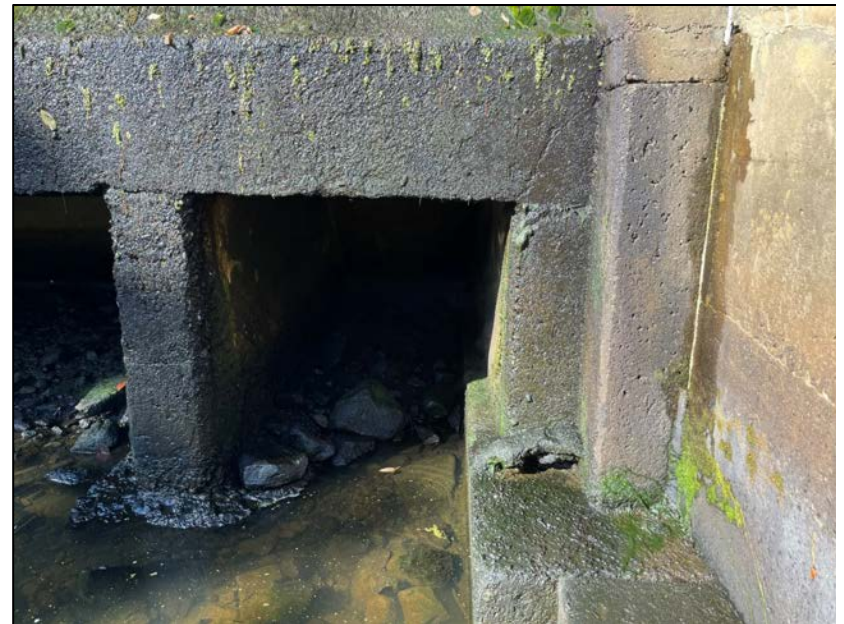
Photo No. 44.: Downstream face of Cell 9.

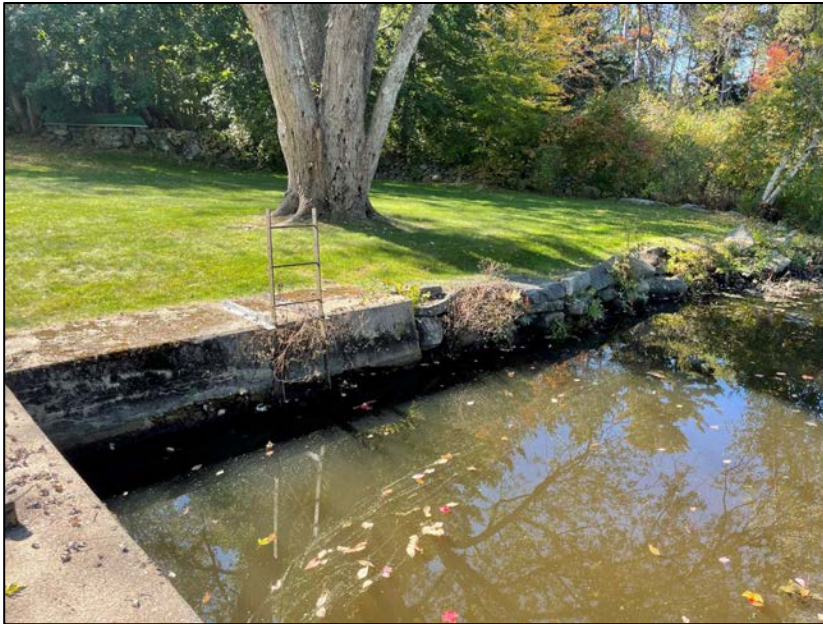
Photo No. 45.: Right abutment upstream of the low-level outlet.

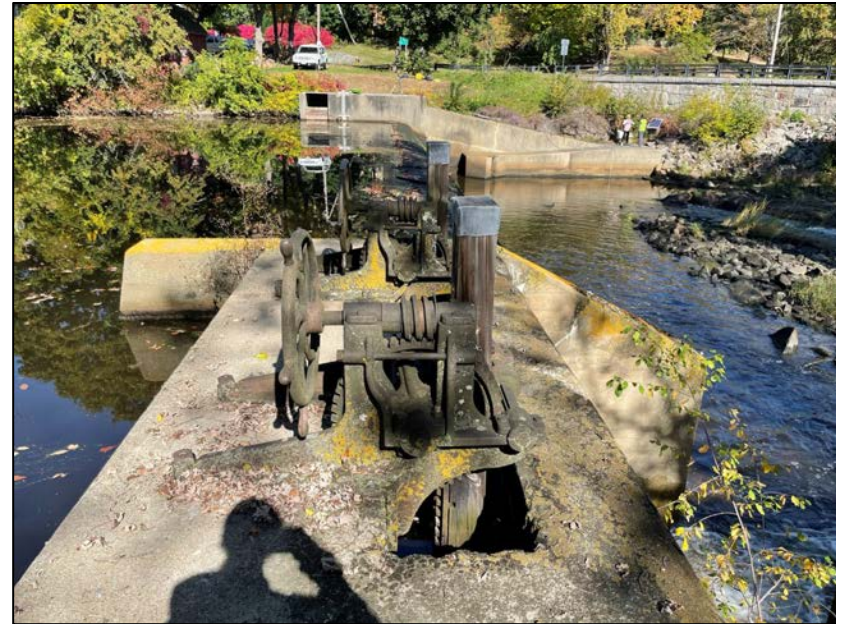
Photo No. 47.: Top of the low-level outlet control structure and gate operators.

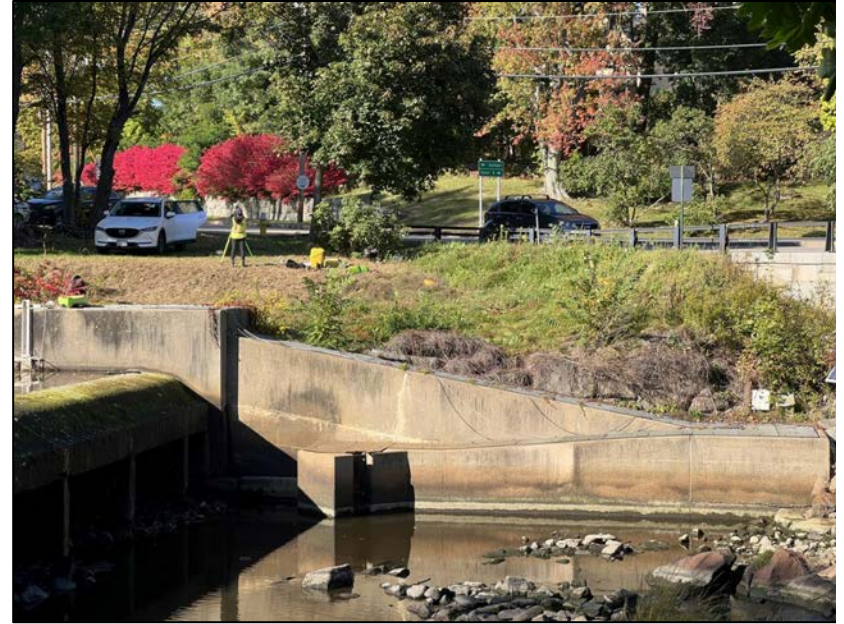
Photo No. 51.: Overview of the fish ladder at the left abutment.

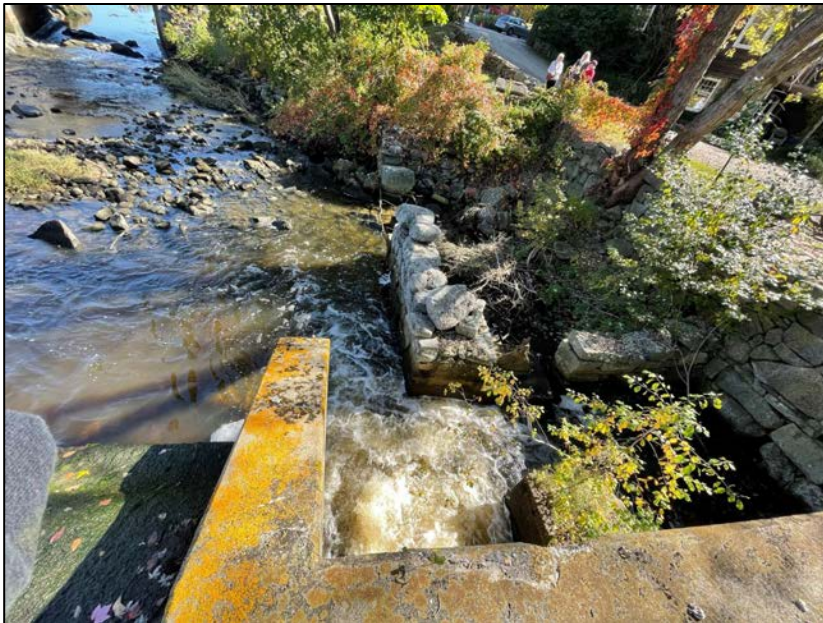
Photo No. 50.: Remnants of mill foundations downstream of the low-level outlet.

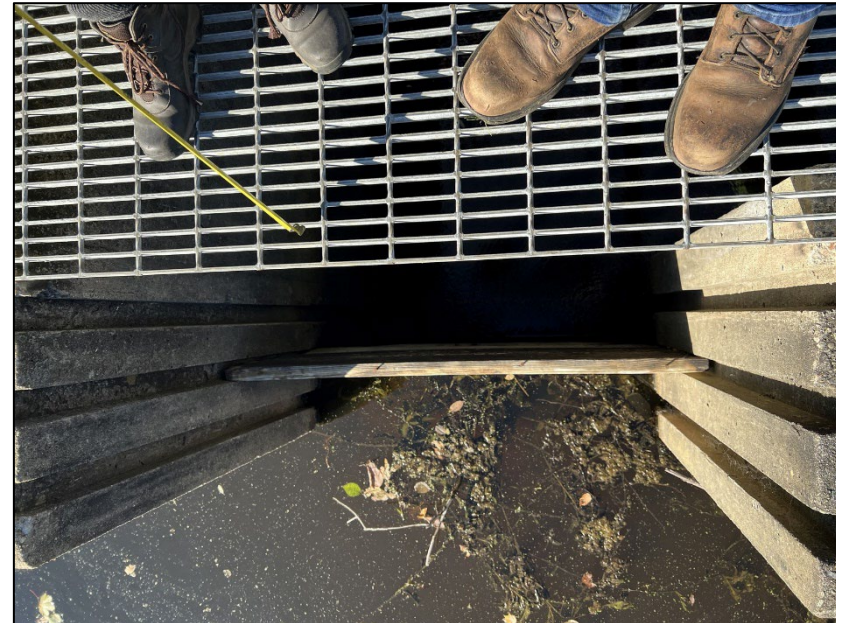
Photo No. 52.: Upstream end of the fish ladder.

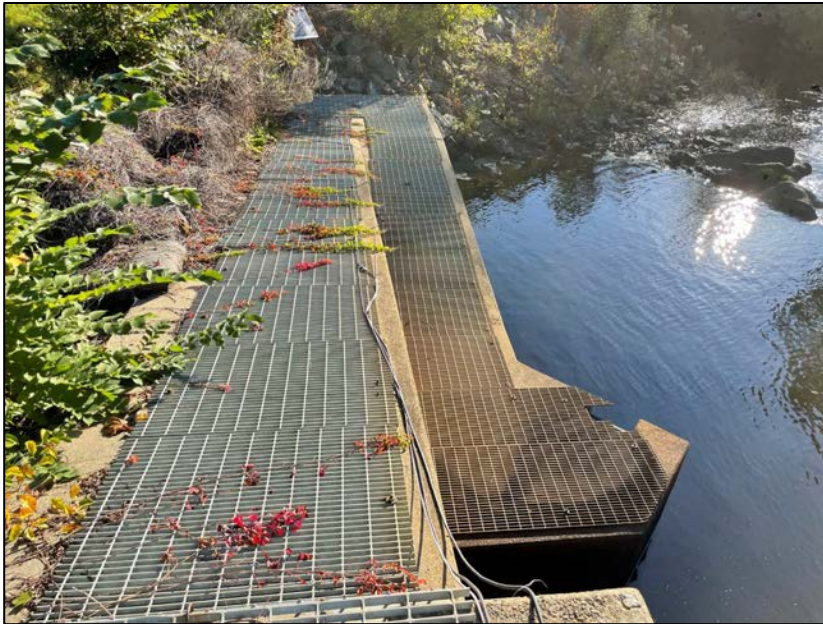
Photo No. 53.: Overview of the top face of the fish ladder.

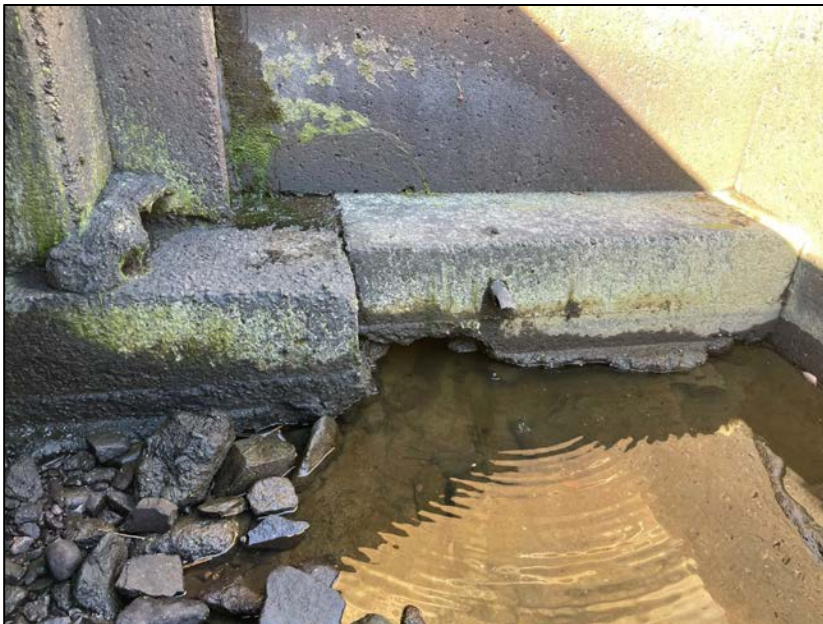
Photo No. 54.: Scour hole at bottom of right fish ladder wall at the downstream channel. Note void was probed approximately 36 inches.

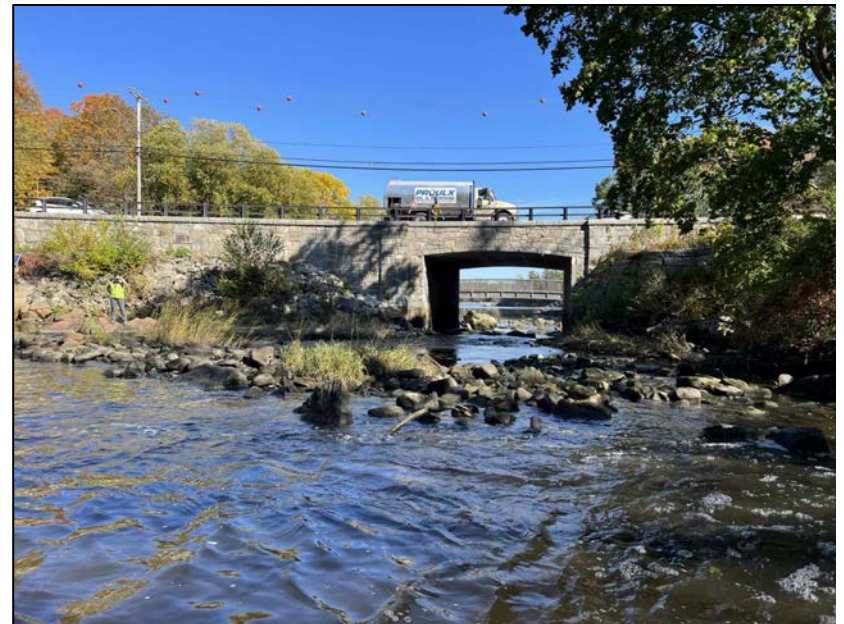
Photo No. 56.: Downstream area of the dam looking downstream at the bridge carrying Newmarket Road.
