Wagon Hill, Master and
Management Plan 1995

Master & Management Plan
Wagon Hill Farm
Durham, New Hampshire

Prepared For
Strafford Regional Planning Commission
& the Town of Durham, New Hampshire

August 21, 1995

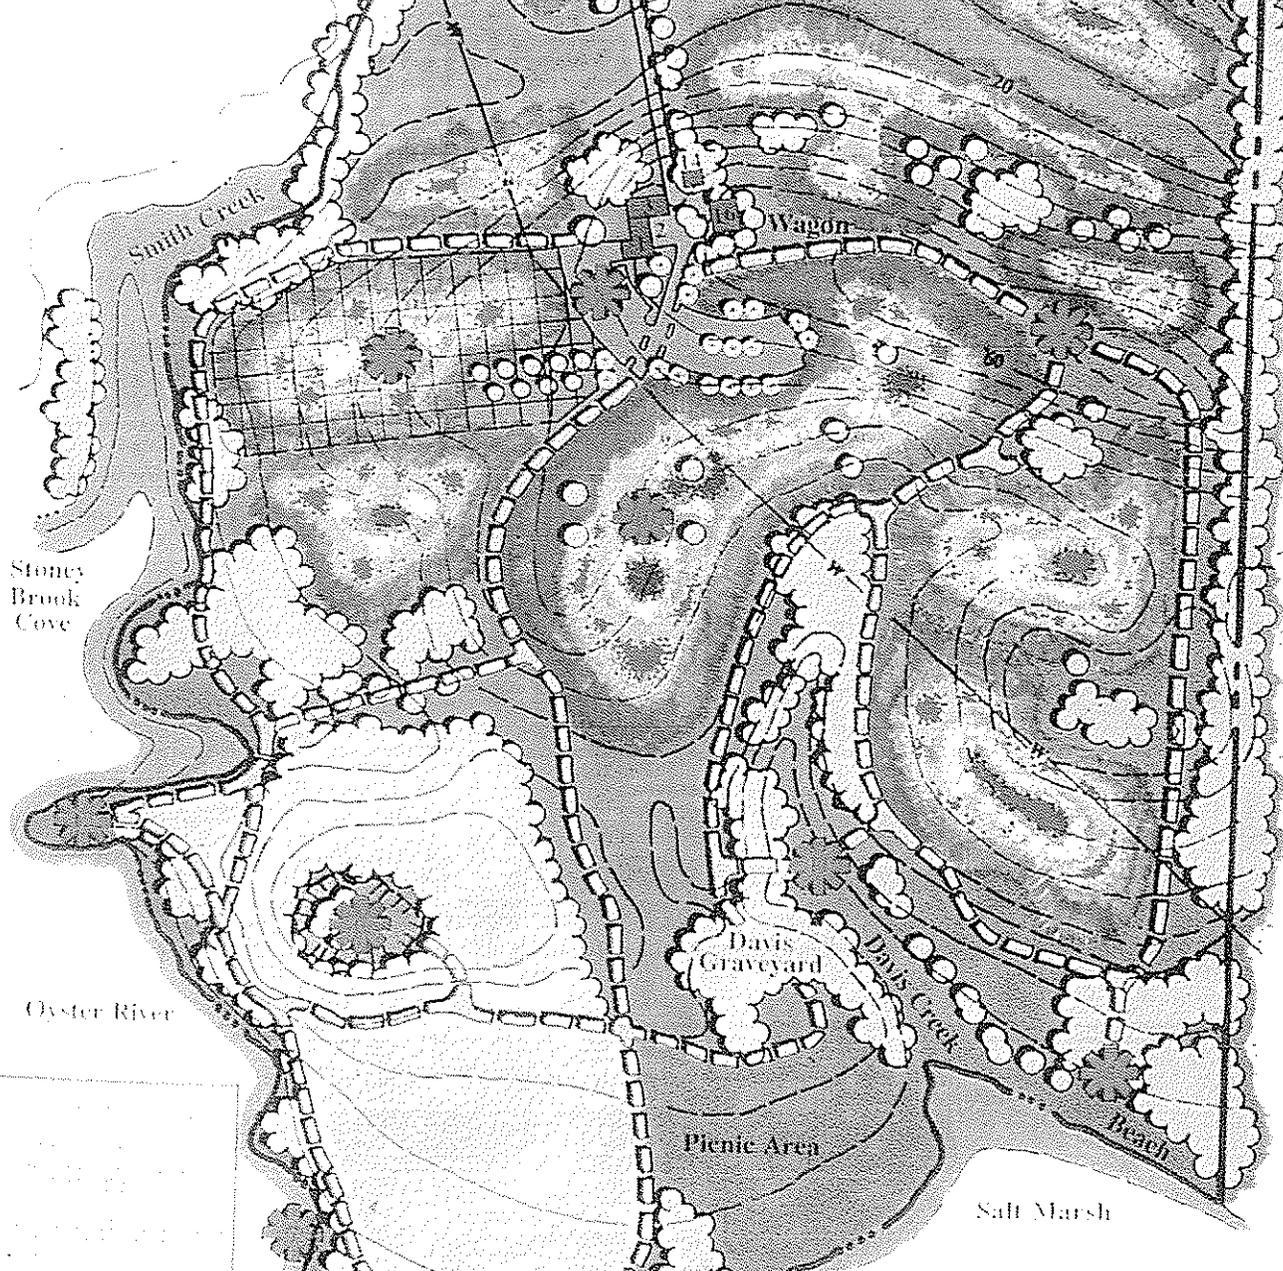
WAGON HILL FARM
 2000 sq. ft. ±
 Concept C
 Wedding Pavilion/ Boathouse

1. The proposed site for the pavilion/boathouse is located on the eastern shore of the Oyster River, adjacent to the Davis Creek and the Salt Marsh. The site is approximately 1.5 acres in size and is bounded by the Oyster River to the west and the Salt Marsh to the east. The site is currently undeveloped and is surrounded by a mix of natural and man-made features.

15. The boat house and/or bathroom facility at the wharf should be looked at closely. The problems of running water, sewer lines, and electricity on a pier can be long-term maintenance issues. The utility lines would be susceptible to freezing or damage from wave and ice conditions under the pier structure. The boathouse may be more suited to an upland location with sufficient room immediately in front for users to work on boats and allow easy transfer of boats in and out of the boathouse. In addition, with the presence of wetland vegetation on the outer portions of the wharf area it is unlikely that construction over that area would be allowed. Cost - \$81,000.00

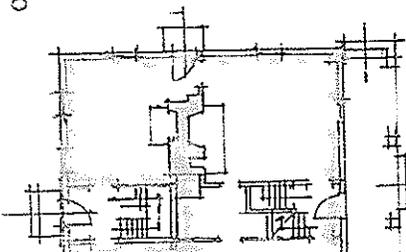
NEW SLAB, REINFORCE
FOUNDATION WALLS,
RESTORE FLOOR
STRUCTURE (TYP.)

NEW W.C.'S A.D.A.
COMPLIANT

RESTORE
PLAZZA

NEW STAIR TO
APARTMENT

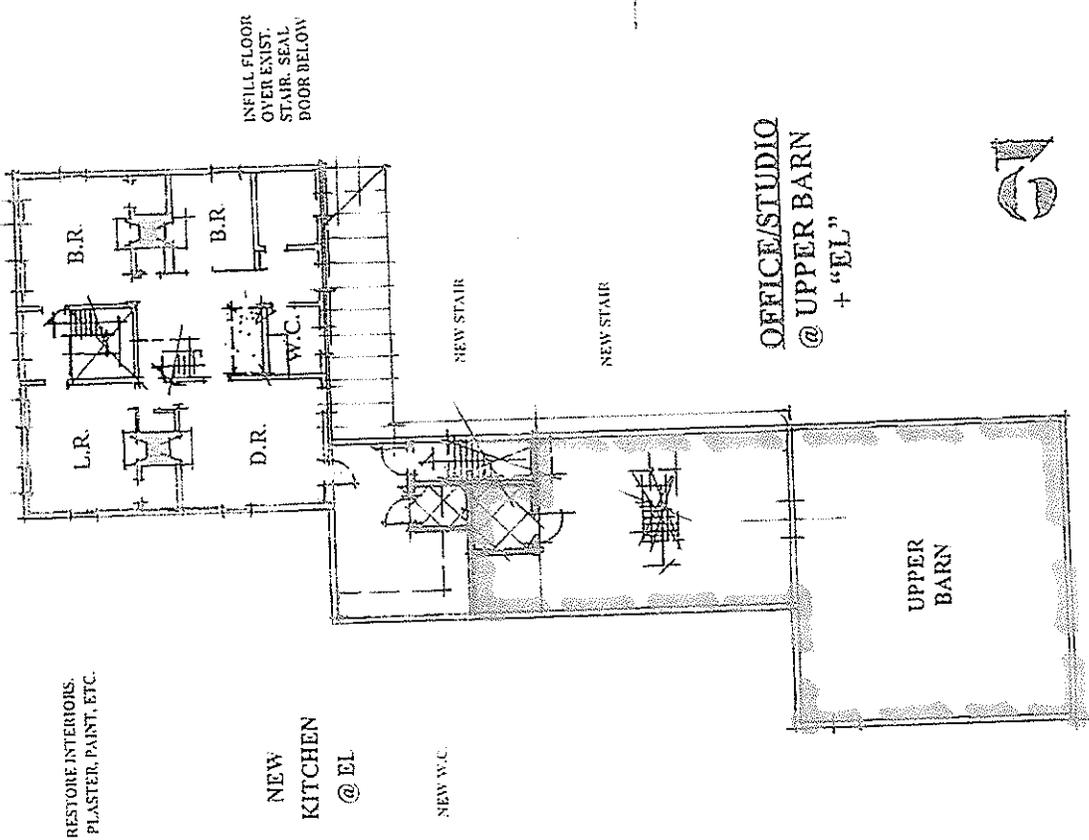
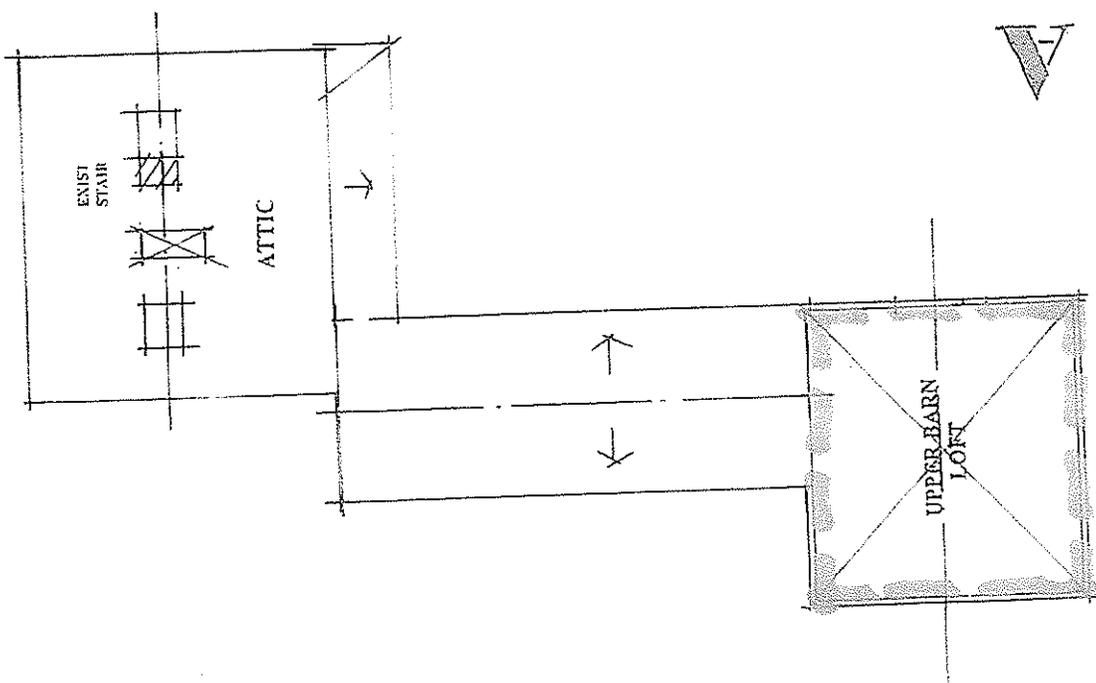
**BICKFORD-CHESLEY HOUSE (CIRCA 1806)
RENOVATIONS**

TENANT ENTRY
@ FRONT DOOR

**APARTMENT @ 2ND
FLOOR**

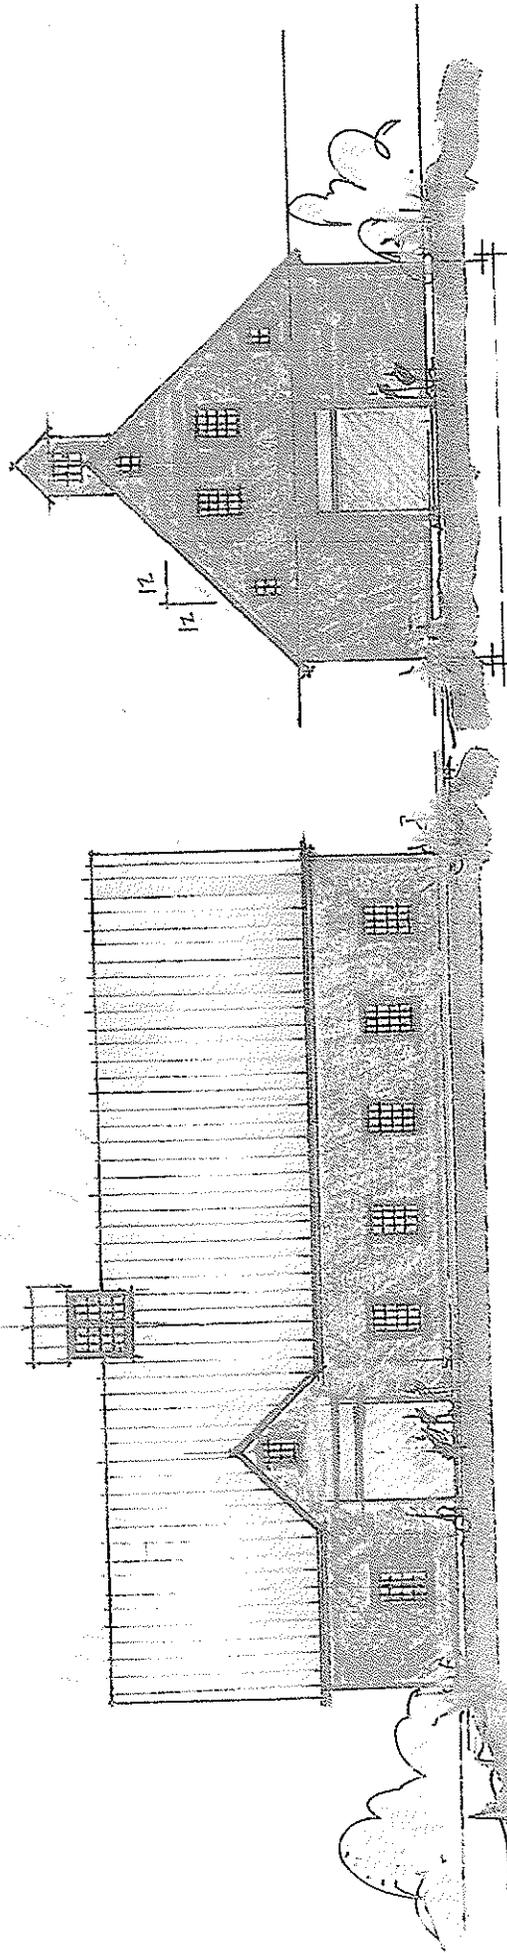
SOUTH ELEVATION

WEST ELEVATION

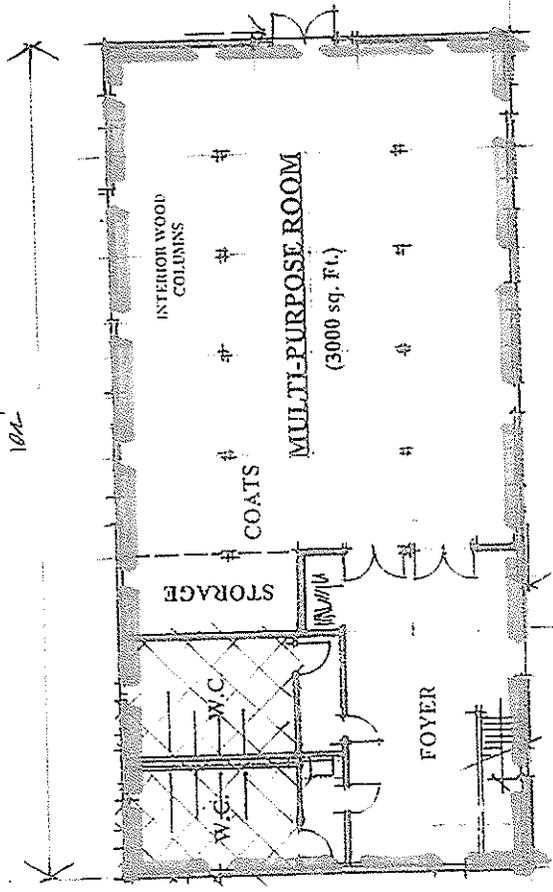
GROUND FLOOR PLAN

- WOOD FRAMED STRUCTURE
- ON SLAB-ON-GRADE
- WOOD WINDOWS
- NATIVE PINE BOARDS

EXISTING GRANITE FOUNDATION
