Wagon Hill, Master and
Management Plan 1995

Master & Management Plan
Wagon Hill Farm
Durham, New Hampshire

Prepared For
Strafford Regional Planning Commission
& the Town of Durham, New Hampshire

August 21, 1995

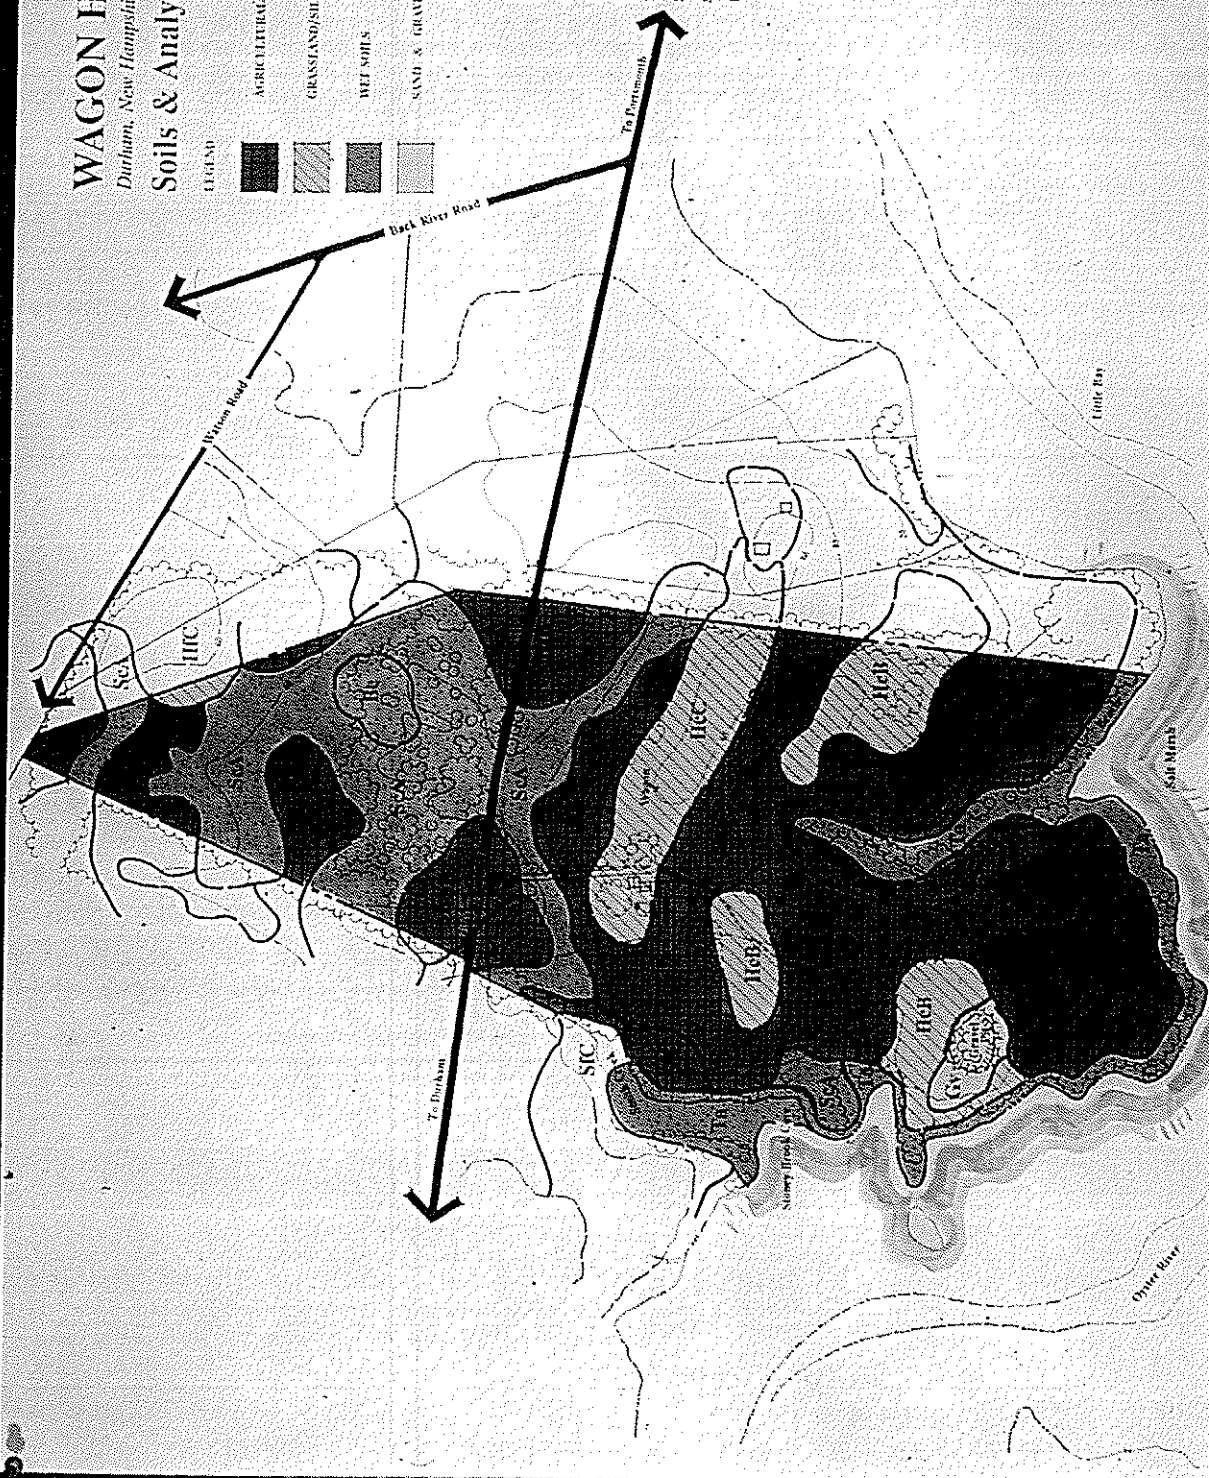
Soil Conservation Service Classification

- Bc - Bluffs and silty clay loam
- Bcb - Bluffs and silty loam
- Gr - Gravel and borrow pit
- Hbc - Heavy-Charleston fine sandy loam, 3 to 8% slopes
- Hbc - Heavy-Charleston fine sandy loam, 8 to 15% slopes
- Hbc - Heavy-Charleston fine sandy loam, 8 to 15% slopes
- Hbc - Heavy-Charleston fine sandy loam, 8 to 15% slopes
- Sa - Scenic till loam, 8 to 15% slopes
- Sic - Surficial till loam, 8 to 15% slopes
- Ta - Tidal marsh

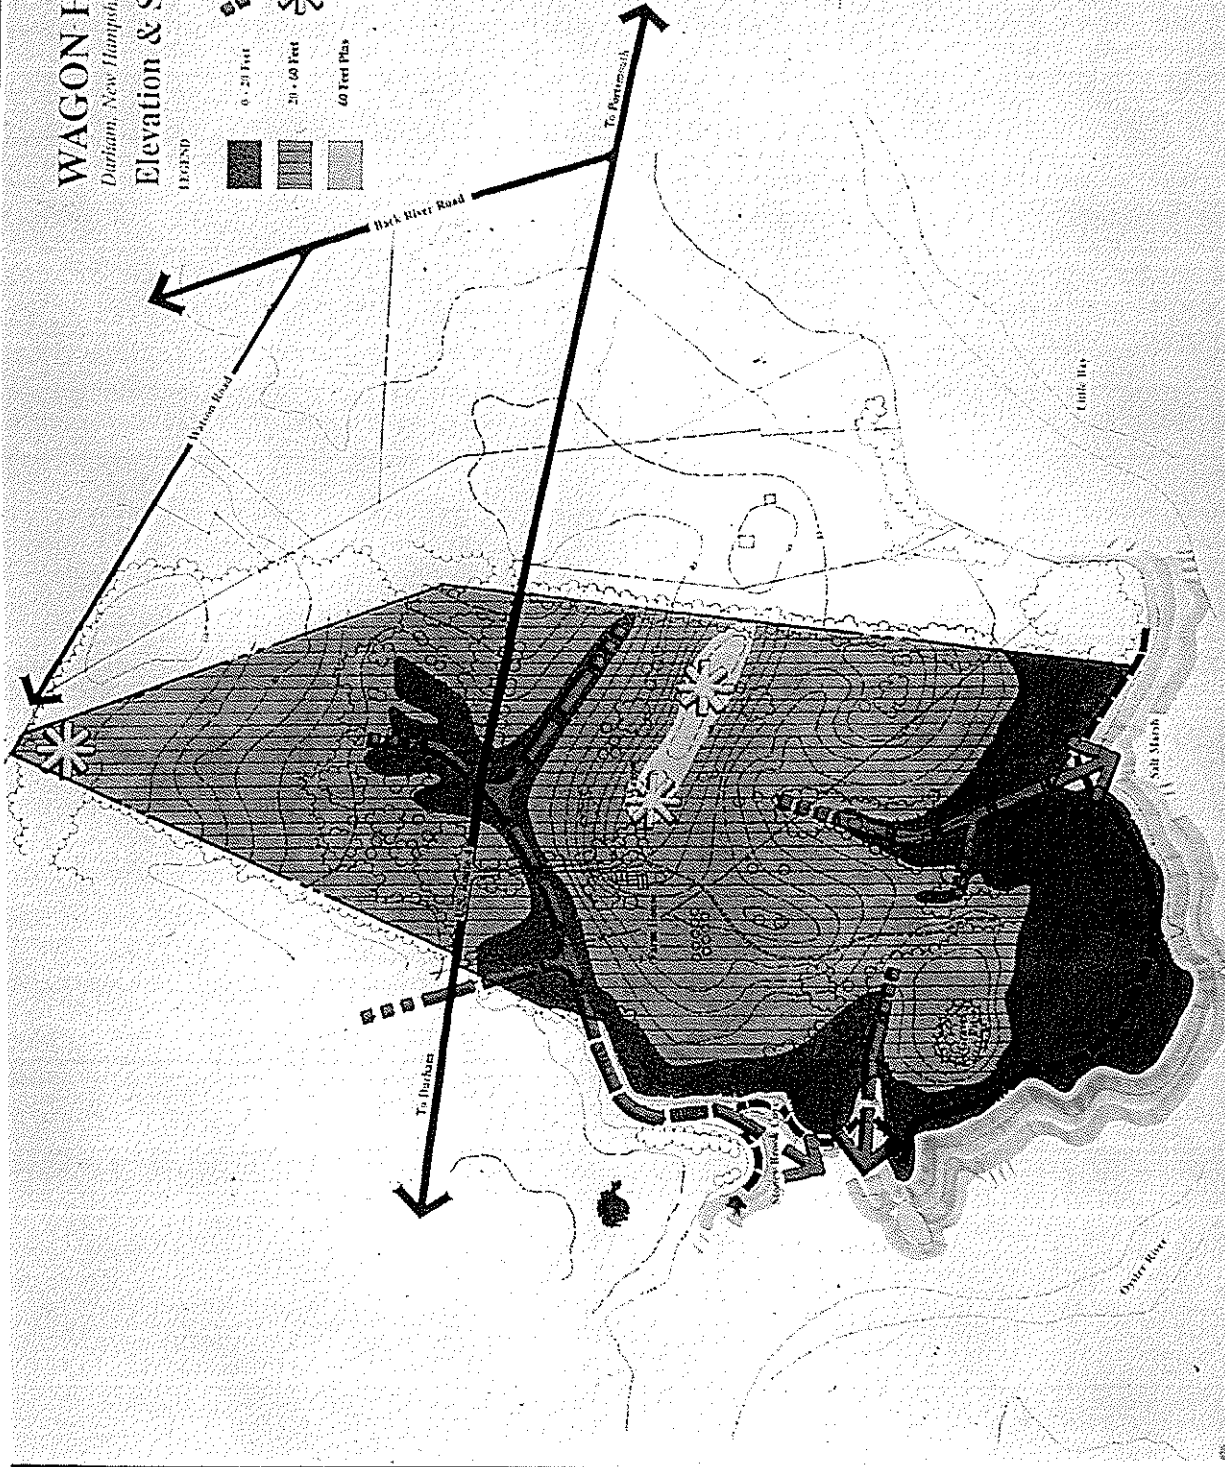
100 Year Flood Line

Note: Check elevations for proposed development. Use the sum of this information to determine the 100 Year Flood Line.

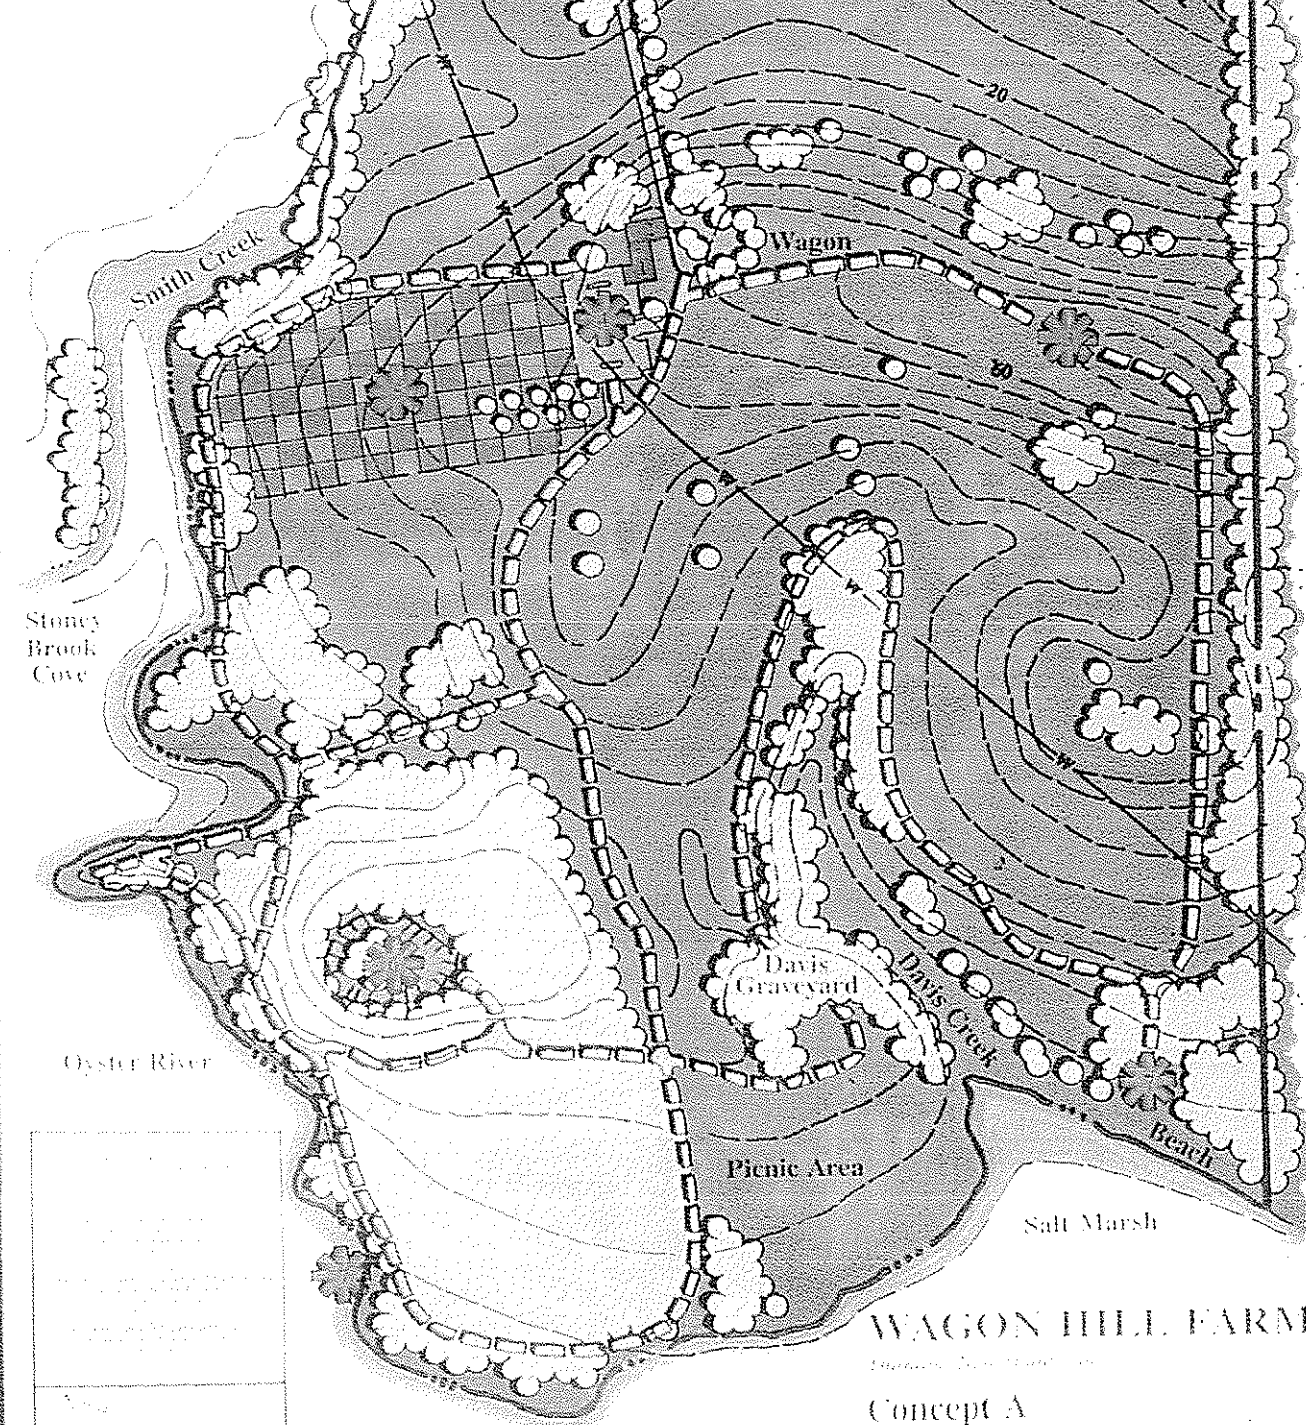
WAGON HILL FARM
 Conservation/ Preservation
 Concept A

1. Existing
 2. Proposed
 3. Contour
 4. U.S. Route 4
 5. Smith Creek
 6. Davis Creek
 7. Stoney Brook Cove
 8. Oyster River
 9. Salt Marsh
 10. Beach
 11. Picnic Area
 12. Davis Graveyard
 13. Wagon Hill

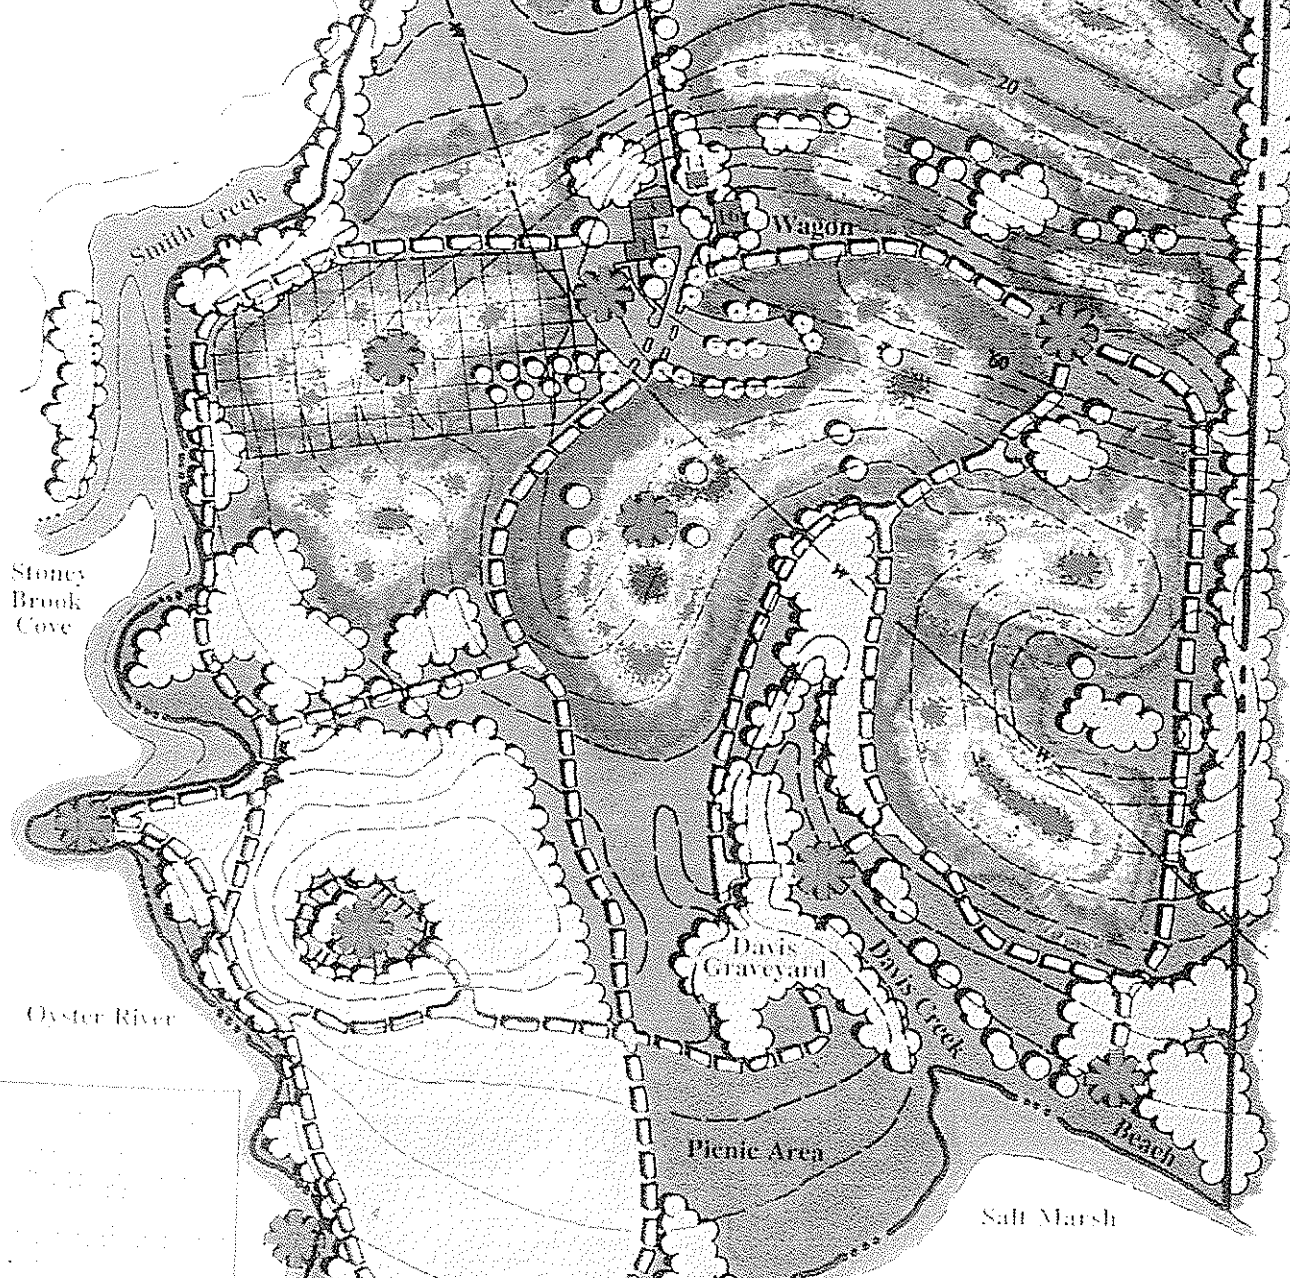
WAGON HILL FARM
 2000 sq. ft. ±
 Concept C
 Wedding Pavilion/ Boathouse

1. The proposed site for the pavilion/boathouse is located on the eastern shore of the Oyster River, adjacent to the Davis Creek and the Salt Marsh. The site is approximately 1.5 acres in size and is bounded by the Oyster River to the west and the Salt Marsh to the east. The site is currently undeveloped and is surrounded by a mix of natural and man-made features.

15. The boat house and/or bathroom facility at the wharf should be looked at closely. The problems of running water, sewer lines, and electricity on a pier can be long-term maintenance issues. The utility lines would be susceptible to freezing or damage from wave and ice conditions under the pier structure. The boathouse may be more suited to an upland location with sufficient room immediately in front for users to work on boats and allow easy transfer of boats in and out of the boathouse. In addition, with the presence of wetland vegetation on the outer portions of the wharf area it is unlikely that construction over that area would be allowed. Cost - \$81,000.00

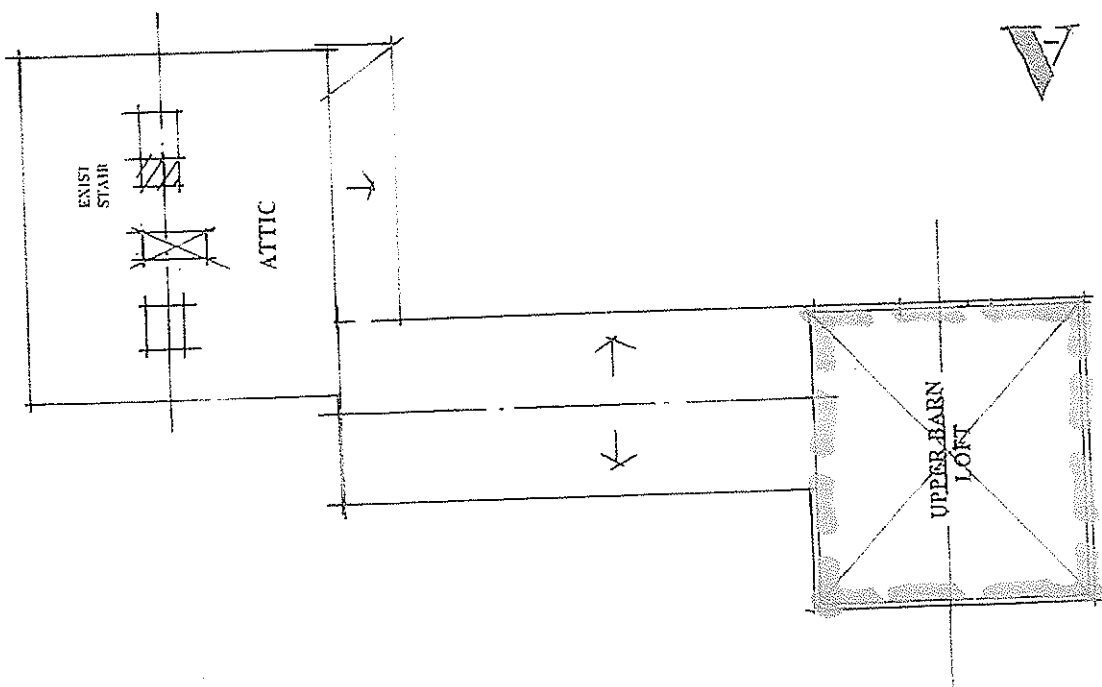
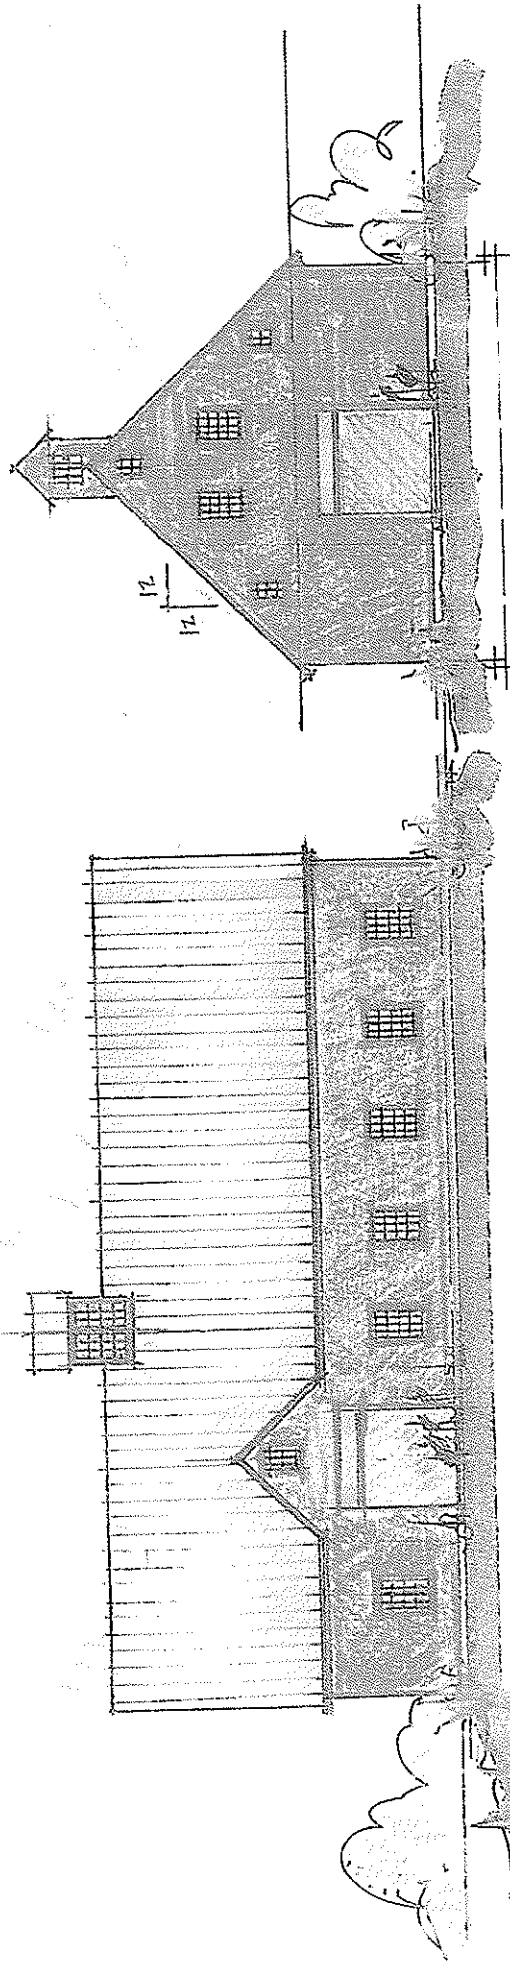
**BICKFORD-CHESLEY HOUSE (CIRCA 1806)
RENOVATIONS**

NEW SLAB, REINFORCE
FOUNDATION WALLS,
RESTORE FLOOR
STRUCTURE (TYP.)

NEW W.C.'S A.D.A.
COMPLIANT

RESTORE
PLAZZA

NEW STAIR TO
APARTMENT

TENANT ENTRY
@ FRONT DOOR

**APARTMENT @ 2ND
FLOOR**

SOUTH ELEVATION

WEST ELEVATION

GROUND FLOOR PLAN

MECH/FUEL ROOM @ BASEMENT (28 X 36)

EXISTING GRANITE FOUNDATION

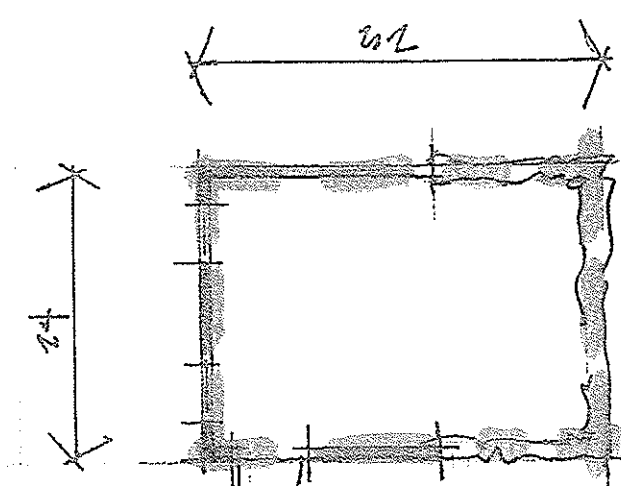
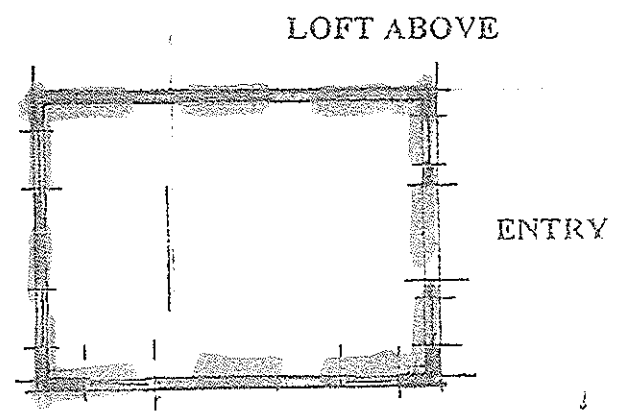
**CIDER MILL
RECONSTRUCTION**

LOWER LEVEL

ENTRY

UPPER LEVEL

The Cider Mill would be reconstructed to provide retail and storage space for the Wildflower Farm program. This phase introduces larger numbers of visitors to the site. A construction of a dairy barn with gable ends facing the road would restore the missing sense of enclosure to the barn yard. The conference center-barn would seat 400 people.

New Cider Mill at existing Stone Foundation 1920 sf x \$80/sf	153,600
New Conference Barn 6768 sf x \$100/sf	676,800
