Durham Falls Bridge
Spanning the Oyster River on State Route #108,
.2 miles southeast of the intersection with
Main Street
Durham
Strafford County
New Hampshire

HAER No. NH-15

Durham Falls Bridge

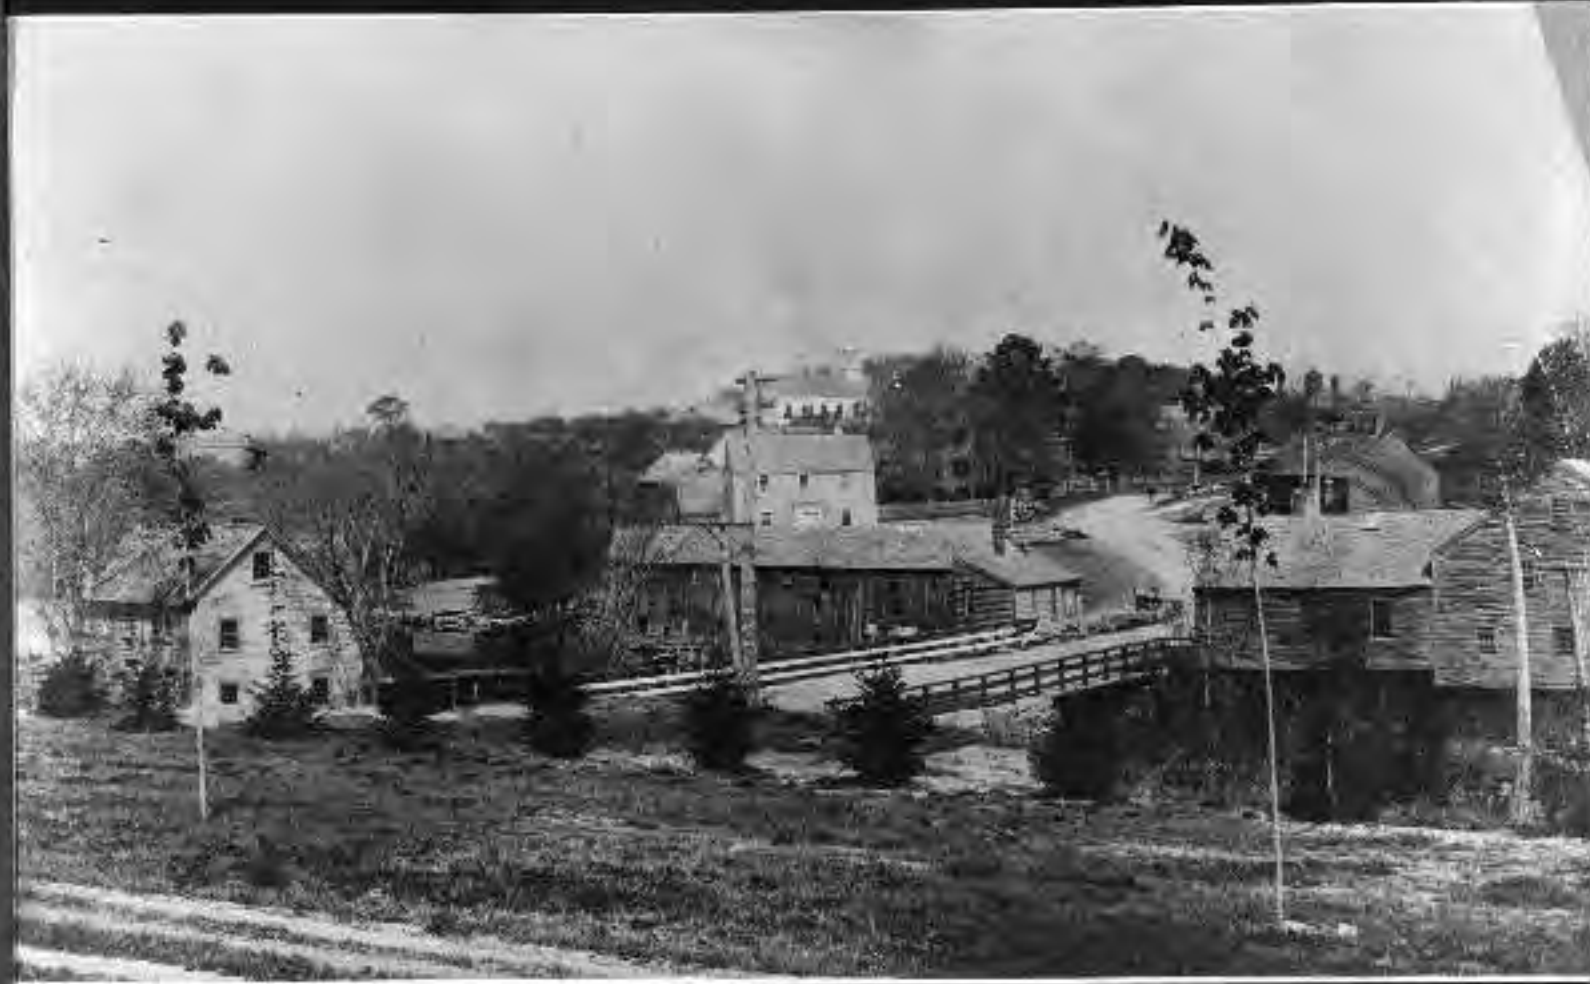
- NH-15-24 LONG VIEW OF WOODEN RAILINGS ON BRIDGE, LOOKING NORTHWEST,
c. 1897
- NH-15-25 VIEW OF WOODEN RAILINGS, FROST'S STORE, LOOKING WEST, c. 1897
- NH-15-26 LONG VIEW OF 1894 BRIDGE AND FROST'S STORE, LOOKING WEST, c. 1897
- NH-15-27 LONG VIEW, SHOWING UNPAVED ROAD, LOOKING SOUTHEAST FROM TOWN
CENTER, c. 1910
- NH-15-28 DETAIL VIEW OF COBBLESTONE PARAPETS, LOOKING SOUTHEAST, c. 1910
- NH-15-29 VIEW OF DAM AND MILL, LOOKING EAST, c. 1910
- NH-15-30 VIEW OF RETAINING WALLS AT "THE LANDING", LOOKING SOUTH, c. 1910
- NH-15-31 VIEW OF NORTH APPROAGH, LOOKING SOUTH, c. 1910
- NH-15-32 VIEW OF EAST ELEVATION, SHOWING COBBLESTONE PARAPET/LATTICE RAIL,
LOOKING WEST THROUGH BRIDGE, c. 1940
