# Mill Pond Dam

## Visual Inspection Report

Durham, New Hampshire

Dam #071.03

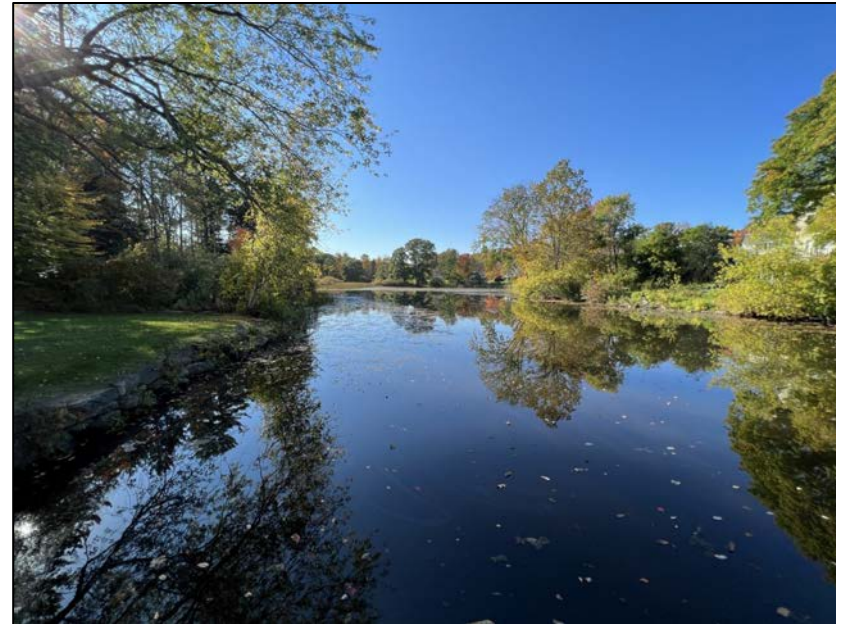
Photo No. 55.: Overview of the Reservoir.
