**Re: Concrete Evaluation Report  
Oyster River (aka Mill Pond) Dam #071.03  
Durham, New Hampshire  
SA Project No. 075-07-003**

**CONCRETE EVALUATION REPORT  
OYSTER RIVER DAM #071.03  
aka Mill Pond Dam, aka Durham Falls Dam  
DURHAM, NEW HAMPSHIRE  
SA PROJECT NO. 075-07-003  
MARCH 31, 2010**

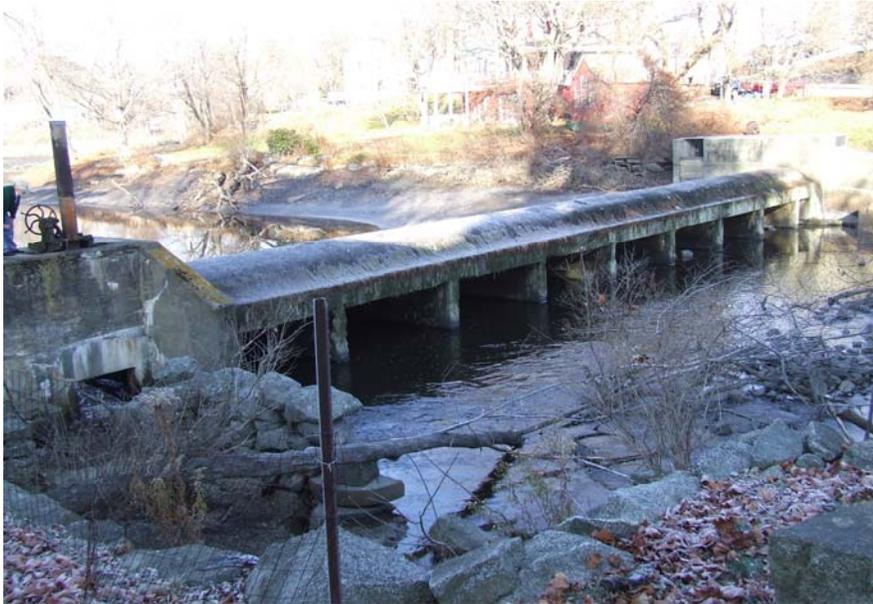
Photo Number: 2

Description: Downstream face of spillway.

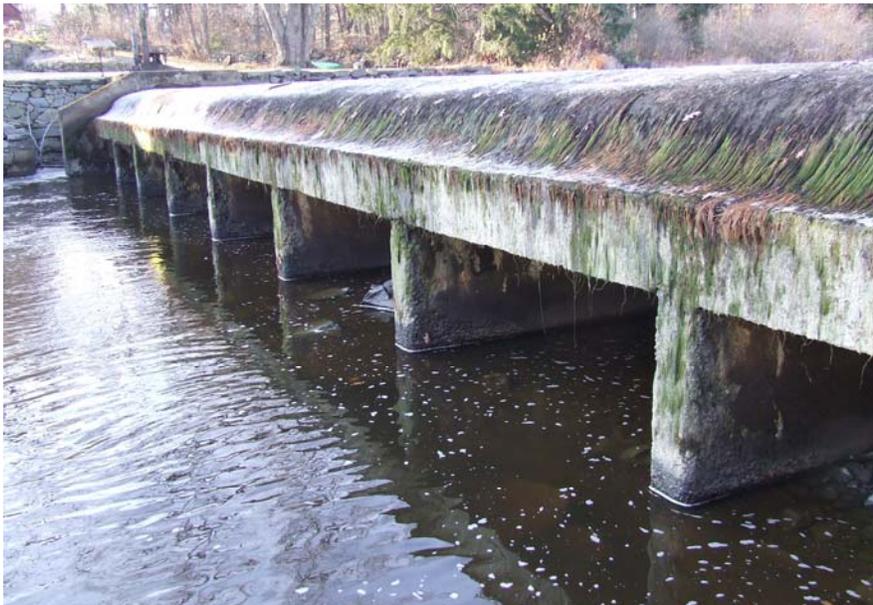
**Photo Number: 3**

**Description:** Upstream face of spillway.

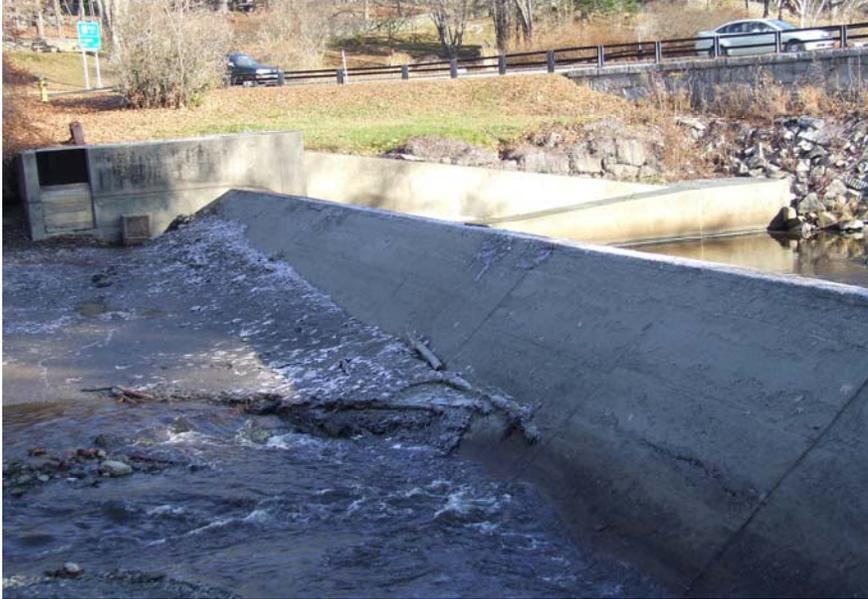
**Photo Number: 4**

**Description:** Upstream face of spillway.

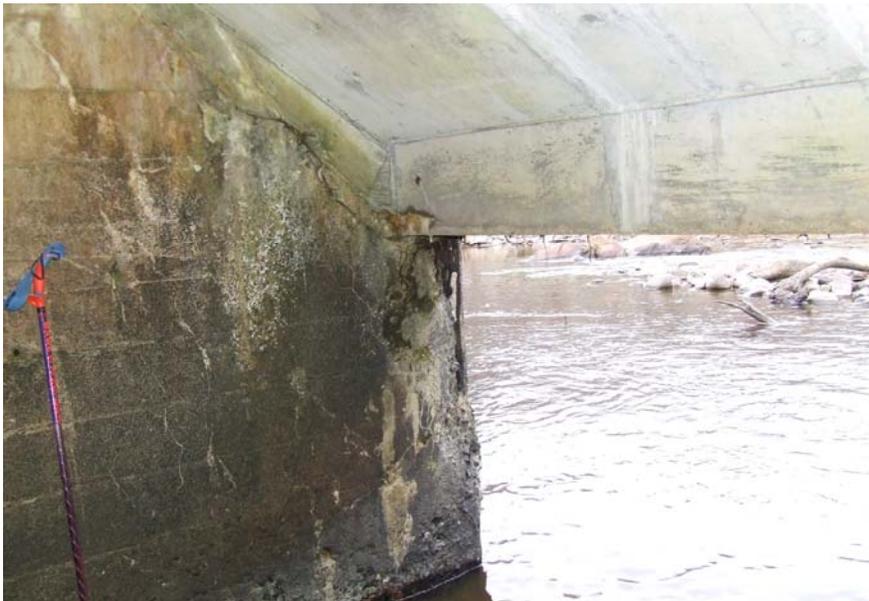
Photo Number: **12**

Description: Crack and delamination at joint between rib and ceiling slab in Cell 7.

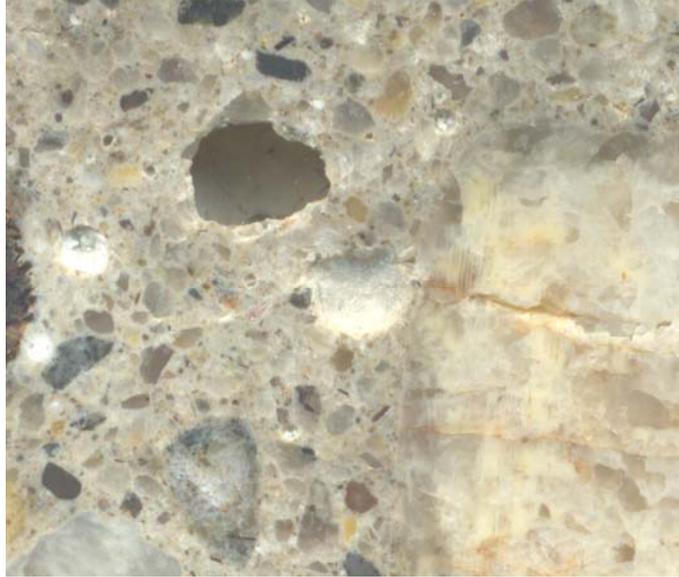
interface. This layer was poorly compacted as shown by the voids at the old interface as well as in the matrix of the layer. Several other voids containing the white powder are shown on the close up view of section E in Figure 7. These voids appear to be interconnected by a crack that initiated in the aggregate particle on the right side of figure 7.

Figure 7 Section E close up of Figure 4 core #5

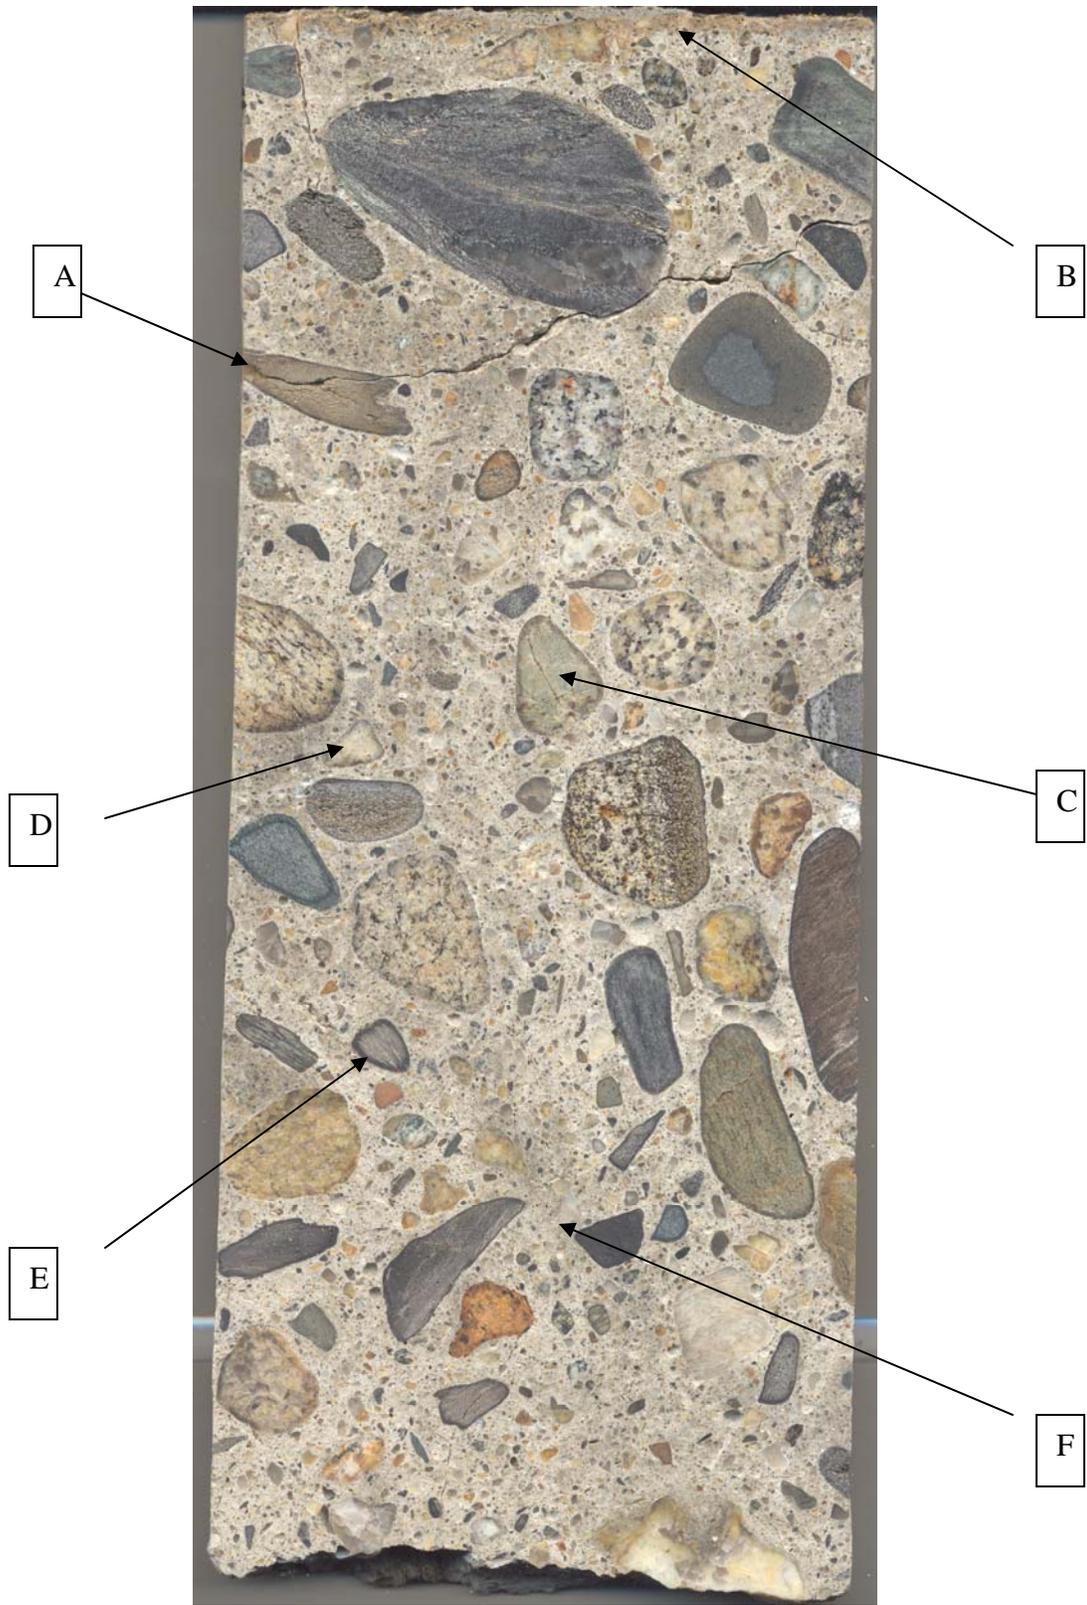
Core # 9 obtained horizontally from the rib is shown on Figure 14. This concrete appears more uniform because the core was taken horizontally. If the core was obtained vertically as the previous cores then it would be expected that several placements would be viewed showing variable mixes. Overall this concrete shows cracking and reaction rims as the previous original concrete. Figure 5 shows a close up of section A with cracking within the aggregate particle as well as around it. Figure 14 shows a crack radiating up towards the surface of the concrete originating from an aggregate particle that has expanded as shown in the close up view in Figure 16. Another aggregate particle that has expanded is shown in Figure 17, a close up view of section C. This aggregate is severely cracked due to internal expansion. Reaction rims are also visible on the outside surface of the aggregate. The aggregate particle of section D, shown in Figure 18 has micro cracks. The interface of the aggregate and the paste also shows cracking. The flat like dark line near the right top side of the aggregate particle is a sliver of mica. These small slivers are randomly dispersed throughout the concrete and most likely came from the very weak granite particles that degraded during the mixing and placement of the concrete. A severely cracked aggregate particle is shown in the close up view of section E in Figure 19. This aggregate particle also has a very dark reaction rim. An advanced crack matrix is shown in the close up view of section F of Figure 20.

Figure 14 Polished section of Core # 9

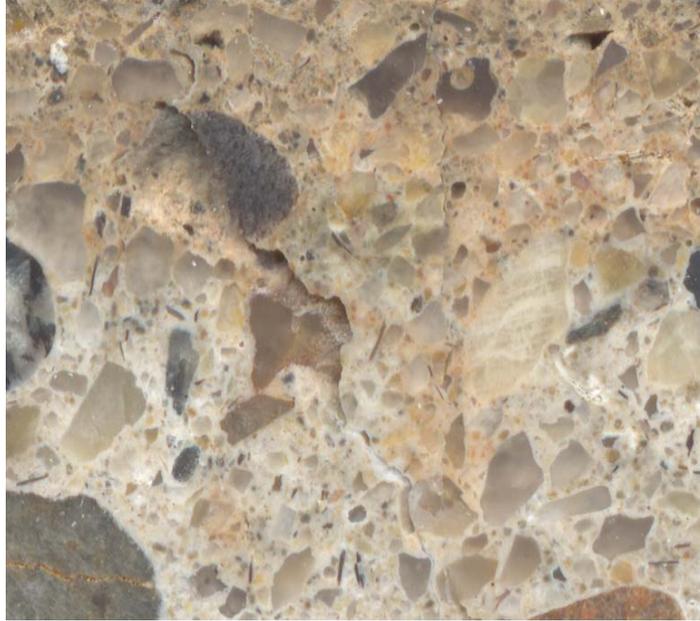
The polished sample of Core # 12 taken from the downstream face of the right abutment is shown on Figure 21. Many of the aggregate particles have reaction rims as noted in the previous polished sections. Section A shows a highly carbonated area with significant cracking. The polished sample shows massive cracking as noted by the arrows radiating from box B. Extreme swelling of the aggregate is noted by the large gap shown in the aggregate particle in the close up of section C in Figure 23. The area of paste to the left of the particle shows a very large crack, the same width as the aggregate crack, which has filled in with a reaction product. Cracking through and around aggregate particles is shown in the close up view of section D in

Figure 22 Section A of Figure 21 core #12

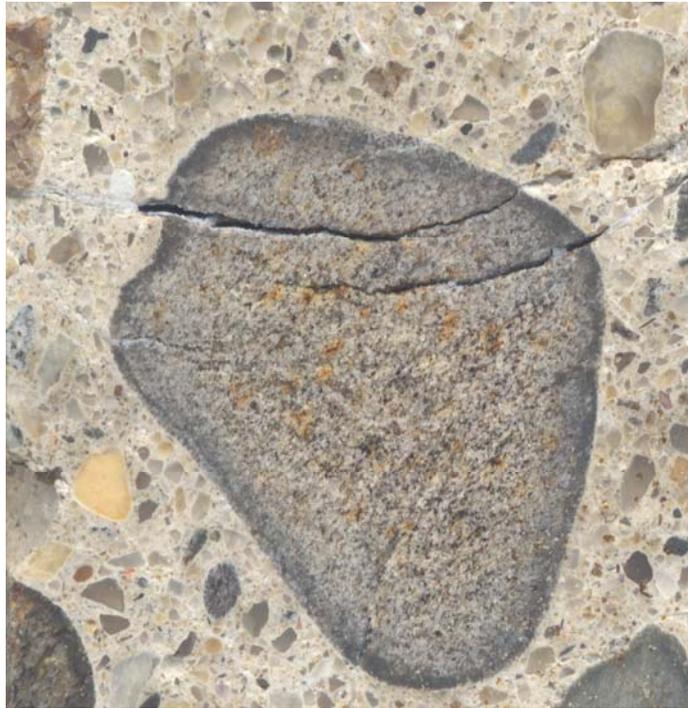
Figure 23 Section C of Figure 21 core #12

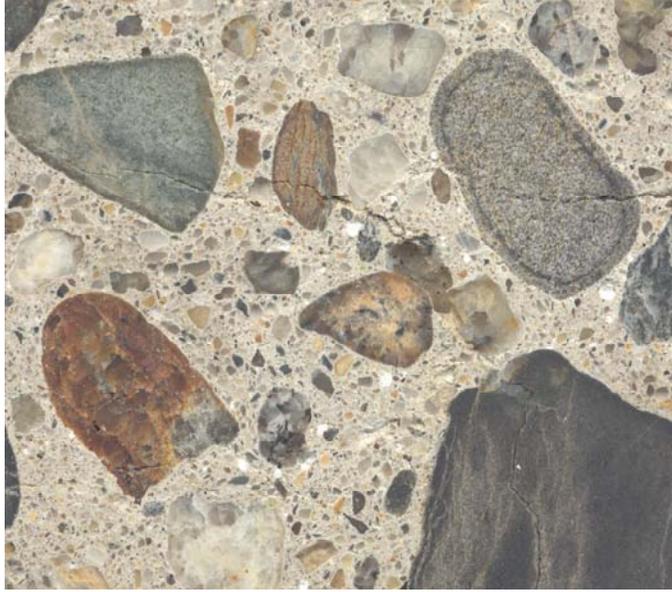
Figure 24. Several aggregate particles in this view also show reaction rims. This concrete has undergone significant expansion.

Figure 24 Section D of Figure 21 core #12

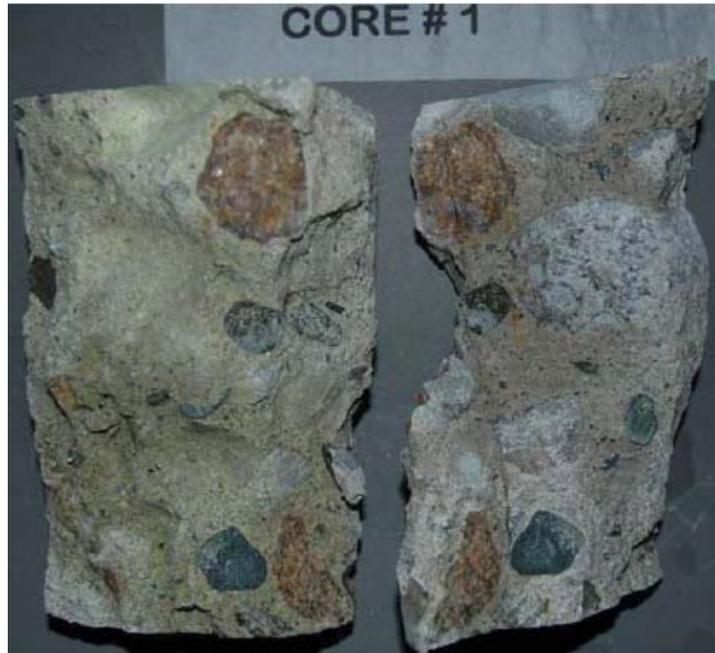
Core # 1 shown in Figure 25 definitely has signs of ASR as noted by the greenish glow under the UV light source. The concrete placed during the 1974 rehabilitation is shown in Figure 26 and 27. Although not significant, several of the aggregate particles definitely show signs of ASR in the repair concrete. The original concrete definitely shows significant signs of ASR as noted by Core # 8 of Figure 28.

Figure 25 Core #1 compression sample treated with Uranyl acetate dihydrate (left side) under normal light (top) and ultra violet light (bottom)

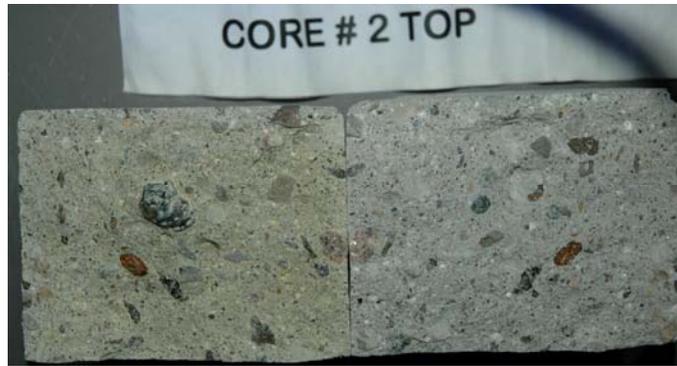
Figure 26 Core #2 tensile sample treated with Uranyl acetate dihydrate (left side) under normal light (top) and ultra violet light (bottom)

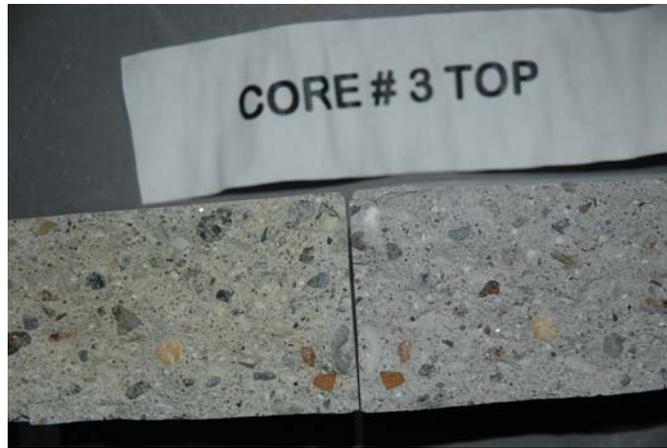
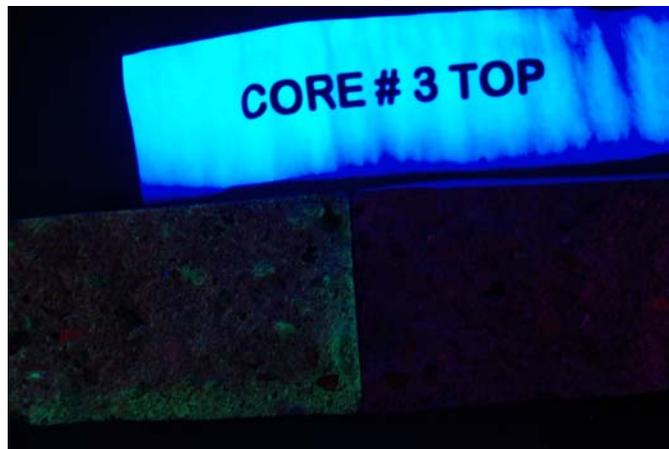
Figure 27 Core #3 Top tensile sample treated with Uranyl acetate dihydrate (left side) under normal light (top) and ultra violet light (bottom)

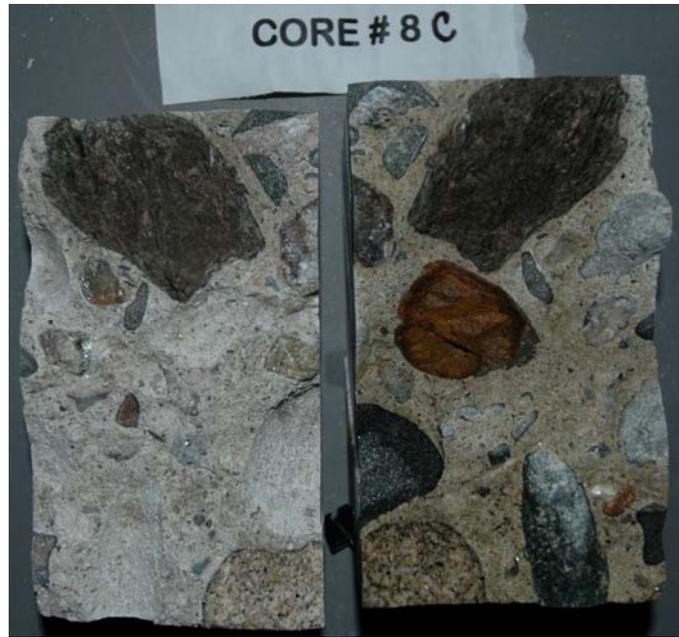
Figure 28 Core # 8C tensile sample treated with Uranyl acetate dihydrate (right side) under normal light (top) and ultra violet light (bottom)
